## Setup photos for HAC RF Emissions and T-Coil Test Report

| Test report no.: | HAC_Photo_RM-1078_03 | Date of report: | 2014-08-28 |
| Tested devices: | RM-1078 | | |
| Testing has been carried out in accordance with: | <b>ANSI C63.19-2011</b><br>American National Standard for Methods of Measurement of Compatibility between Wireless Communications Devices and Hearing Aids | | |

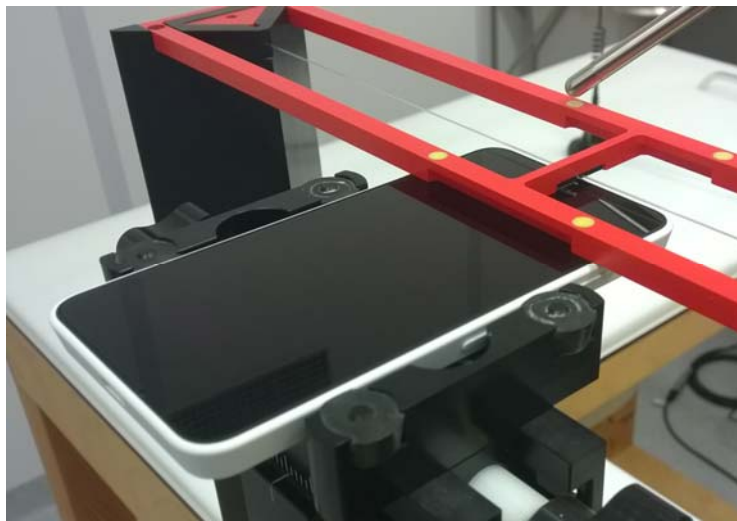
The device was positioned such that Device Reference plane was touching the bottom of the Test Arch. The scan is centered at the acoustic output by aligning the acoustic output with the intersection of the Test Arch's middle bar and dielectric wire.

Photo of the device positioned under Test Arch
