## Setup photos for HAC RF Emissions and T-Coil Test Report

Test report no.:	HAC_Photo_RM-717_03		Date of report:	2010-09-16			
Template version:	3.0		Number of pages:	3			
Testing laboratory:	TCC Nokia Salo Laboratory P.O.Box 86 Joensuunkatu 7H / Kiila 1B FIN-24101 SALO, FINLAND Tel. +358 (0) 7180 08000 Fax. +358 (0) 7180 45220		Client:	Nokia Corporation Beijing Economic and Technological Development Area No.5 Donghuan Zhonglu Beijing PRC China 100176 Tel. +86 10 8711 8888 Fax. +86 10 8711 4550			
Responsible test engineer:	Heikki Haloila	Product contact person:		Qiu Rain			
Measurements made by:	Heikki Haloila						
Tested devices:	RM-717						
FCC ID:	QTLRM-717	IC: 661AB-RM717					
Supplement reports:	RF_RM-717_01, T-Coil_RM-717_02						
Testing has been carried out in accordance with:	<b>ANSI C63.19-2007</b> American National Standard for Methods of Measurement of Compatibility between Wireless Communications Devices and Hearing Aids						
Documentation:	The documentation of the testing performed on the tested devices is archived for 15 years at TCC Nokia.

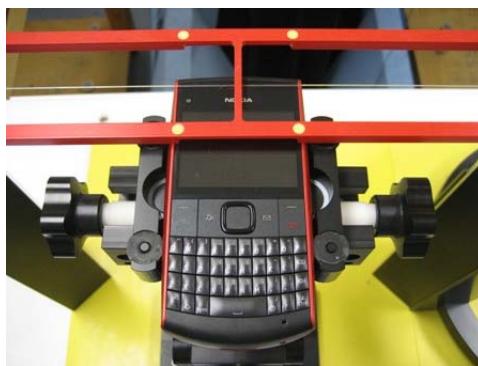
The device was positioned such that Device Reference plane was touching the bottom of the Test Arch. The scan is centered at the acoustic output by aligning the acoustic output with the intersection of the Test Arch's middle bar and dielectric wire.

Photo of the device positioned under Test Arch
