## Setup photos for HAC RF Emissions and T-Coil Test Report

<b>Test report no.:</b>	HAC_Photo_RM-917_03	<b>Date of report:</b>	2013-02-20
<b>Template version:</b>	3.0	<b>Number of pages:</b>	3
<b>Testing laboratory:</b>	TCC Nokia Salo Laboratory P.O.Box 86 Joensuunkatu 7H / Kiila 1B FIN-24101 SALO, FINLAND Tel. +358 (0) 7180 08000 Fax. +358 (0) 7180 45220	<b>Client:</b>	Nokia Corporation Beijing Economic and Technological Development Area No.5 Donghuan Zhonglu Beijing PRC China 100176 Tel. +86 10 8711 8888 Fax. +86 10 8711 4550
<b>Responsible test engineer:</b>	Janne Hirsimäki	<b>Product contact person:</b>	Helen Hu
<b>Measurements made by:</b>	Juha-Matti Varjonen		
<b>Tested devices:</b>	RM-917		
<b>FCC ID:</b>	QTLRM-917	<b>IC:</b>	-
<b>Supplement reports:</b>	RF_RM-917_01, T-Coil_RM-917_02		
<b>Testing has been carried out in accordance with:</b>	<p><b>ANSI C63.19-2007</b> American National Standard for Methods of Measurement of Compatibility between Wireless Communications Devices and Hearing Aids</p>

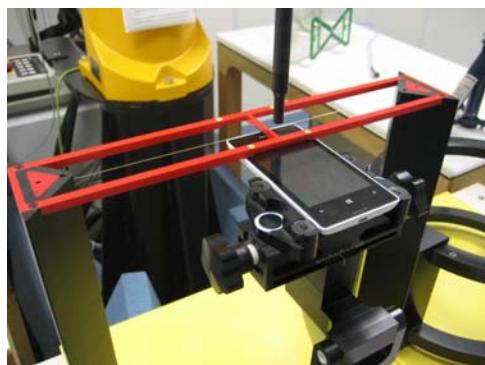
The device was positioned such that Device Reference plane was touching the bottom of the Test Arch. The scan is centered at the acoustic output by aligning the acoustic output with the intersection of the Test Arch's middle bar and dielectric wire.

Photo of the device positioned under Test Arch
