Figure 1 –
Overall internal
view of EUT -
PWR-08-03
with metal
shielding
removed

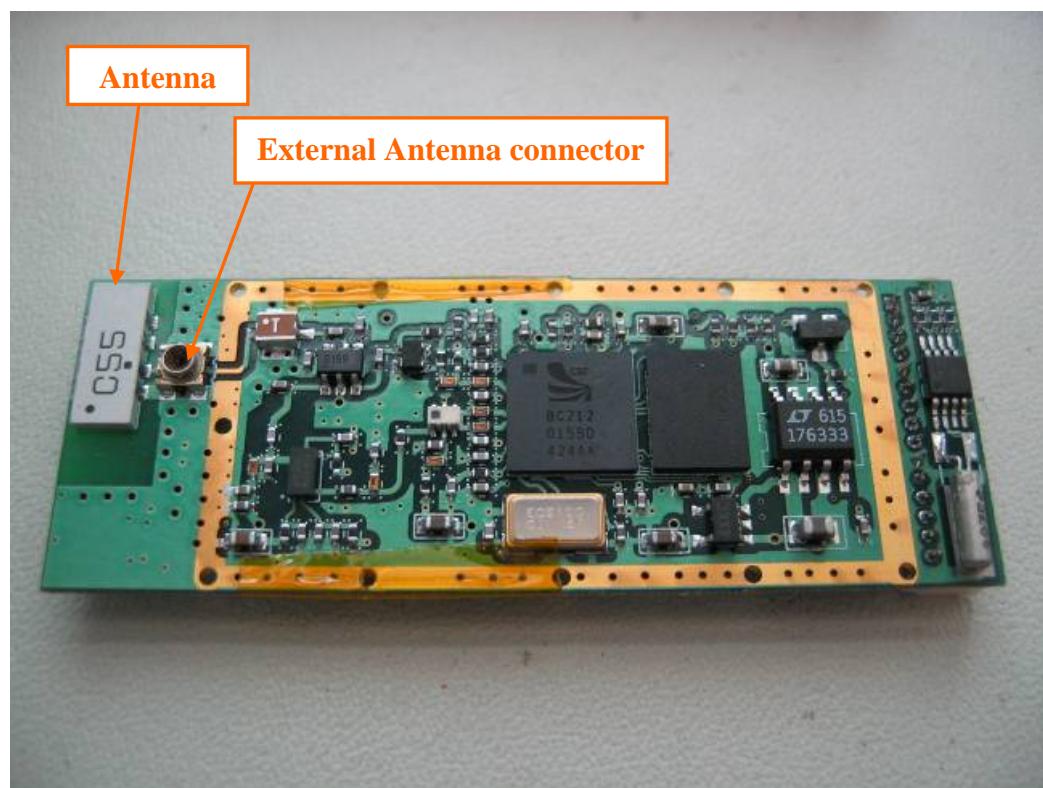
Note: This was
the model of
device tested

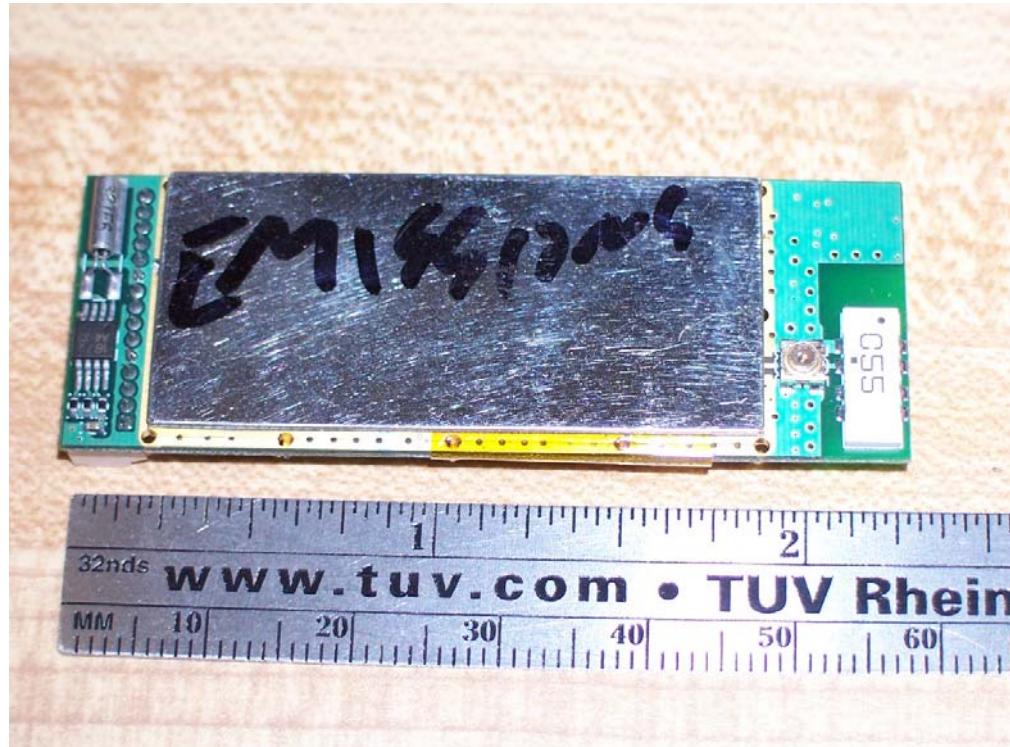
Figure 2 –
Overall internal
view of
PWR-08-03 with
metal shielding

1. This was the model of device tested
2. The RF connector is normally not installed. It was installed in the test sample to allow direct measurements of the transmitter.

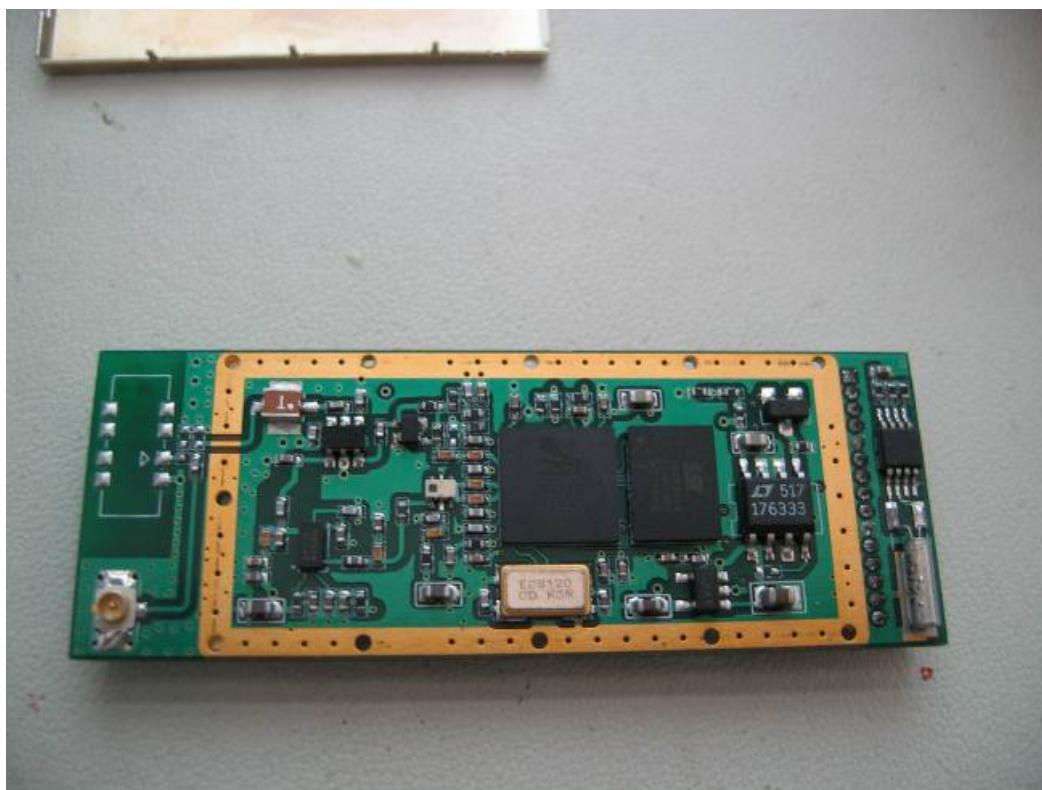
Figure 3 –
Overall internal
view of
PWR-08-01/02
(Identical layout
for both) with
metal shielding
removed

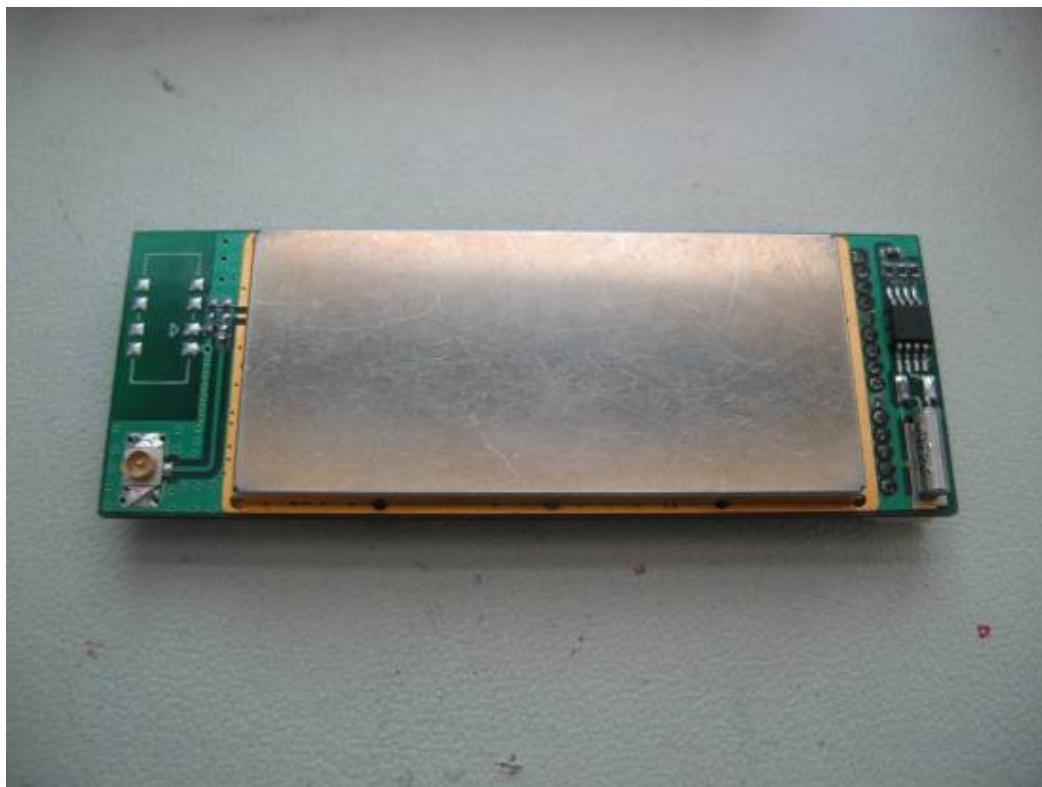
Figure 4 –
Overall internal
view of
PWR-08-01/02
(Identical layout
for both) with
metal shielding

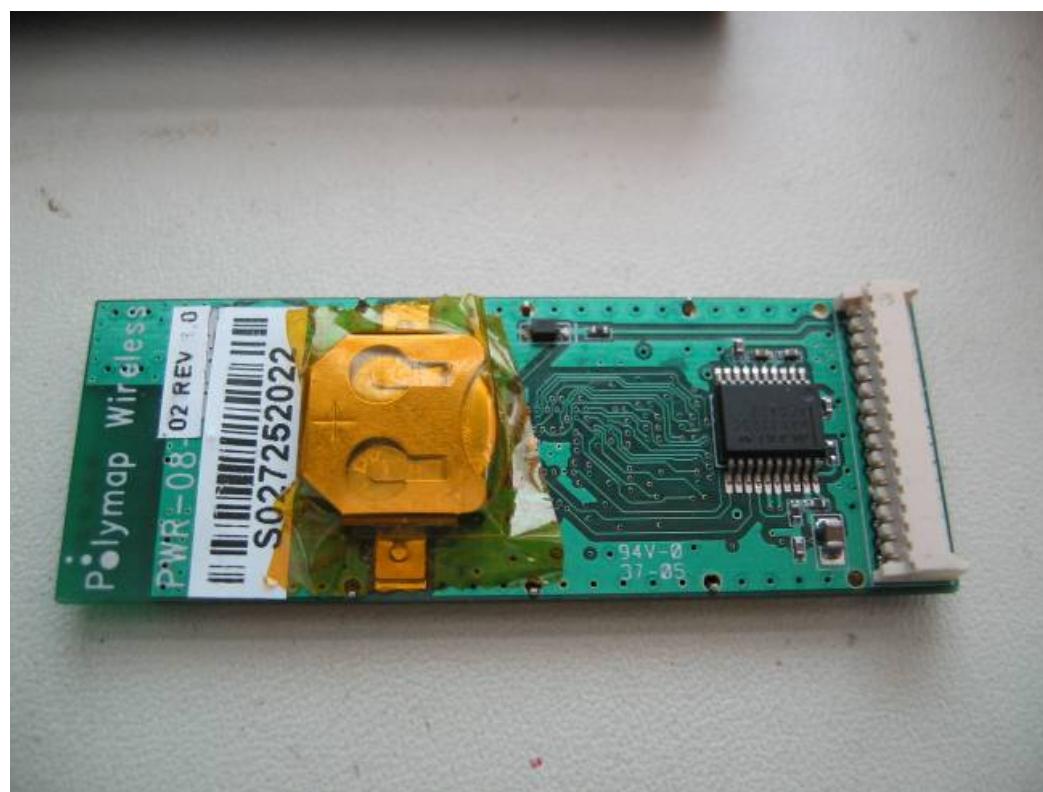
Figure 5 – View of
PWR-08-01/-02
(Identical layout
for both models)

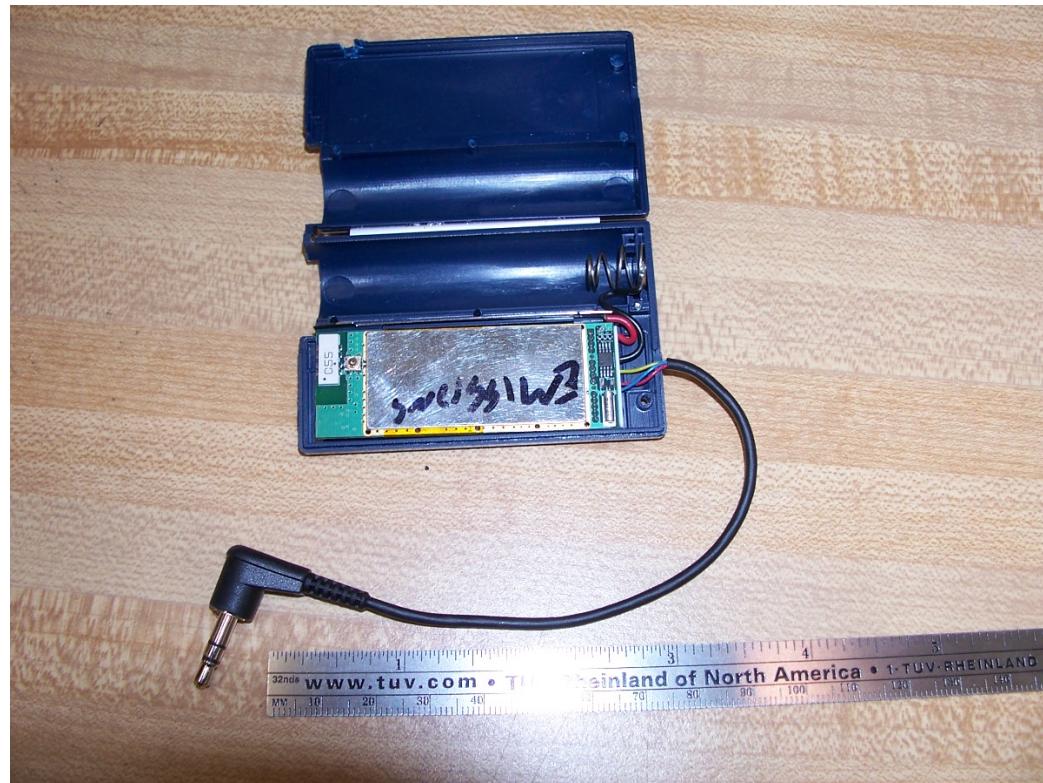
Figure 6 –
Internal view of
PWR-08-03 w/
connector to
connect to
glucose meter.

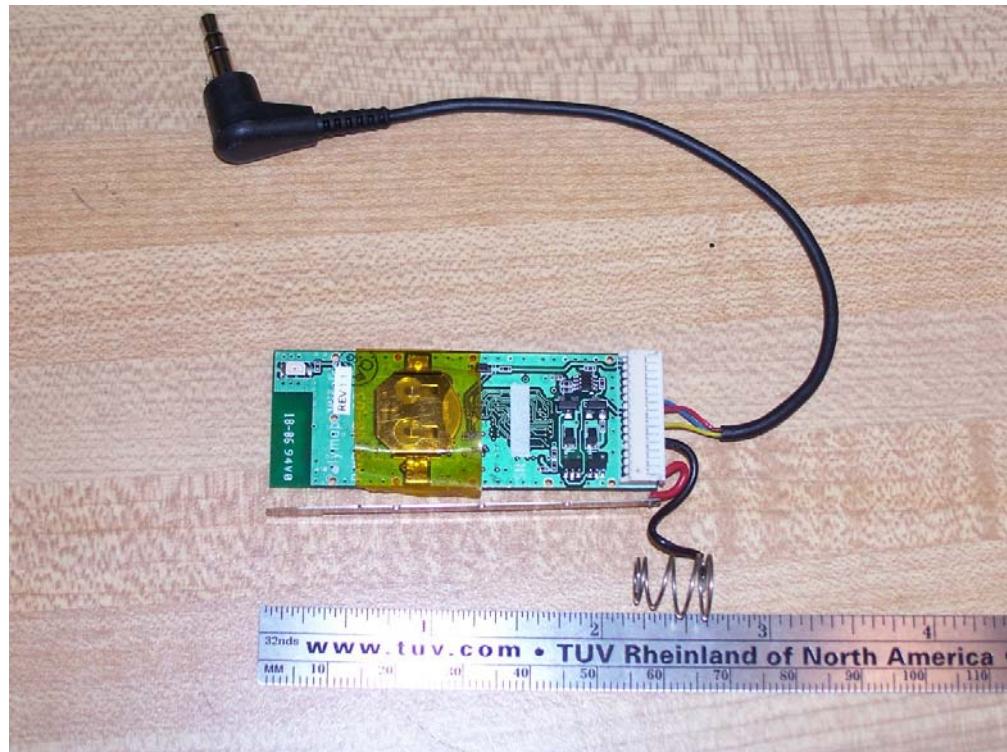
Figure 7 –
Internal view of
PWR-08-03
with battery
connections and
data connections
to connect to
glucose meter.

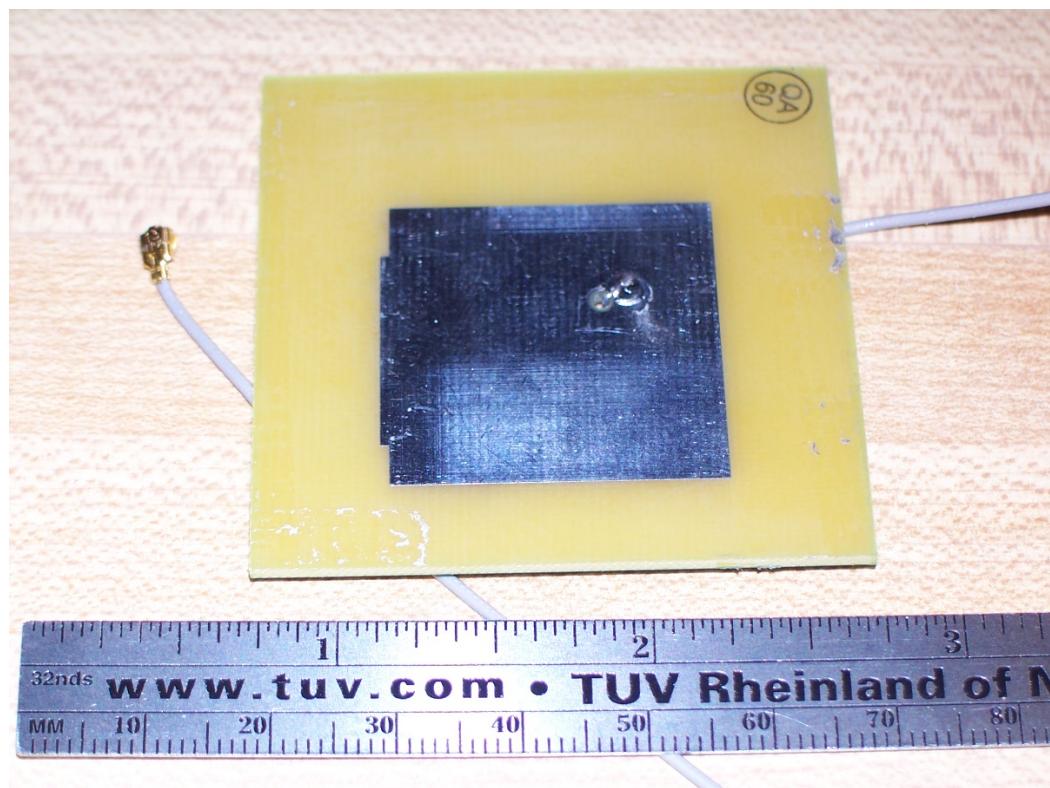
Figure 8 – View of
external patch
antenna for
specific
application(s)
