**Prüfbericht - Nr.: 16005509 001**  
Test Report No.:

## 6 Photographs of the Test Set-Up

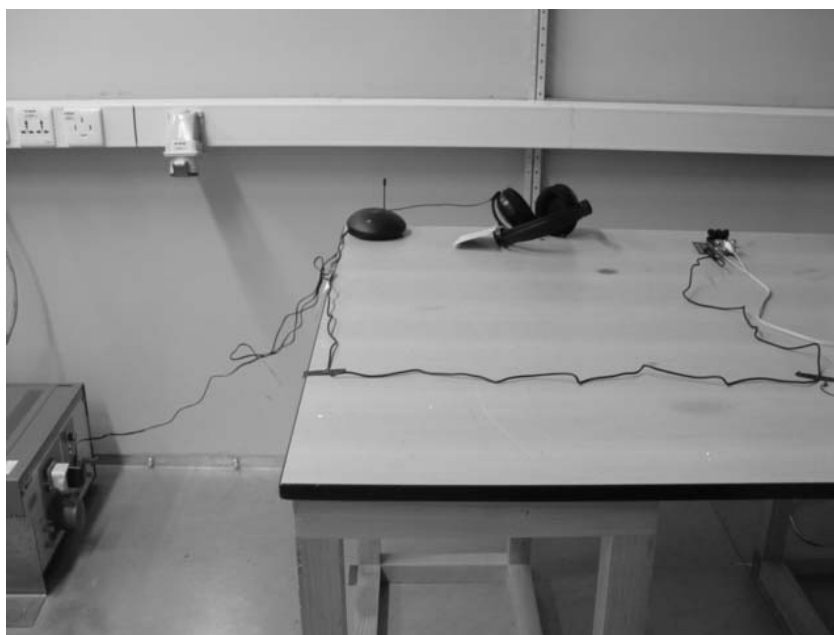
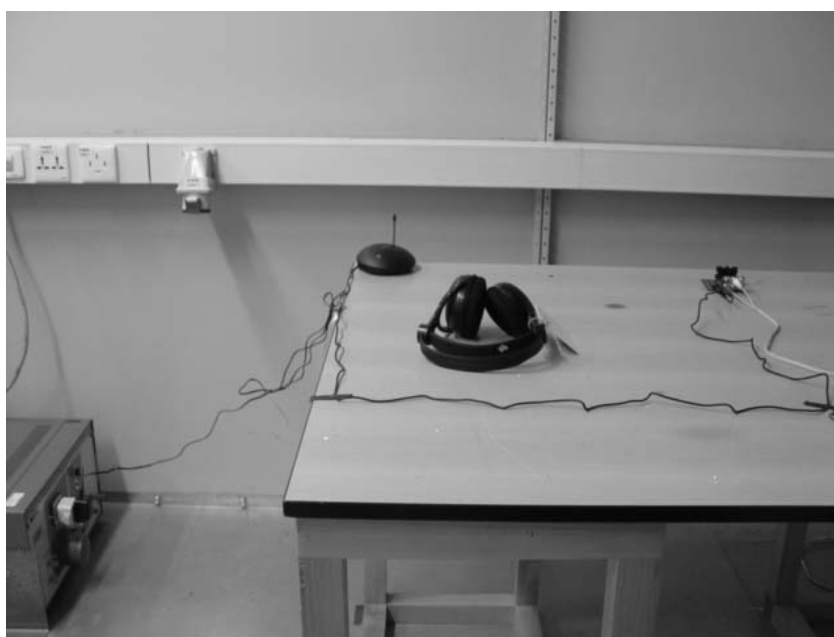
**Photograph 1: Set-up for Conducted Emission on AC Mains**

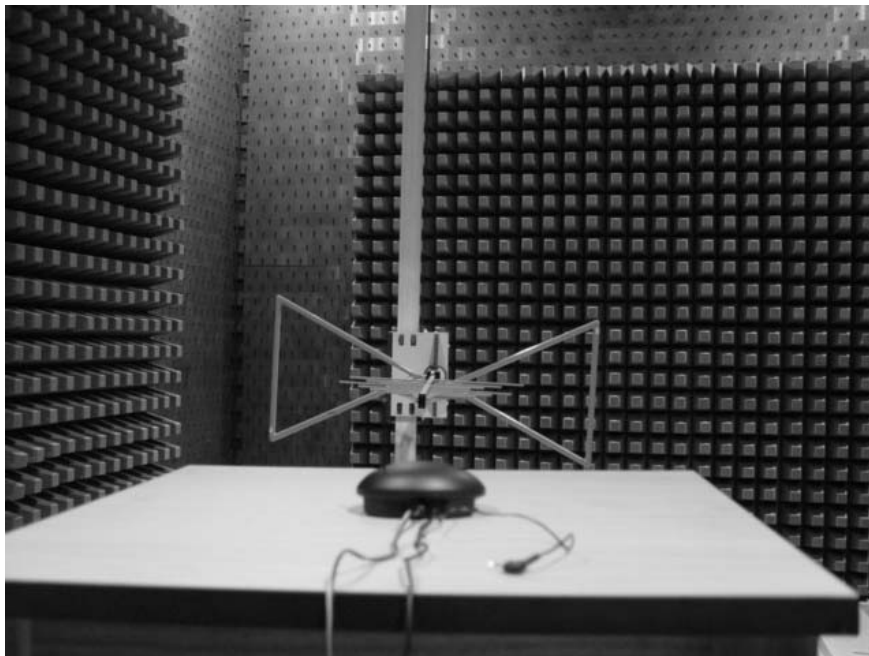
**Photograph 2: Set-up for Radiation Measurement Below 1GHz**

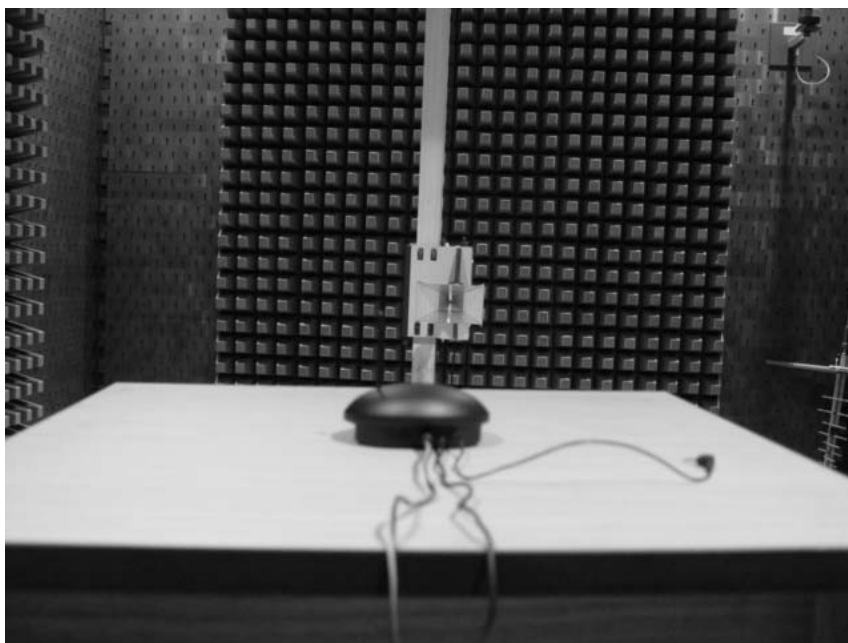
**Photograph 3: Set-up for Radiation Measurement Above 1GHz**
