**Prüfbericht - Nr.: 16005847 001**  
Test Report No.:

## 6 Photographs of the Test Set-Up

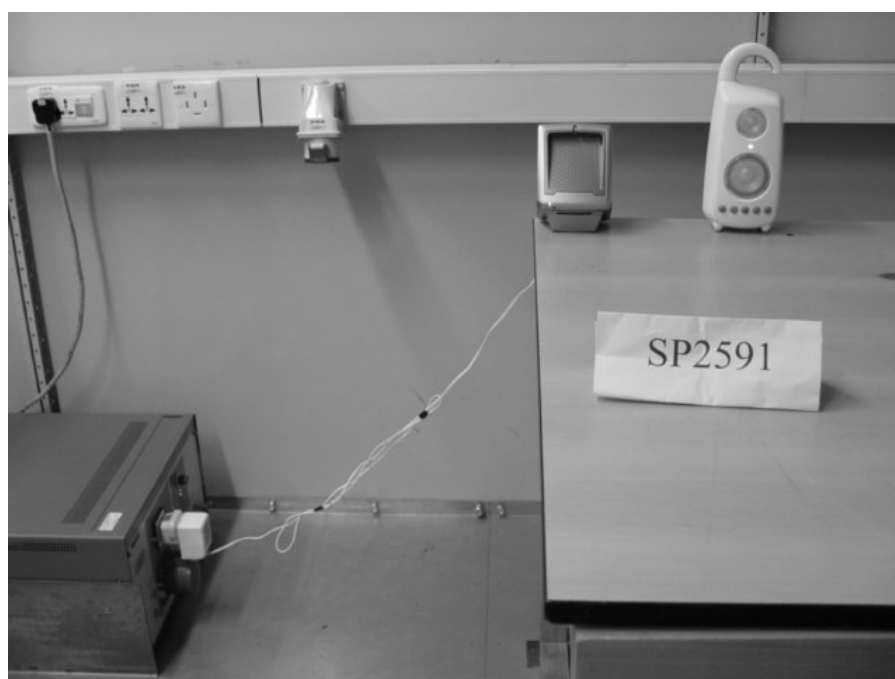
**Photograph 1: Set-up for Conducted Emission on AC Mains**

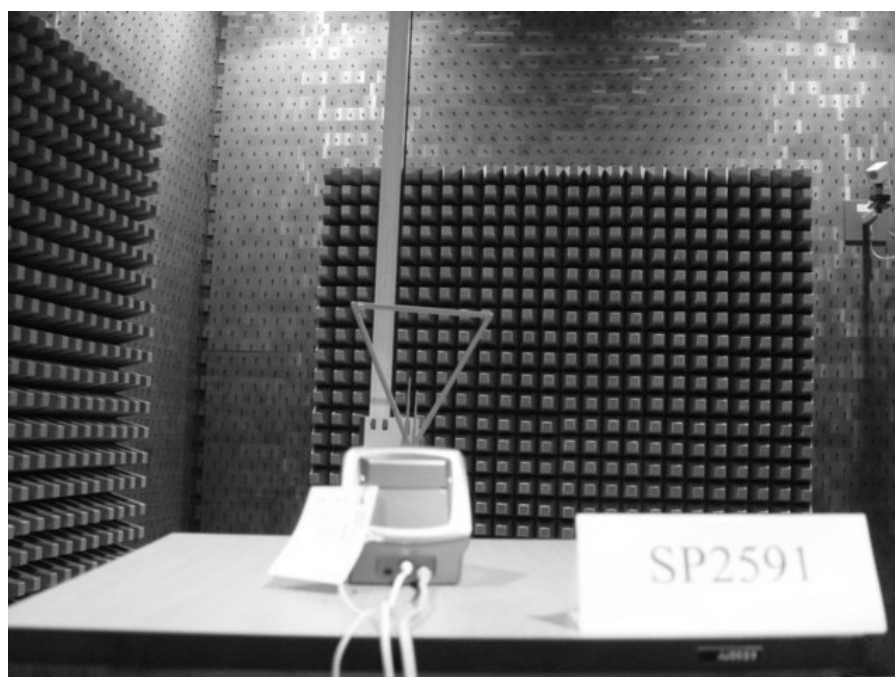
**Photograph 2: Set-up for Radiation Measurement Below 1GHz**

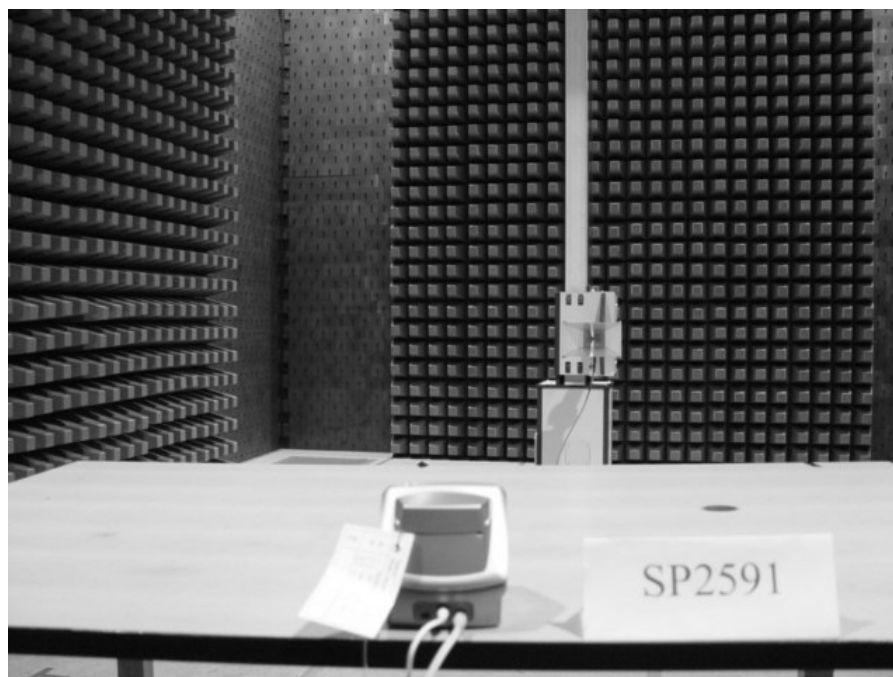
**Photograph 3: Set-up for Radiation Measurement Above 1GHz**
