FIGURE 6: OCCUPIED BANDWIDTH

| Description: | RF amplifier | | |

2.1051 Spurious Emissions at Antenna Terminals (IC RSS-131 Clause 4.4)

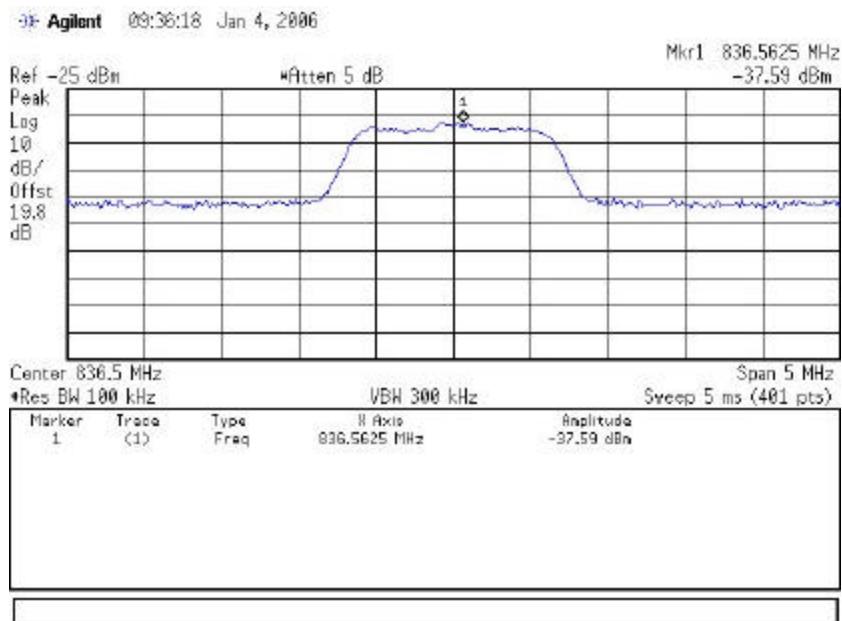
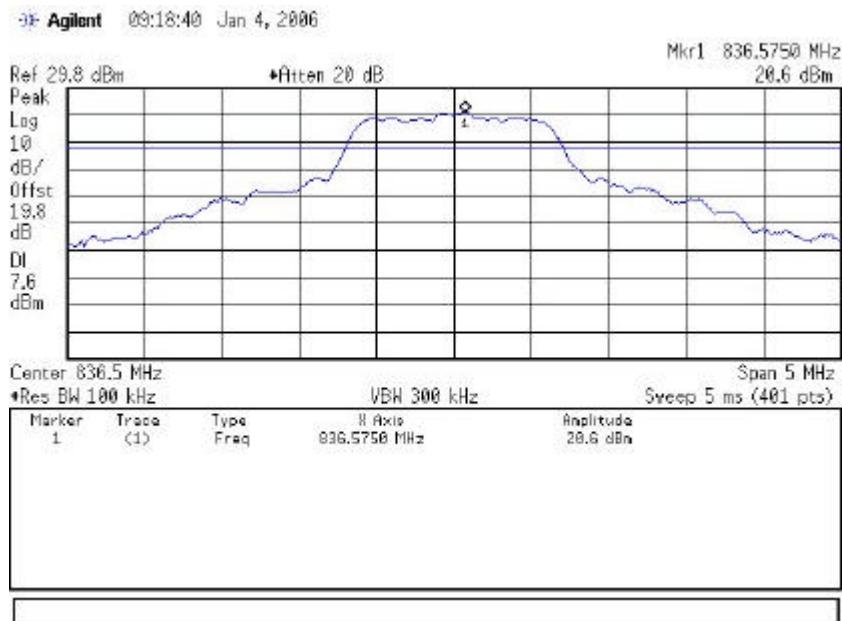
| | Uplink – CDMA – Mid Channel – 836.5 MHz | | |
| | Plots – Top = Input / Bottom = Output | | |

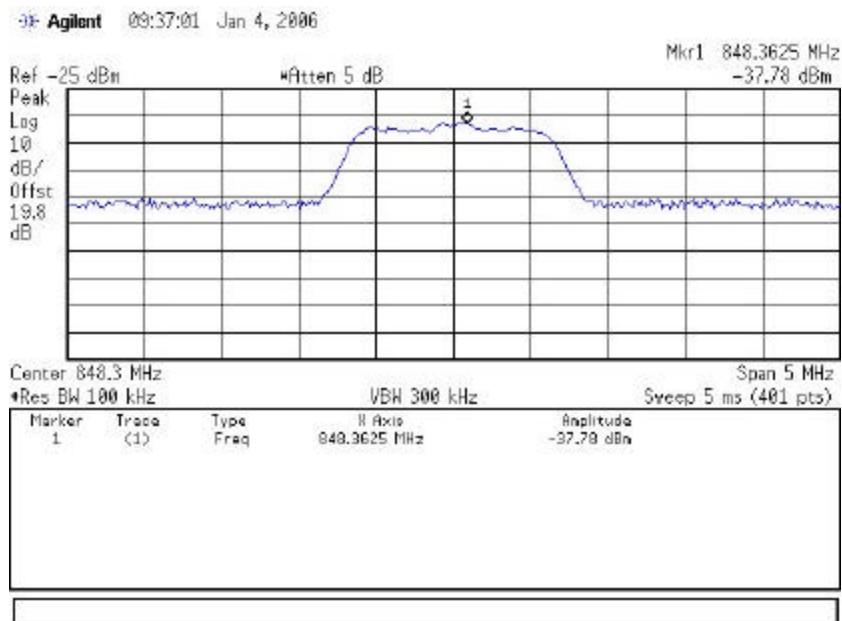
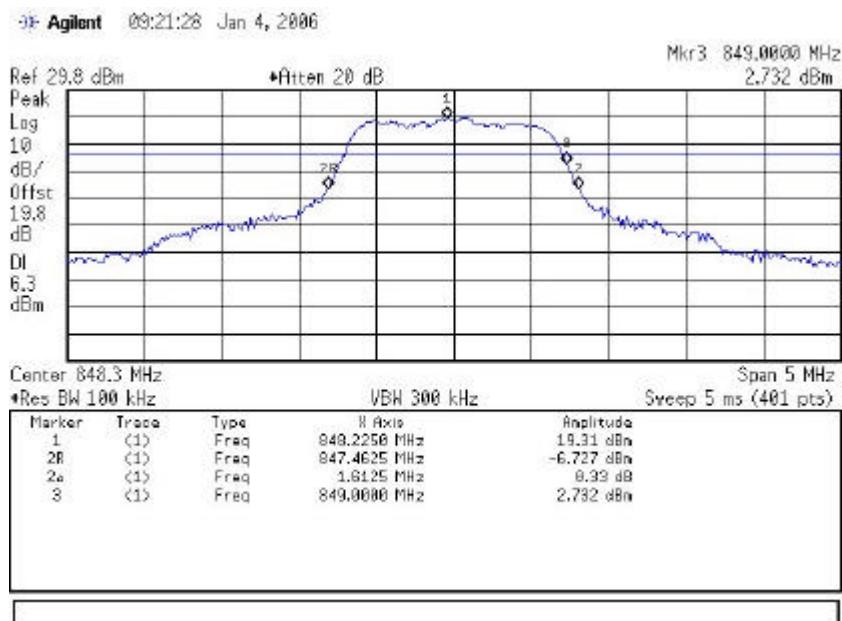
FIGURE 6: OCCUPIED BANDWIDTH

| | Uplink – CDMA – Hi Channel – 848.3 MHz | | |
| | Plots – Top = Input / Bottom = Output | | |

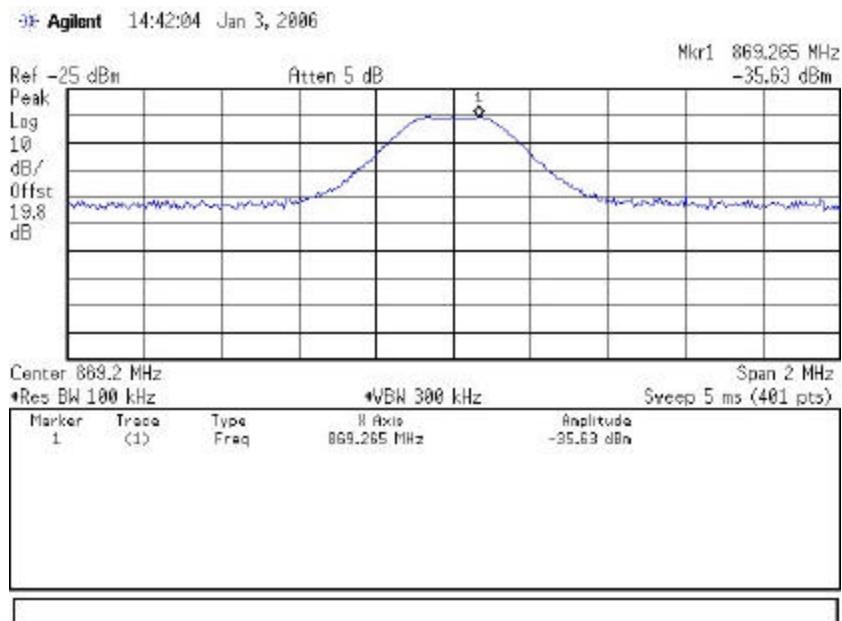
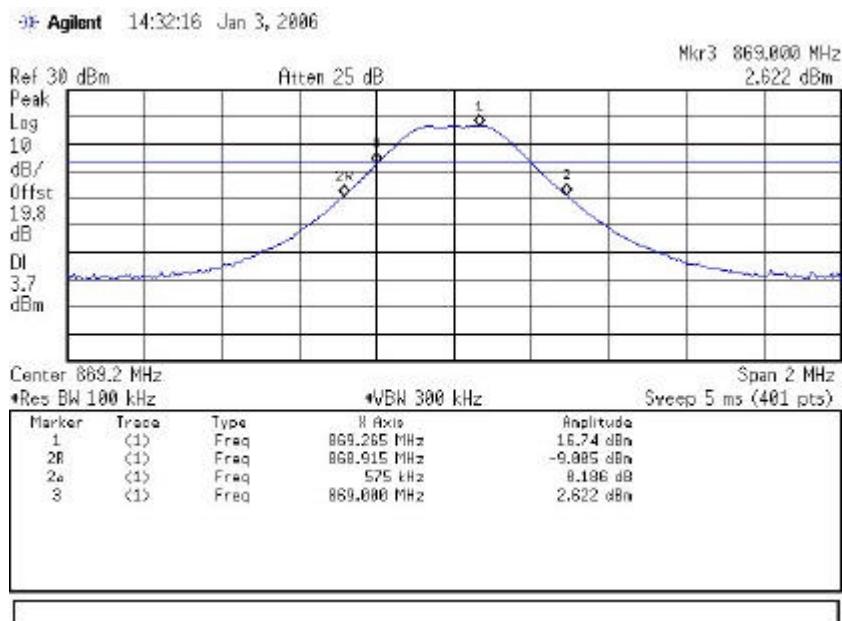
FIGURE 6: OCCUPIED BANDWIDTH

| | Downlink – GSM – Lo Channel – 869.2 MHz | | |
| | Plots – Top = Input / Bottom = Output | | |

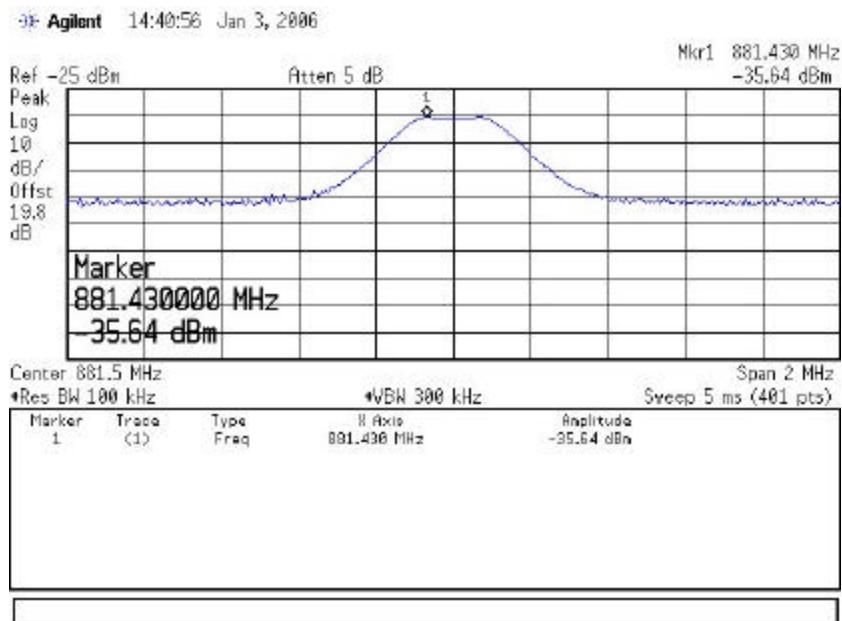
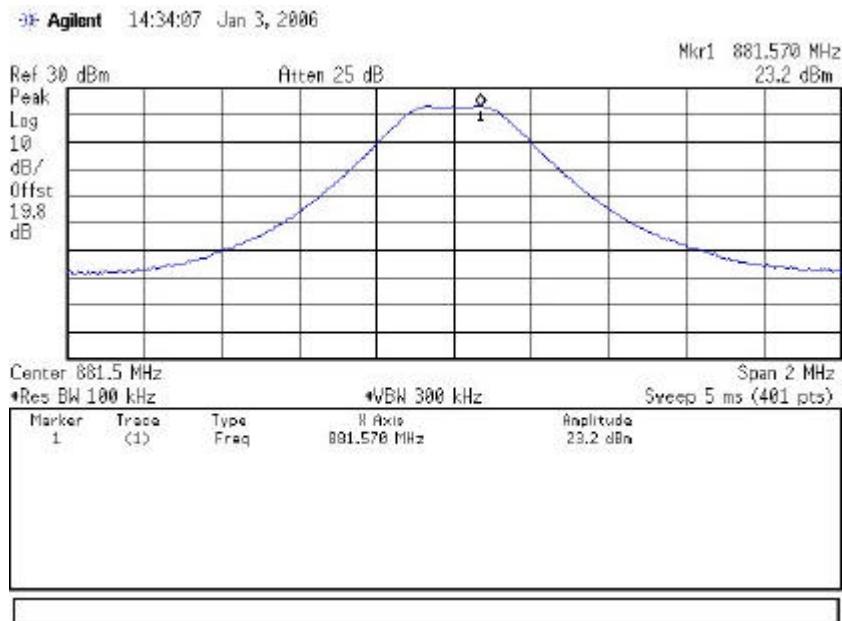
FIGURE 6: OCCUPIED BANDWIDTH

| | Downlink – GSM – Mid Channel – 881.5 MHz | | |
| | Plots – Top = Input / Bottom = Output | | |

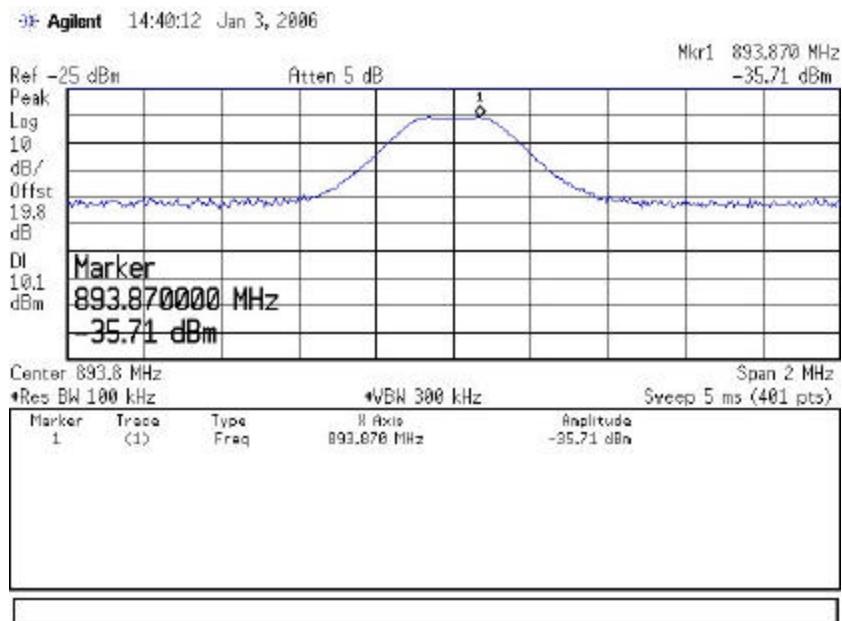
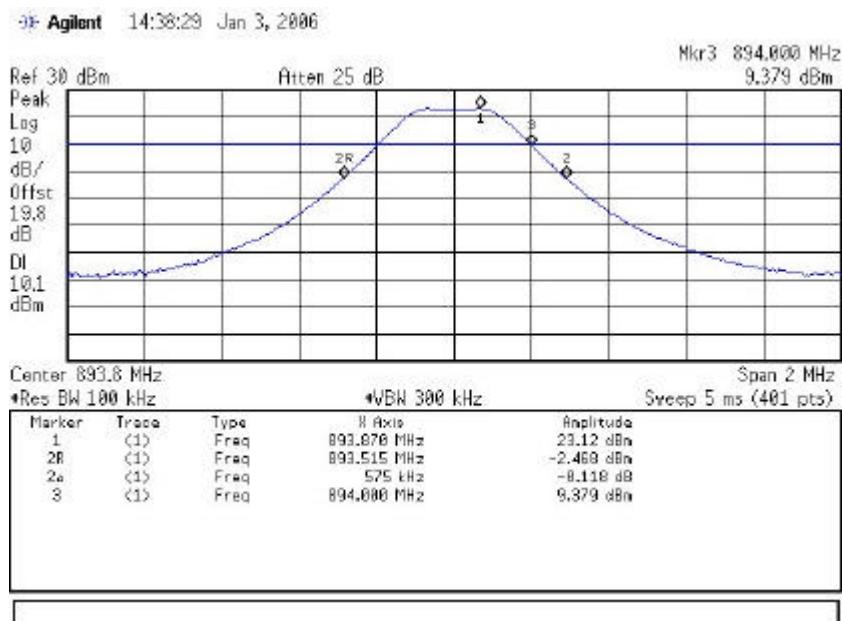
FIGURE 6: OCCUPIED BANDWIDTH

| | Downlink – GSM – Hi Channel – 893.8 MHz | | |
| | Plots – Top = Input / Bottom = Output | | |

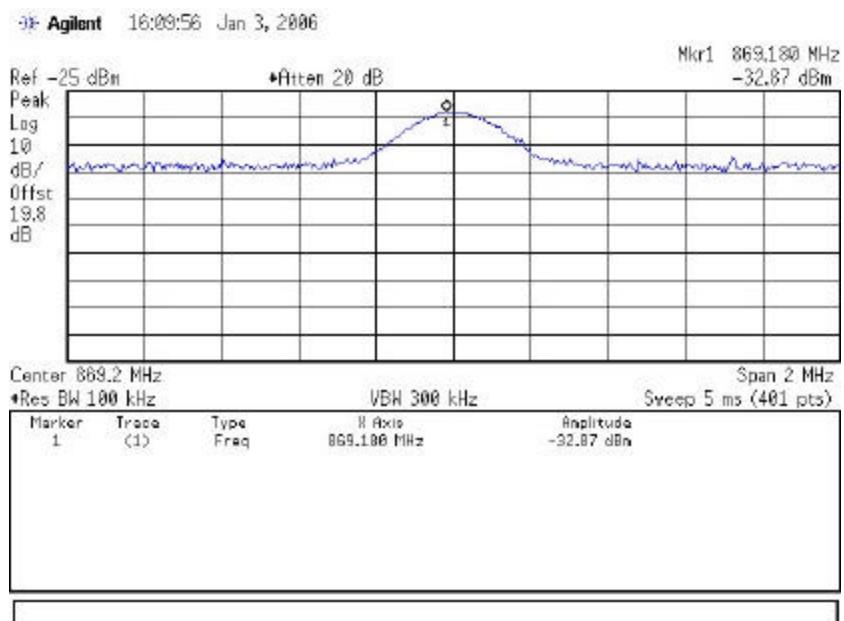
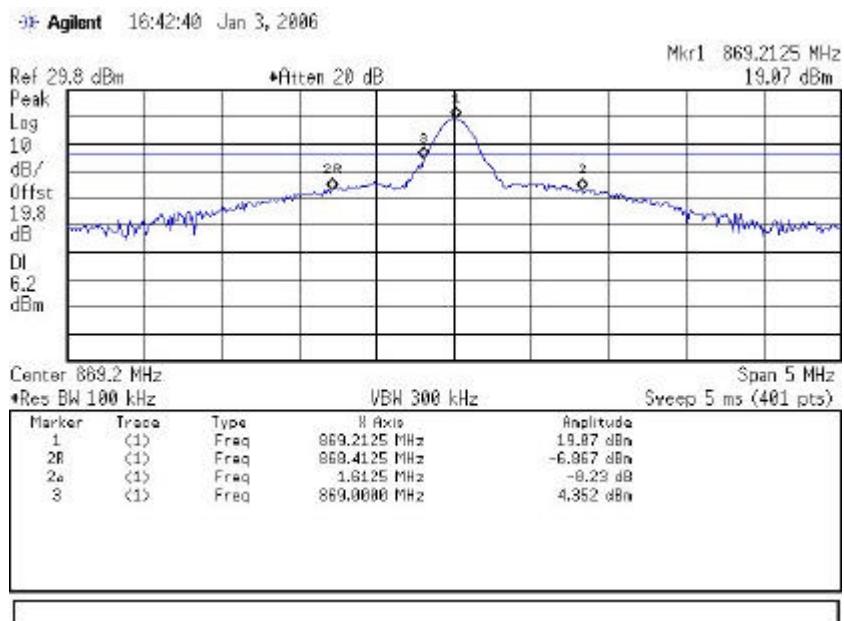
FIGURE 6: OCCUPIED BANDWIDTH

| | Downlink – TDMA – Lo Channel – 869.2 MHz | | |
| | Plots – Top = Input / Bottom = Output | | |

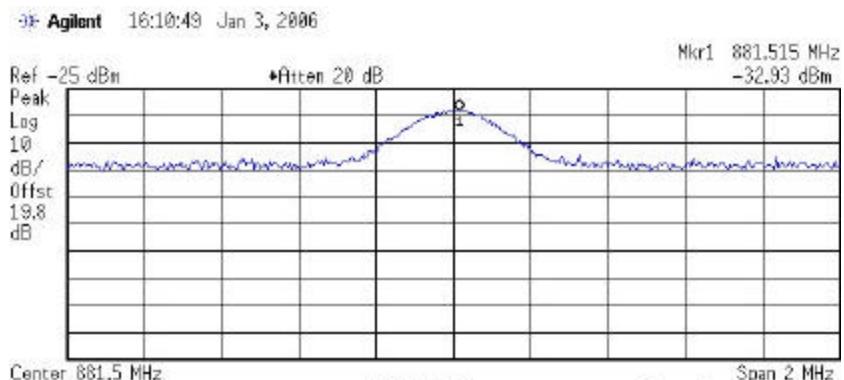
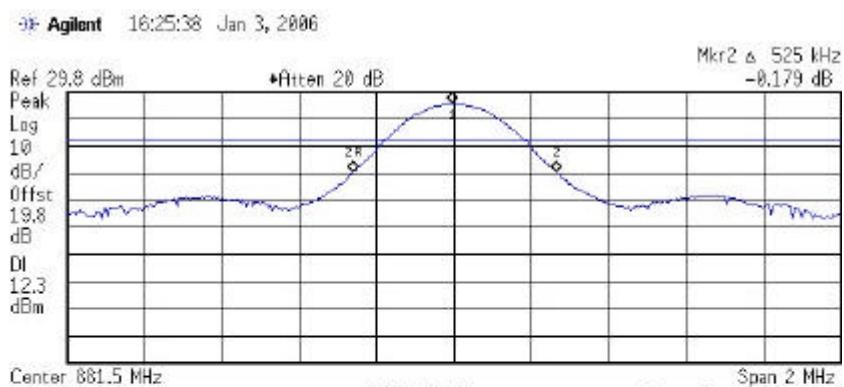
FIGURE 6: OCCUPIED BANDWIDTH

| | Downlink – TDMA – Mid Channel – 881.5 MHz | | |
| | Plots – Top = Input / Bottom = Output | | |

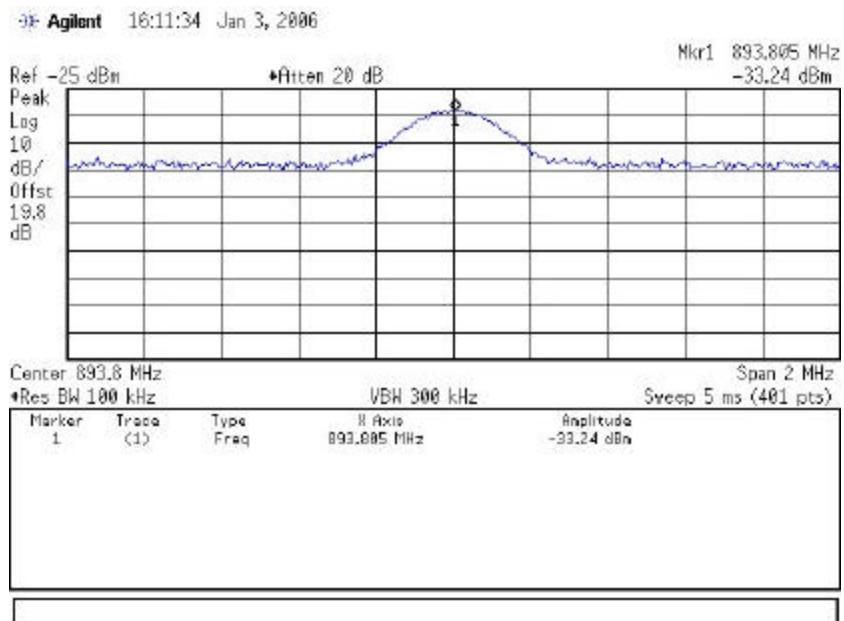
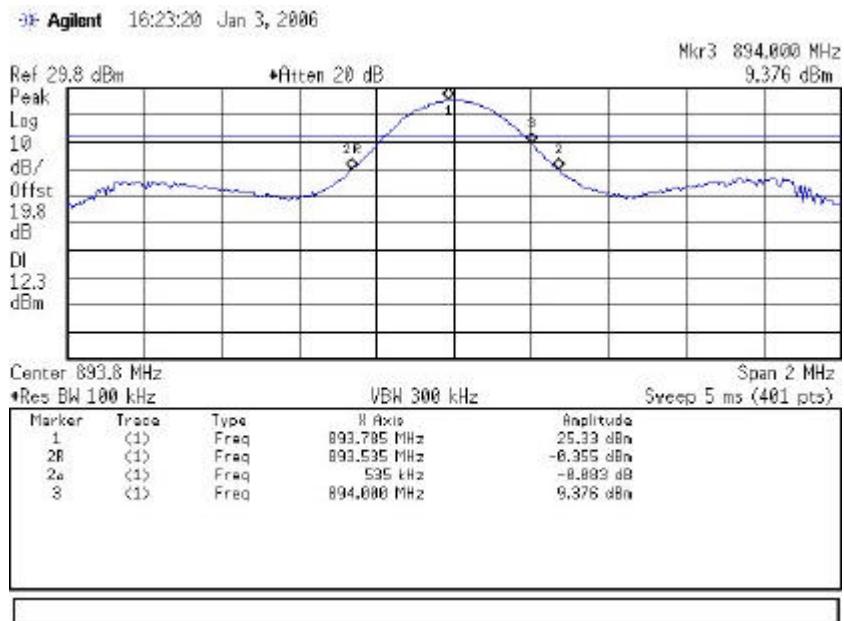
FIGURE 6: OCCUPIED BANDWIDTH

| | Downlink – TDMA – Hi Channel – 893.8 MHz | | |
| | Plots – Top = Input / Bottom = Output | | |

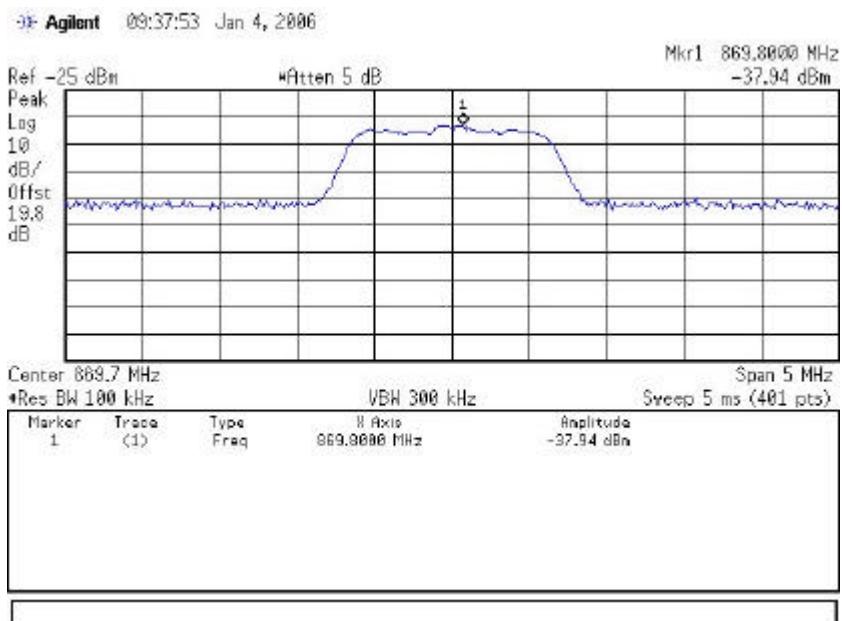
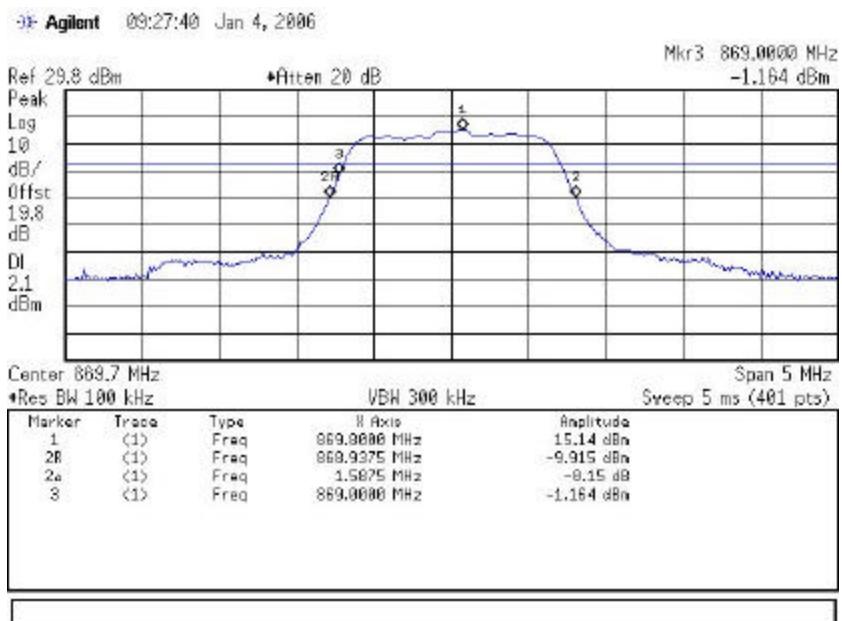
FIGURE 6: OCCUPIED BANDWIDTH

| | Downlink – CDMA – Lo Channel – 869.7 MHz | | |
| | Plots – Top = Input / Bottom = Output | | |

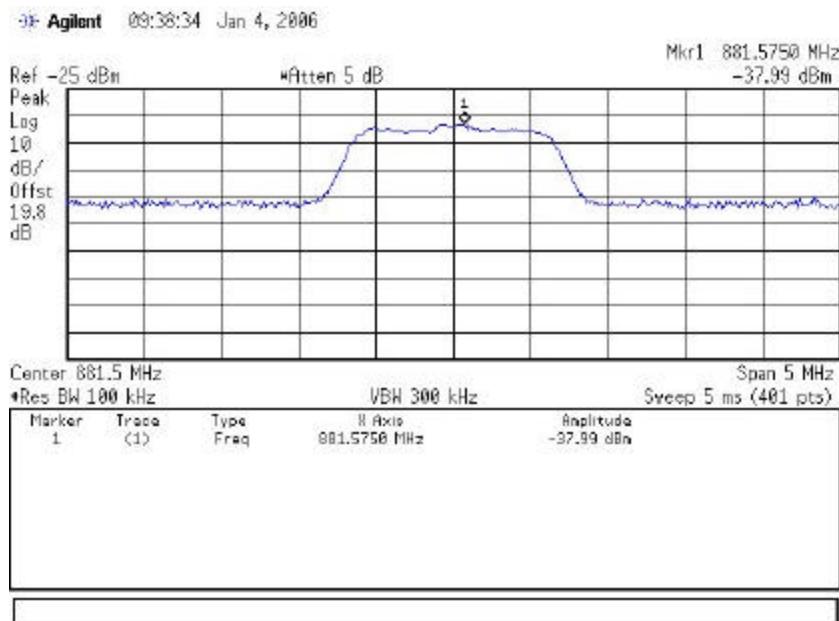
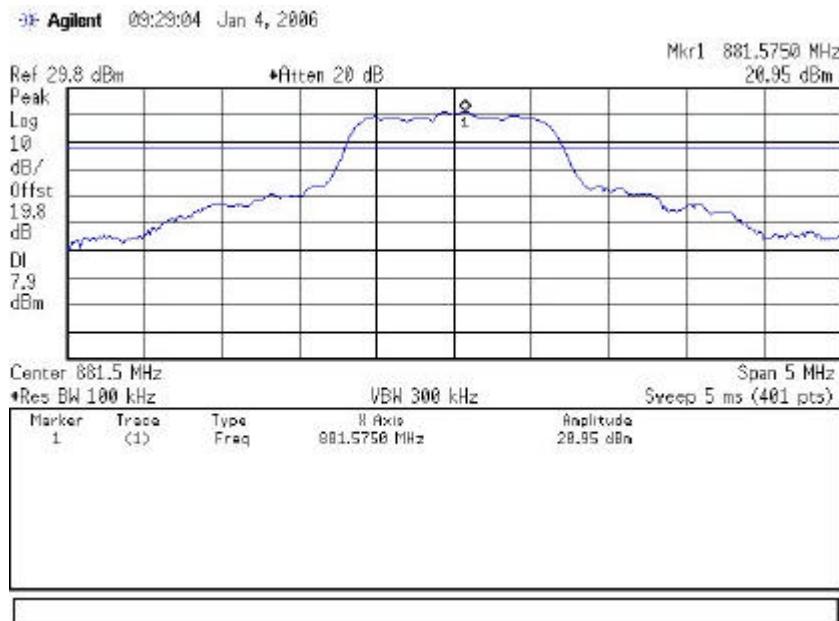
FIGURE 6: OCCUPIED BANDWIDTH

| | Downlink – CDMA – Mid Channel – 881.5 MHz | | |
| | Plots – Top = Input / Bottom = Output | | |

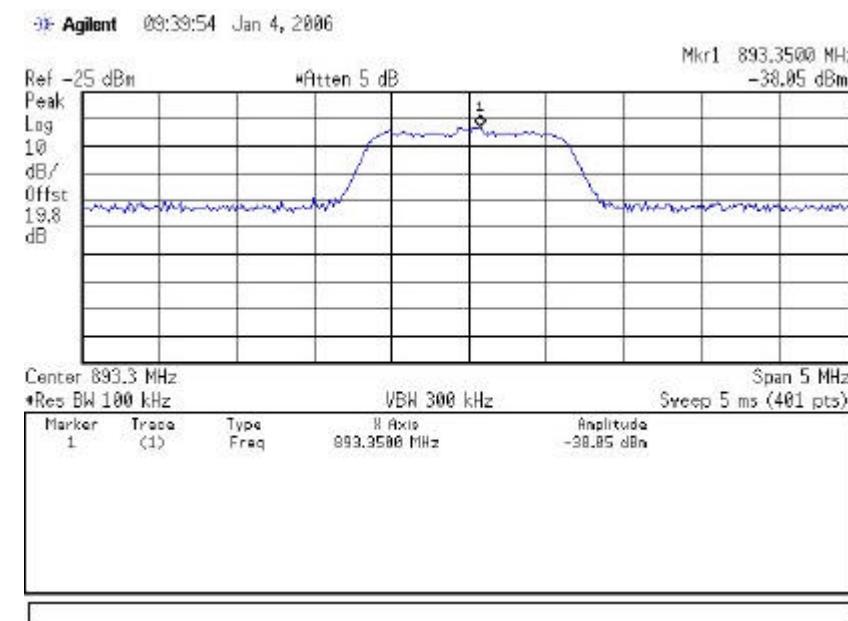
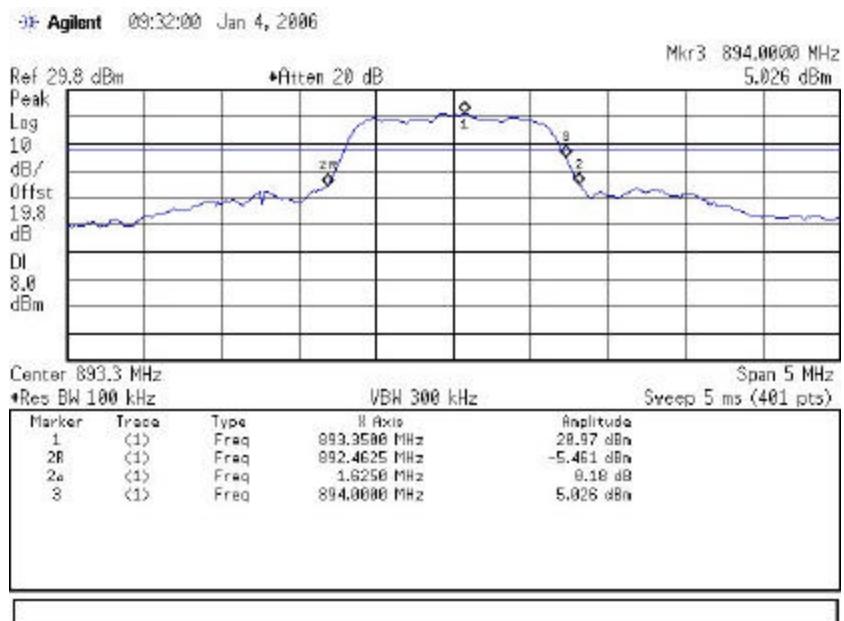
FIGURE 6: OCCUPIED BANDWIDTH

| Description: | RF amplifier Downlink – CDMA – Hi Channel – 893.3 MHz Plots – Top = Input / Bottom = Output | Conformance Standards [X] IC RSS-131 [X] FCC Part 22 | |

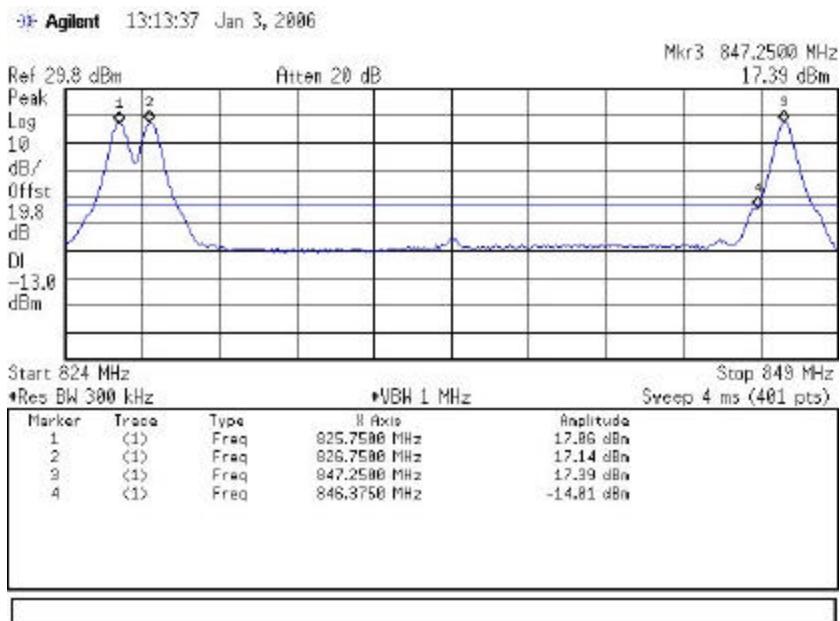
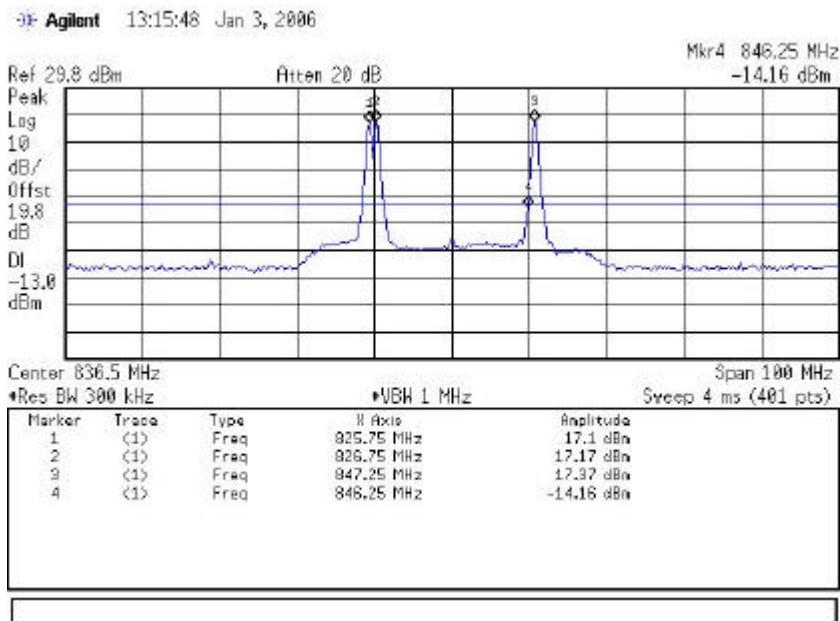
FIGURE 6: OCCUPIED BANDWIDTH

| | Uplink – CW – Input – Lo / Near Lo / Hi channels | | |
| | Plots: Top = Allowable Band / Bottom = 100MHz span | | |

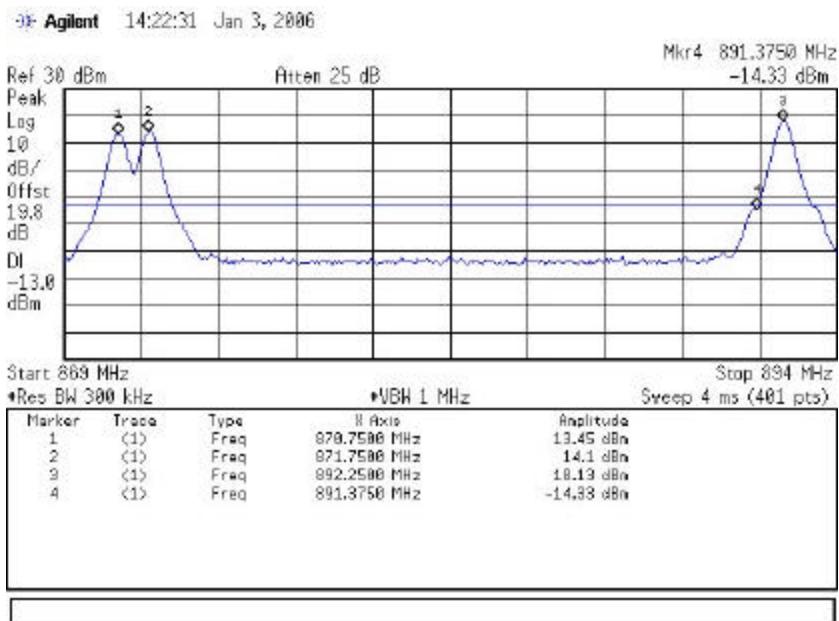
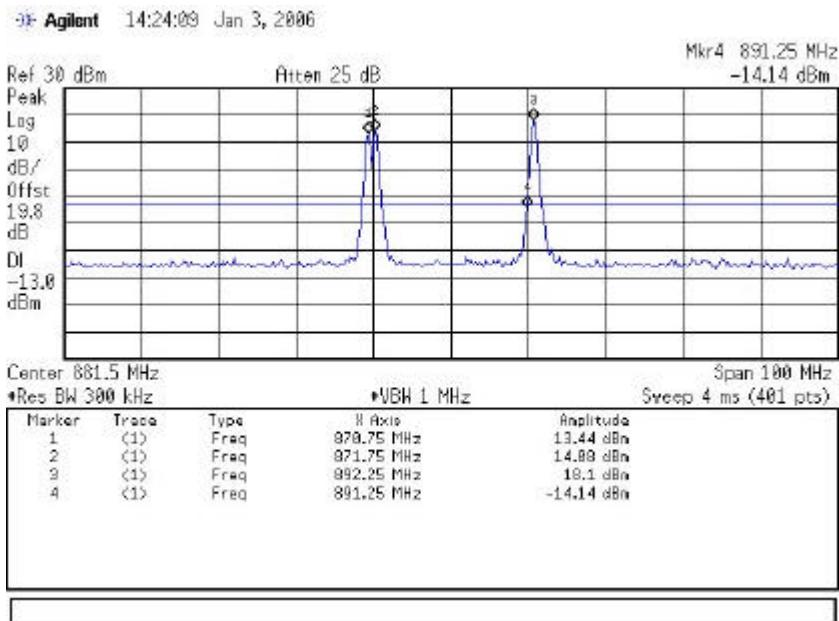
FIGURE 6: OCCUPIED BANDWIDTH

| | Uplink – CW – Input – Lo / Near Lo / Hi channels | | |
| | Plots: Top = Allowable Band / Bottom = 100MHz span | | |

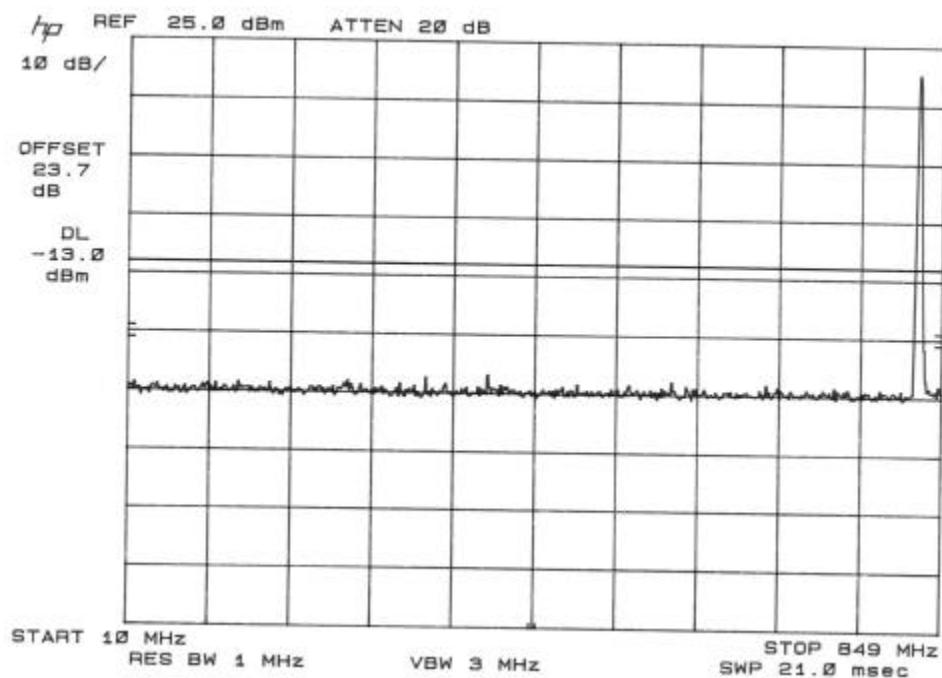
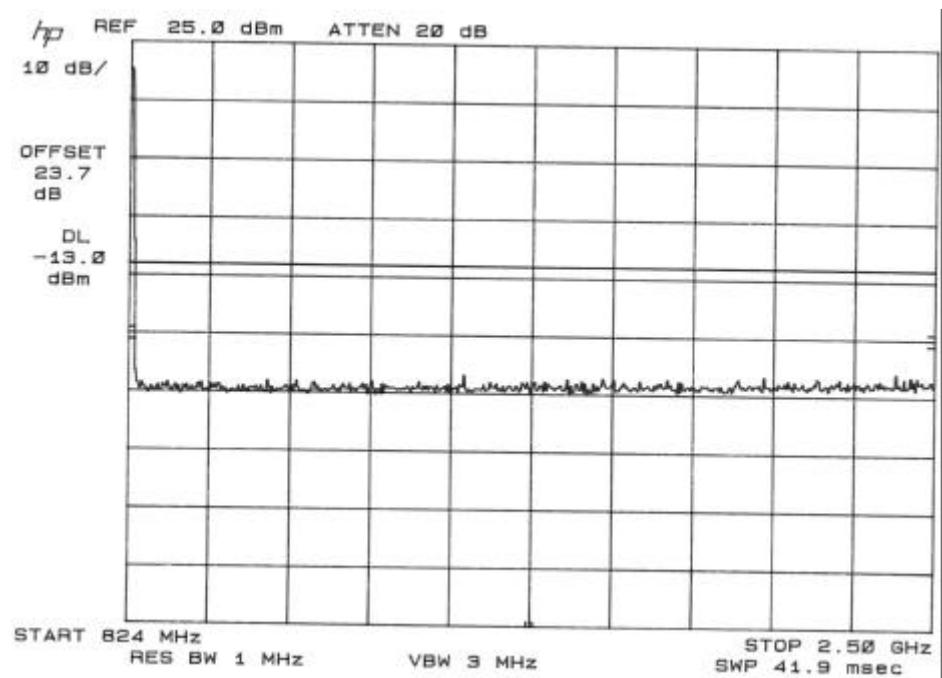
Figure 7: Conducted Spurious Emissions at Antenna Terminals, Uplink.

| Description: | RF amplifier Uplink – GSM – Lo Channel – 824.2 MHz | | |

All spurious emissions at the antenna terminals are below the IC/FCC specifications

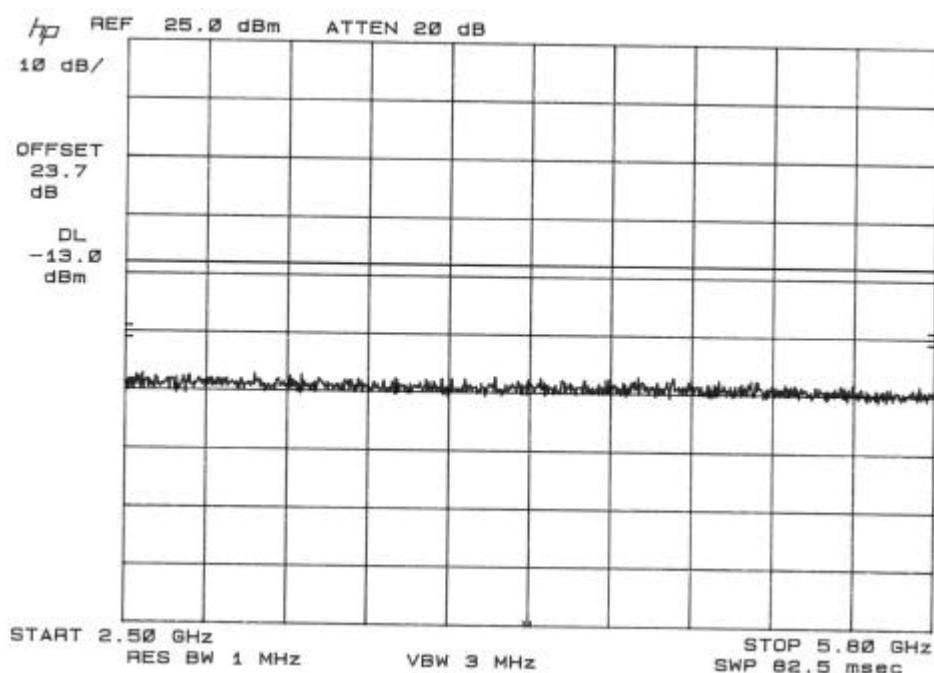
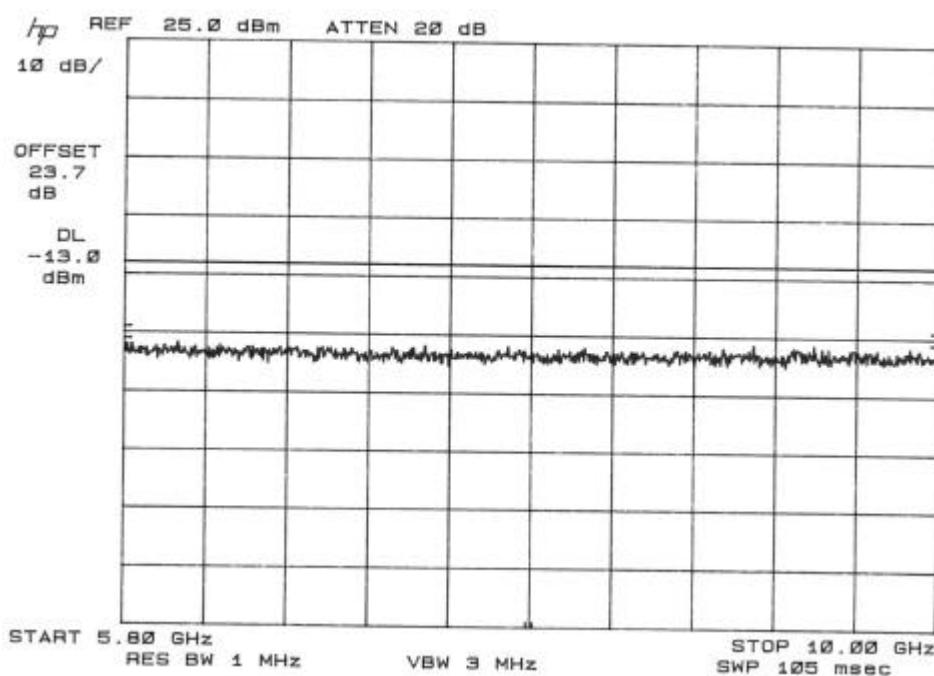
Figure 7: Conducted Spurious Emissions at Antenna Terminals, Uplink.

| Description: | RF amplifier Uplink – GSM – Lo Channel – 824.2 MHz | | [X] FCC Part 22 |

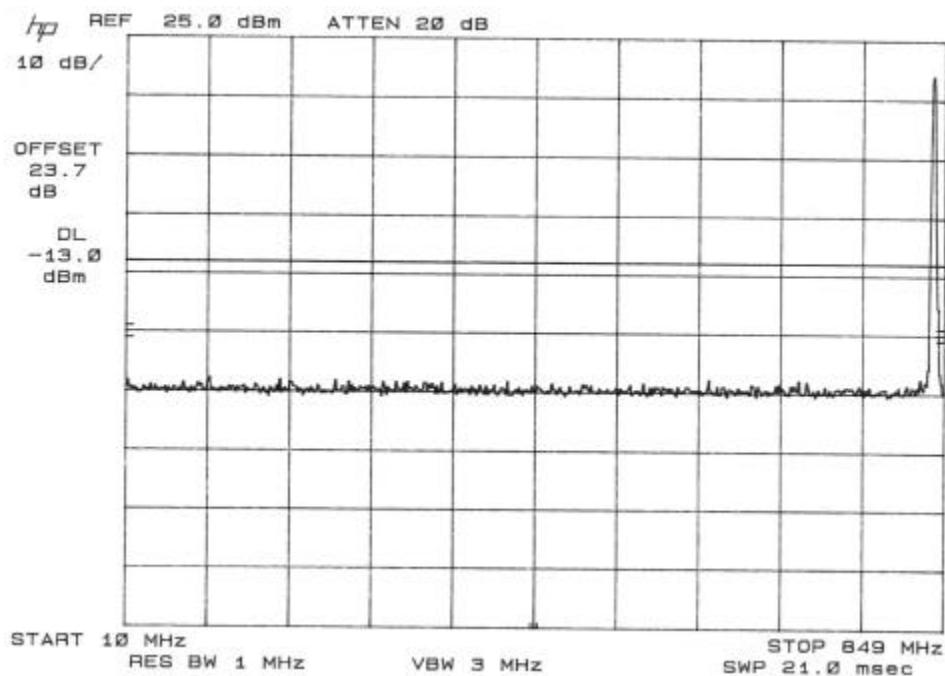
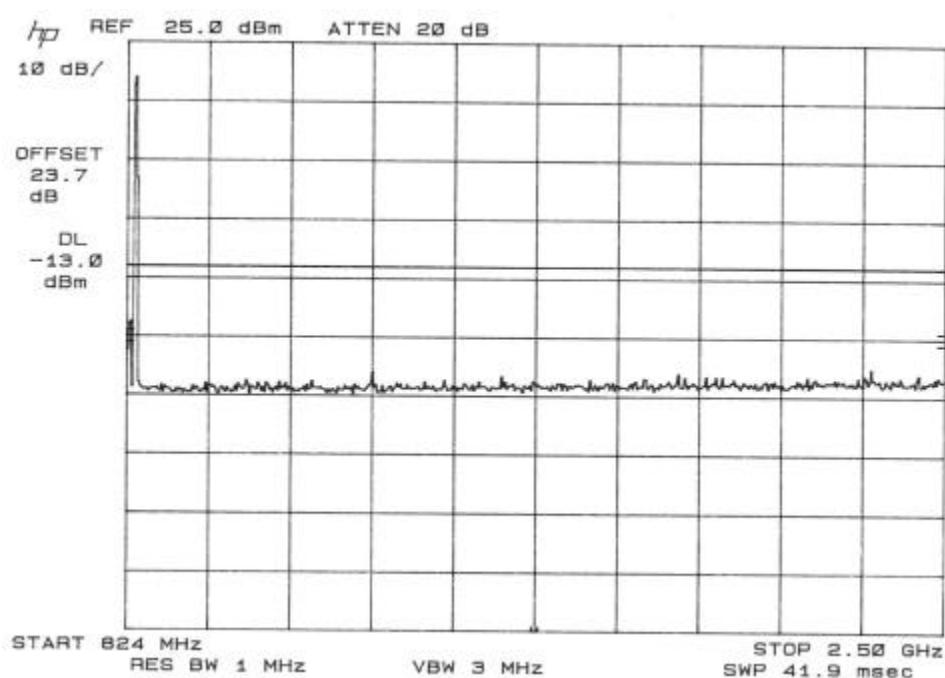
Figure 7: Conducted Spurious Emissions at Antenna Terminals, Uplink.

| Description: | RF amplifier Uplink – GSM – Mid Channel – 836.5 MHz | | |

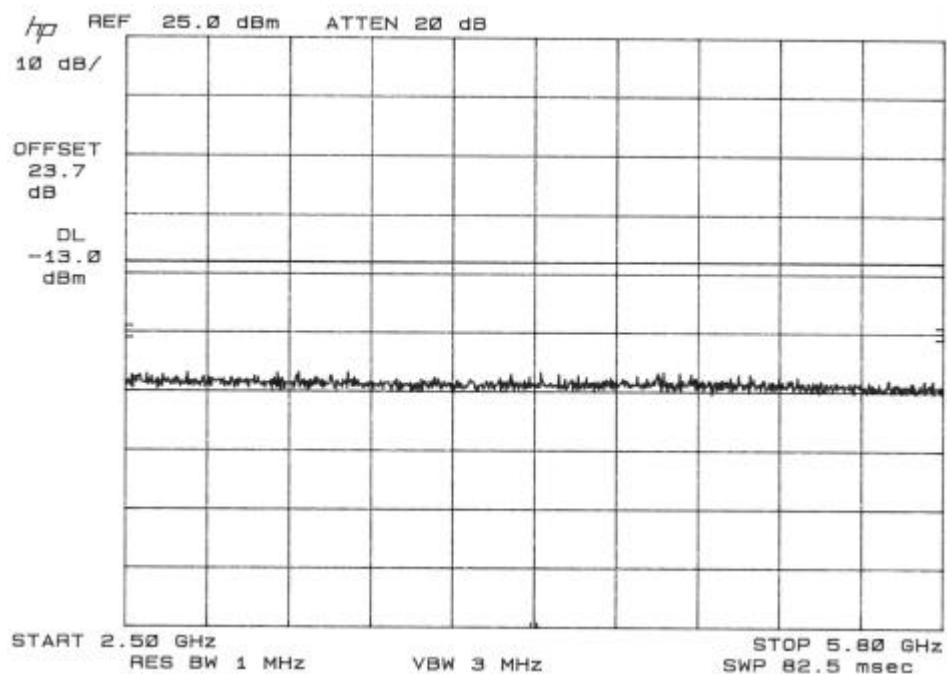
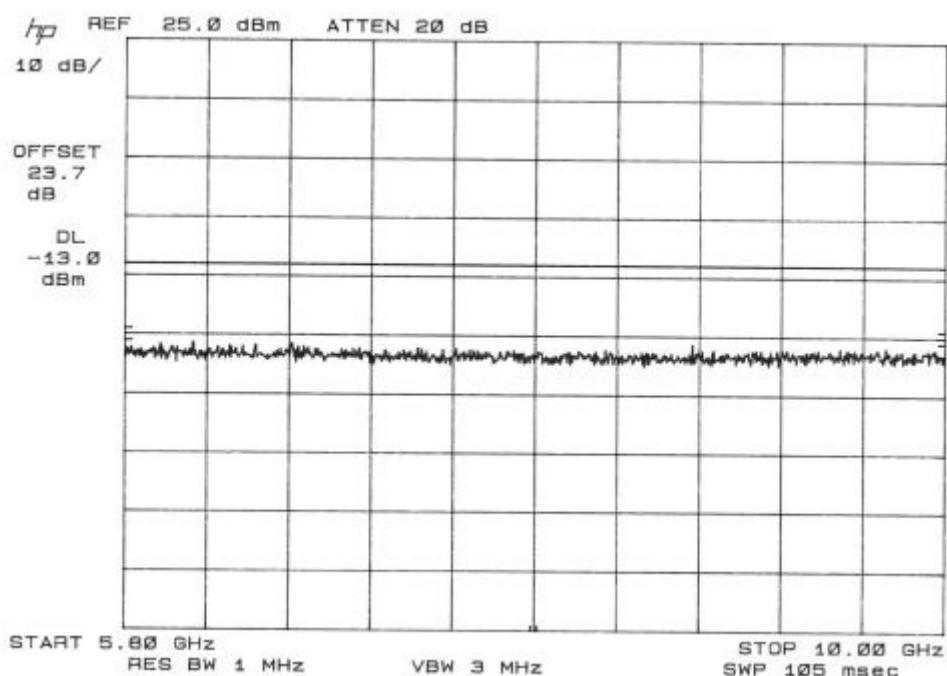
Figure 7: Conducted Spurious Emissions at Antenna Terminals, Uplink.

| | Uplink – GSM – Mid Channel – 836.5 MHz | | |

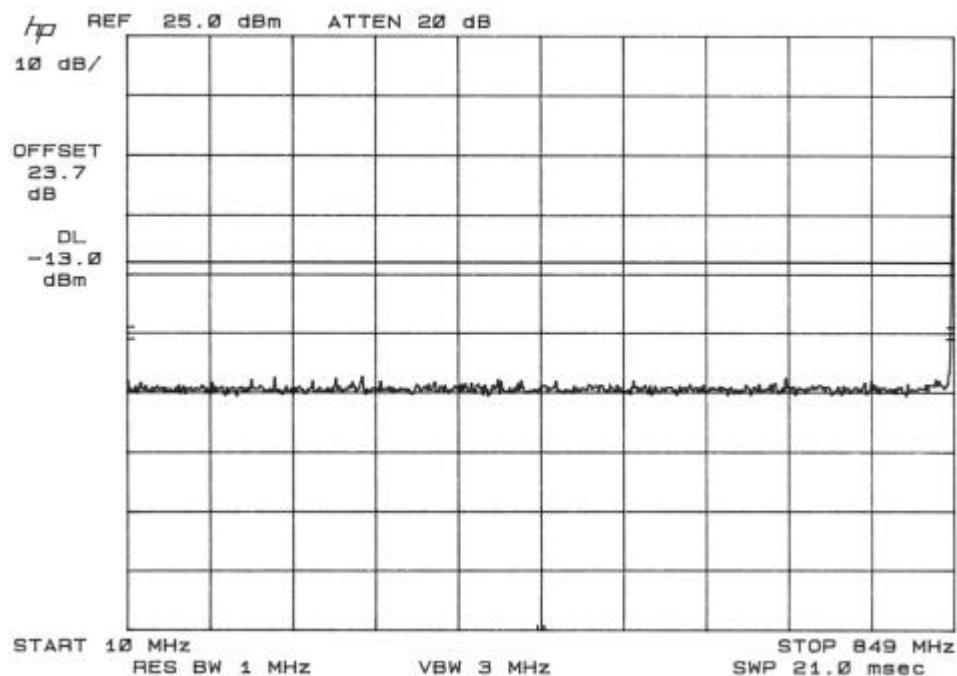
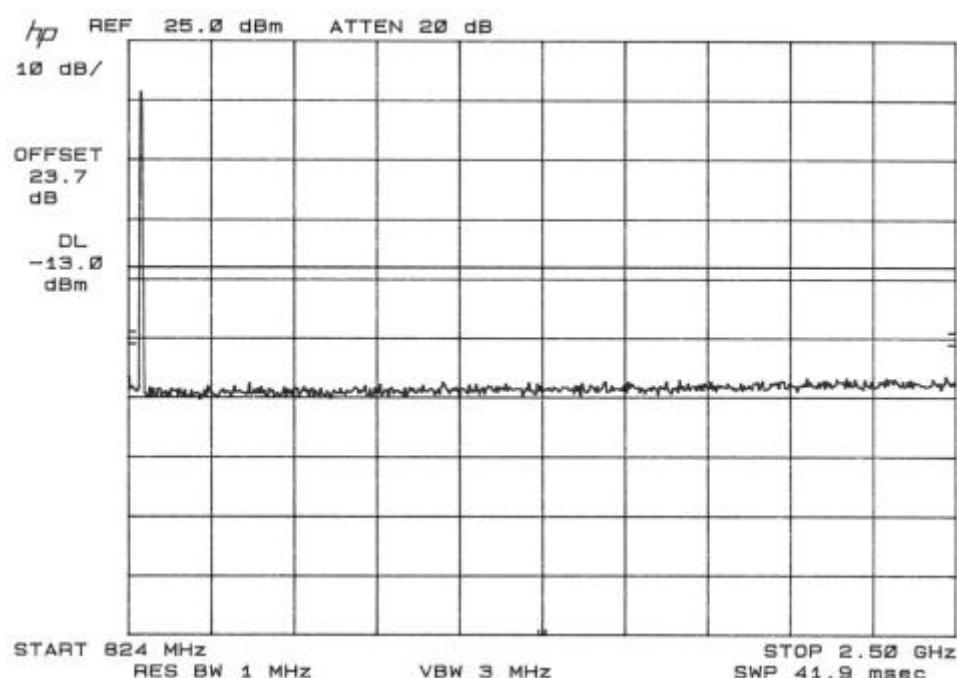
Figure 7: Conducted Spurious Emissions at Antenna Terminals, Uplink.

| | Uplink – GSM – Hi Channel – 848.8 MHz | | |

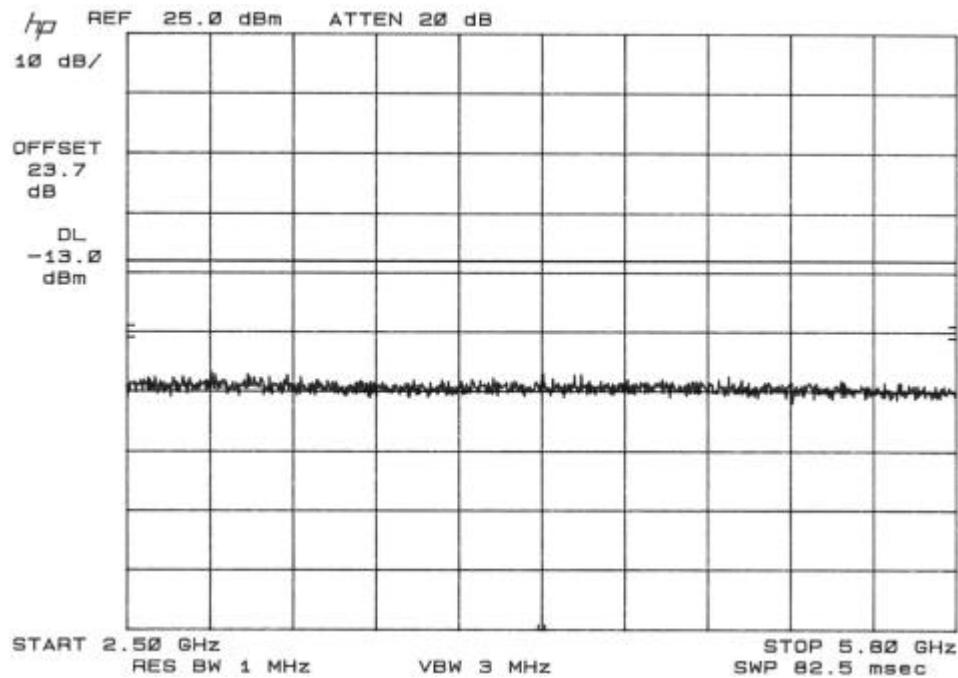
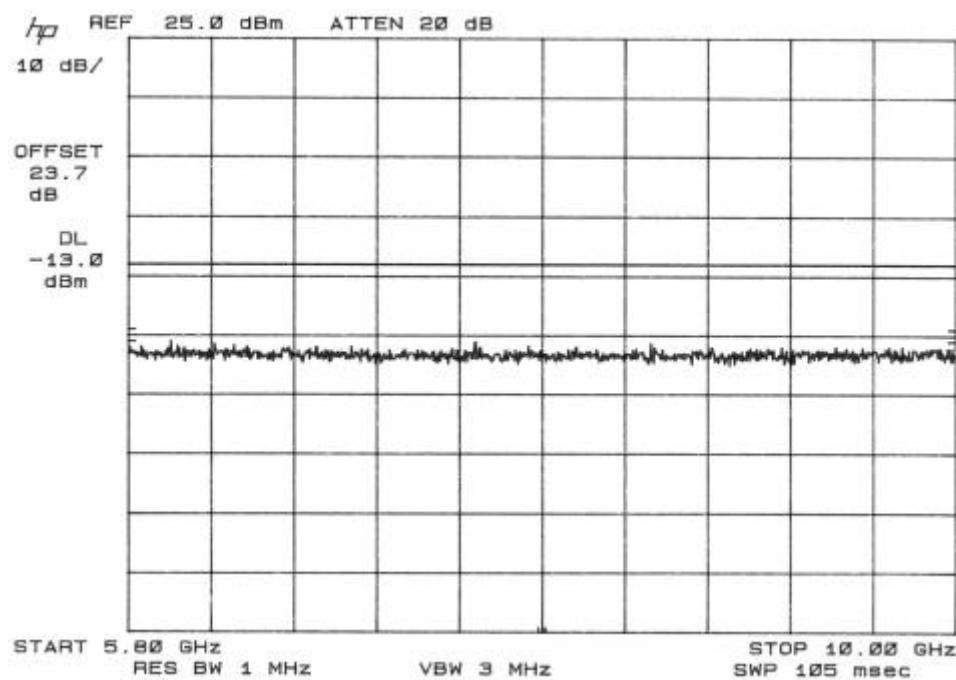
Figure 7: Conducted Spurious Emissions at Antenna Terminals, Uplink.

| | Uplink – GSM – Hi Channel – 848.8 MHz | | |

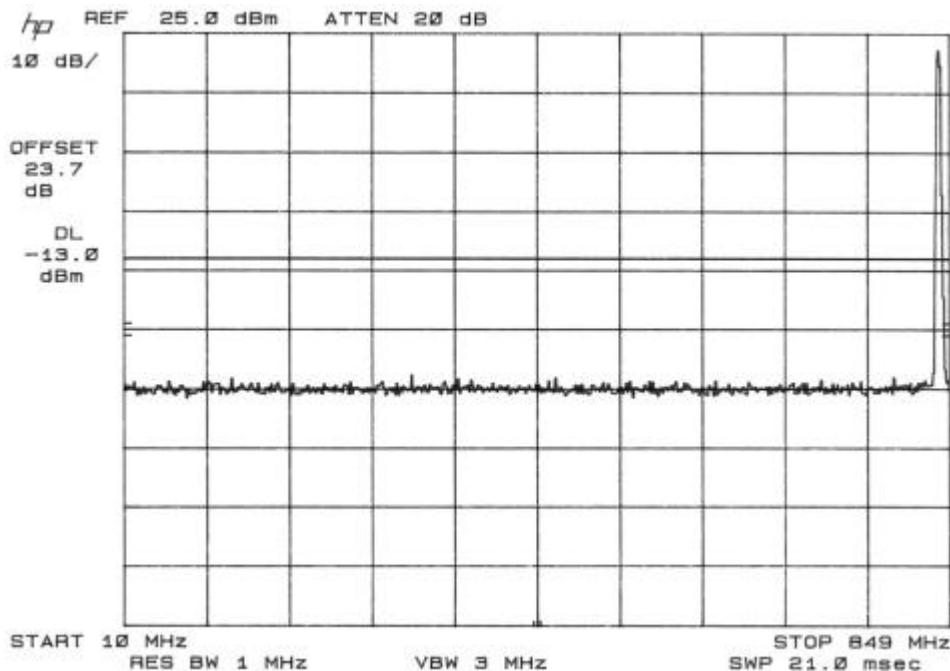
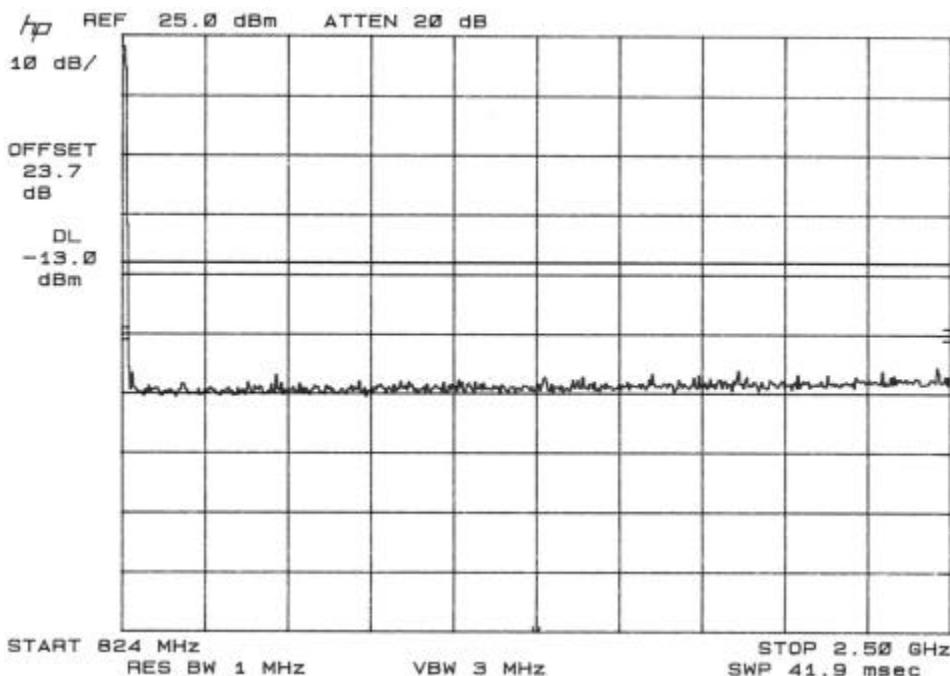
Figure 7: Conducted Spurious Emissions at Antenna Terminals, Uplink.

| | Uplink – TDMA – Lo Channel – 824.2 MHz | | |
