FIGURE 6: OCCUPIED BANDWIDTH

| Description: | RF amplifier | | |

2.1051 Spurious Emissions at Antenna Terminals (IC RSS-131 Clause 4.4)

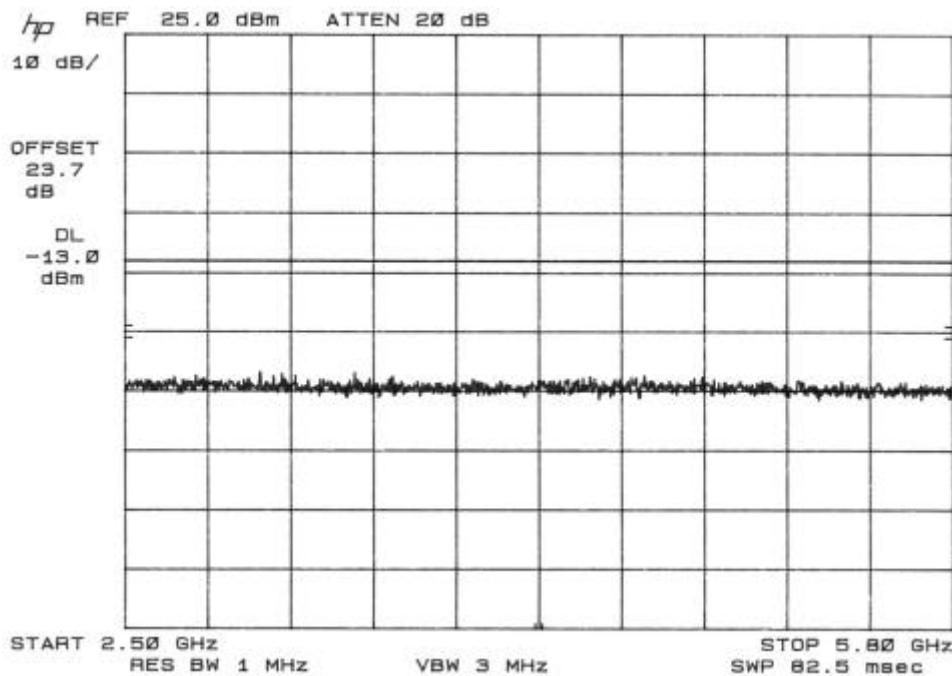
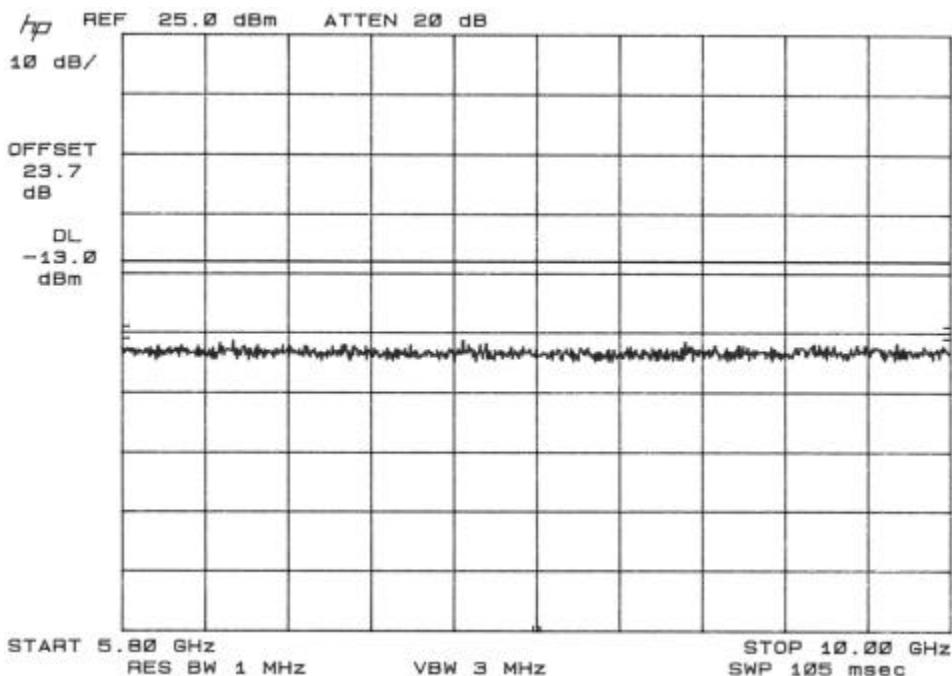
Figure 7: Conducted Spurious Emissions at Antenna Terminals, Uplink.

| | Uplink – TDMA – Lo Channel – 824.2 MHz | | |

All spurious emissions at the antenna terminals are below the IC/FCC specifications

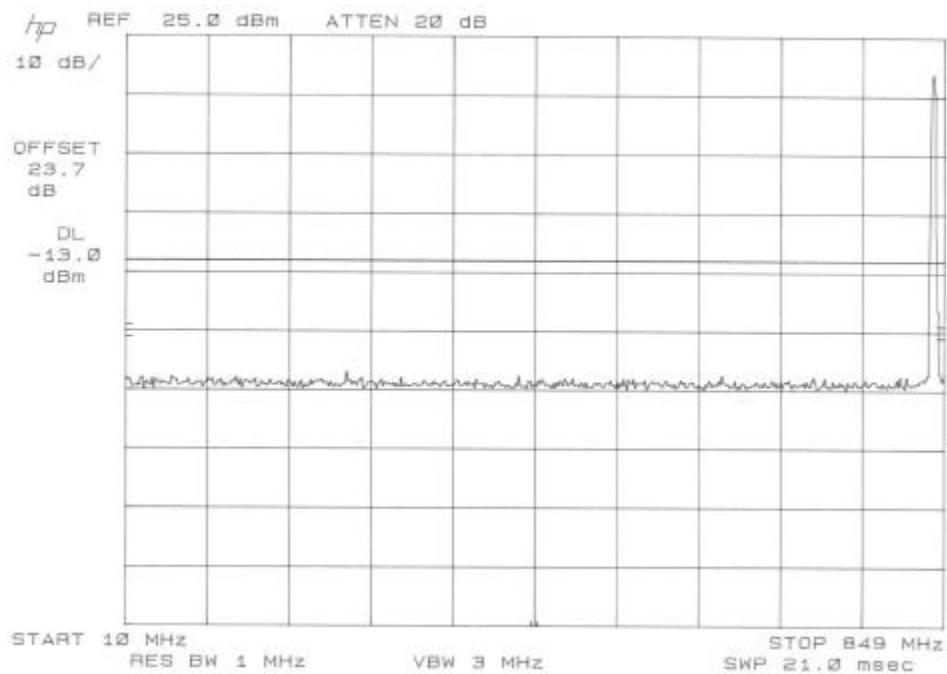
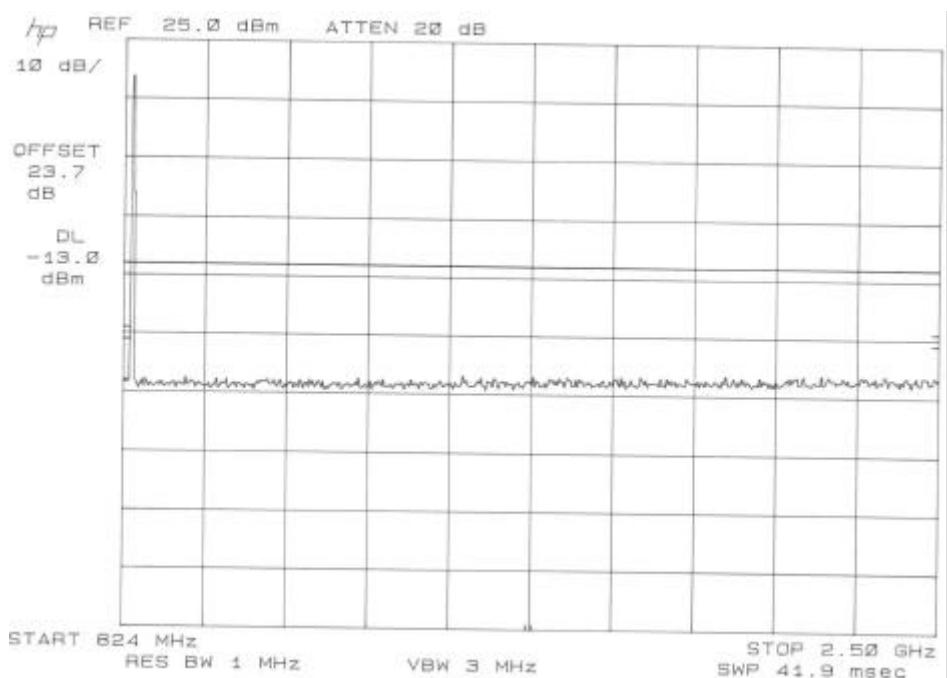
Figure 7: Conducted Spurious Emissions at Antenna Terminals, Uplink.

| Description: | RF amplifier Uplink – TDMA – Mid Channel – 836.5 MHz | | |

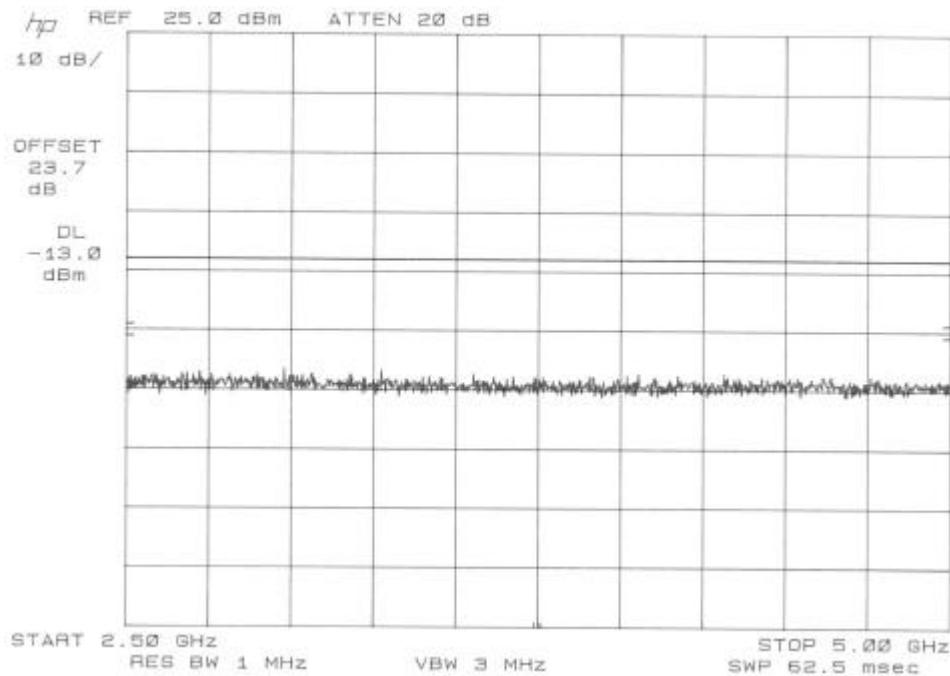
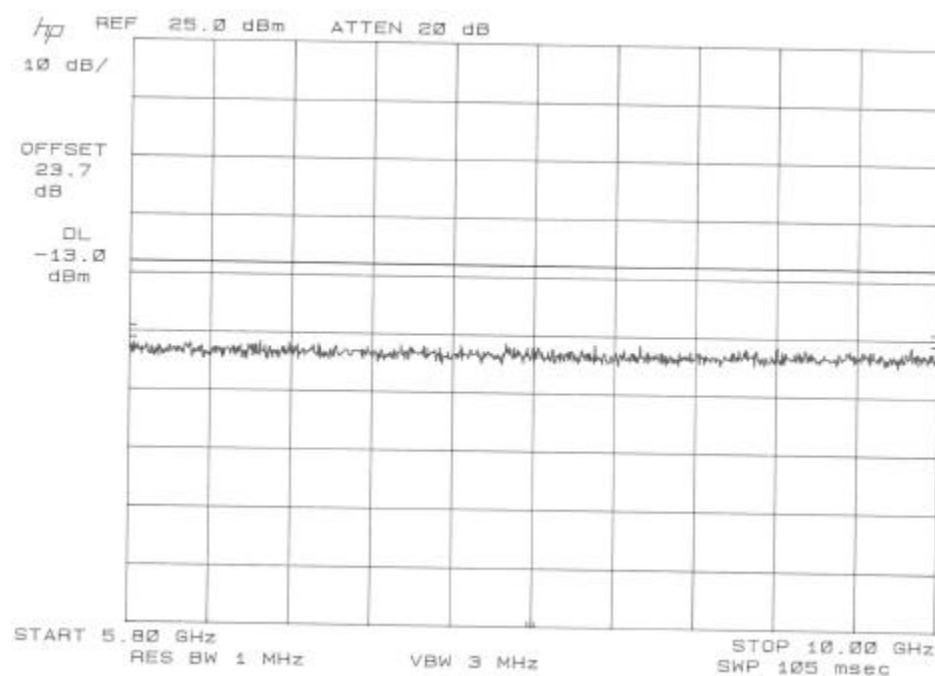
Figure 7: Conducted Spurious Emissions at Antenna Terminals, Uplink.

| | Uplink – TDMA – Mid Channel – 836.5 MHz | | |

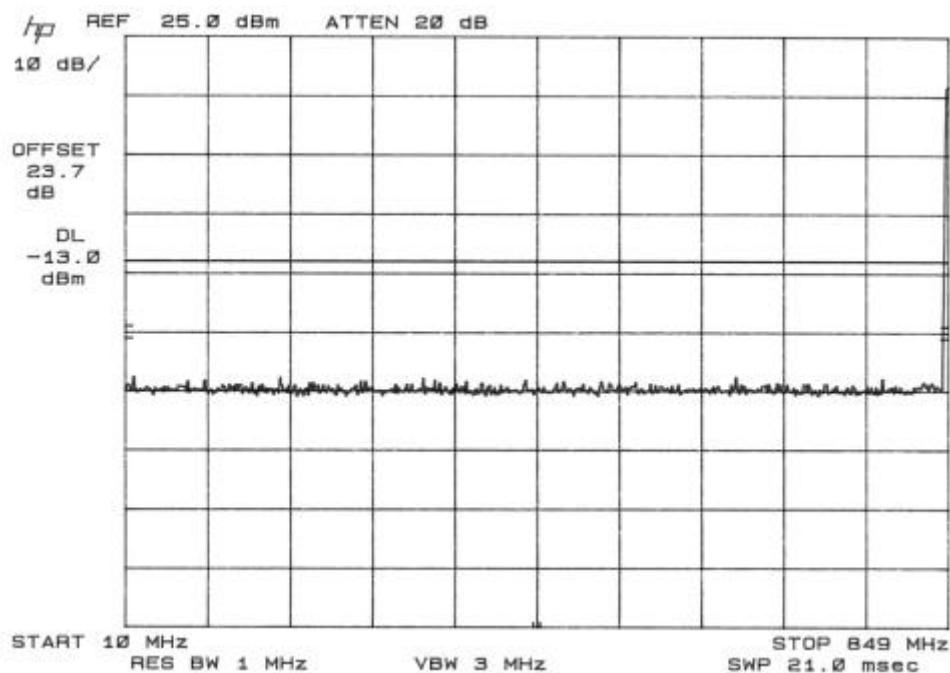
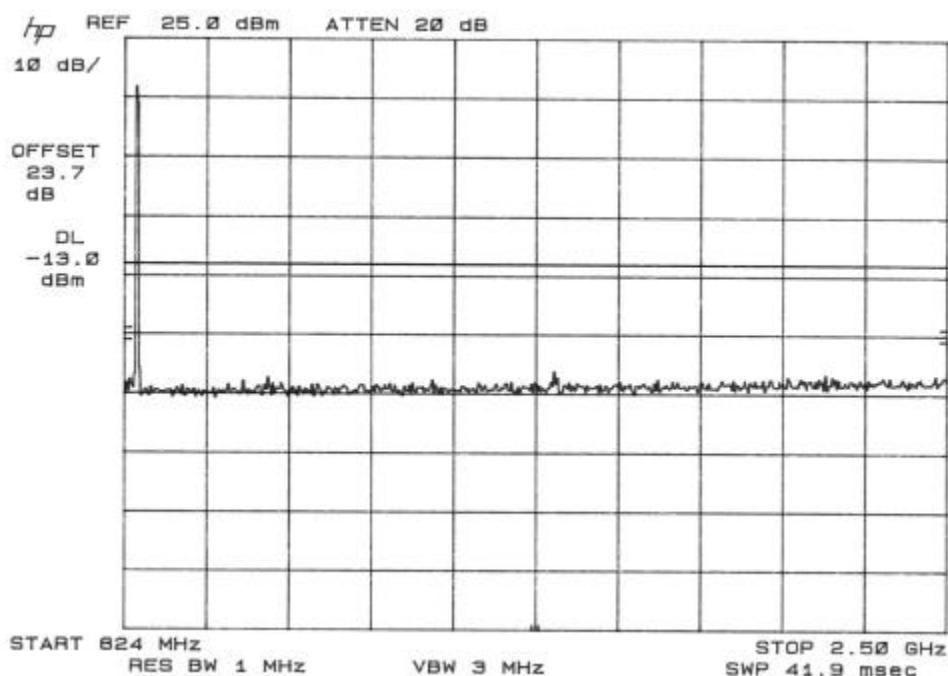
Figure 7: Conducted Spurious Emissions at Antenna Terminals, Uplink.

| | Uplink – TDMA – Hi Channel – 848.8 MHz | | |

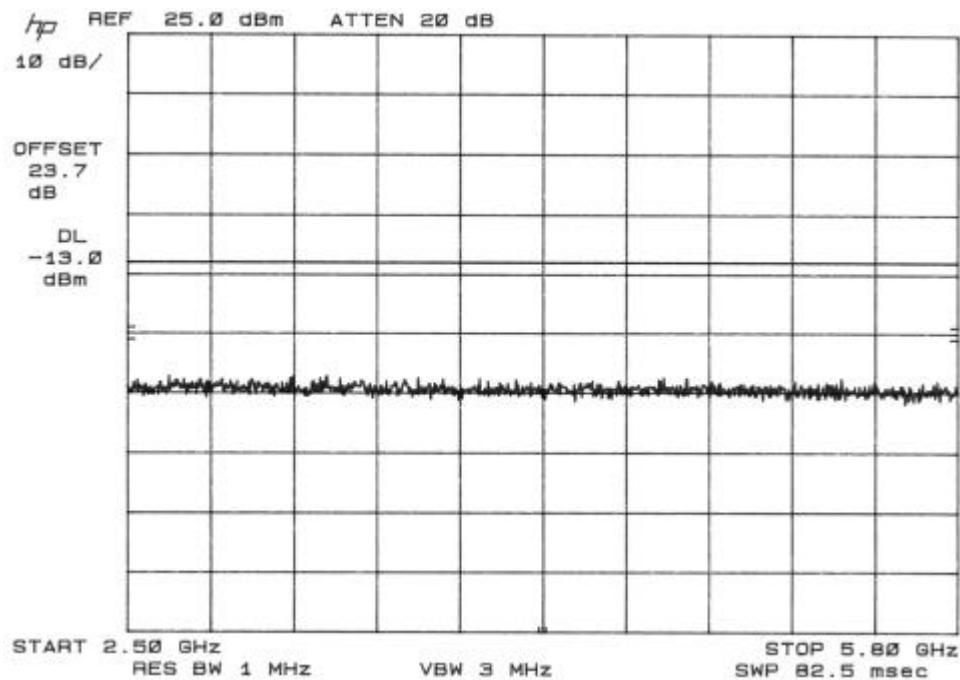
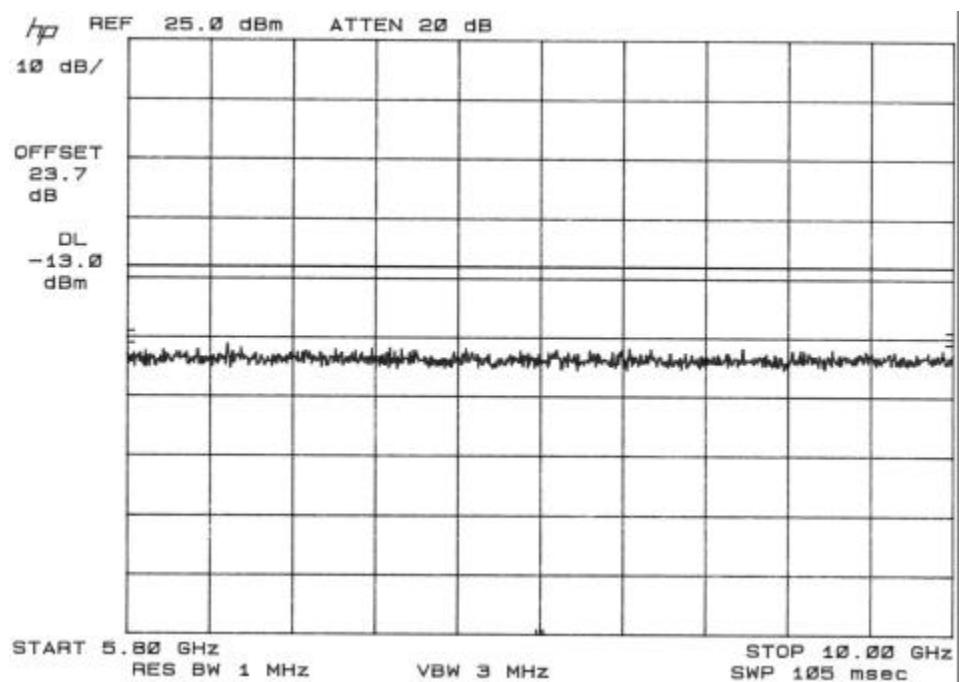
Figure 7: Conducted Spurious Emissions at Antenna Terminals, Uplink.

| | Uplink – TDMA – Hi Channel – 848.8 MHz | | |

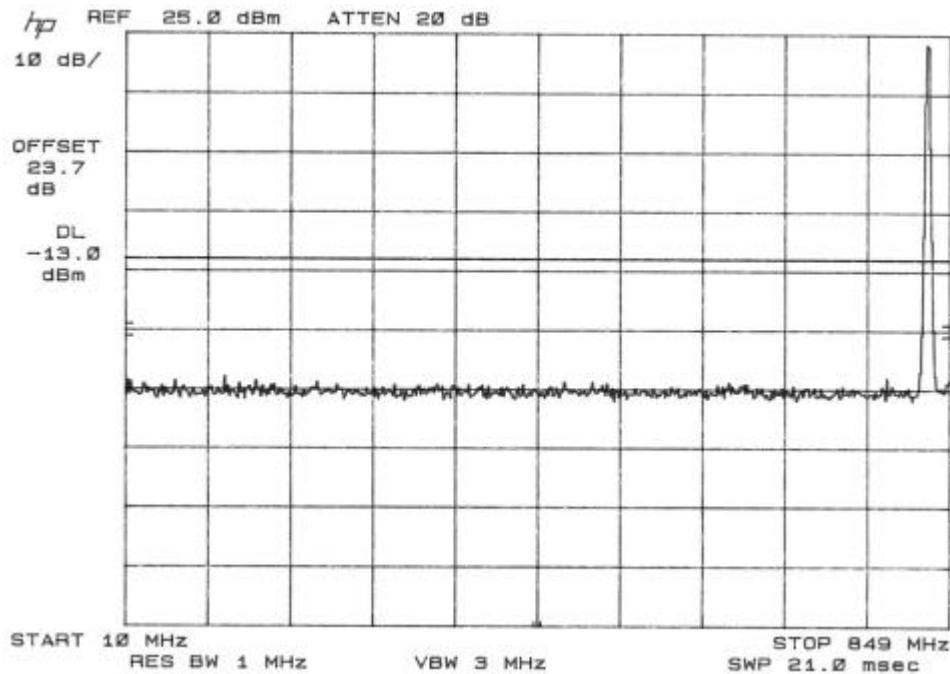
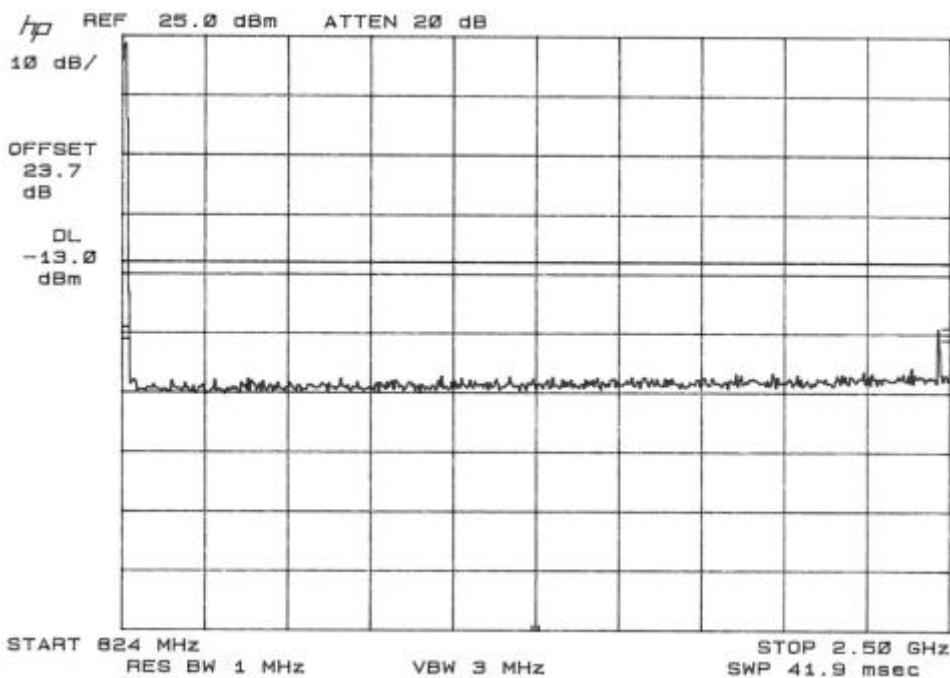
Figure 7: Conducted Spurious Emissions at Antenna Terminals, Uplink.

| Description: | RF amplifier Uplink – CDMA – Lo Channel – 824.7 MHz | | |

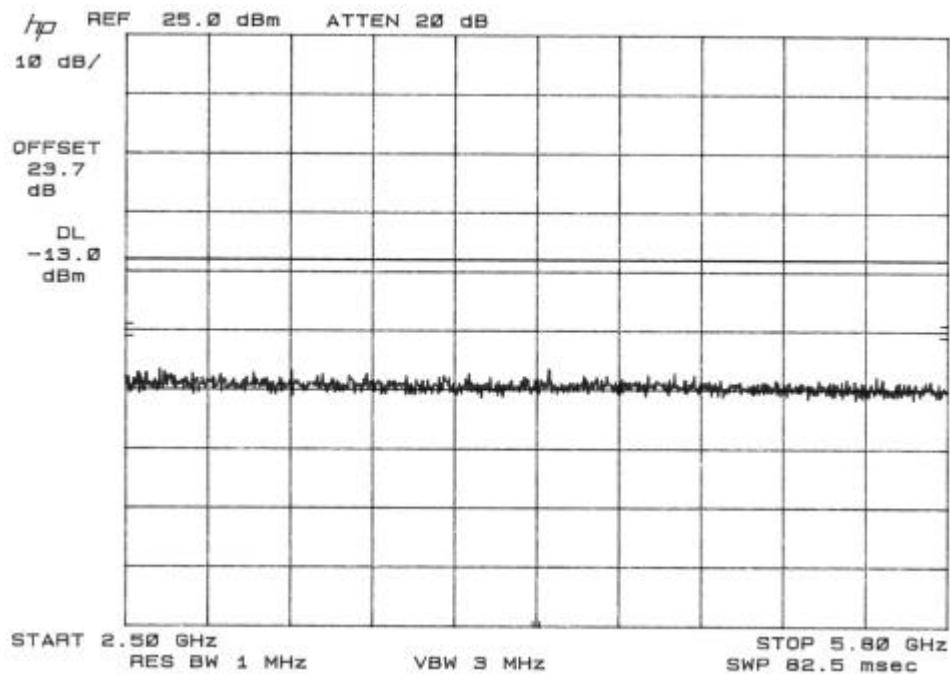
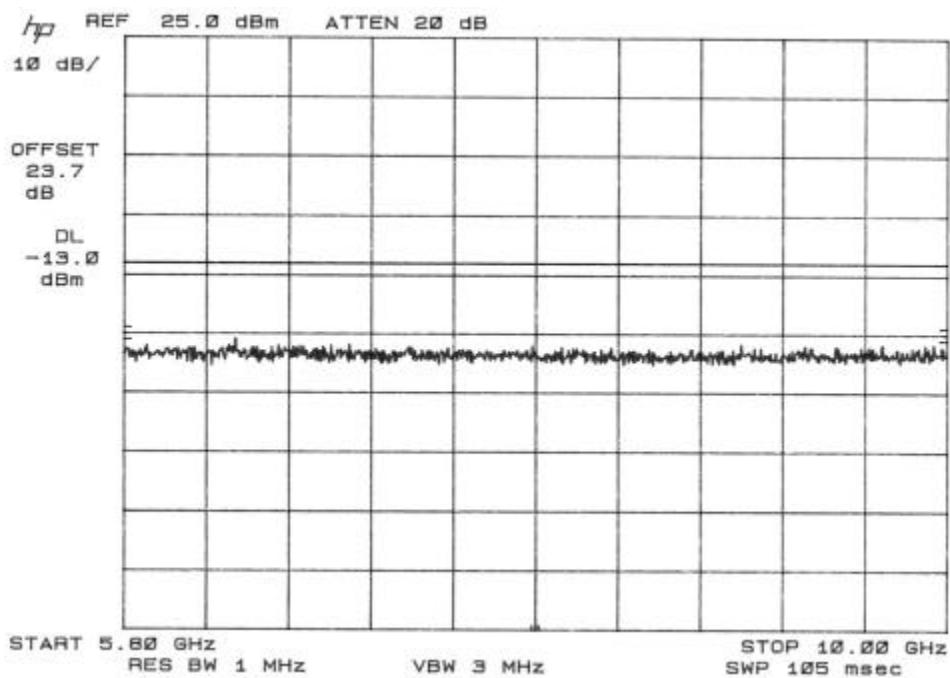
Figure 7: Conducted Spurious Emissions at Antenna Terminals, Uplink.

| Description: | RF amplifier Uplink – CDMA – Lo Channel – 824.7 MHz | | |

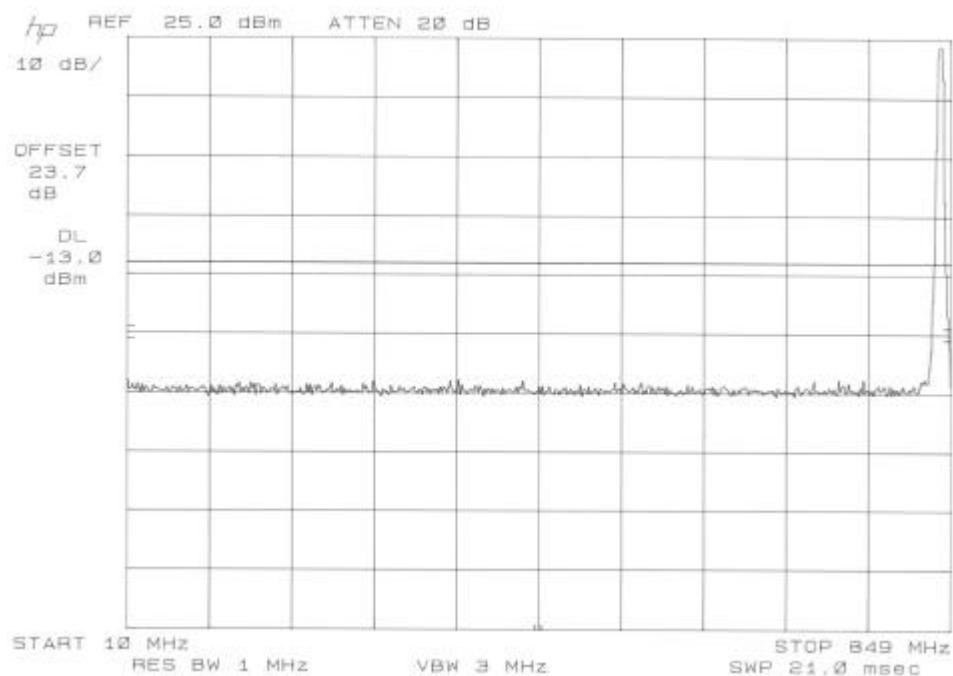
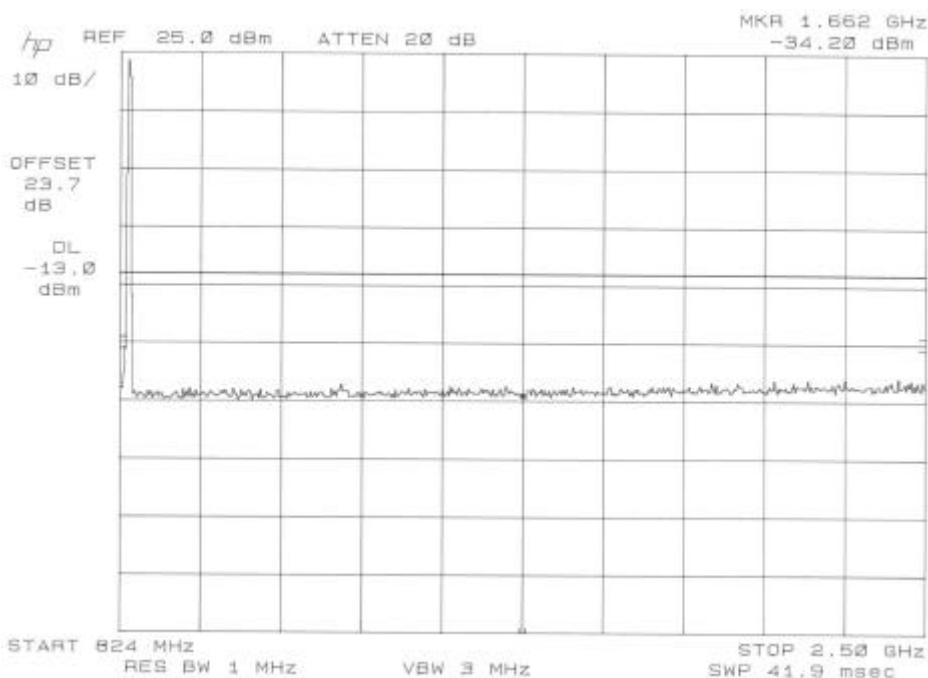
Figure 7: Conducted Spurious Emissions at Antenna Terminals, Uplink.

| Description: | RF amplifier Uplink – CDMA – Mid Channel – 836.5 MHz | | |

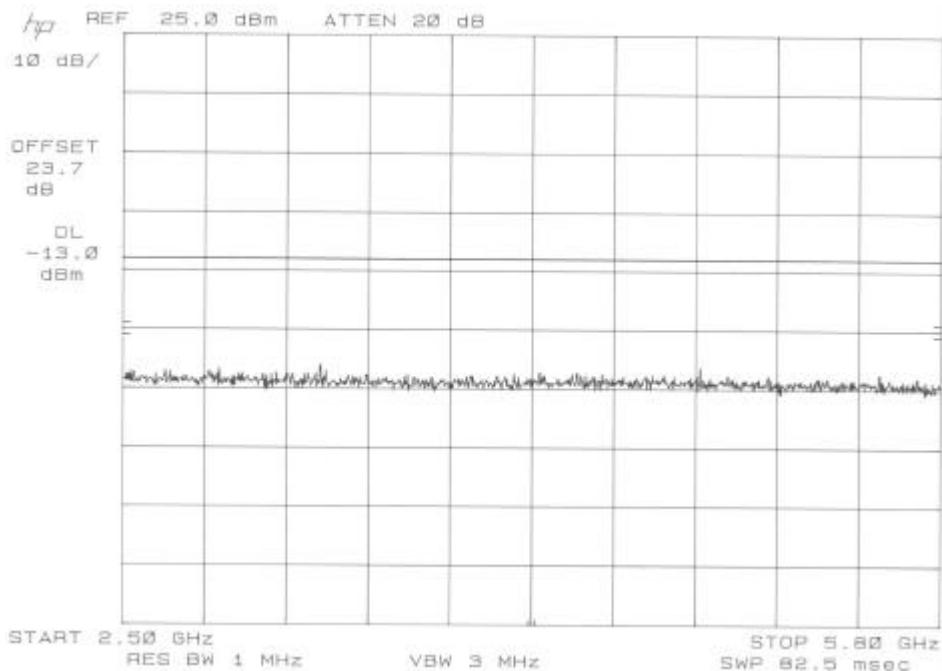
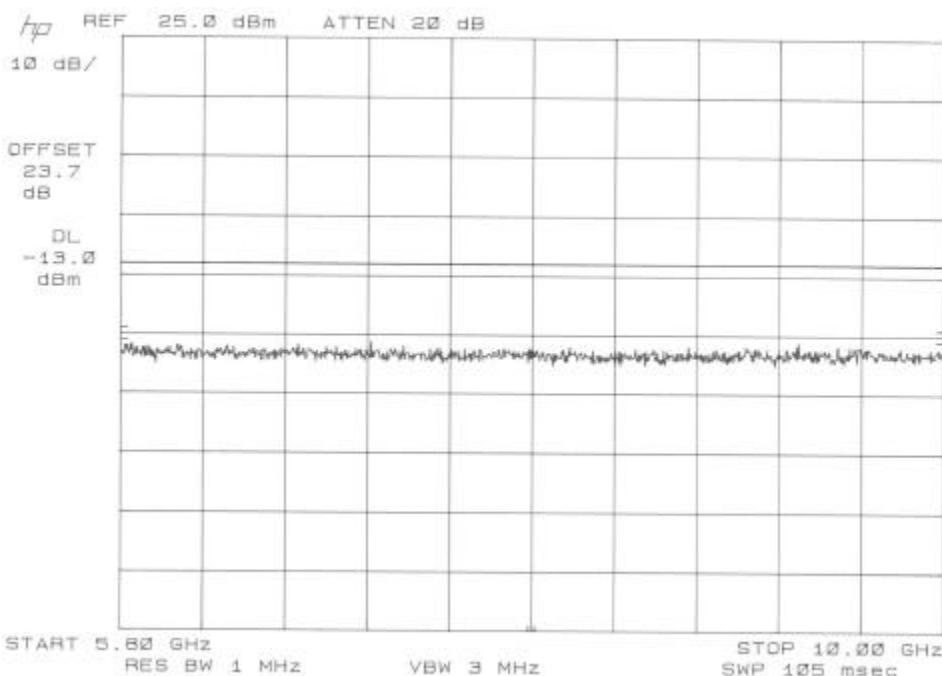
Figure 7: Conducted Spurious Emissions at Antenna Terminals, Uplink.

| Description: | RF amplifier Uplink – CDMA – Mid Channel – 836.5 MHz | | |
