USER TEST REPORT

Salt Spray Tests

1. Project :	Hawaii
2. Product reference :	Hawaii DV2
3. Date of the test :	06/08/2013 to 12/08/2013
4. Responsible:	Protocol : N. STEINMETZ Test : N. STEINMETZ
5. place of the test :	Exotest lab – Compiègne (60)

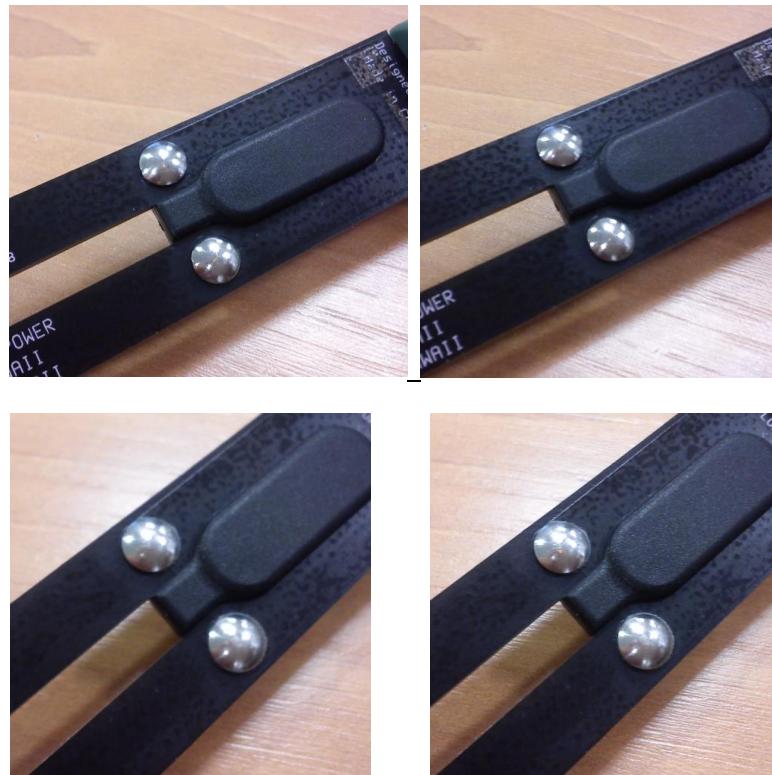
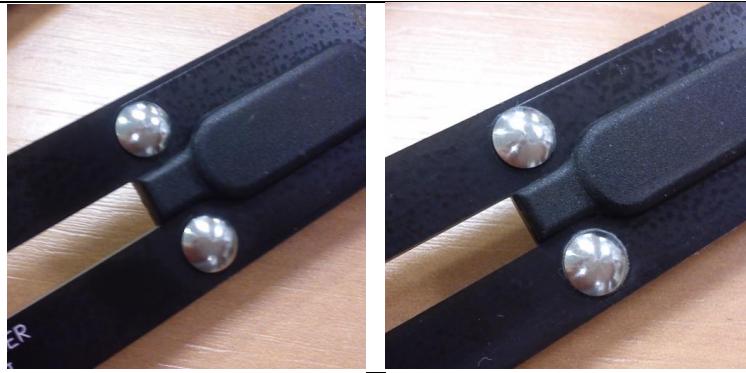
Pictures of the rivets :

No marks of corrosion have been noticed on the samples

- Airtightness test is OK
- Rivets look ok – no marks of corrosion on them
- No breakage nor cracks noticed on the sample
- No color changes occurred during the test
