# USER TEST REPORT

Abrasive tests

1. Project :	Hawaii
2. Product reference :	Hawaii DV2
3. Date of the test :	14/08/2013
4. Responsible:	<u>Protocol</u> : N. STEINMETZ <u>Test</u> : F.GOUBLE
5. place of the test :	Parrot office in Paris

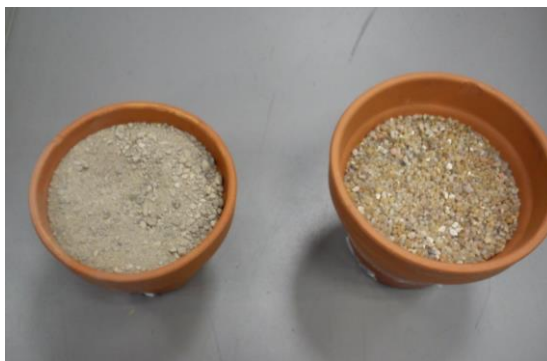
3. Test equipment reference:	Binder MK53 climatic chamber
<b>4. Result</b>	
1. Events sequence:	<p>The sample under test underwent the following test before this one :</p> <ul style="list-style-type: none"> <li>- Salt Spray test</li> </ul> <p>Test according to protocol</p> <p>Pots used for the test (sand on the left, gravels on the right) :</p>

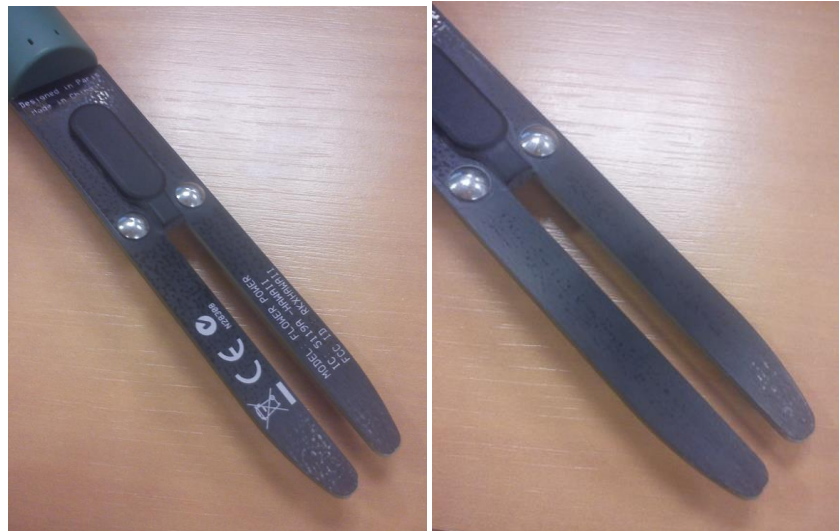
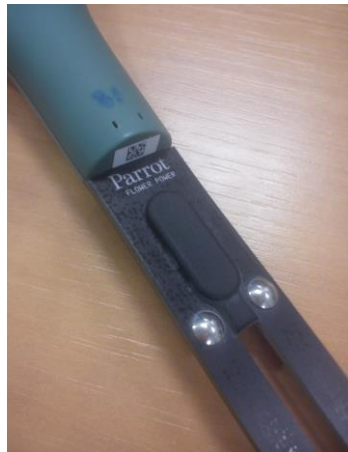
#### **3) Pictures after test**

Parrot logo is still legible ; no issue found on the fork.

- All sensors are OK. Deviations respect expectations.
- Mechanical parts are OK. Logo is still legible
