Report No.: HK08101049-1  
Tx Mode  
AC Mains “L”

Report No.: HK08101049-1  
Tx Mode  
AC Mains “N”

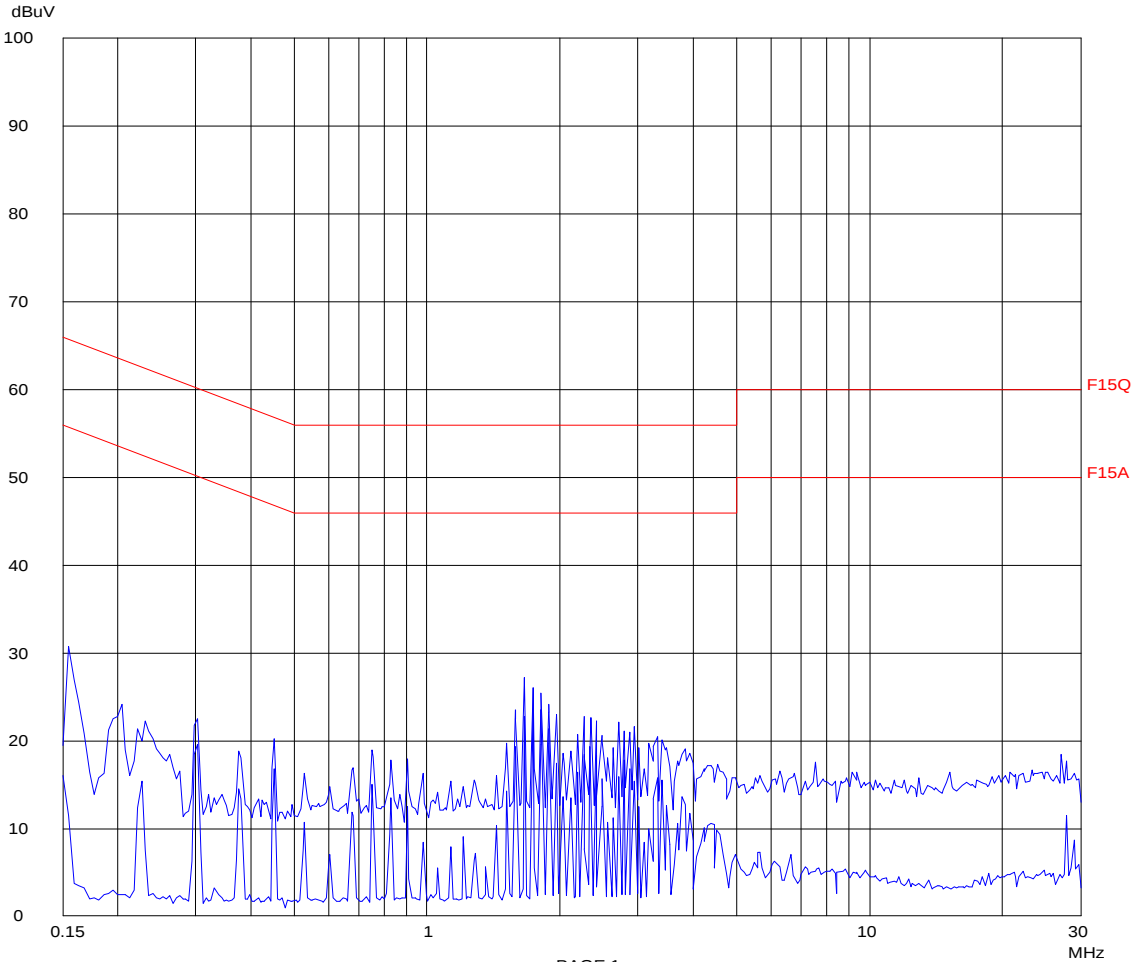
Scan Settings (1 Range)

| Frequencies | | | Receiver Settings | | | | |
|---|---|---|---|---|---|---|---|
| 150k | 30M | 4.5k | 10k | PK+AV | 10ms | AUTO | LN OFF 60dB |

Final Measurement: x QP / + AV  
Meas Time: 1 s  
Subranges: 16  
Acc Margin: 20dB

no Results

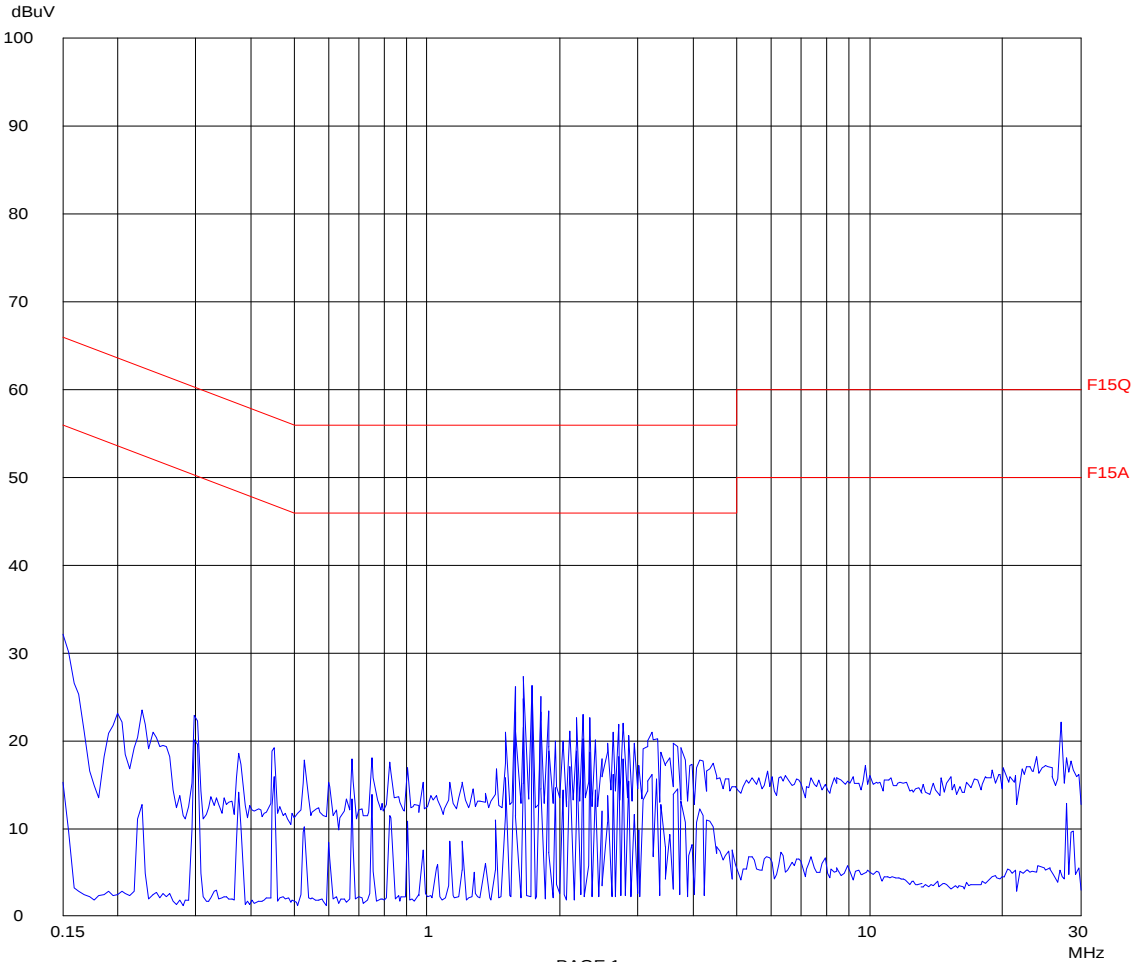
Scan Settings (1 Range)

| Frequencies | | | Receiver Settings | | | | |
|---|---|---|---|---|---|---|---|
| 150k | 30M | 4.5k | 10k | PK+AV | 10ms | AUTO | LN OFF 60dB |

Final Measurement: x QP / + AV  
Meas Time: 1 s  
Subranges: 16  
Acc Margin: 20dB

no Results
