### **APPENDIX 3: Photographs of test setup**

#### **Radiated Spurious Emission**

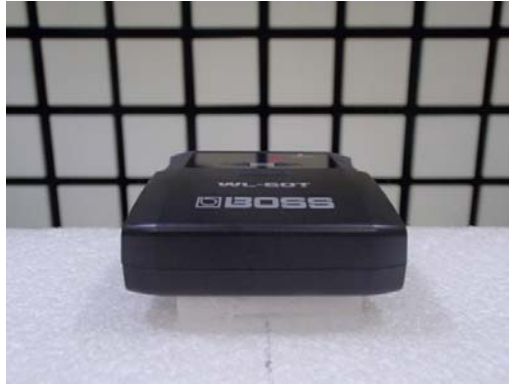
**X-axis**

Below 1GHz (Horizontal: X-axis / Vertical: X-axis)

Above 1GHz Carrier (Horizontal: X-axis / Vertical: Z-axis)

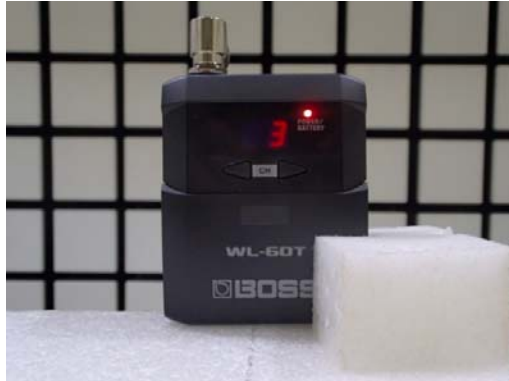
**Y-axis**

Above 1GHz Harmonic (Horizontal: Z-axis / Vertical: Y-axis)
