### **APPENDIX 3: Photographs of test setup**

#### **Radiated Spurious Emission**

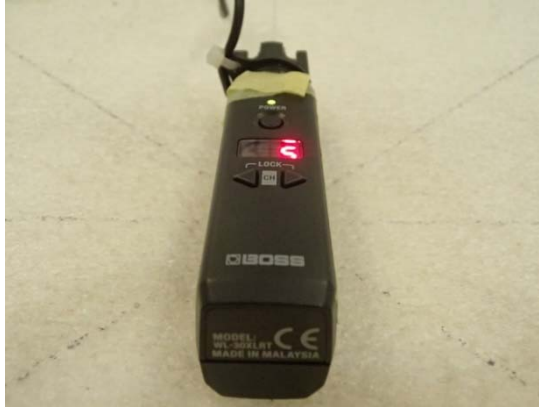
**X-axis**

**Worst Case Position**

**Above 1GHz (Horizontal: Z-axis/ Vertical:X-axis)**

**Below 1GHz (Horizontal: X-axis/ Vertical:X-axis)**

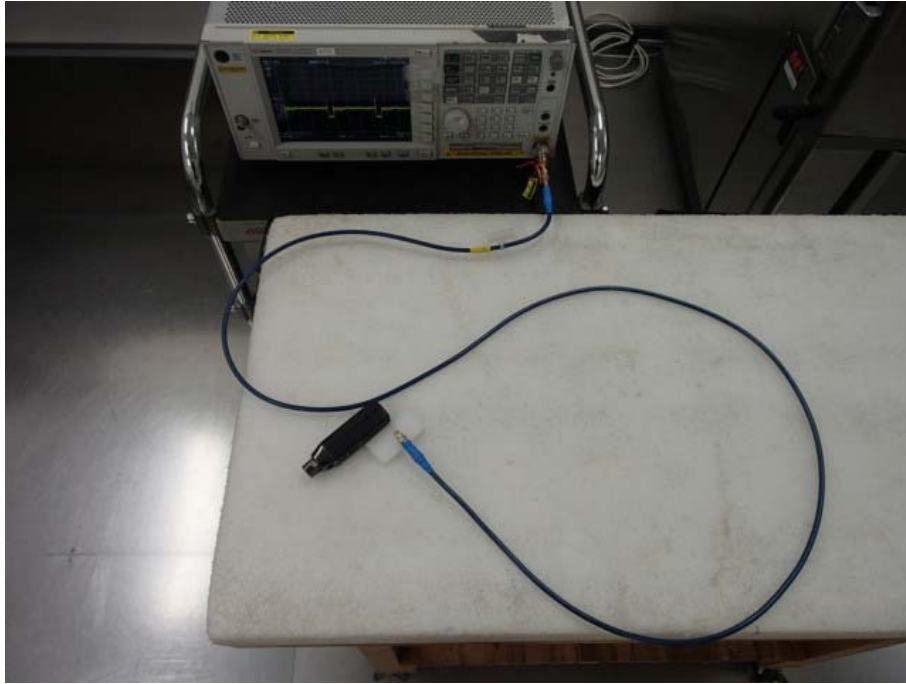
**Photo 1**

### Antenna Terminal Conducted Tests
