**Prüfbericht - Nr.:** 15059842 001  
*Test Report No.:*

## 7. Photographs of the Test Setup

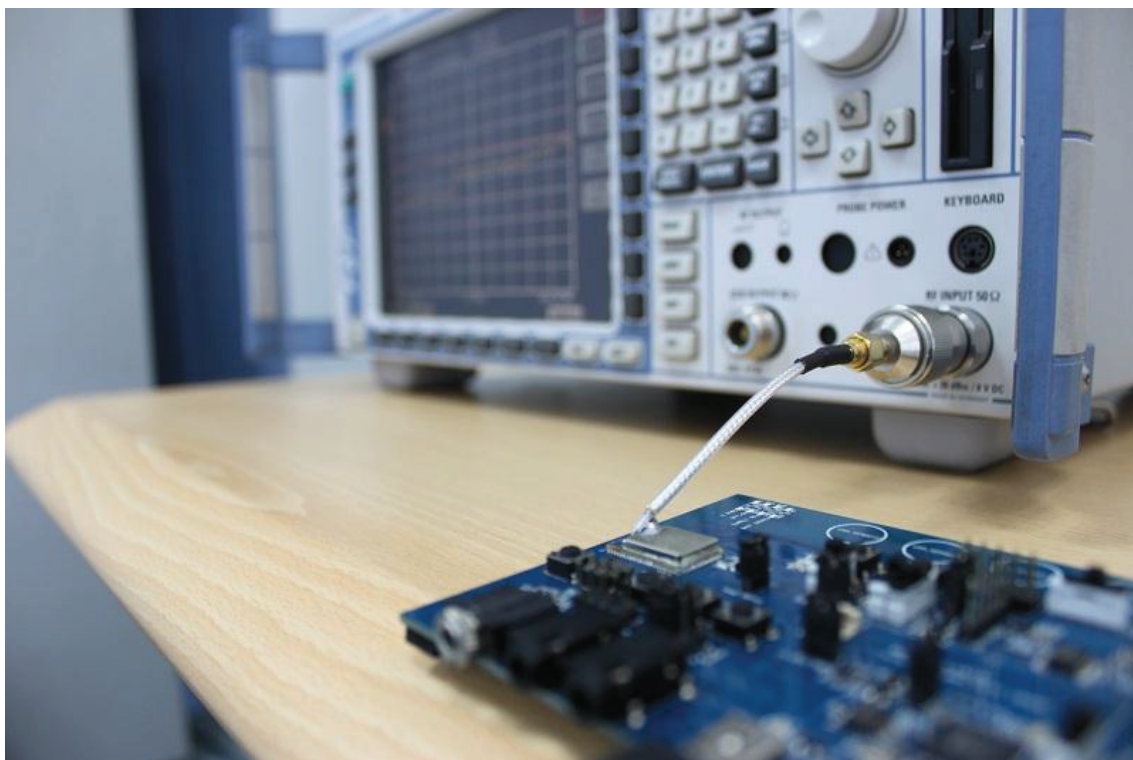
**Photograph 1: Set-up for Conducted RF test at Antenna Port**

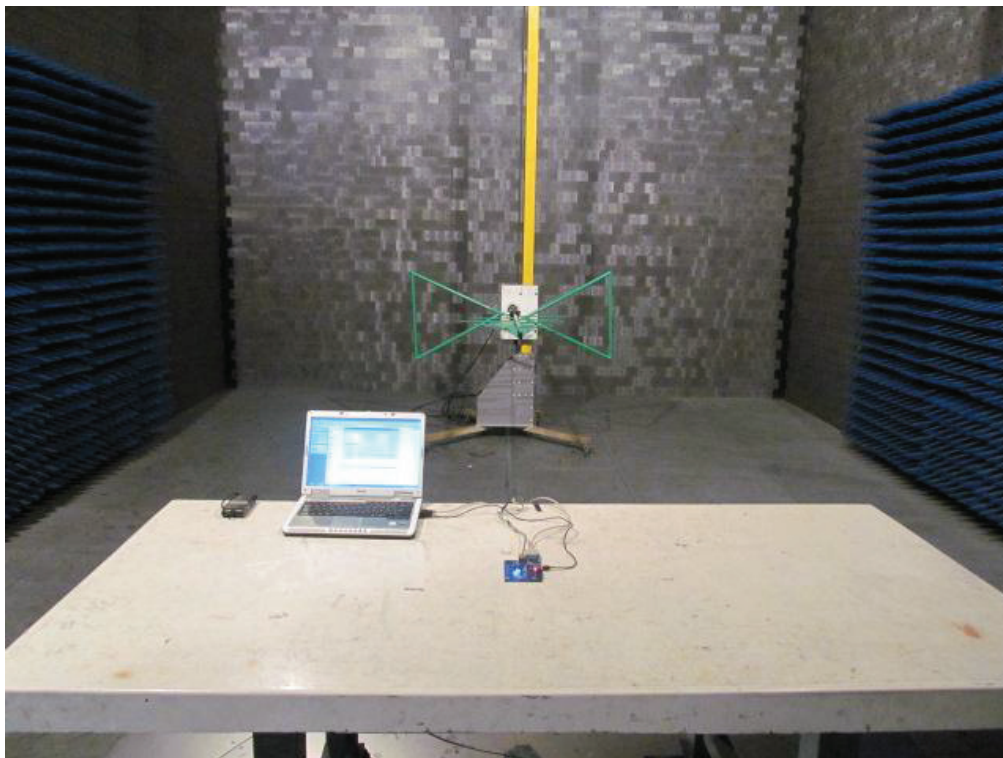
**Photograph 2: Set-up for Radiated Emission, 30MHz-1000MHz**

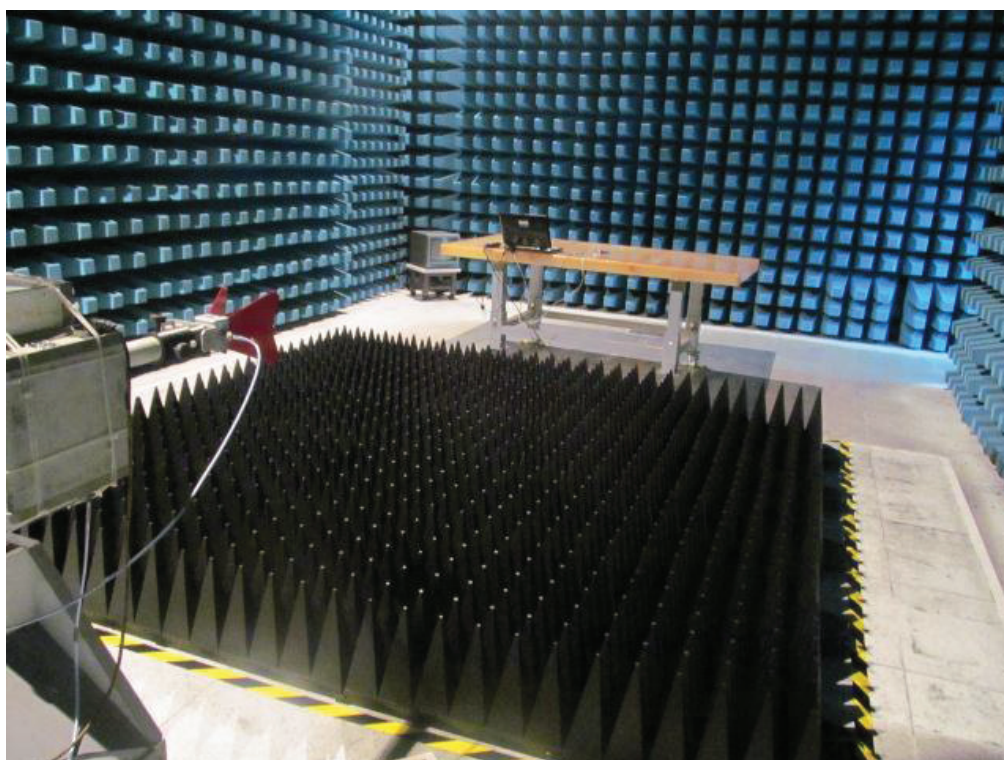
**Photograph 3: Set-up for Radiated Spurious Emission, 1G-18GHz**
