**Prüfbericht - Nr.: 16008030 001**  
Test Report No.:

## 6 Photographs of the Test Set-Up

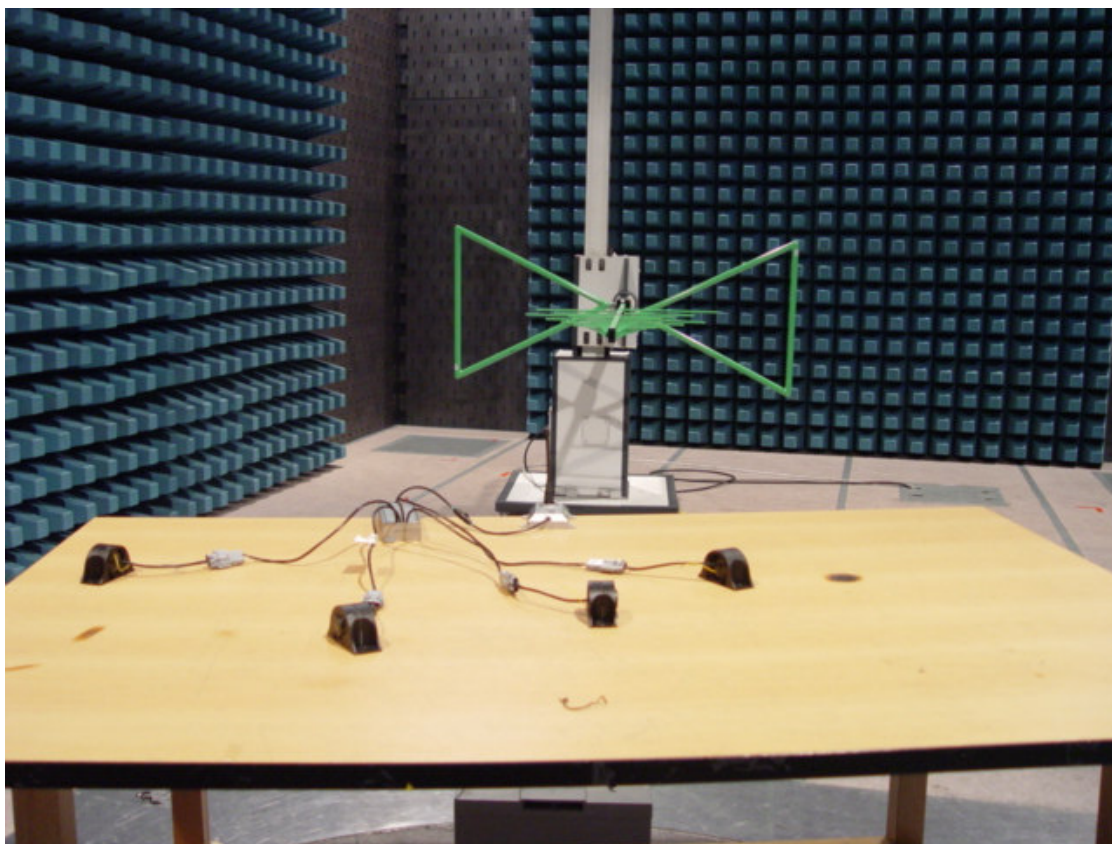
**Photograph 1: Set-up for Radiation Measurement Below 1GHz**

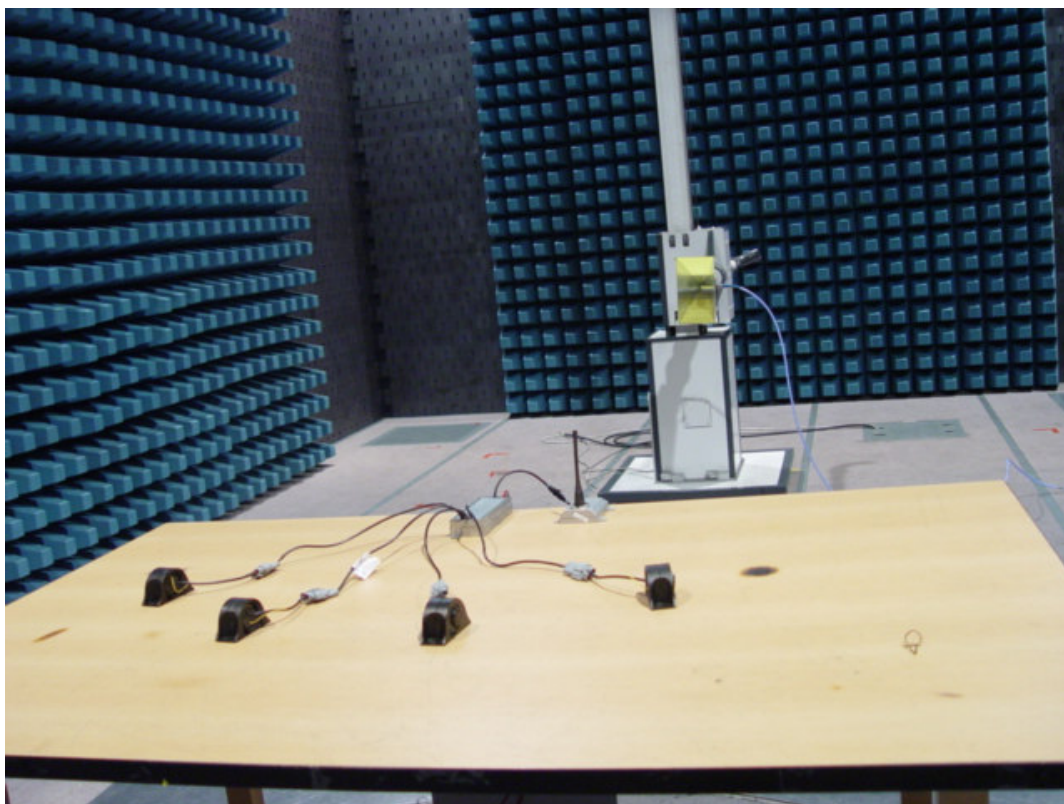
**Photograph 2: Set-up for Radiation Measurement Above 1GHz**
