FS-P6501C EMC Modification list for FCC Permissive change

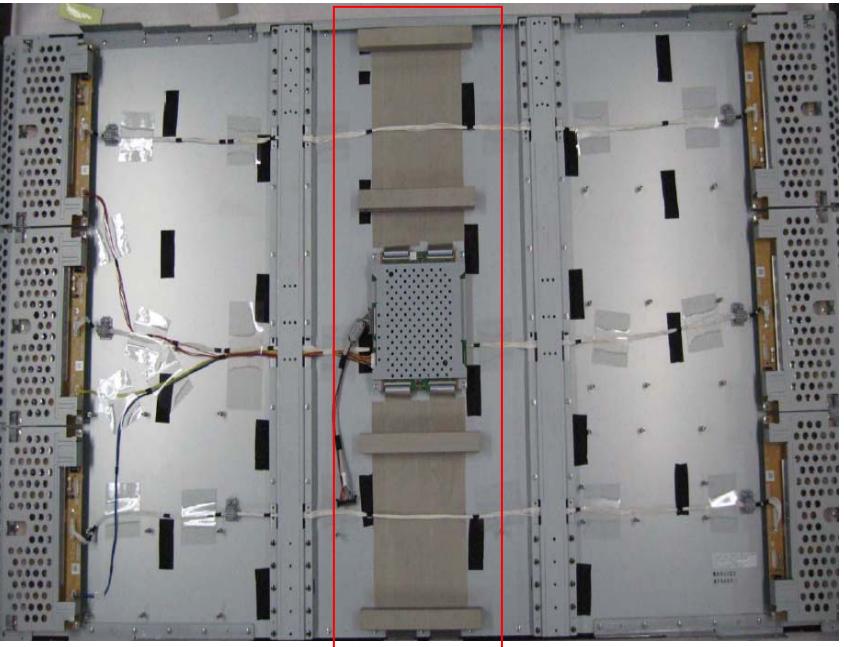
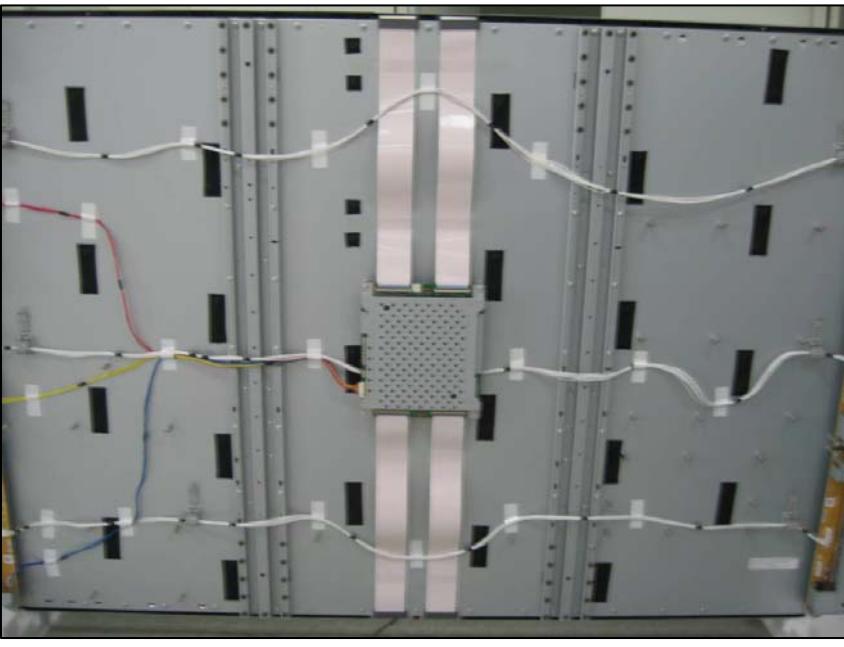
1. On the LCD Panel Module Assembly.

1) Removed all kind of EMI tape and gasket on the LCD Panel

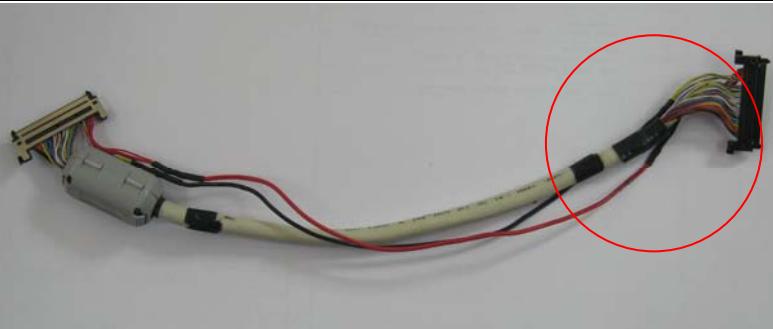
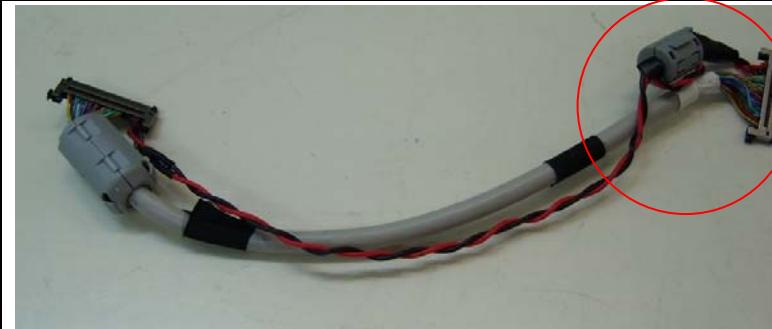
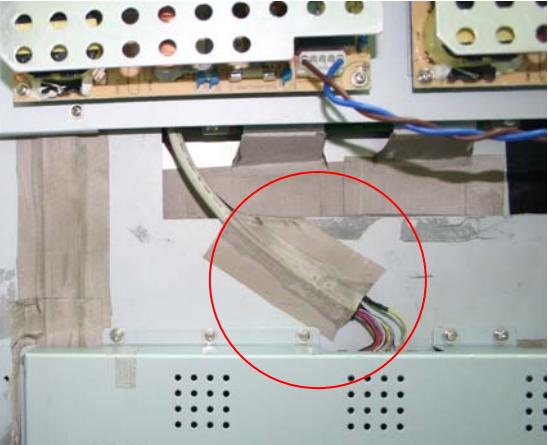
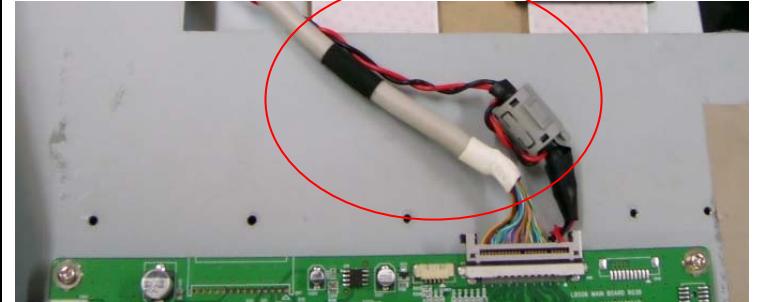
2. On the LVDS Cable.

<p>1) One more ferrite core(ZCAT1518-0730A, TDK) installed on the DC power wire with one time turning.</p>	
<p>2) Both DC power wire(Black and white) must be twisted each other</p>	
<p>3) EMI Tape removed on this cable</p>

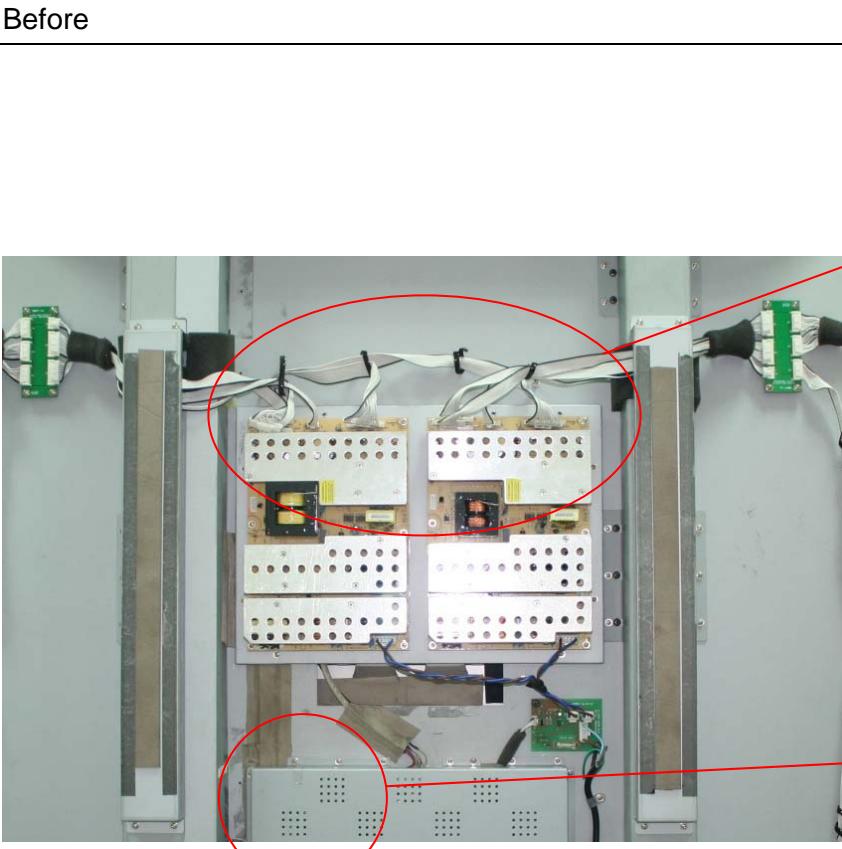
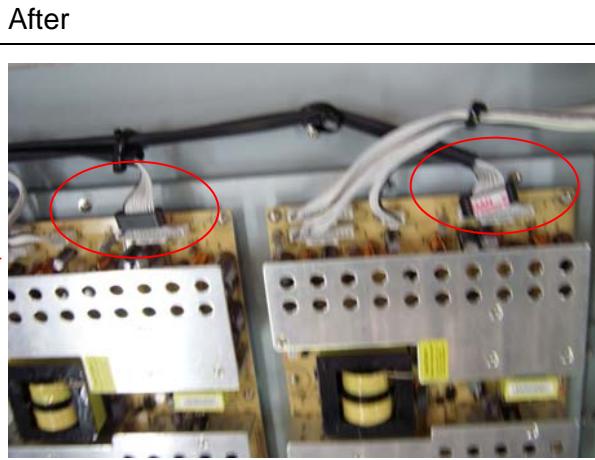
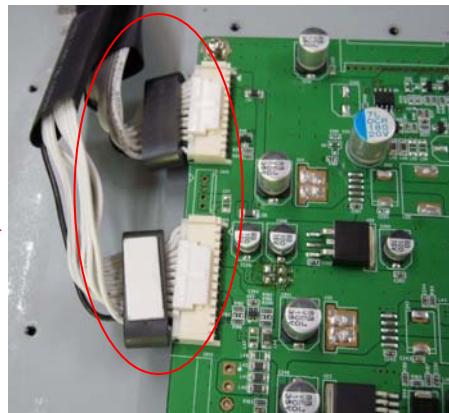
3. On the SMPS cable

<p>1) Four Ferrite core(PC2910, SCC) installed on this cable.</p>

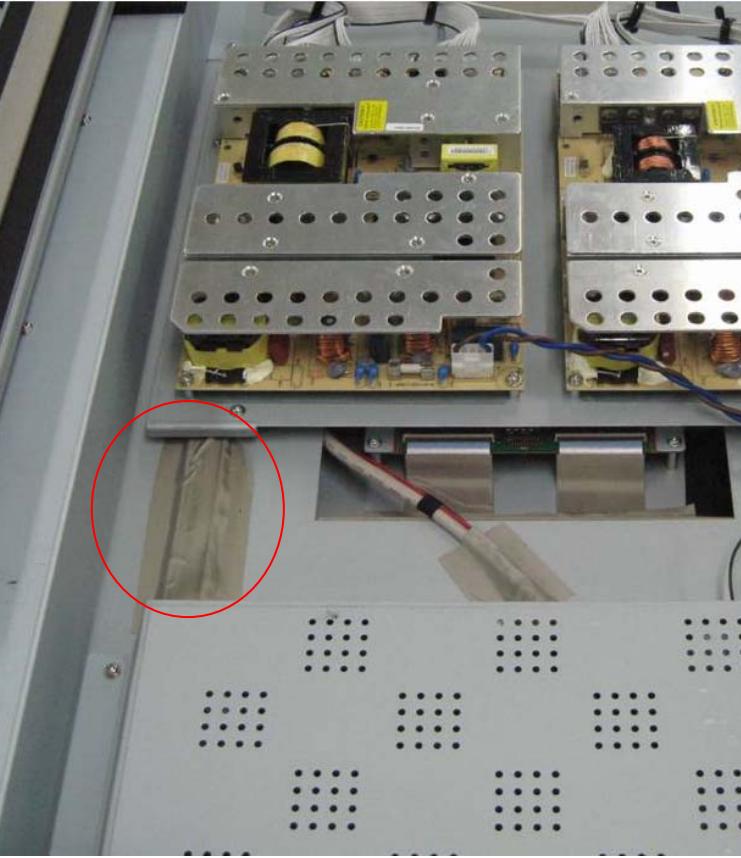
4. SMPS Cable Arrangement

A photograph showing the internal components of a power supply unit. Two SMPS (Switched Mode Power Supply) modules are mounted on metal heat sinks. A red circle highlights a cable that is loosely arranged and appears to be in direct contact with the metal chassis of the unit.

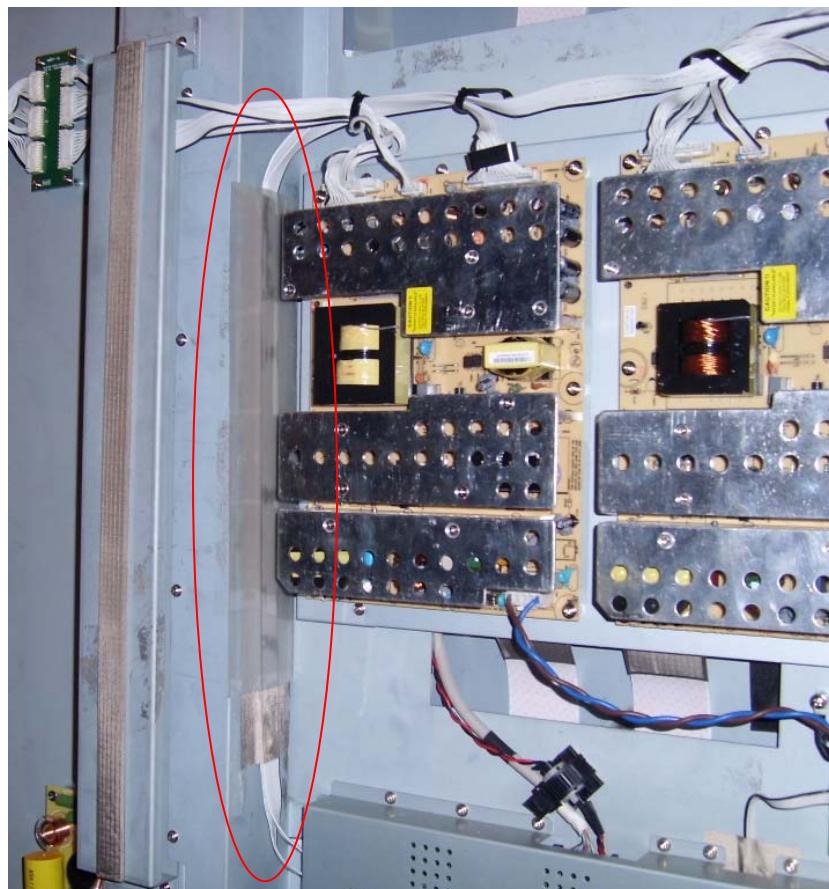
A photograph showing the same power supply unit after the cables have been properly arranged. A red circle highlights a cable that is now properly insulated from the metal chassis by a sheet of insulation, preventing any potential short circuits or electrical hazards.

1) both SMPS cable must be arranged in this way with insulation sheet to prevent touching SMPS circuit.

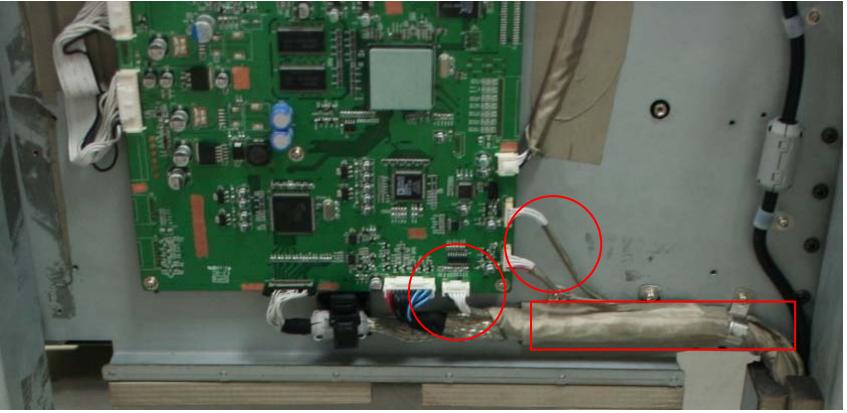
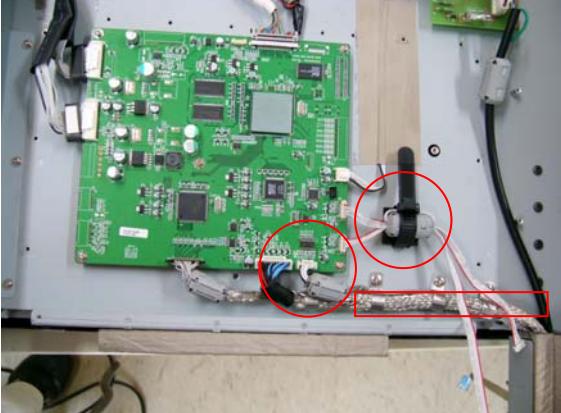
6. Signal cable arrangement

1) one ferrite core(ZCAT1730-0730A,TDK) installed on the RS232C wire	
2) One ferrite core(ZCAT2035-0930A,TDK) installed on both inductor cable with 1 time turning.	
3) EMI Tape removed on this wire

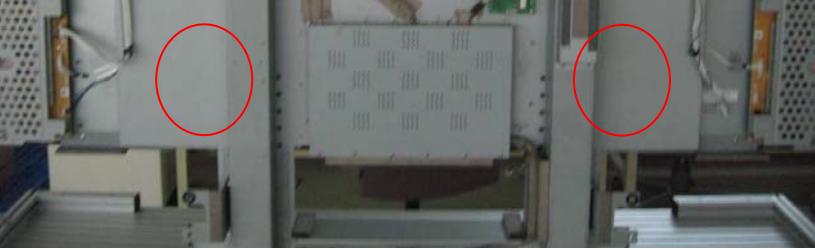
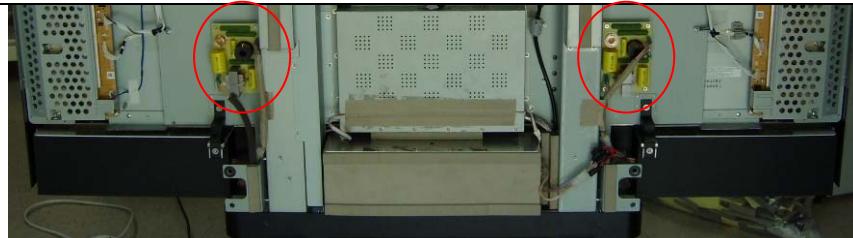
7. Crossover filter board

<p>1) Crossover filter board installed on the main chassis : Originally this board was installed in the speaker cabinet before, but now it will be moved on the main chassis</p>

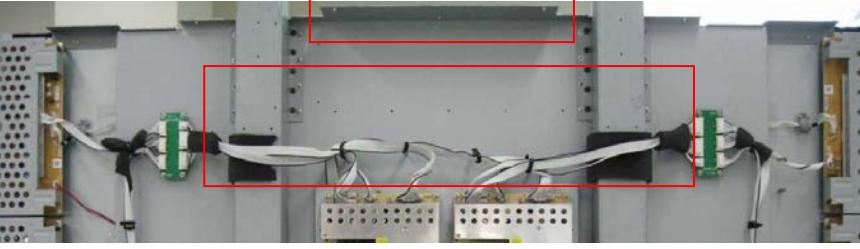
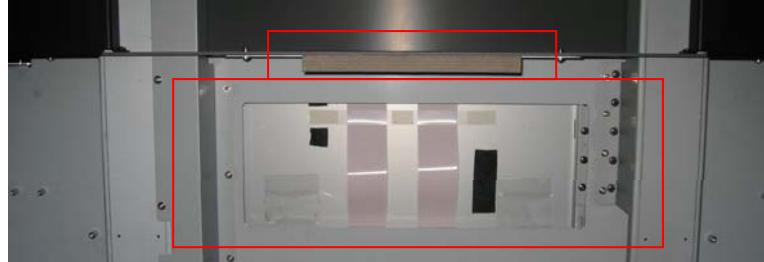
8. Main chassis

<p>1) Main chassis cut off for the heat ventilation. 2) EMI Form gasket installed on this point to make contact with rear cover.</p>

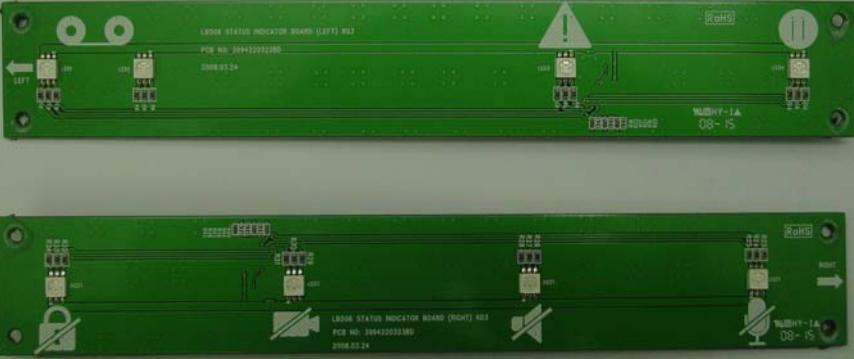
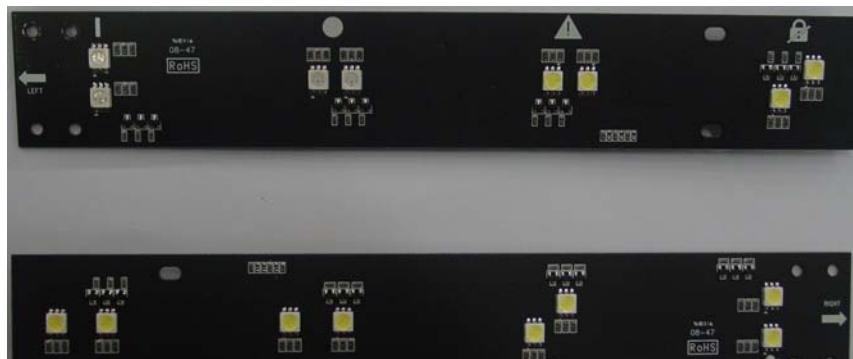
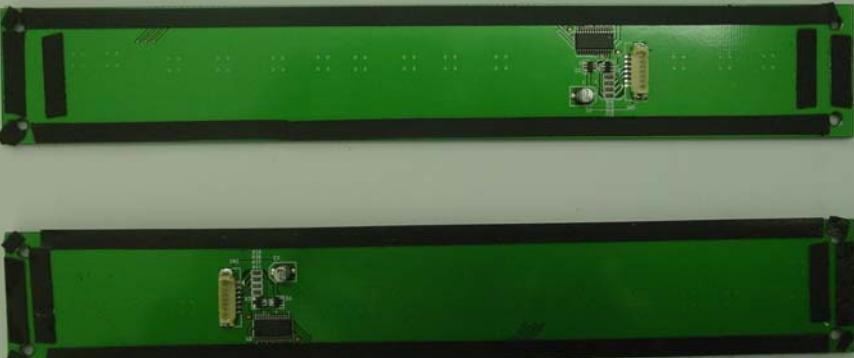
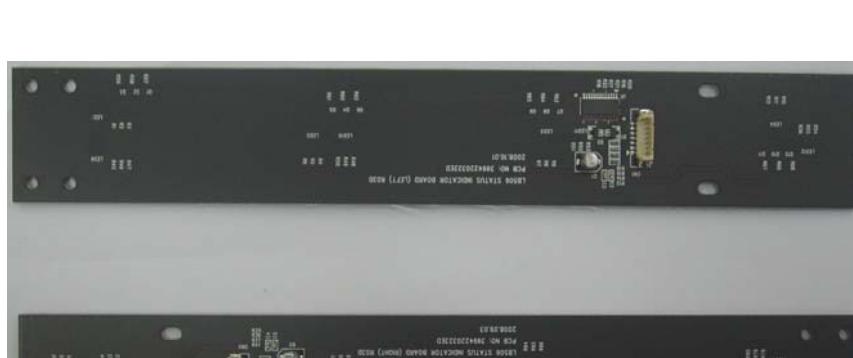
10. Status indicator board

<p>2 kinds of Status indicator board will be modified</p> <ol style="list-style-type: none">1) one more LED will be added for each indication logo2) PCB Coating color will be changed from green to black
