FS-S5201C EMC Modification list for FCC Permissive change

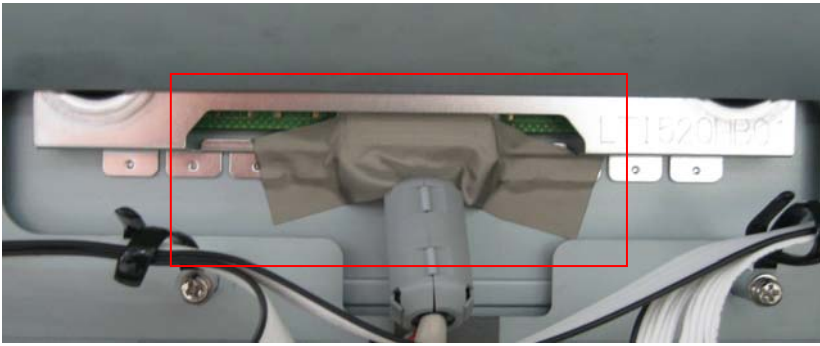
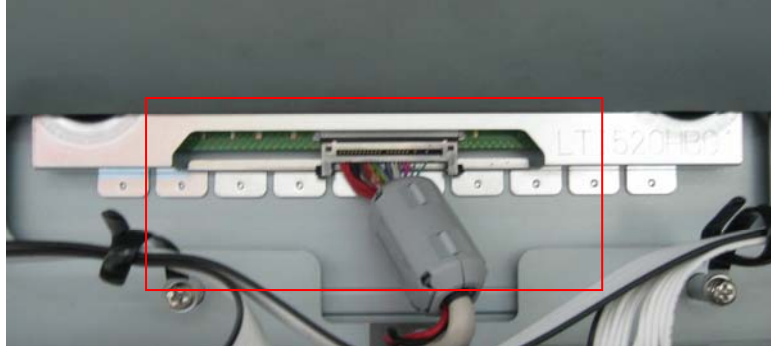
1. On the LVDS cable

A close-up photograph of an LVDS cable connector. A piece of tan-colored EMI tape is wrapped around the green pin headers of the connector. A red rectangular box highlights the area where the tape is applied. The connector is labeled "LT1520HBC".

A close-up photograph of the same LVDS cable connector after the EMI tape has been removed. The green pin headers are now visible. A red rectangular box highlights the area where the tape was previously located. The connector is labeled "LT1520HBC".
1) EMI tape removed on the LVDS Cable

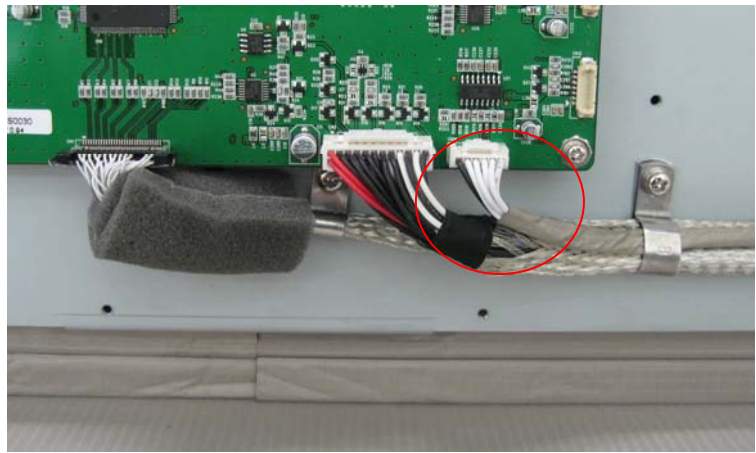
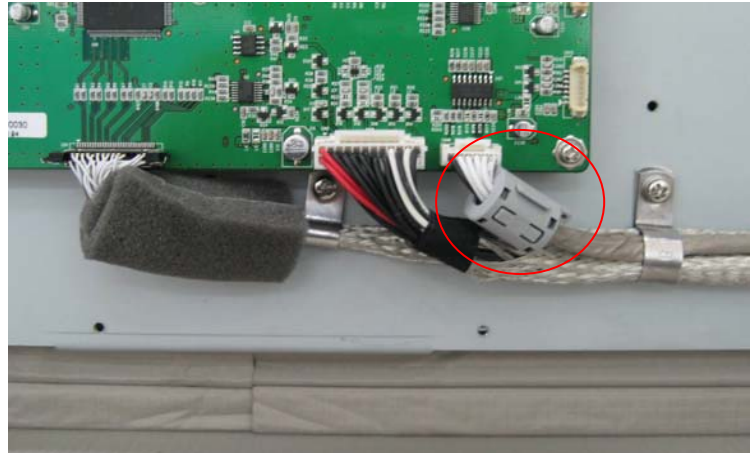
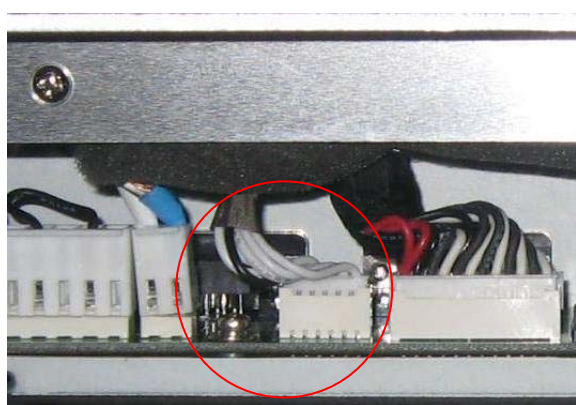
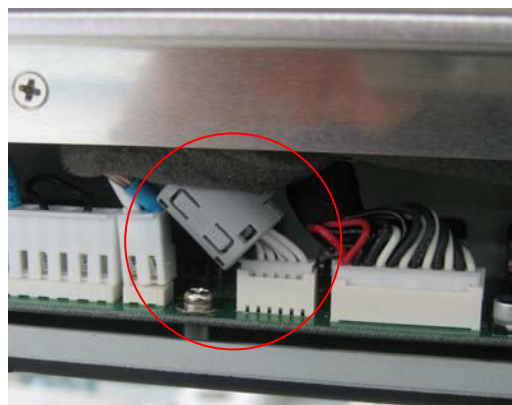
2. On the RS232C cable

1) Two ferrite core(ZCAT1518-0730A, TDK) installed on the RS232C cable.

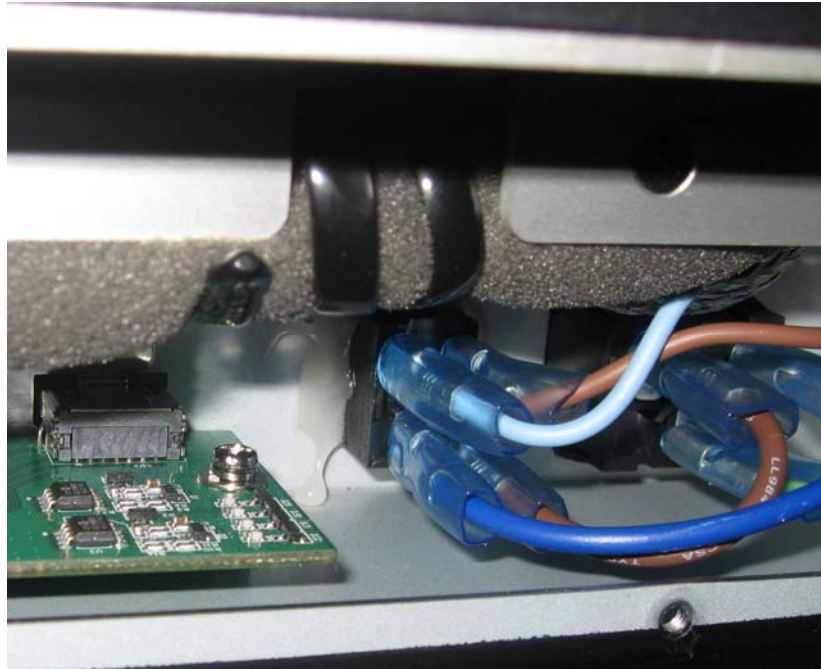
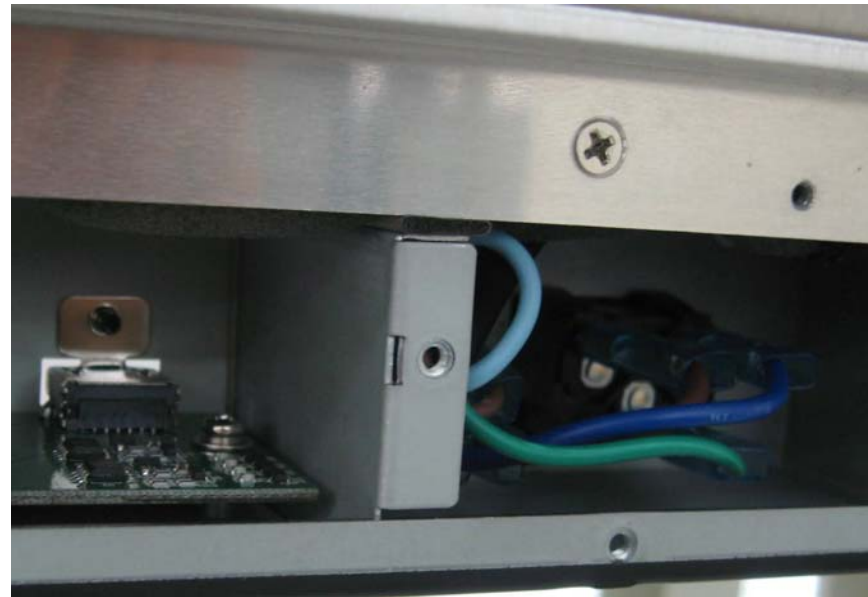
3. In the IO box

1) Fence installed between AC switch and IO board to prevent interference of high frequency.
