Annex 3 of Test Report INO-EEC 12478-1: Photos of the Test Set-ups

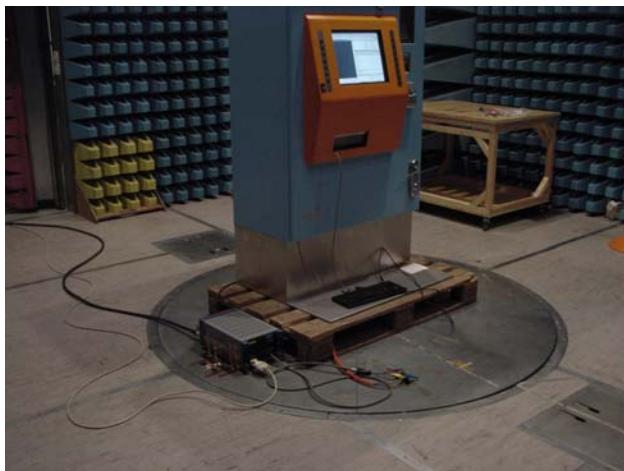
Conducted disturbances according to ANSI C 63-4-2003 (see chap. 5.1 of test report):

Photo 1: Conducted disturbances (Front view)

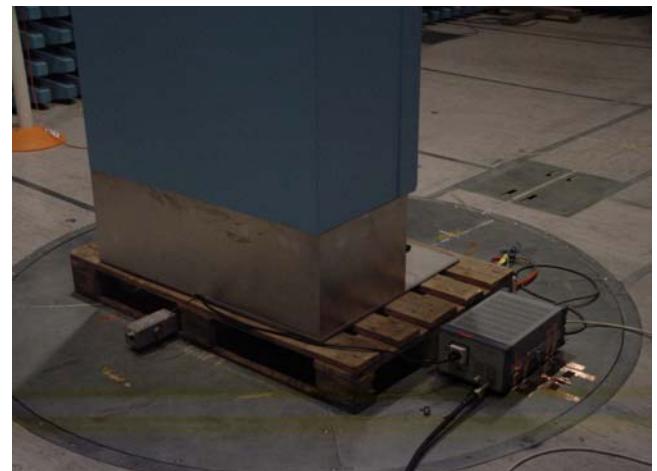
Photo 2: Conducted disturbances (Rear view)

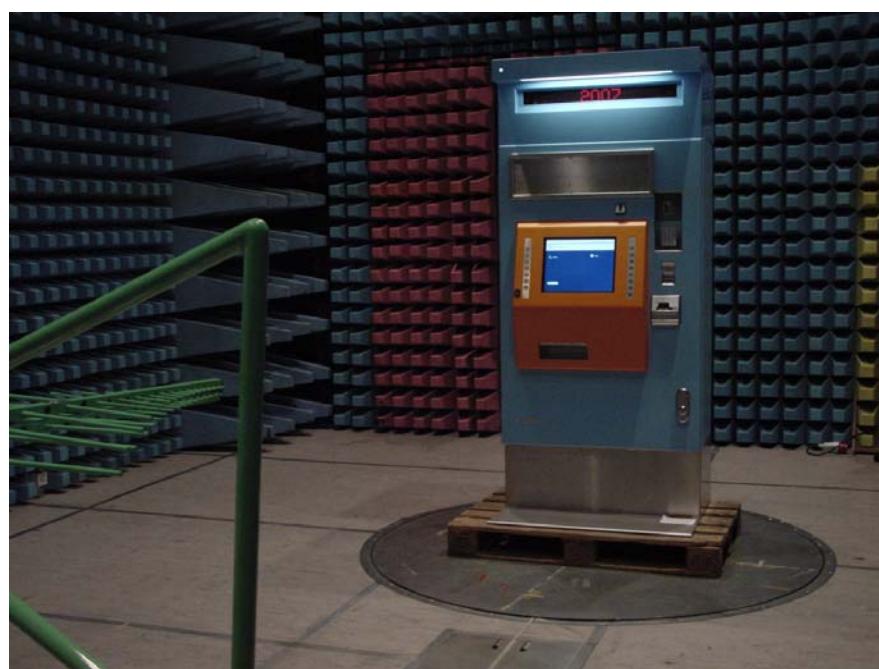
Radiated E-Field according to ANSI C 63-4-2003 (see chap. 5.2 of test report):

Photo 3: E-Field Measurement

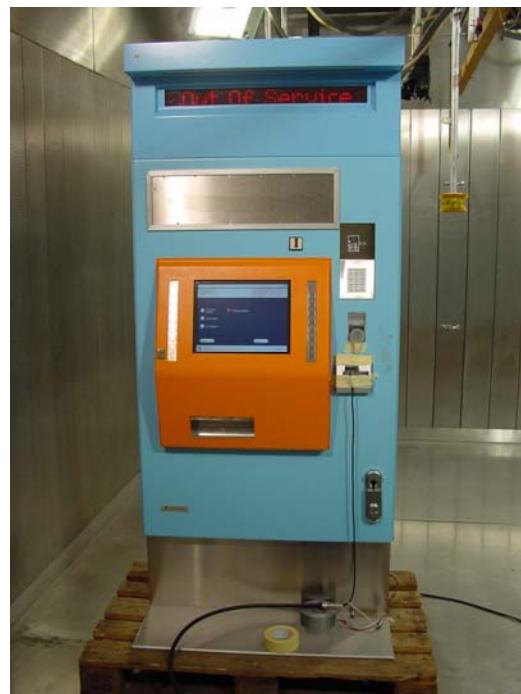
Measurement of the carrier stability in the climatic chamber (see chap. 5.5 of test report):

Photo 5: H-Field Measurement in the climatic chamber

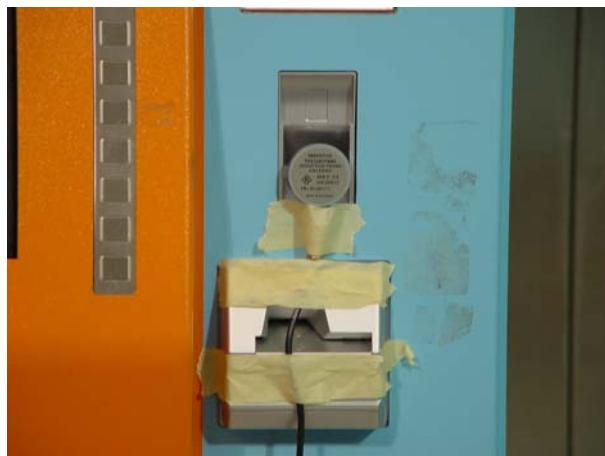
Photo 6: Set-up H-Field antenna

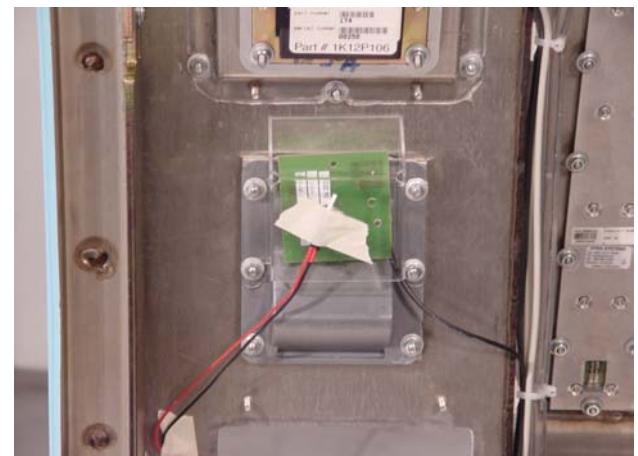
Photo 7: Set-up of the temperature sensor inside the system close to the detector antenna
