## 6 Photographs of the Test Set-Up

**Prüfbericht - Nr.:** CN23WJ7J 002  
*Test report no.*

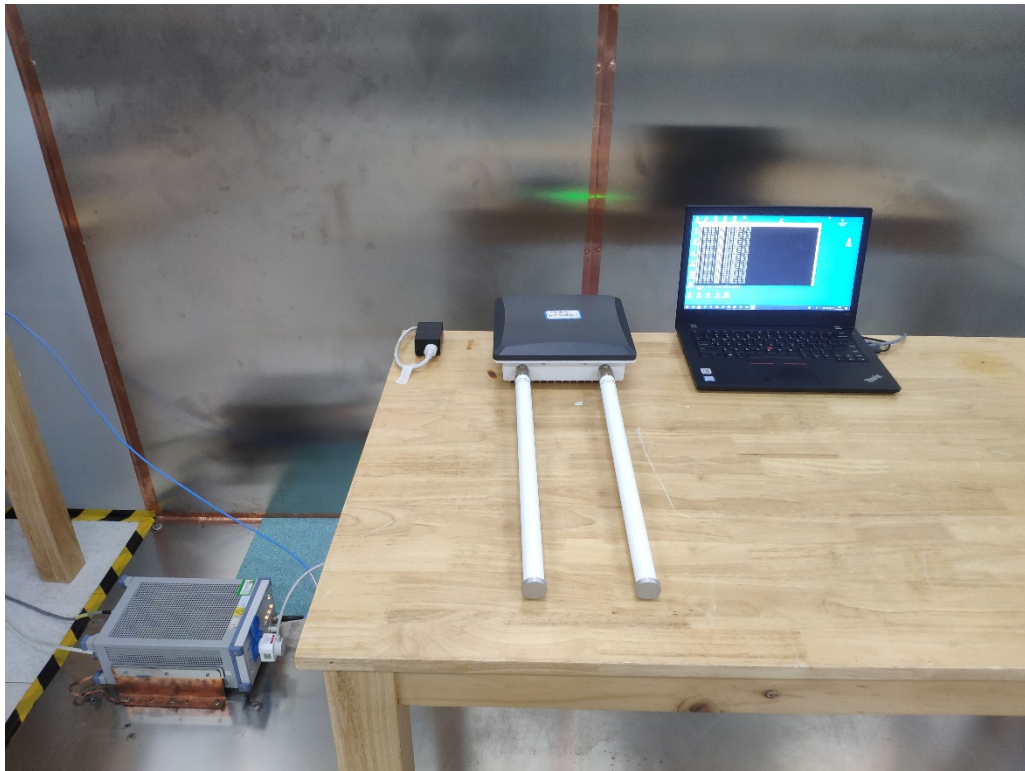
**Photograph 1: Set-up for Conducted Emissions, AC Mains**

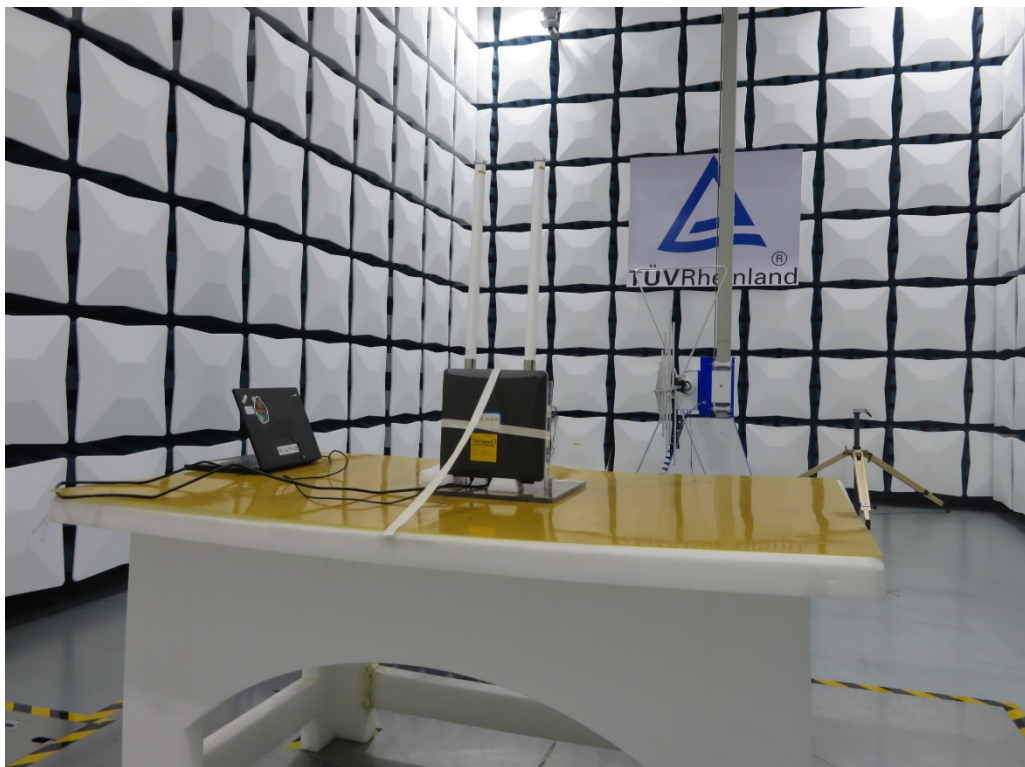
**Photograph 2: Set-up for Co-Located Radiated Spurious Emissions, below 1GHz**

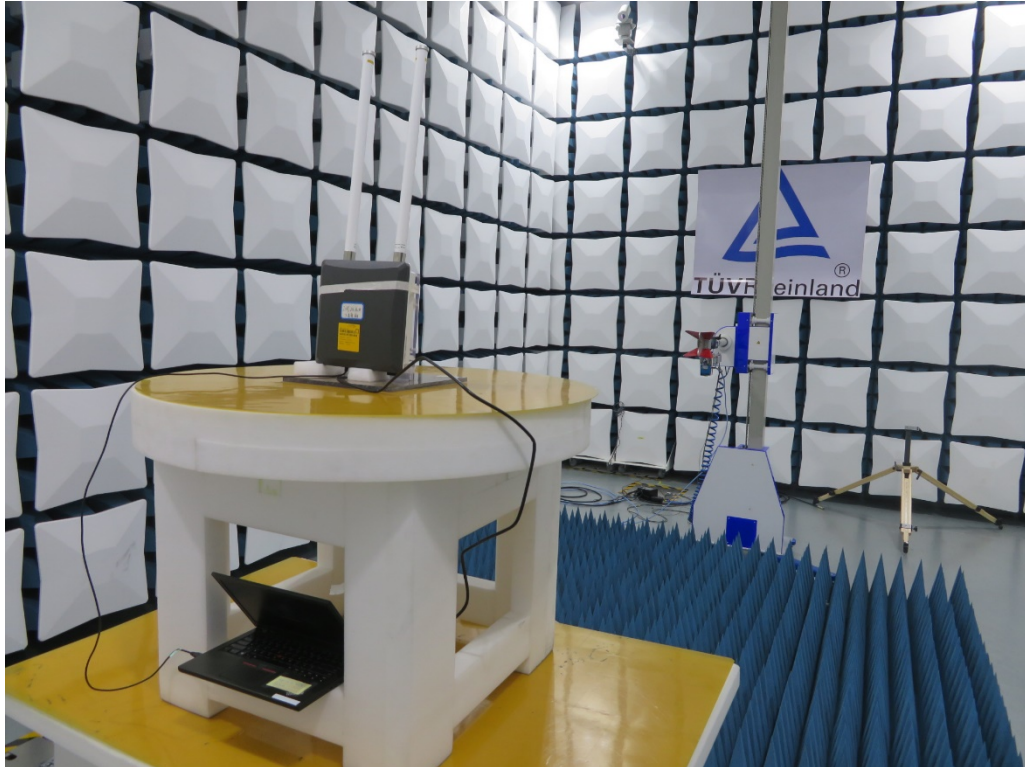
**Photograph 3: Set-up for Co-Located Radiated Spurious Emissions, above 1GHz**
