Equipment Under Test (EUT): rescueME PLB1, s/n TA5**SW version:** Issue 00.03**Test Date:** 08.11.2012**Test Conditions:**

TEST PROGRAM

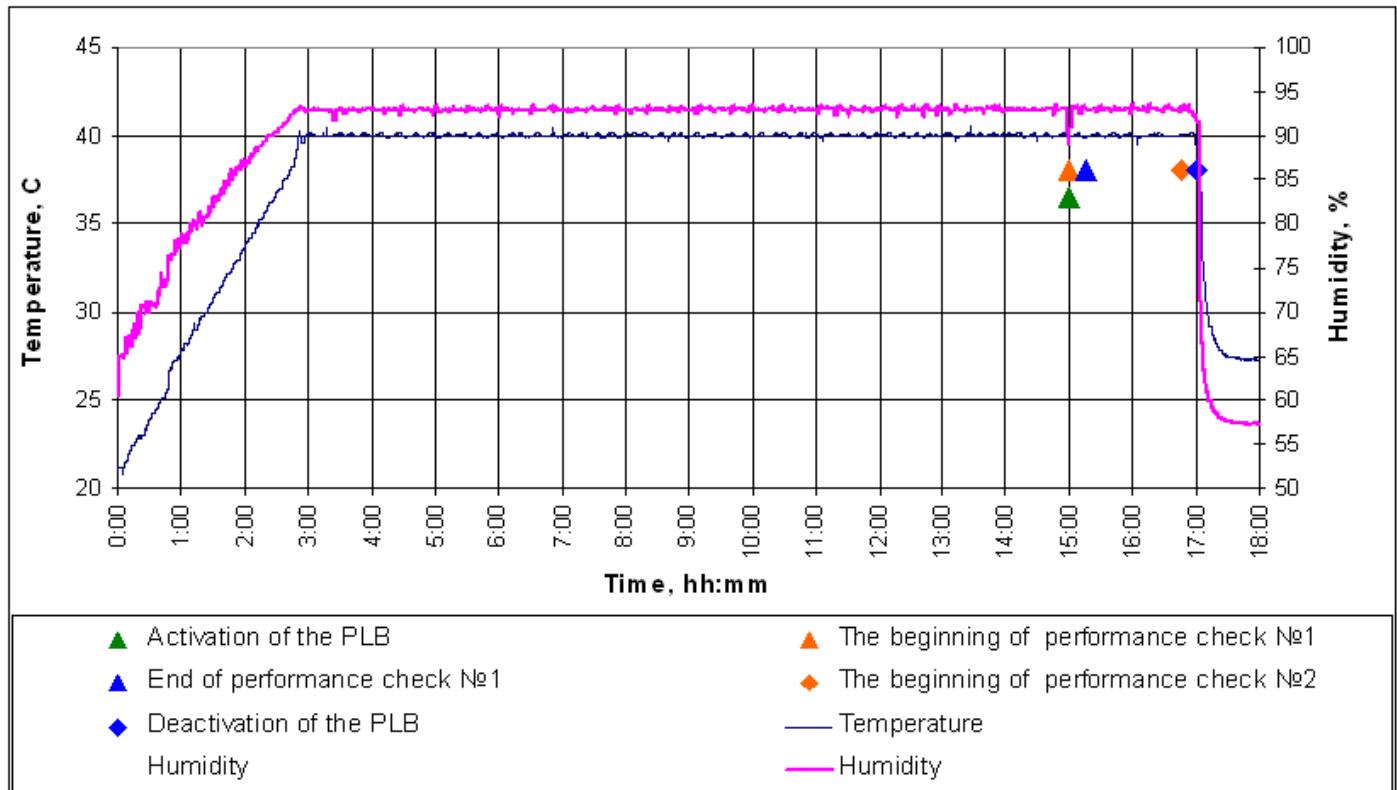
Figure 3.2 – Humidity Module Test Conditions Plot

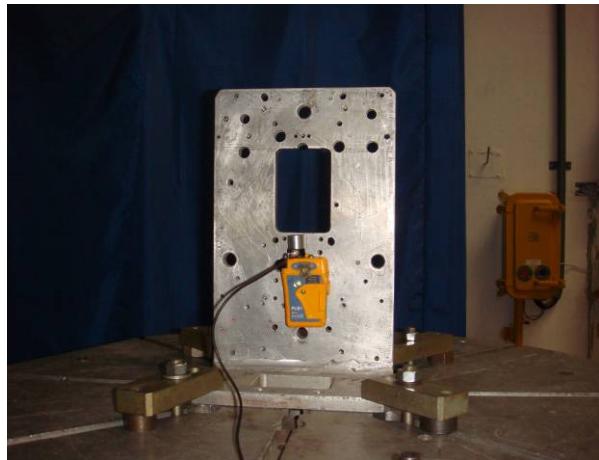
For vertical vibration in Z vertical axis EUT was fastened to the vibration table in its normal attitude using special brackets (see Figure 5.1).

Figure 5.1 - General view of the test site vertical vibration

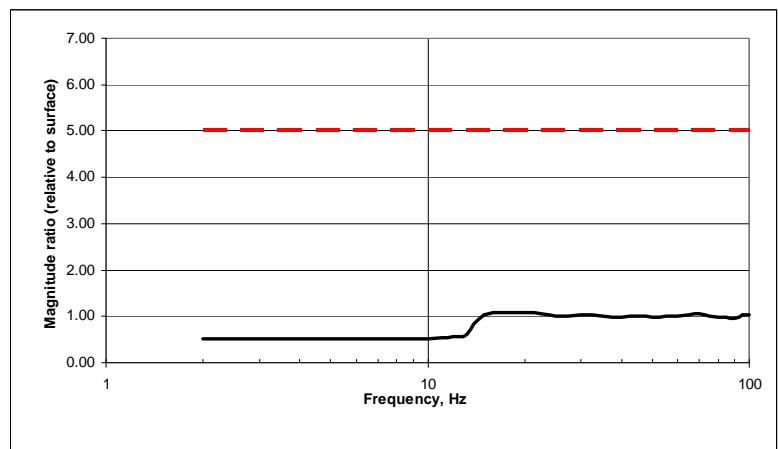
Figure 5.2 - Magnitude ratio vs. frequency during vibration on vertical axis Z

During the search of EUT resonance, tested specimen was externally observed by unaided aural and visual means. Relative magnitude is shown in table below.

Frequency, Hz	Magnitude ratio	Frequency, Hz	Magnitude ratio
2	0.52	55	0.72
4	0.52	60	0.71
6	0.51	65	0.74
8	0.53	70	0.75
10	0.52	75	0.71
12	0.52	80	0.70
13.2	0.56	85	0.70
15	0.74	90	0.69
20	0.77	95	0.73
25	0.72	100	0.74
30	0.73		
35	0.72		
40	0.70		
45	0.71		
50	0.70

As no resonance with magnitude ratio ≥ 5 occurred, the endurance test was carried out at one single observed frequency 30 Hz during 2 hours.

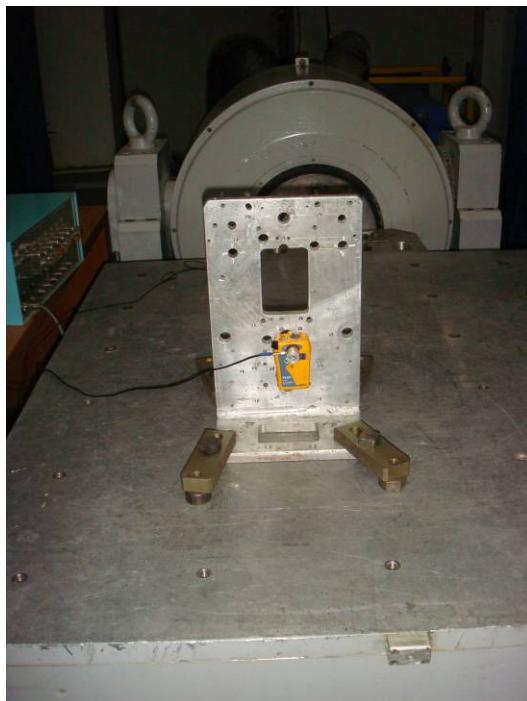
For horizontal vibration in X horizontal axis, EUT was then fastened to the vibration table in its normal attitude using special brackets (see Figure 5.3).

Figure 5.3 - General view of the horizontal axis X vibration test

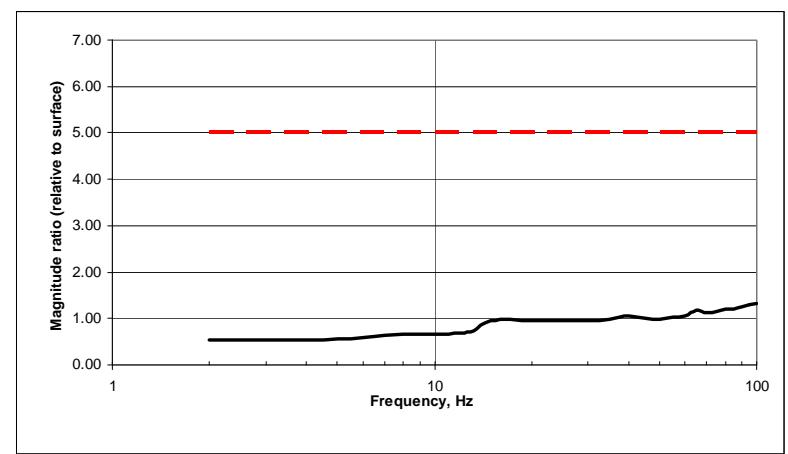
Figure 5.4 - Magnitude ratio vs. frequency during vibration on horizontal axis X

During the search of EUT resonance, tested specimen was externally observed by unaided aural and visual means. Relative magnitude is shown in table below.

Frequency, Hz	Magnitude ratio	Frequency, Hz	Magnitude ratio
2	0.53	55	1.04
4	0.54	60	1.05
6	0.58	65	1.19
8	0.67	70	1.14
10	0.66	75	1.16
12	0.70	80	1.21
13.2	0.73	85	1.21
15	0.97	90	1.26
20	0.95	95	1.30
25	0.97	100	1.32
30	0.95		
35	0.98		
40	1.07		
45	1.01		
50	0.98

As resonance with magnitude ratio ≥ 5 occurred, the endurance test was carried out at resonance frequency 30 Hz during 2 hours.

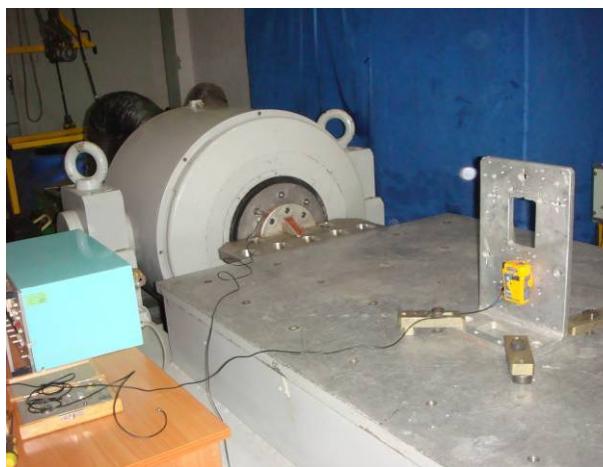
For horizontal vibration in Y axis, EUT was fastened to the vibration table in its normal attitude using special brackets (see Figure 5.5).

Figure 5.5 - General view of the horizontal Y vibration test

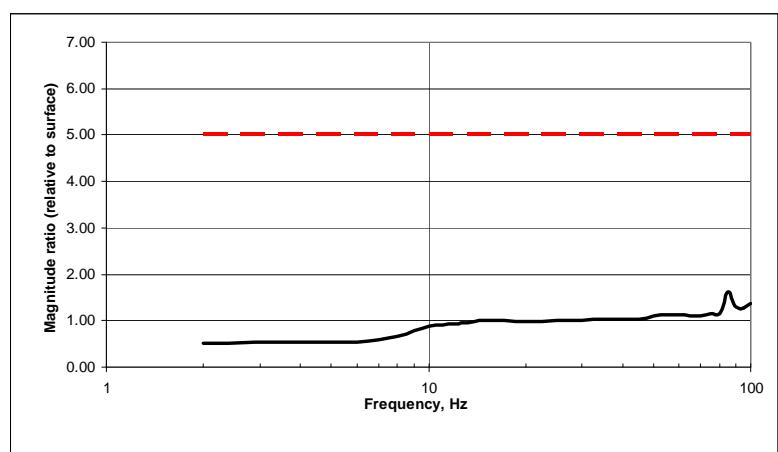
Figure 5.6 - Magnitude ratio vs. frequency during vibration on horizontal axis Y

During the search of EUT resonance, test specimen was externally observed by unaided aural and visual means. Relative magnitude is shown in table below.

Frequency, Hz	Magnitude ratio	Frequency, Hz	Magnitude ratio
2	0.53	55	1.14
4	0.54	60	1.12
6	0.55	65	1.09
8	0.68	70	1.11
10	0.89	75	1.16
12	0.93	80	1.15
13.2	0.97	85	1.61
15	1.00	90	1.30
20	0.98	95	1.28
25	1.00	100	1.37
30	1.01		
35	1.02		
40	1.04		
45	1.04		
50	1.09

As no resonance with magnitude ratio ≥ 5 occurred, the endurance test was carried out at one single observed frequency 30 Hz during 2 hours.

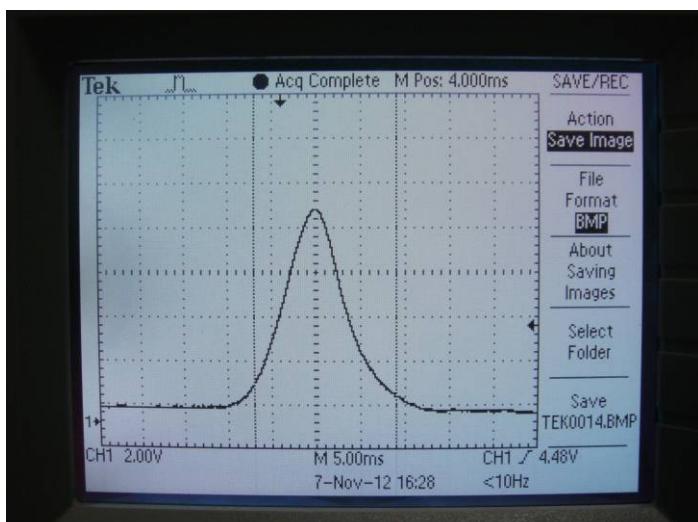
- Peak Acceleration: 98 m/s²
- Pulse Duration: 16 ms
- Waveshape: Half-cycle Sinewave
- Number of Bumps: 4000

Figure 6.1 – Diagram of the bump testing equipment control channel (16 ms)

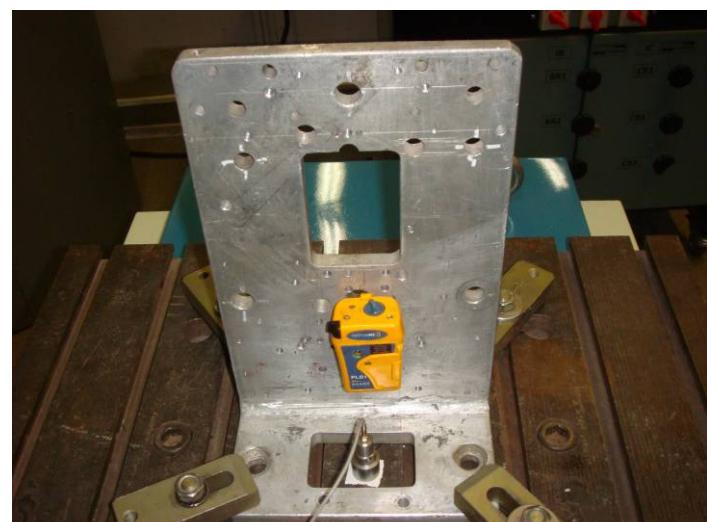
The EUT was secured to the bump testing equipment through its normal attachments for use in service conditions, using no additional straps or other holding means.

Figure 6.2 - Test Set-up. Vertical axis of the EUT

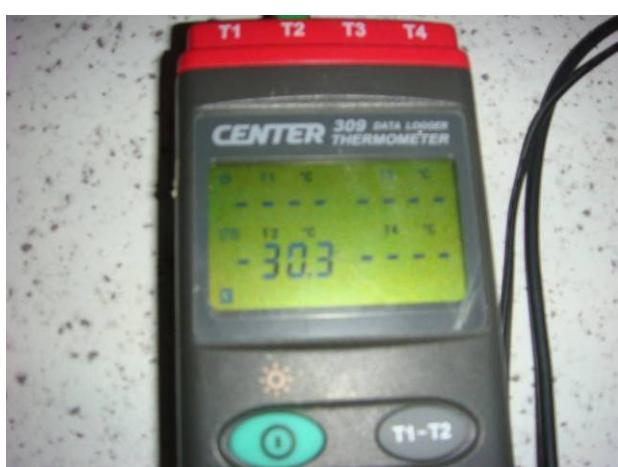
The EUT was soaked at minimum stowage temperature -30°C for 2 hours. EUT antenna was secured in its normal stowage position for this test.

Figure 7.1 - Detailed measurement of the EUT temperature before the drop test

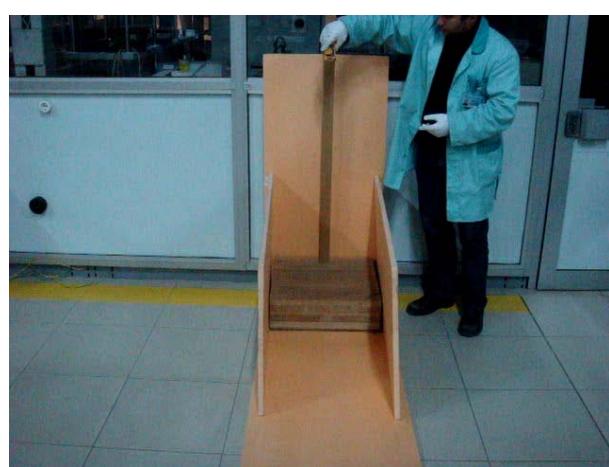
The test surface consists of a piece of solid hard wood with a thickness of at least 150 mm and a mass of 30 kg. The height of the lowest part of the EUT relative to the test surface at the moment of release was 1000 mm \pm 10 mm.

Figure 7.2 - Total view of test site of the drop from a height of 1 m above the test surface

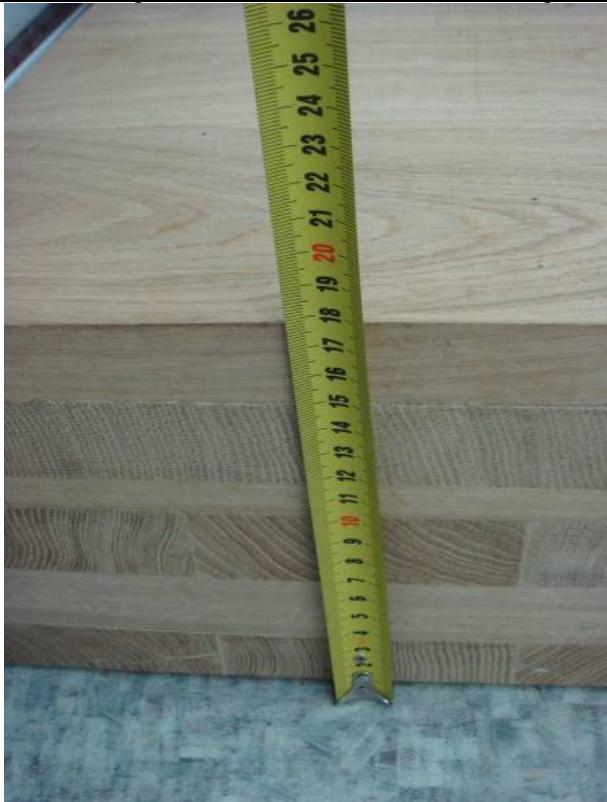
Figure 7.3 - Thickness of wood test surface

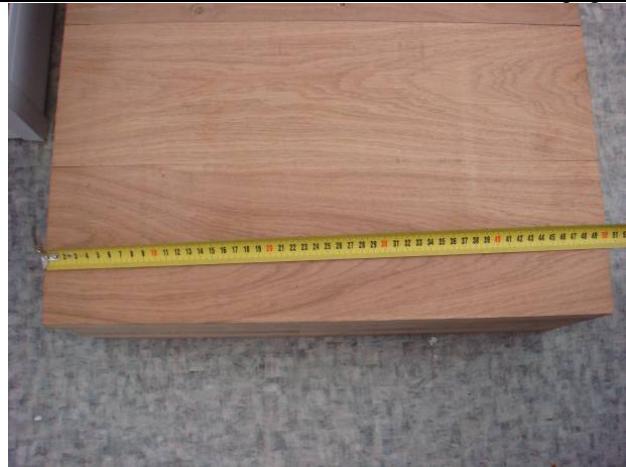
Figure 7.4 - Dimensions of the wood test surface

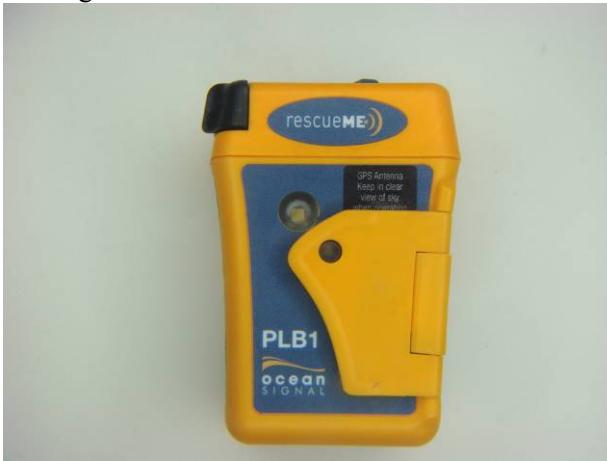
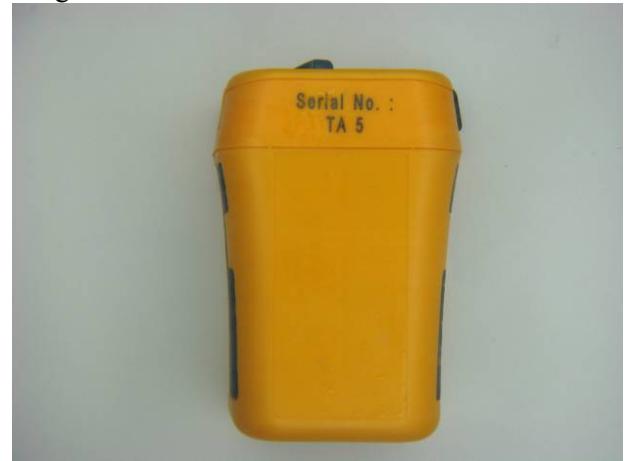
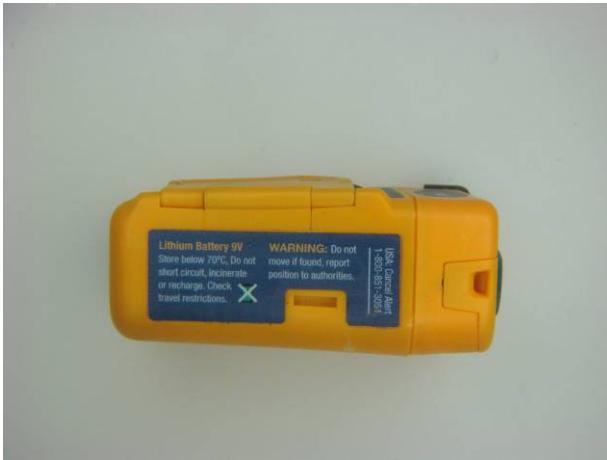
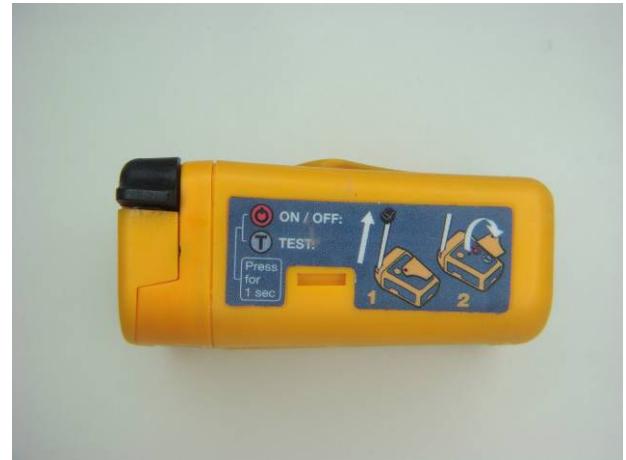
Figure 7.5 - View EUT upon completion of the drop test

Figure 7.6 - View EUT upon completion of the drop test

Figure 7.7 - View EUT upon completion of the drop test

Figure 7.8 - View EUT upon completion of the drop test

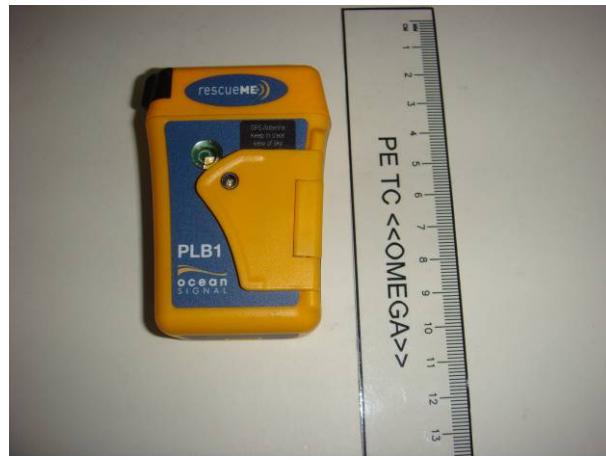
Figure 8.2 – View of the EUT upon completion of the Thermal shock test.

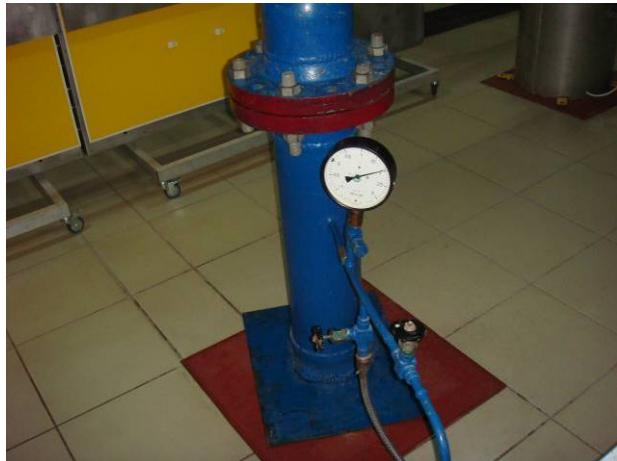
Figure 9.1 –View of immersion test site

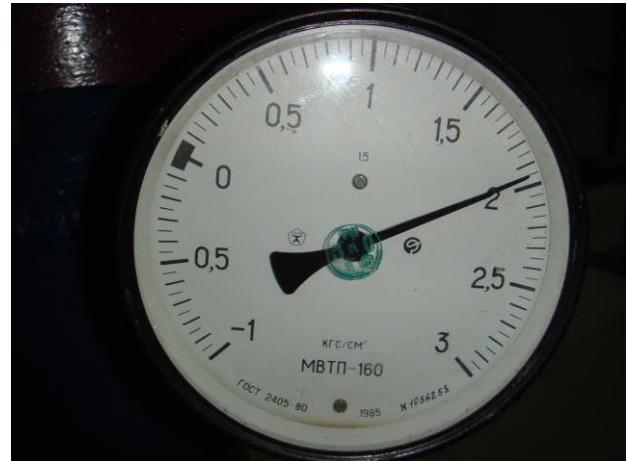
- STEP 3. Then pressure was increased to 1,95 bar (relative to atmospheric pressure) that corresponds total depth of immersion of 20 meters and maintained for one hour.
- STEP 4. The EUT was removed from the water and wiped dry.
- STEP 5. At the end of the test period:
 - the EUT was subjected to a performance check,
 - the EUT was opened and inspected for signs of any ingress of water.

Figure 9.2 –Manometer of immersion test site shows 1,95 bar.

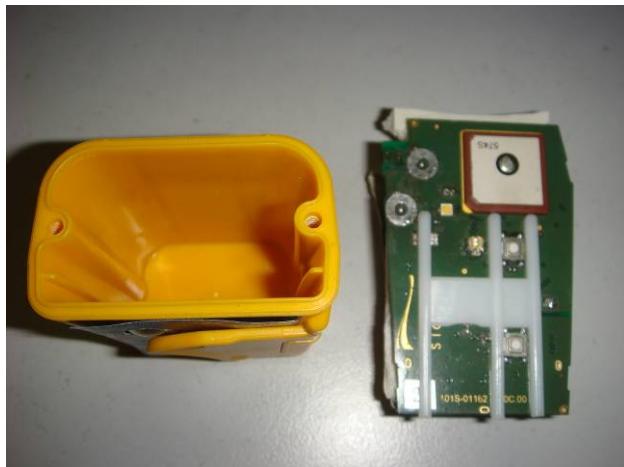
Figure 9.3 – View of the interiors of the Beacon upon completion of the Immersion Test. There is no water inside

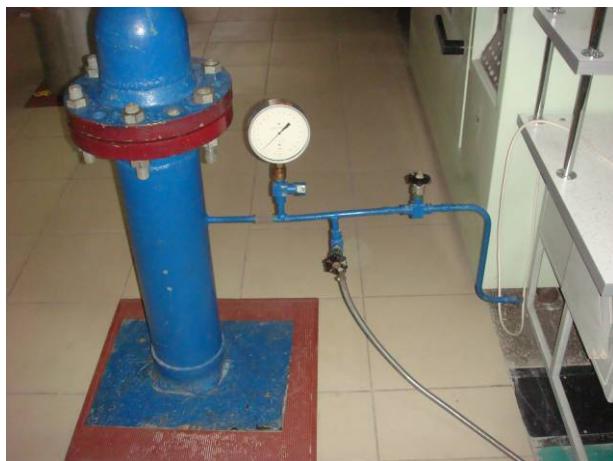
Figure 10.4 –View of immersion test site

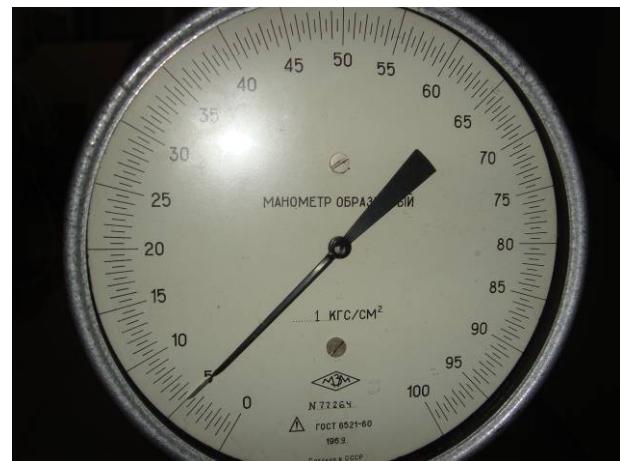
Figure 10.5 –Manometer of immersion test site shows 50 mbar.

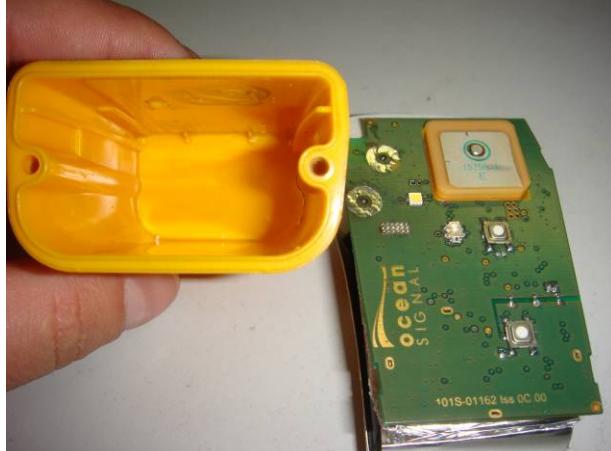
Figure 10.6 – View of the interiors of the Beacon upon completion of the Immersion Test. There is no water inside

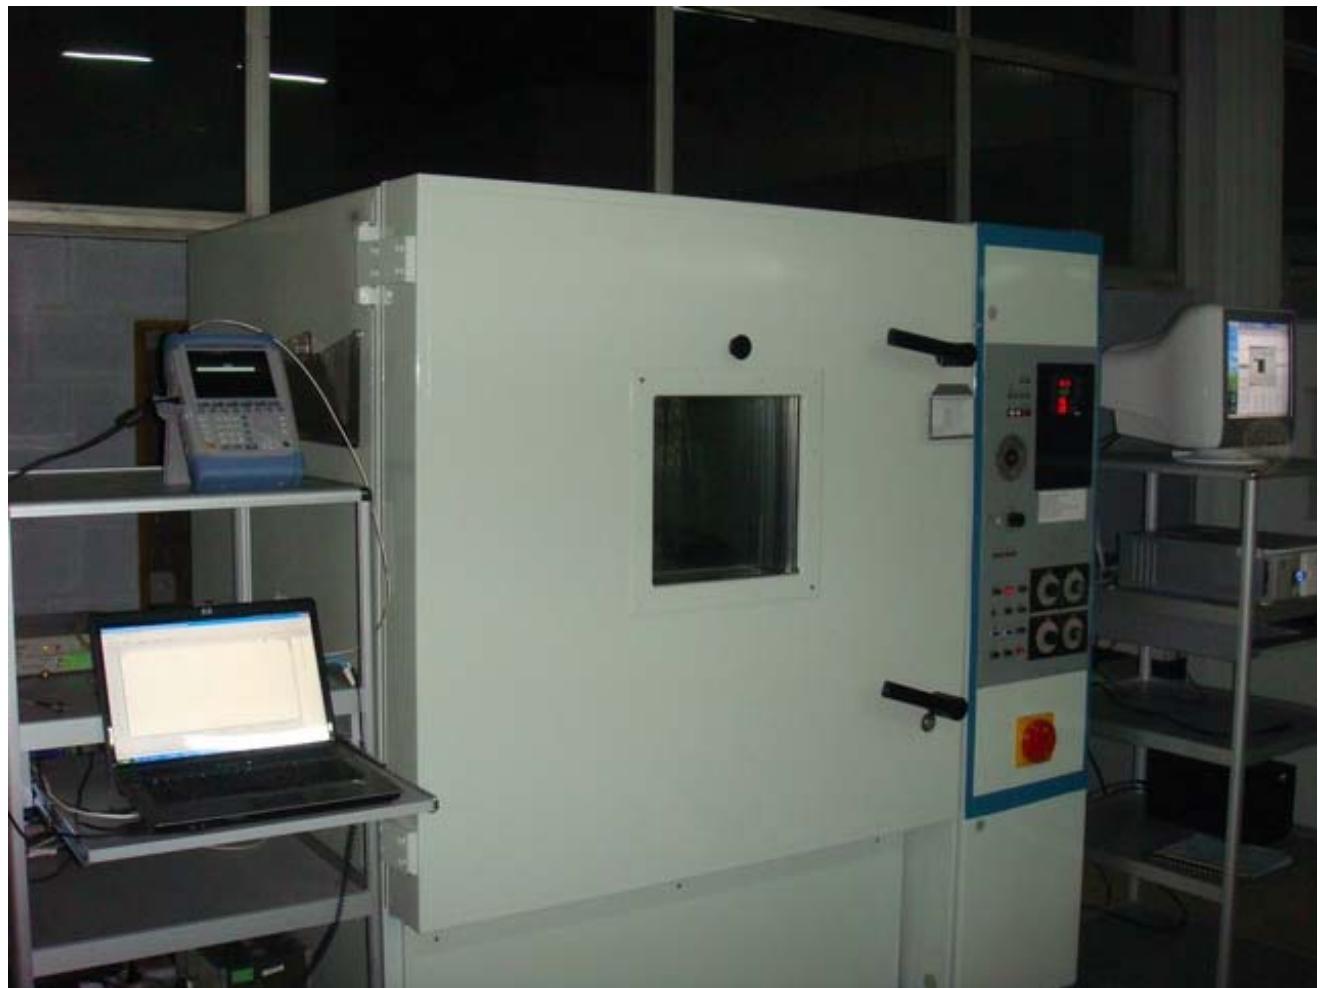
Lifetime test at minimum temperature minus -20°C with preliminary discharged battery was carried out for 33 hours 00 minutes.

The Ocean Signal PLB 1 exceeds the operational Life requirement of 29 hours 08 minutes.

Figure 11.1 – The test site view of the Operational life test

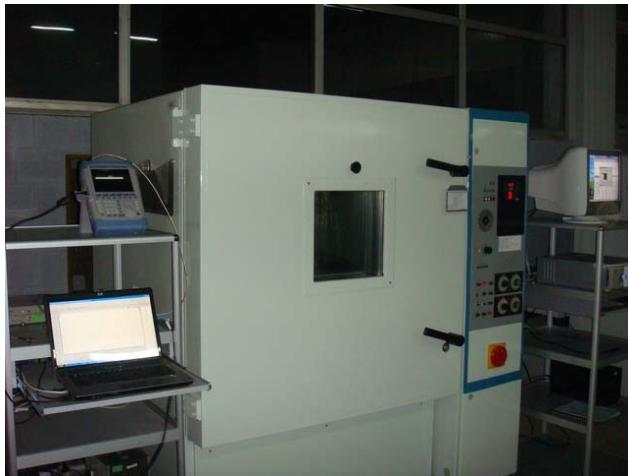
Figure 13.2 – Site for Carrier Frequency Test and Modulation Characteristic Measurement at the minimum, ambient and maximum operating temperatures

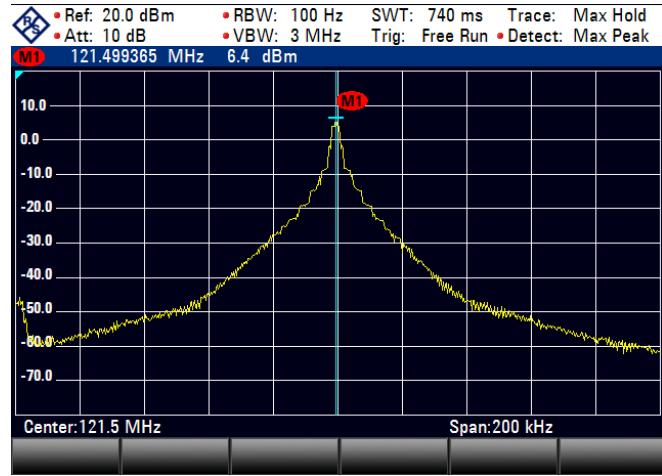
Figure 13.3 – Screenshot of Carrier Frequency Test Result at the minimum operating temperature

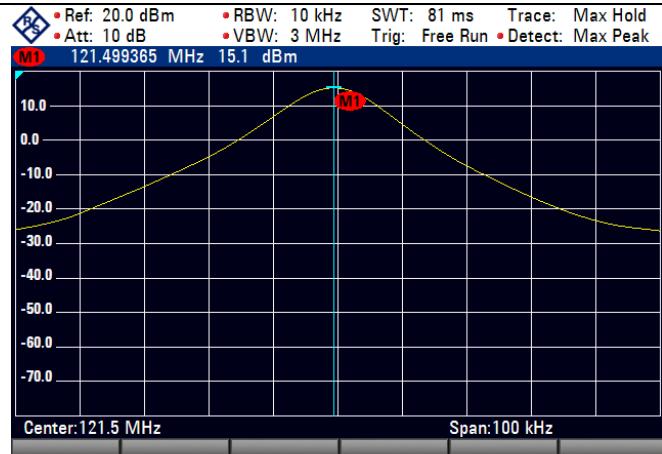
- I.F. bandwidth: 10 kHz
- Video filter: OFF or as wide as possible
- Scan time: 100 ms./div.
- Amplitude scale: 5 dB/div.
- Scan width: 10 kHz/div.
- Center frequency: 121.5 MHz

(ii) Record the amplitude in dBm. (Figure 13.4)

Figure 13.4 – Screenshot of Frequency Coherence Measurement Test Result (transmitted power at wide band) at the minimum operating temperature

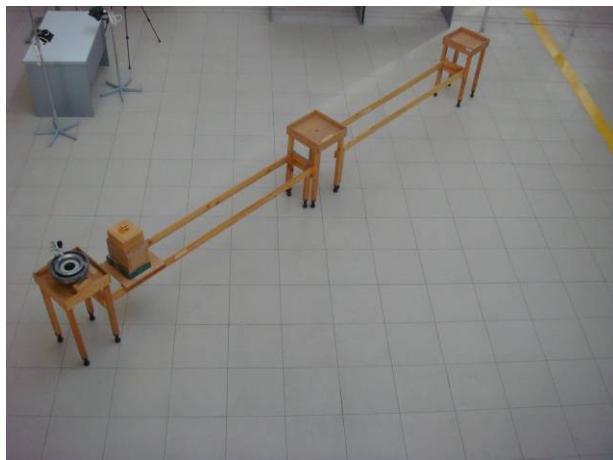
Figure 18.1 - Test installation.

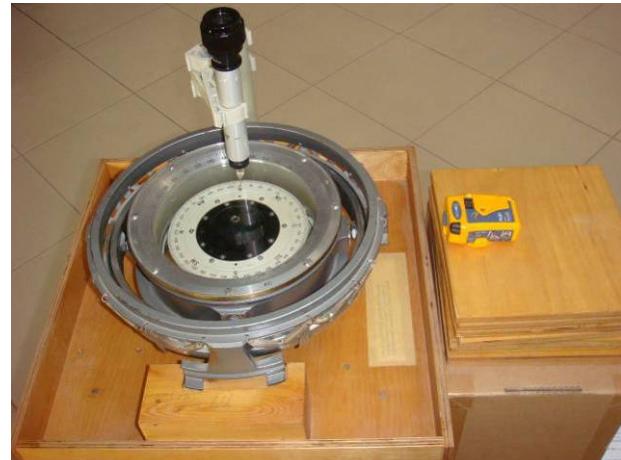
Figure 18.2 - The safety distance from EUT in stand-by mode to standard compass is 0,21 m.

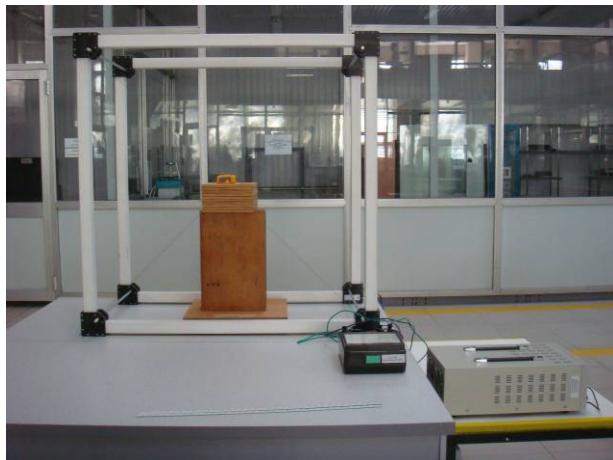
Figure 18.3 - Installation for normalizing

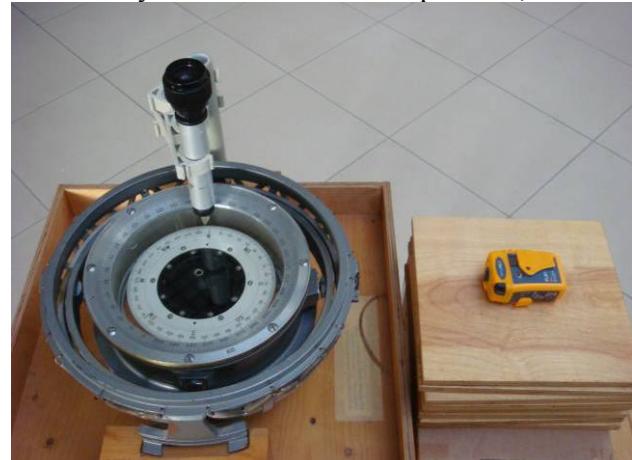
Figure 18.4 - The safety distance from EUT, after normalizing in stand-by mode to standard compass is 0,27 m.

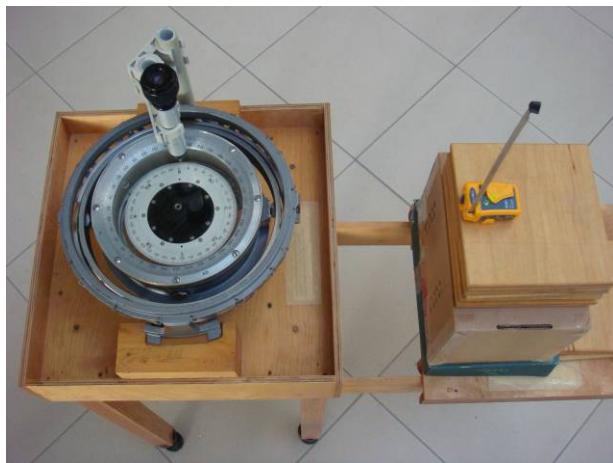
Figure 18.5 - The safety distance from EUT in operation mode to standard compass is 0,32 m.
