## Exhibit 07A

Test Setup Photos

Testing of the rescueME PLB3 (PLB-450) in accordance with  
Cospas-Sarsat T.007

25th January 2023

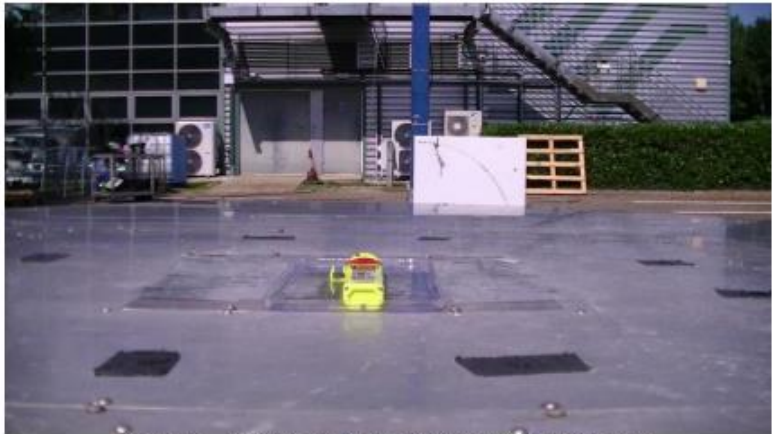
Figure 2 – Showing plastic container for 'Wet' configuration
