For Sea Marshall®AU9-HT 121.5MHz Digital Personal Locator Beacon

Final Report rev002

Sea Marshall® AU9-HT Helicopter Transit 121.5MHz PLB environmental test report

Test Type – Eurocae ED-14F

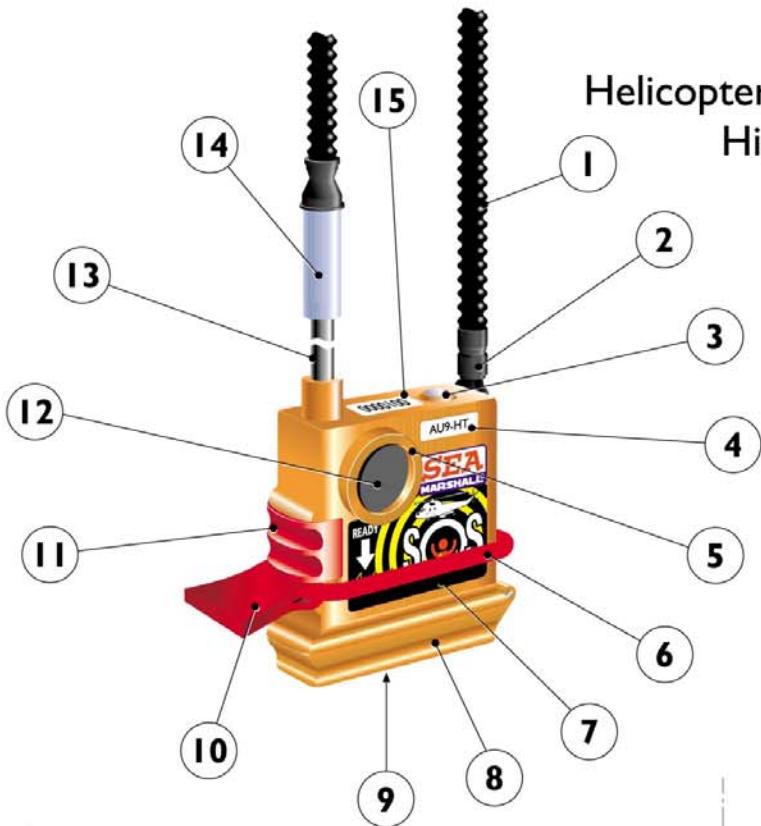
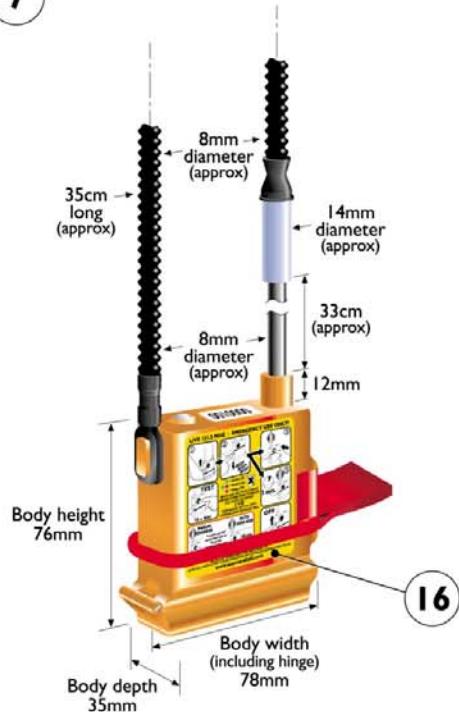
Fig: 001

- ① Helical antenna
- ② Antenna end lug
- ③ Auto-activation waterpin screw
- ④ Product code label
- ⑤ Activation button guard
- ⑥ Arm/Ready switch restrainer 'O' ring
- ⑦ Front label
- ⑧ Base cap (hinged - not separate)
- ⑨ Base cap screw (Auto-activation waterpin screw)
- ⑩ Arm/Ready switch restrainer grab tag
- ⑪ Arming/Ready switch
- ⑫ Activation button
- ⑬ Antenna cord
- ⑭ LED strobe
- ⑮ Serial number label
- ⑯ Rear instruction label

The following components of the AU9-HT, which are greater than 50mm in their largest dimension are required under ED-14F to meet the flammability tests and do so through merit of their composition/fire retardant characteristic:

- Body + Base Cap + PCB holder.

No. 8 (Body and Base Cap) on fig.001 on Page 9 (PCB holder internal component not shown)

- Antenna Cord

No. 13 on fig.001 on page 9

- Antenna Spring Cover

No.1 on fig.001 on page 9

- Front and rear label

No.7, 15 on fig.001 on page 9

- Arm switch restrainer ‘O’ ring

No.6 on fig.001 on page 3
