## Appendix G: Band edge measurements

## Appendix H: Conducted Spurious Emission Test Result

14. TEST SETUP PHOTO

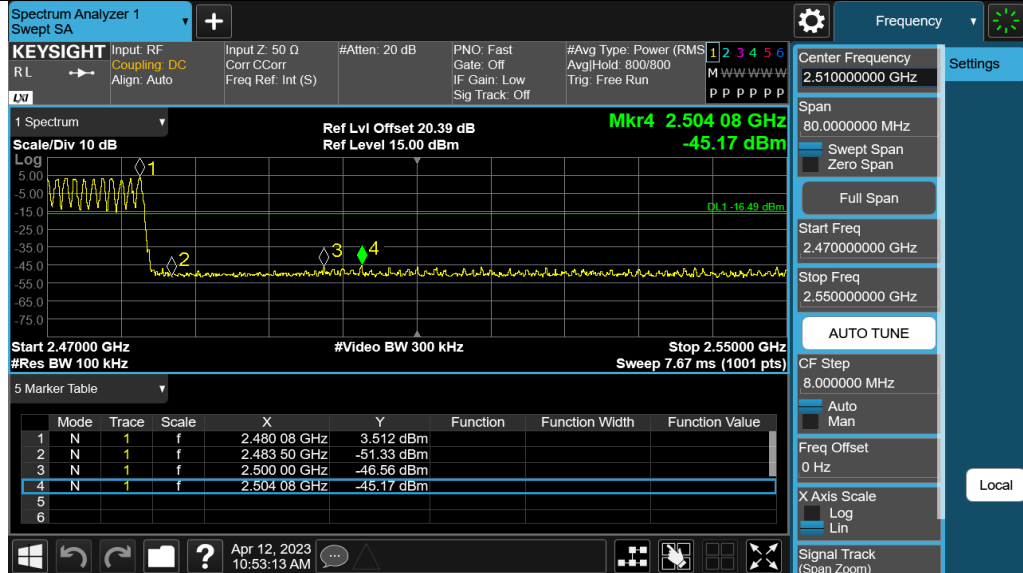
## DH5 Ant1 High Hop 2480

| Test Mode | Antenna | Ch Name | Freq(MHz) | Ref Level [dBm] | Result [dBm] | Limit [dBm] | Verdict |
|---|---|---|---|---|---|---|---|
| | | High | Hop_2480 | 3.51 | -45.17 | $\leq -16.49$ | PASS |

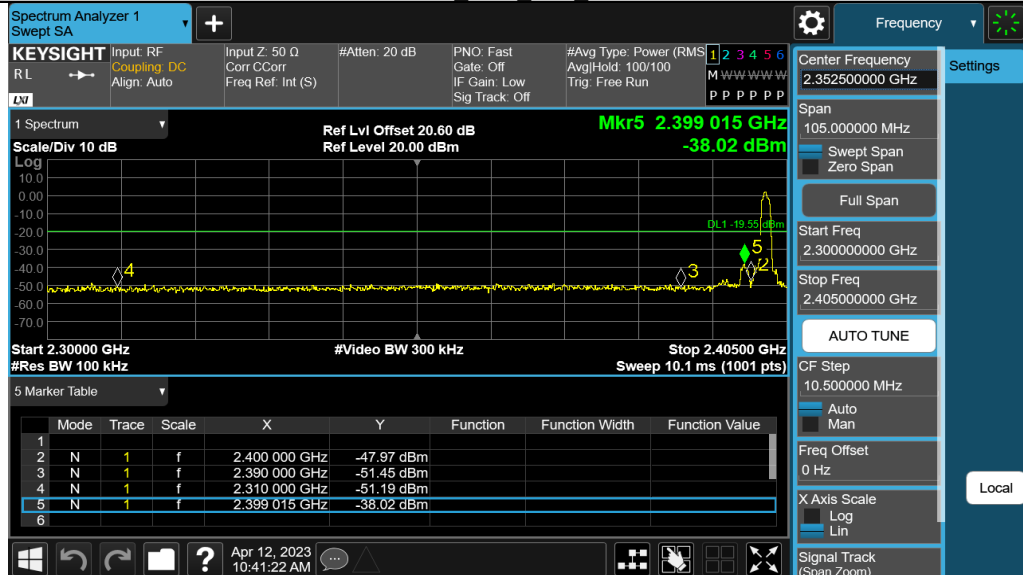
## 2DH5 Ant1 Low 2402

| Test Mode | Antenna | Ch Name | Freq(MHz) | Ref Level [dBm] | Result [dBm] | Limit [dBm] | Verdict |
|---|---|---|---|---|---|---|---|
| 2DH5 | Ant1 | Low | 2402 | 0.45 | -38.02 | $\leq -19.55$ | PASS |

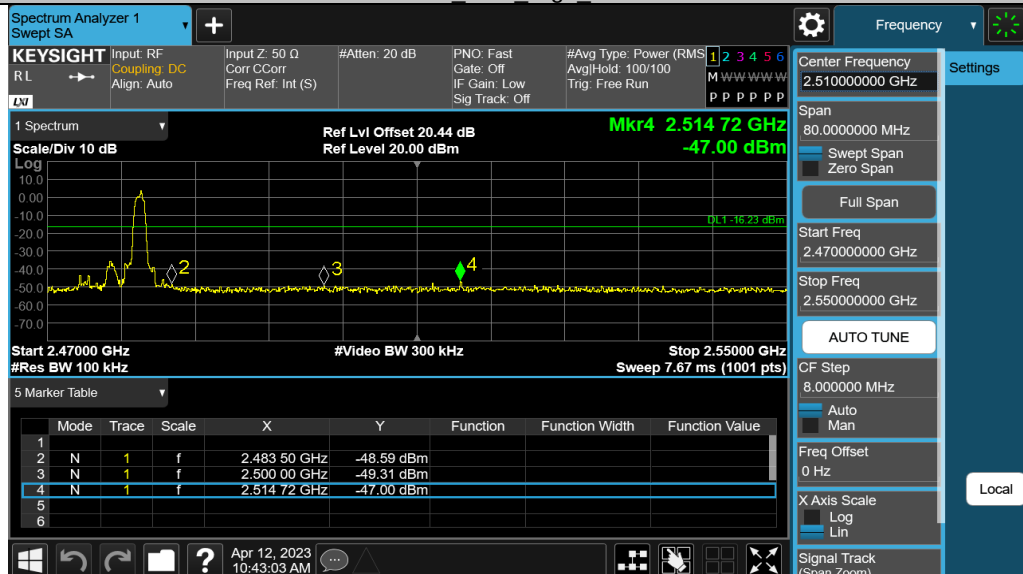
## 2DH5 Ant1 High 2480

| Test Mode | Antenna | Ch Name | Freq(MHz) | Ref Level [dBm] | Result [dBm] | Limit [dBm] | Verdict |
|---|---|---|---|---|---|---|---|
| | | High | 2480 | 3.77 | -47 | $\leq -16.23$ | PASS |

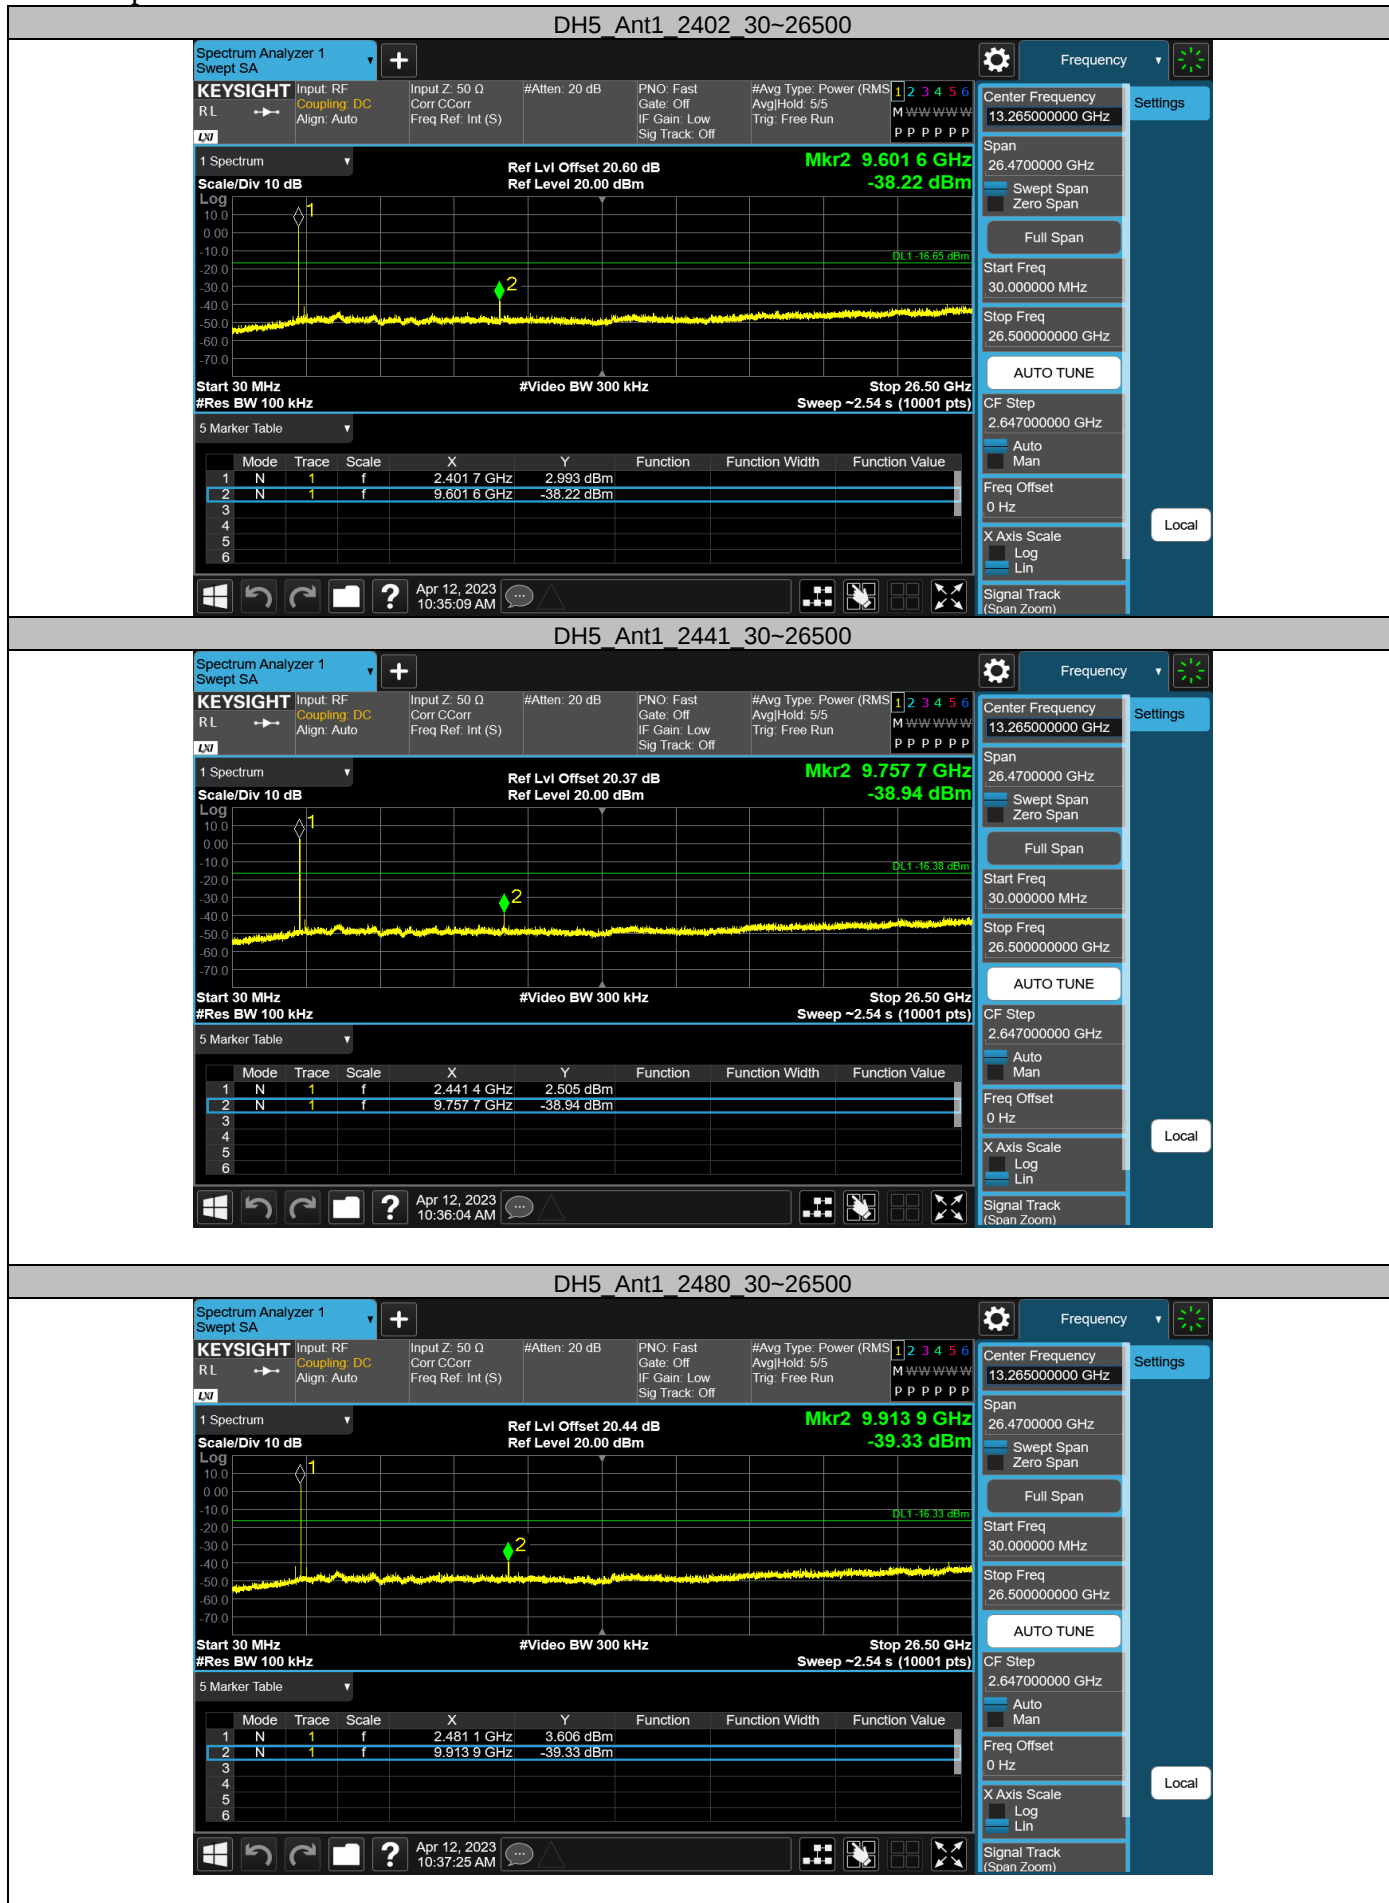
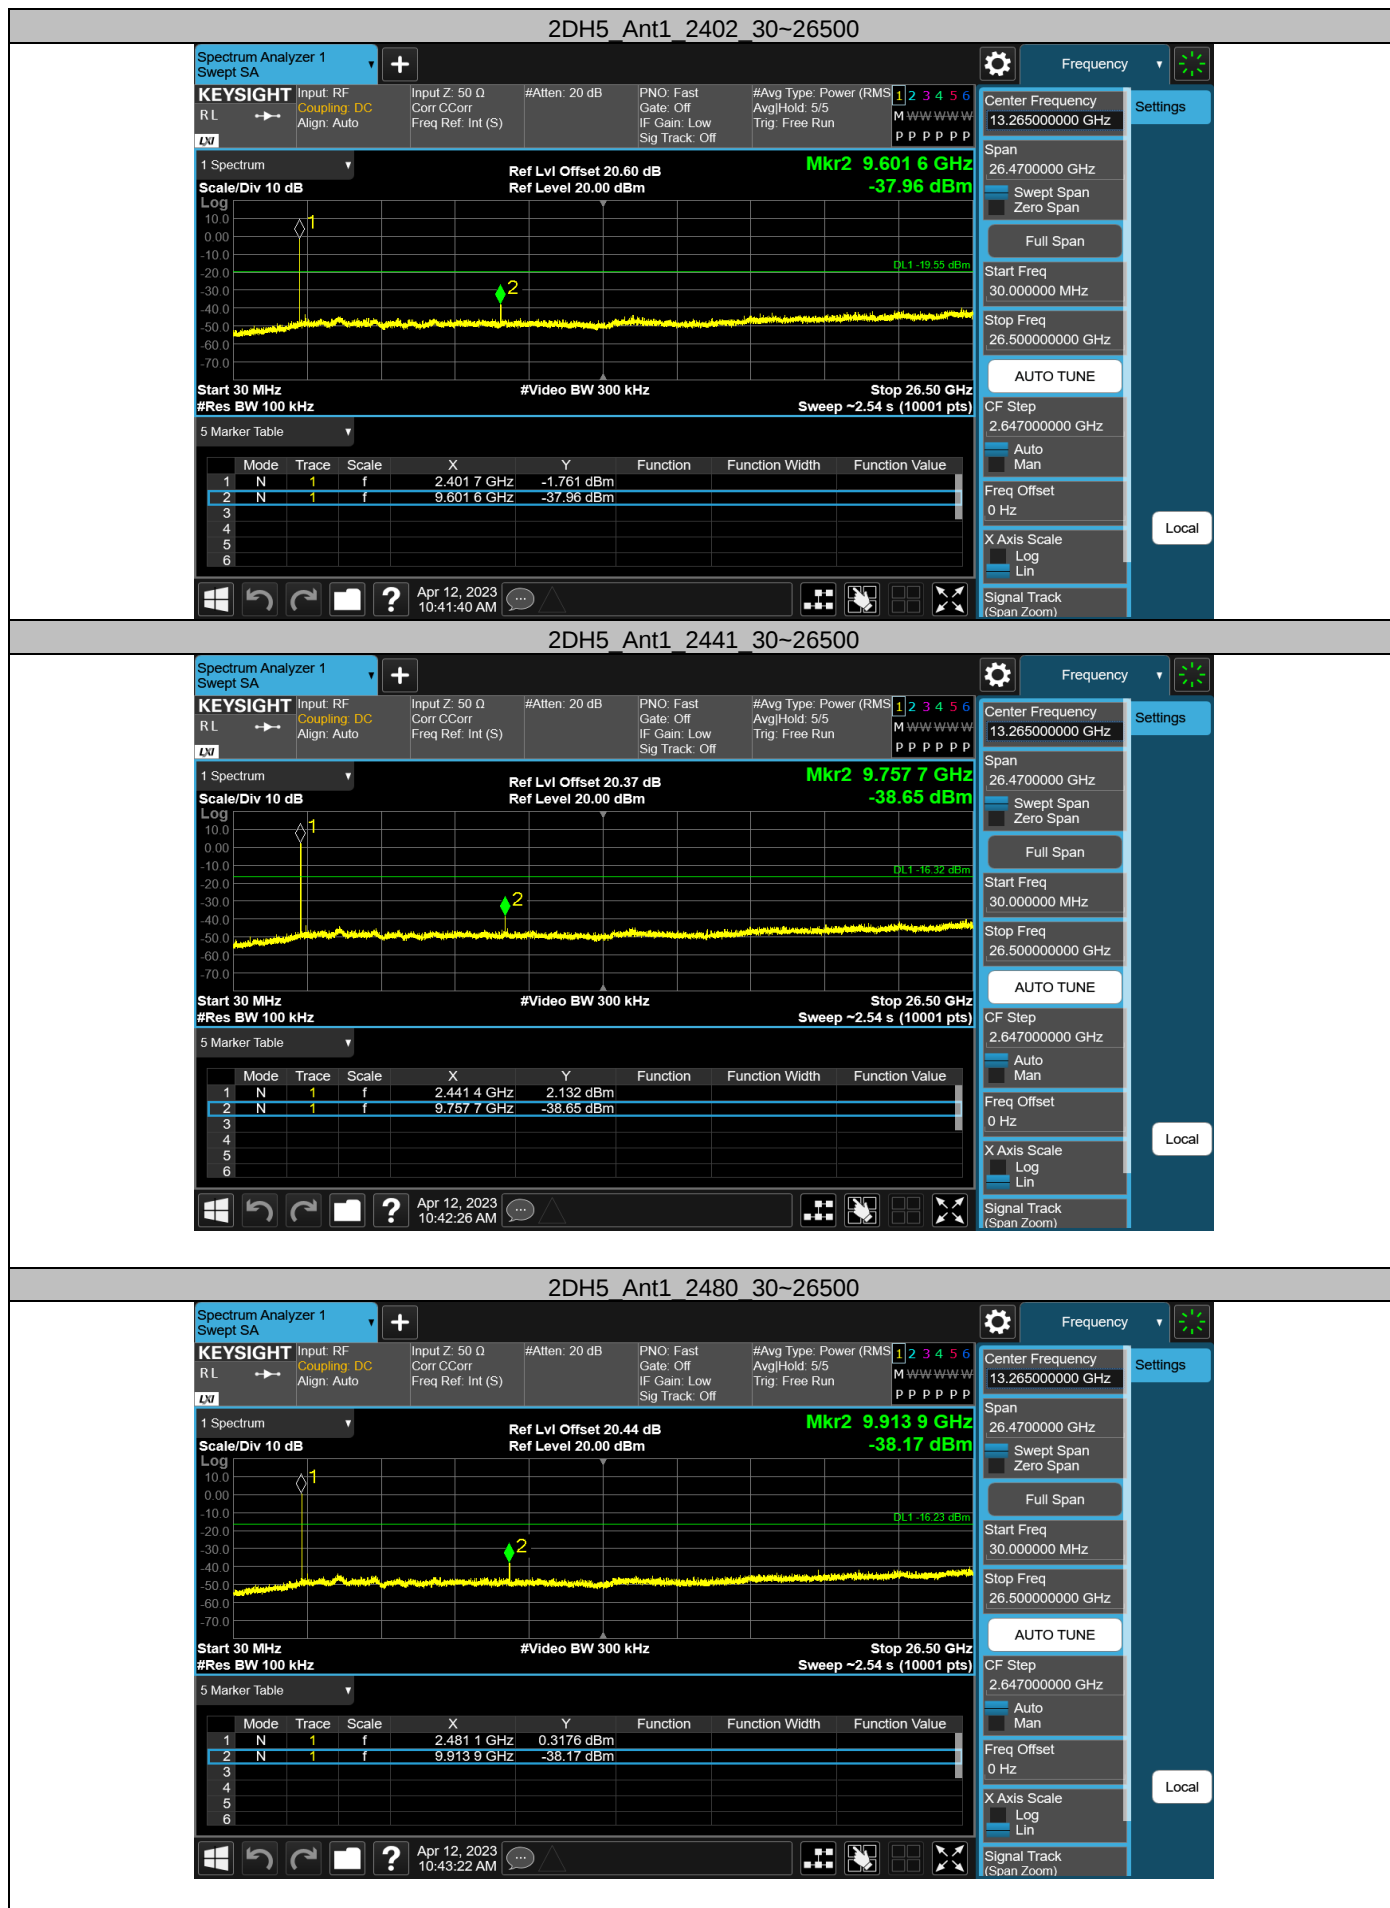
## Test Graphs

| Test Mode | Antenna | Freq(MHz) | Freq Range<br>[MHz] | Ref Level<br>[dBm] | Result<br>[dBm] | Limit<br>[dBm] | Verdict |
