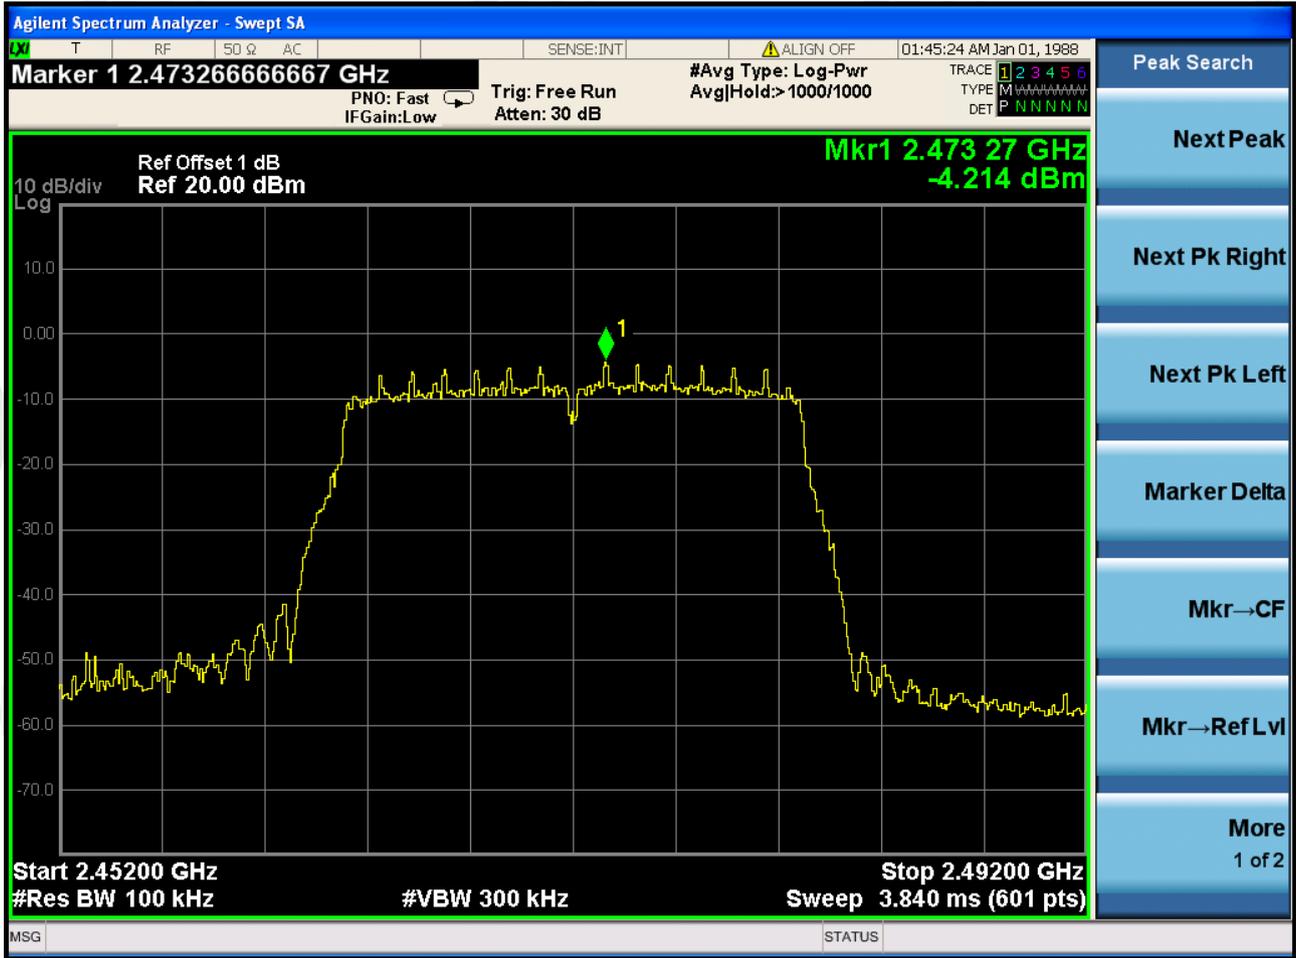
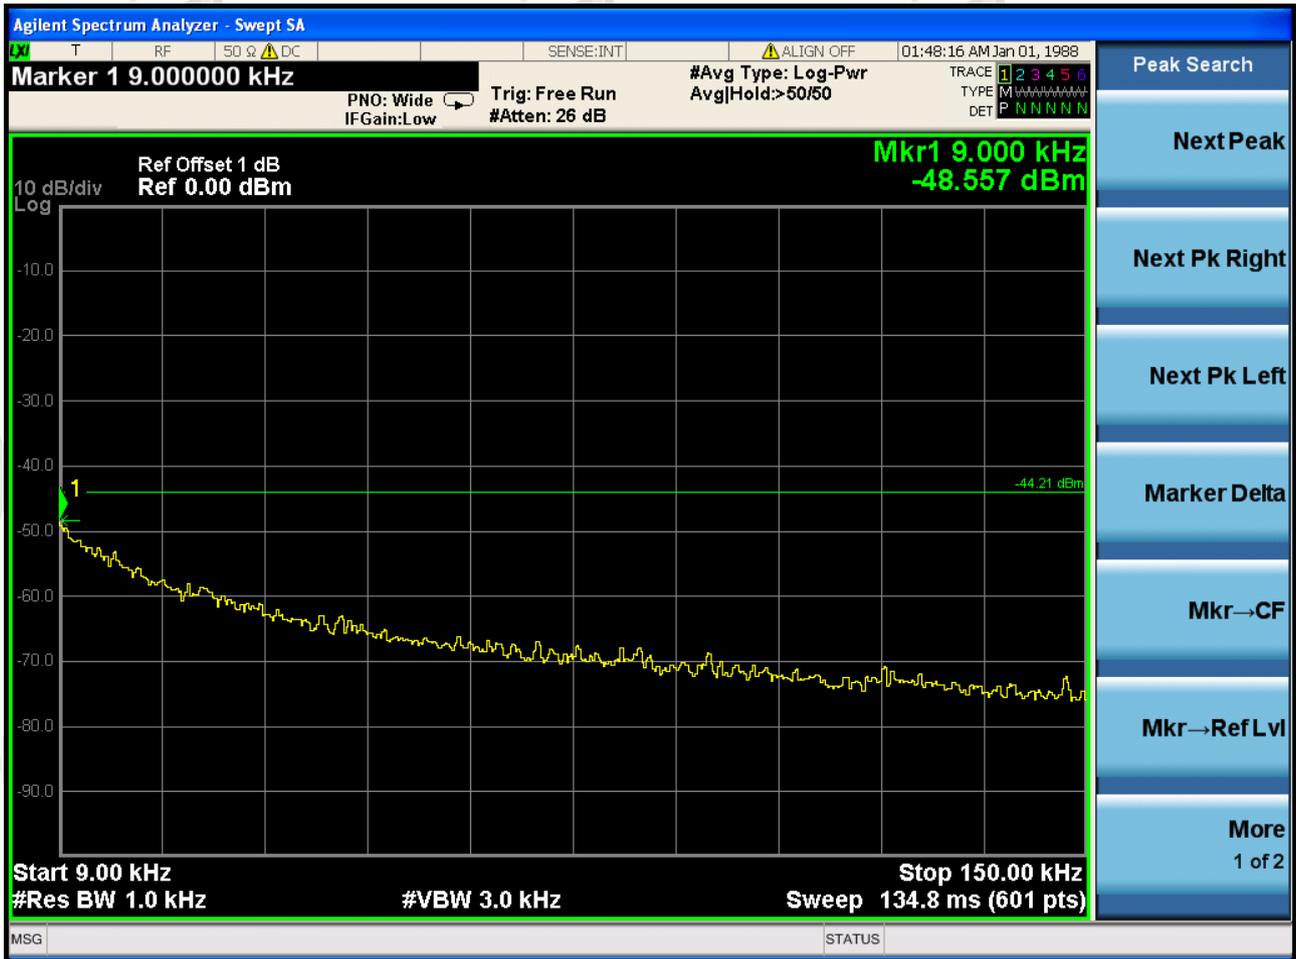
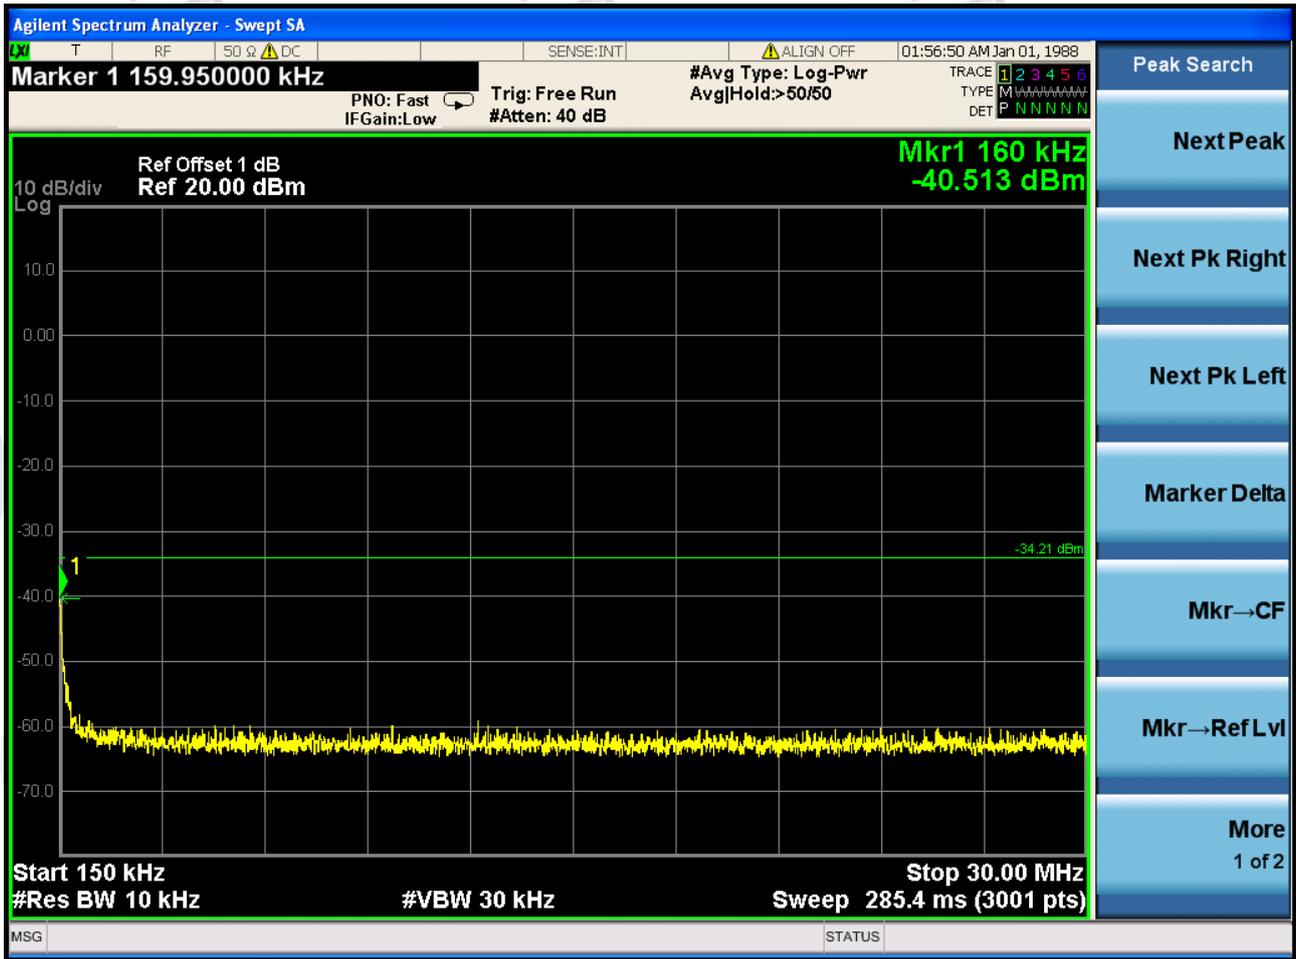
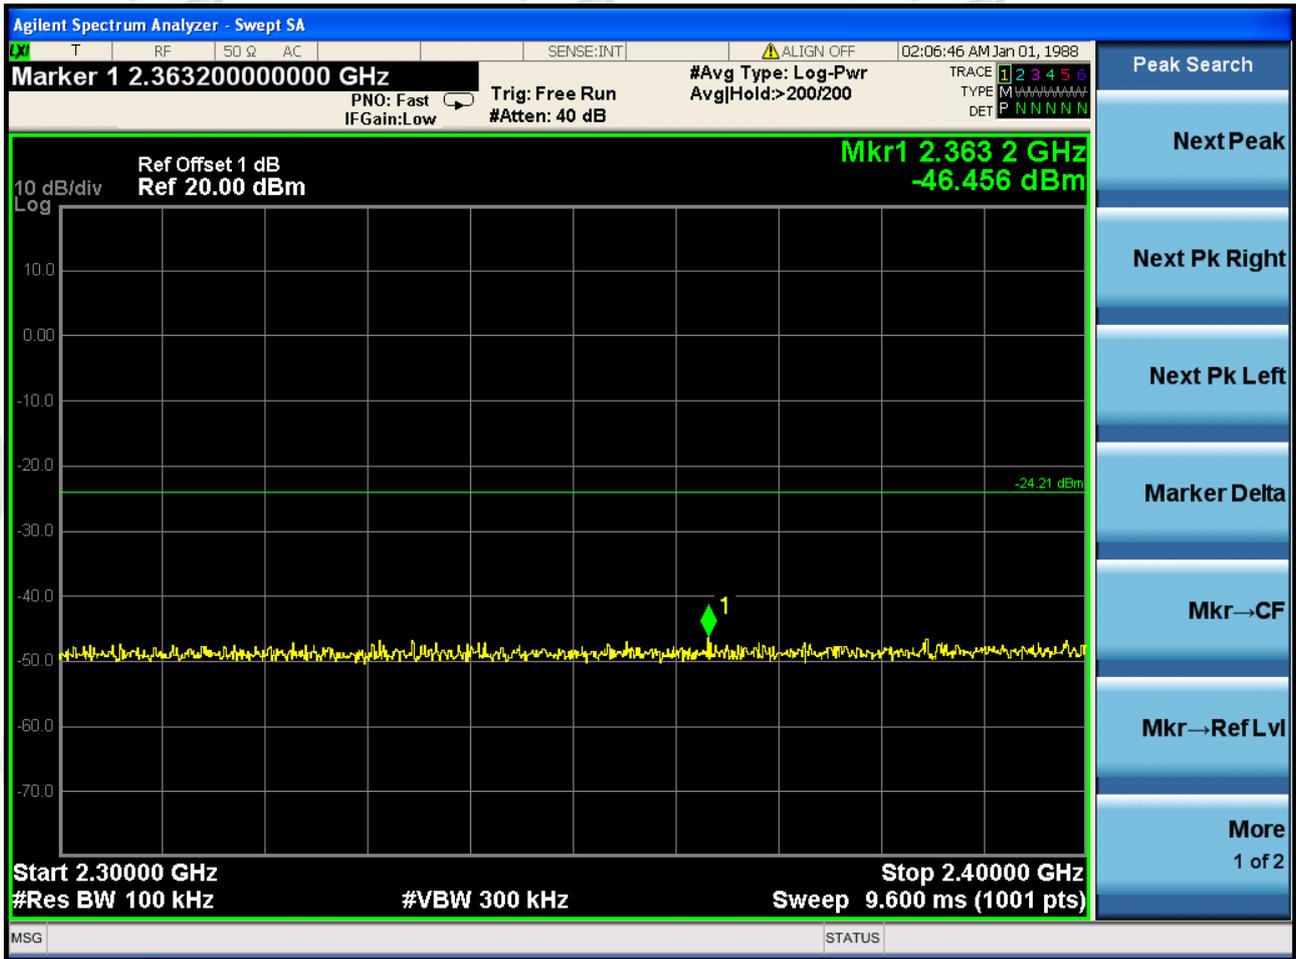
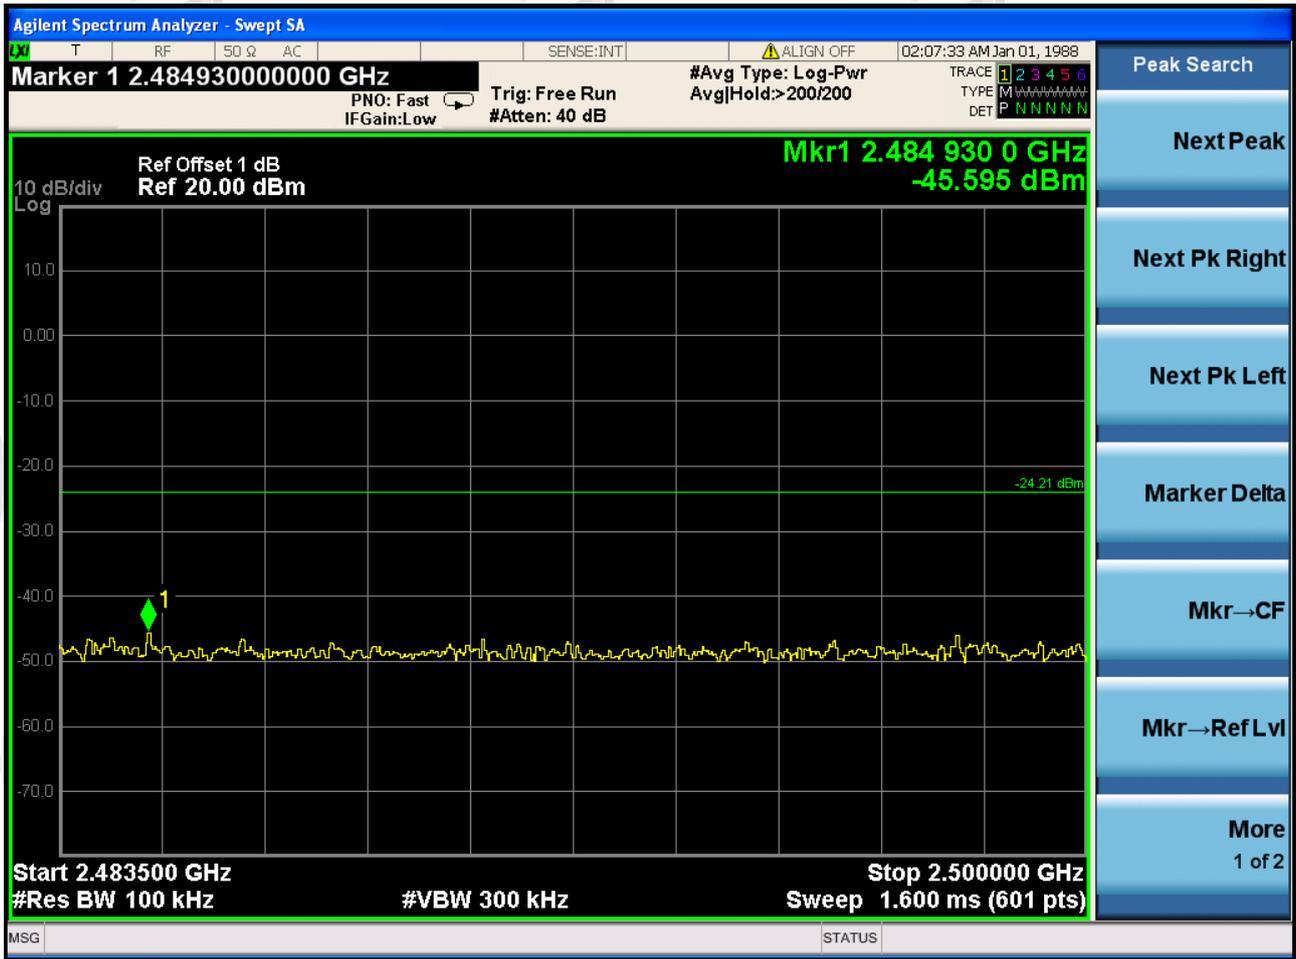
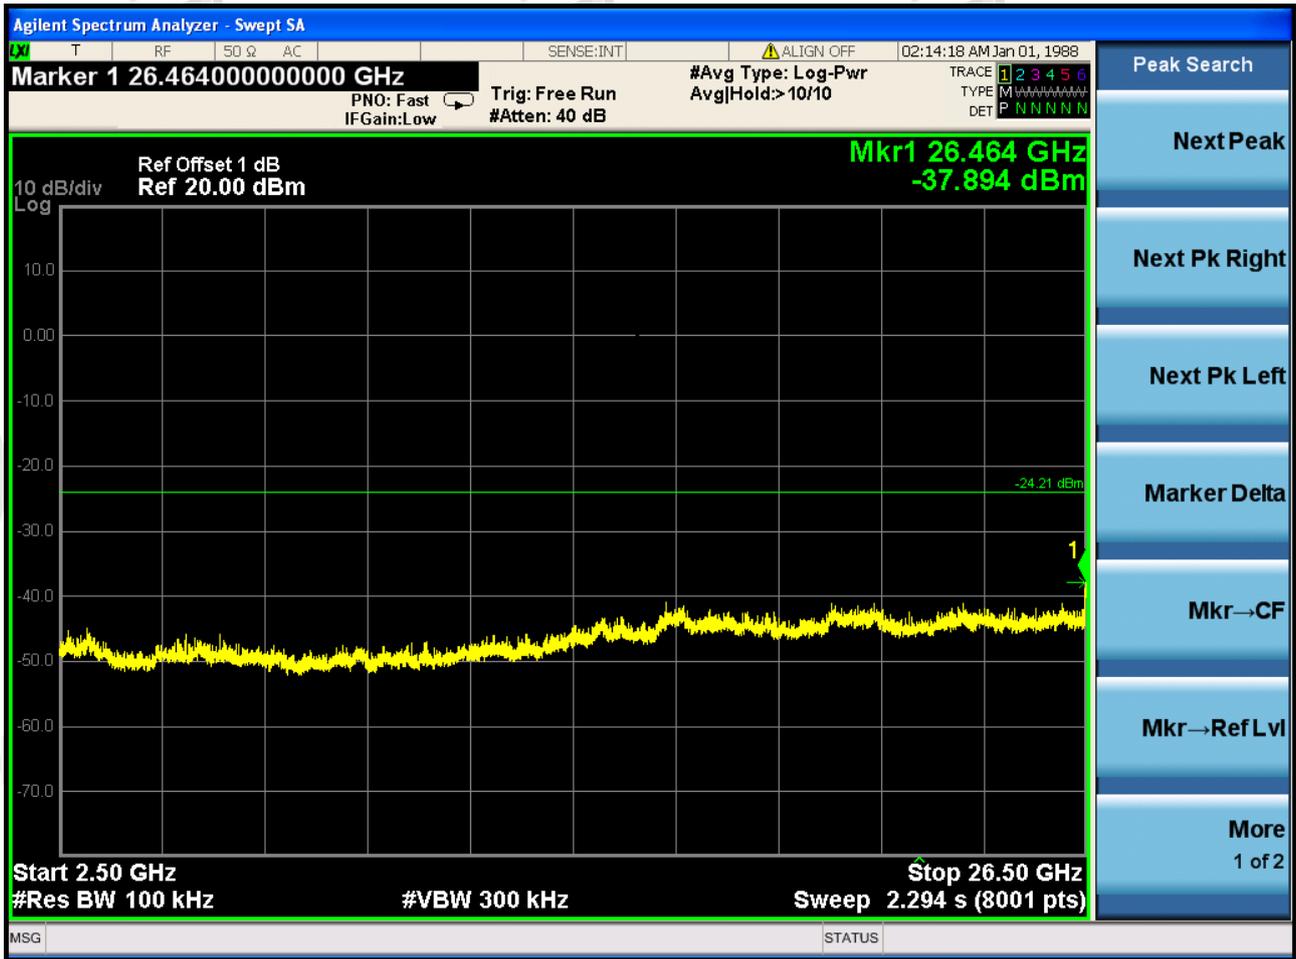
802.11N20_CH13

Scan from 9kHz to 25GHz, the disturbance between 9KHz to 30MHz was very low, and the above harmonics were the CH11 point could be found when testing, The amplitude of spurious emissions from the radiator which are attenuated more than 20dB below the limit need not be reported.
