# Reports

## • Day Burners

# BranchNode Optimum Placement Guide pt. 2

# Adding a Spatial Diversity Provider to improve communication black spots.

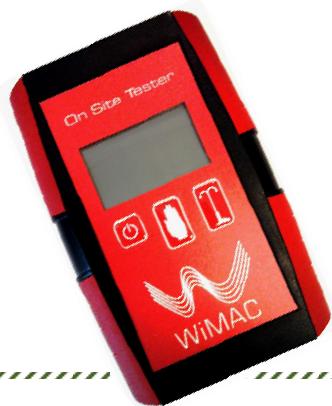
Use a WiMac Sniffer as a quick way to check ID numbers and test node to ballast connections

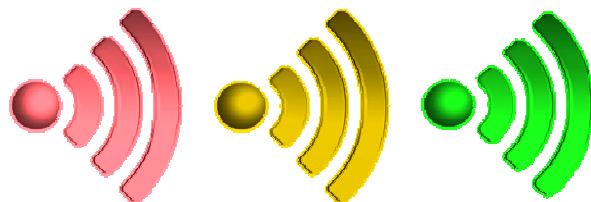
BranchNodes require GSM signal to communicate with the trunk. Check an area has O2 signal if in doubt, before installing your Branch.

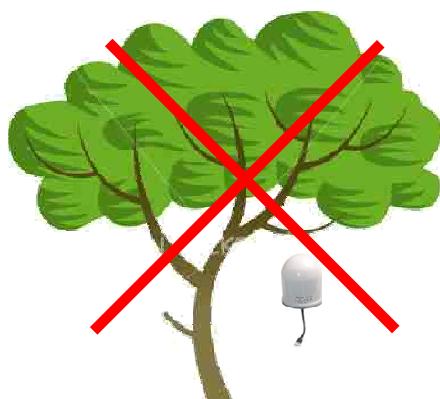
The operation of a BranchNode will be affected by its surroundings. Trees, tall buildings, metal structures etc. Will all affect operation as they absorb or reflect or break up radio signals. Choose a tall, clear column on which to place your BranchNode. Don’t place it under a bridge.

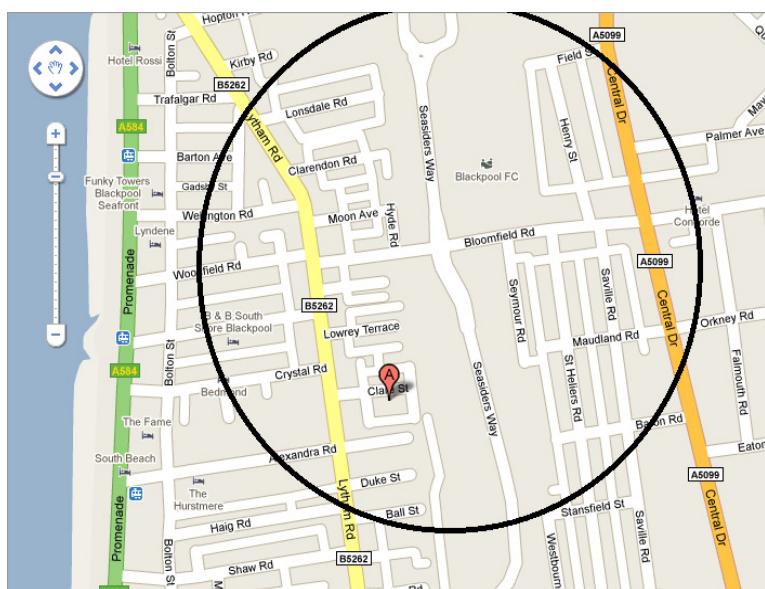
A Branch should be added in the centre of a deployment, with nodes placed all around it. As nodes communicate best with line-of-sight communication with their branch, junctions of two long straight roads often make great branch locations. Choose a tall column, in a clear area. Avoid columns which are very close to buildings or trees. The column **MUST** have a constant supply to it. This is important for a LeafNode and VITAL for a BranchNode.

Assuming the branch is currently at point A and all nodes lie within the black circle, where would you relocate this branch to?

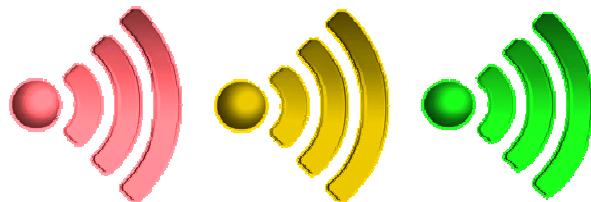
SDP's require good signal to operate. They cannot "pass on" a message which they didn't "hear".

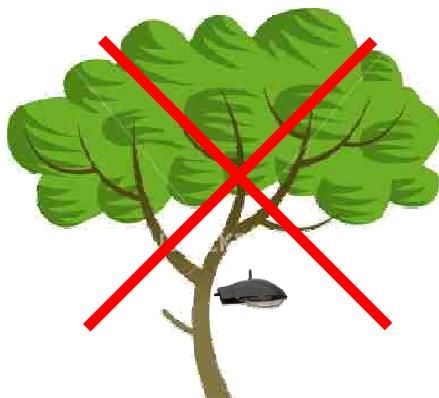
SDP's operation, as BranchNodes, will be affected by their surroundings. Trees, tall buildings, metal structures etc. Will all affect the operation of an SDP as they absorb or reflect or break up radio signals. Choose a tall, clear column.

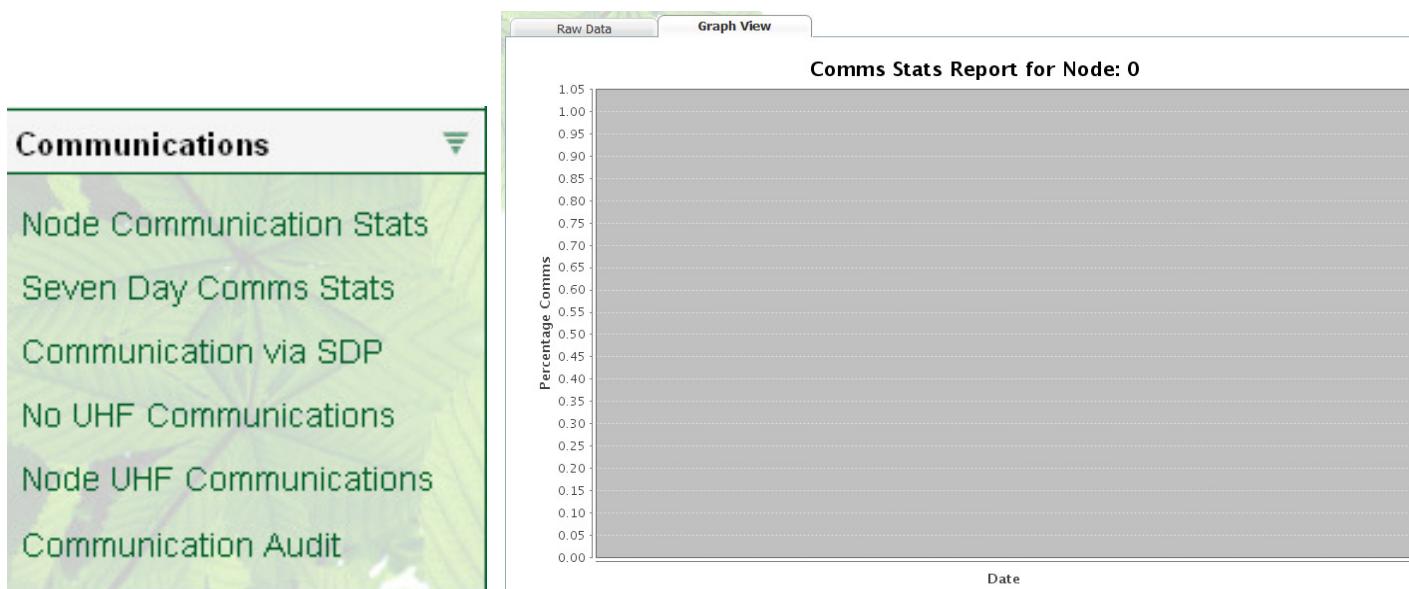
Go to the reports section and check the “communication by node” history for the shortlisted nodes. The graph tab at the top of the report will give you a good visual representation to ensure that the node has consistently good communication.

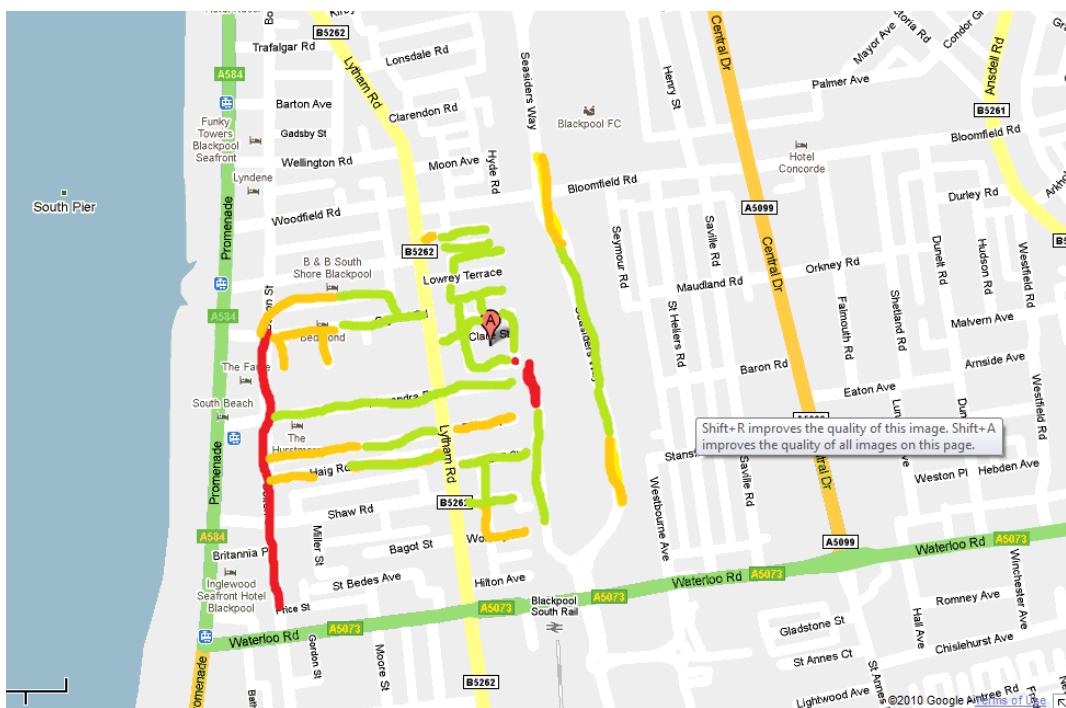
As more nodes are added to a branch, you may find it worthwhile going back and removing SDP's added early on in installation, to place them somewhere with greater efficacy. For larger branches, it is often worth removing all SDP's, then colour coding streets on a printed map, red for no comms, orange for poor comms, and green for ok or good comms. You can then visually see where the most black spots are and choose an optimum position for an SDP.
