Variant FCC RF Test Report

APPLICANT : Hewlett Packard Company
EQUIPMENT : HP iPAQ KB1
BRAND NAME : HP
MODEL NAME : HSTNH-P21C
FCC ID : B94HHP21C
STANDARD : FCC 47 CFR Part 2, 22(H), 24(E)
CLASSIFICATION : PCS Licensed Transmitter Held to Ear (PCE)
Tx/Rx FREQUENCY RANGE : GSM850 : 824.2 ~ 848.8 MHz /
869.2 ~ 893.8 MHz
GSM1900 : 1850.2 ~ 1909.8 MHz /
1930.2 ~ 1989.8 MHz
WCDMA Band V : 826.4 ~ 846.6 MHz /
871.4 ~ 891.6 MHz
WCDMA Band II : 1852.4 ~ 1907.6 MHz /
1932.4 ~ 1987.6 MHz
MAX. ERP POWER : WCDMA Band V (RMC 12.2Kbps) : 0.13 W

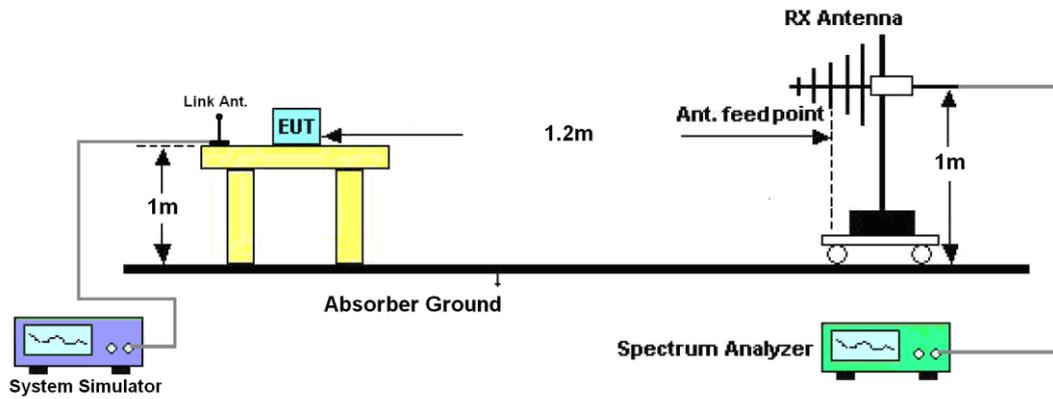
3.1.4 Test Setup

8. Repeat step 3 to step 5 to get the maximum ERP of the substitution antenna.
9. $ERP = P_s + E_t - E_s + G_s = P_s + R_t - R_s + G_s$
Ps (dBm) : Input power to substitution antenna.
Gs (dBi or dBd) : Substitution antenna Gain.
Et = Rt + AF
Es = Rs + AF
AF (dB/m) : Receive antenna factor
Rt : The highest received signal in spectrum analyzer for EUT.
Rs : The highest received signal in spectrum analyzer for substitution antenna.

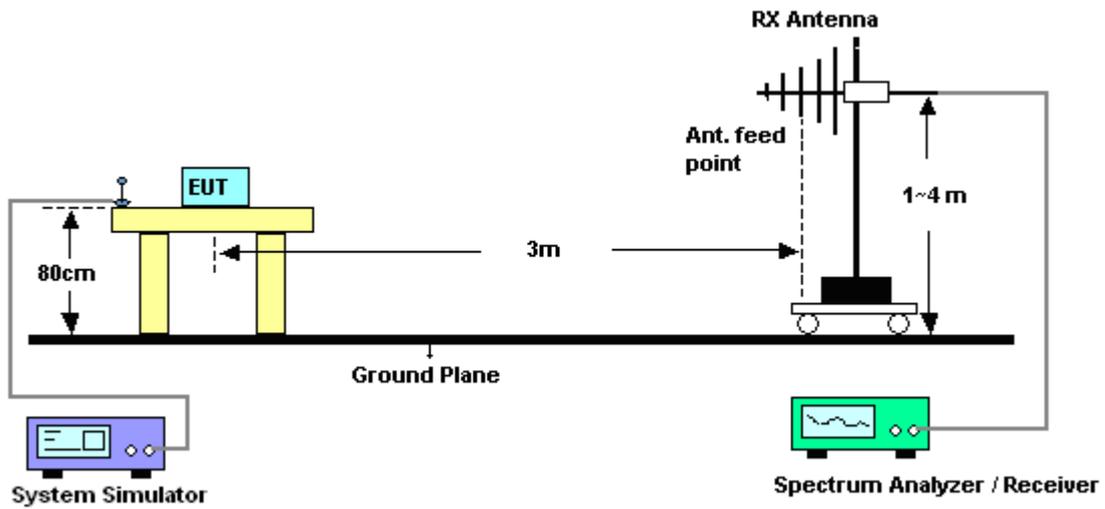
3.2.4 Test Setup

11. $ERP \text{ (dBm)} = EIRP - 2.15$

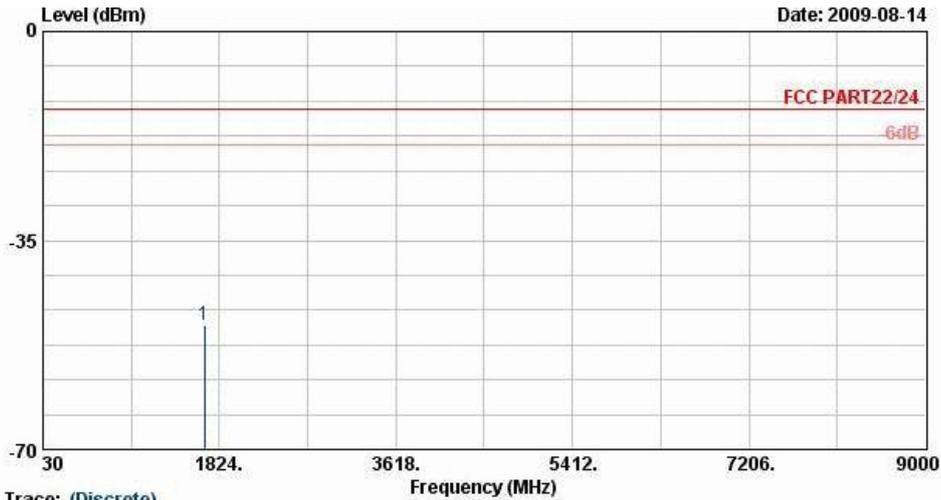
Band :	WCDMA Band V	Temperature :	28~29°C
Test Mode :	RMC 12.2Kbps Link	Relative Humidity :	39~40%
Test Engineer :	Kay Wu	Polarization :	Horizontal
Remark :	Spurious emissions within 30-1000MHz were found more than 20dB below limit line.

Trace: (Discrete)
 Site : 03CH07-RY
 Condition : FCC PART22/24 HF-ETRP(080306) HORIZONTAL
 Project : RC 961307-04

Frequency (MHz)	ERP (dBm)	Limit (dBm)	Over Limit (dB)	SPA Reading (dBm)	S.G. Power (dBm)	TX Cable loss (dB)	TX Antenna Gain (dBi)	Polarization (H/V)	Result
1669	-49.29	-13	-36.29	-56.42	-49.14	3.39	5.39	H	Pass

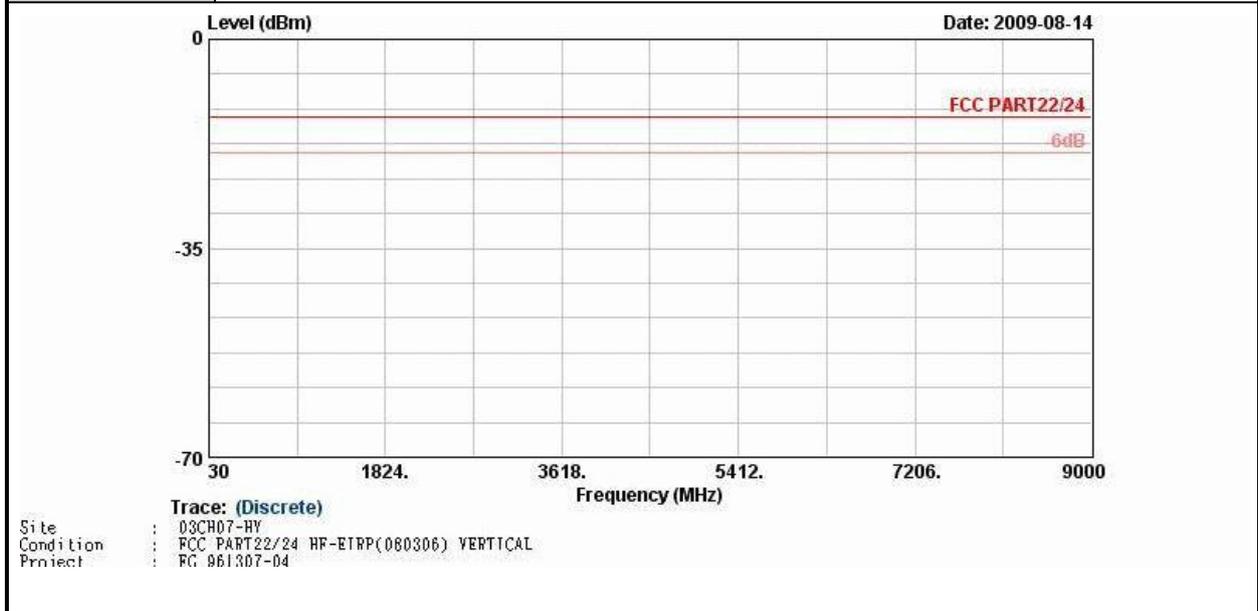
Band :	WCDMA Band V	Temperature :	28~29°C
Test Mode :	RMC 12.2Kbps Link	Relative Humidity :	39~40%
Test Engineer :	Kay Wu	Polarization :	Vertical
Remark :	1. Spurious emissions within 30-1000MHz were found more than 20dB below limit line. 2. Spurious emissions within 1000MHz ~ 10th harmonic were not found any signals.
