Subject: FCC ID: MAU030

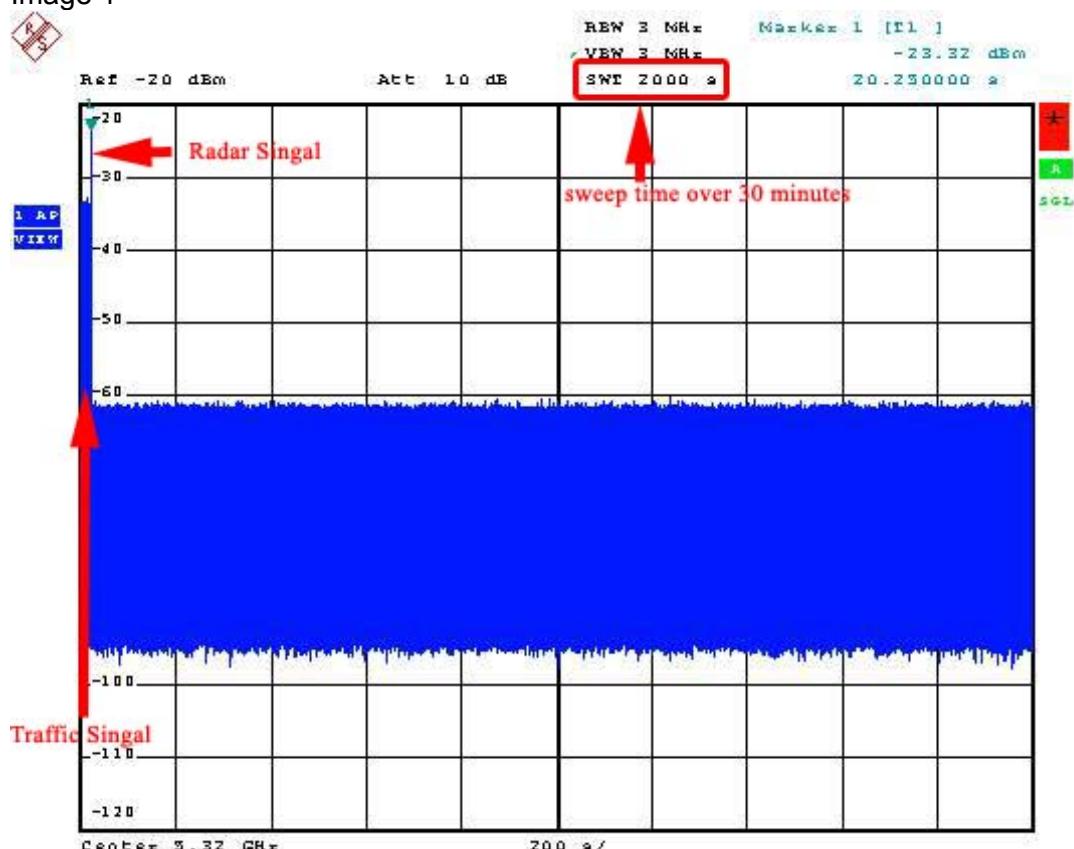
Image 1

Ans: We take a image capture from spectrum for sweep time 2000 seconds (Image 1) to monitor the connection. The device was complied with the 30 minute non-occupancy requirement for a channel after moving off of a channel when radar is detected. And we prepare the other image (Image 2) capture from web form of the support access point (Cisco 1240AG) for your reference.
