AS4000

Wireless Local Loop System.

Operations and Maintenance

Fault Diagnostic Guide

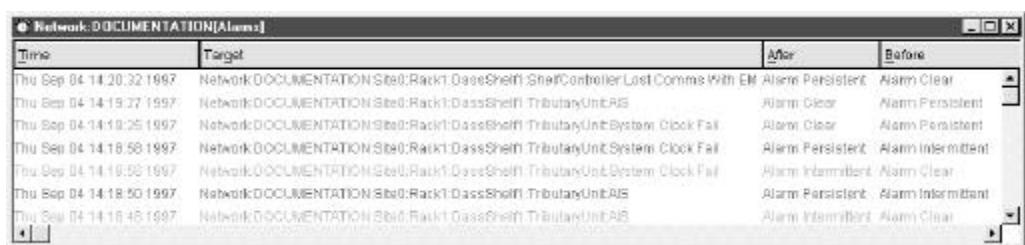
5. The Alarm View shows the current alarm status. Events when viewed as Objects in Sitespan are colour coded to help identify groups of alarms that occur:

Red : Persistent Alarm
Orange: Intermittent
Green: Clear

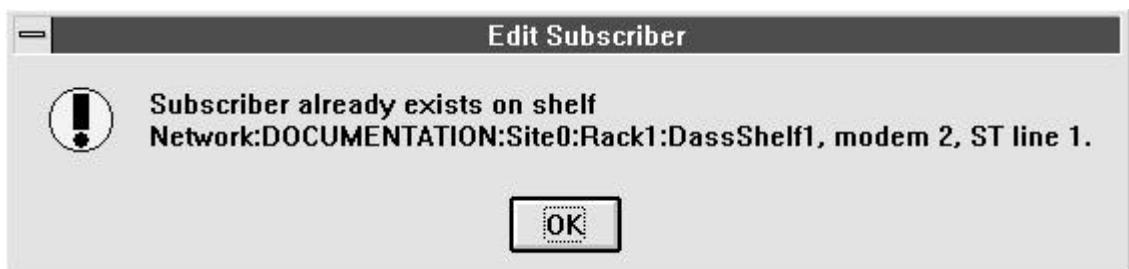
Figure 2-4. Existing Subscriber Warning

4. Select the hardware configuration by selecting The Shelf, (the field may be dropped by clicking the mouse on the (E) Modem and Line number. If the modem / line is already in use then the Sitespan will give a message, select a new modem / line.
