## Appendix B: photographs of test setup

## Appendix C: photographs of EUT

Reference to the test report no. BLA-EMC-202506-A1501

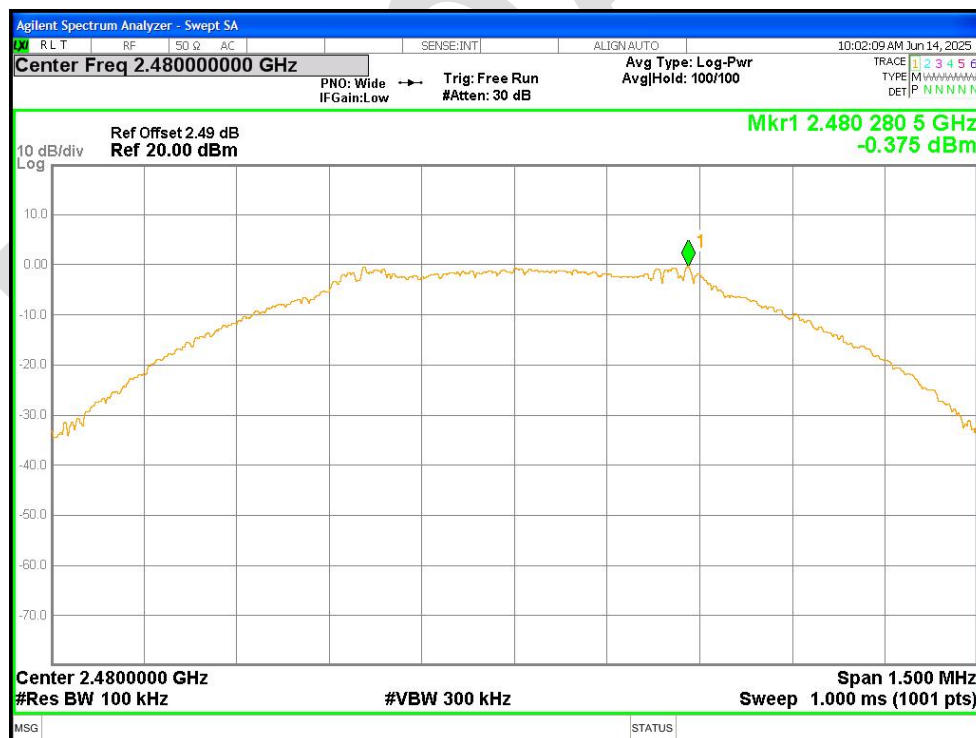
Tx. Spurious NVNT BLE 1M 2480MHz Ant1 Ref

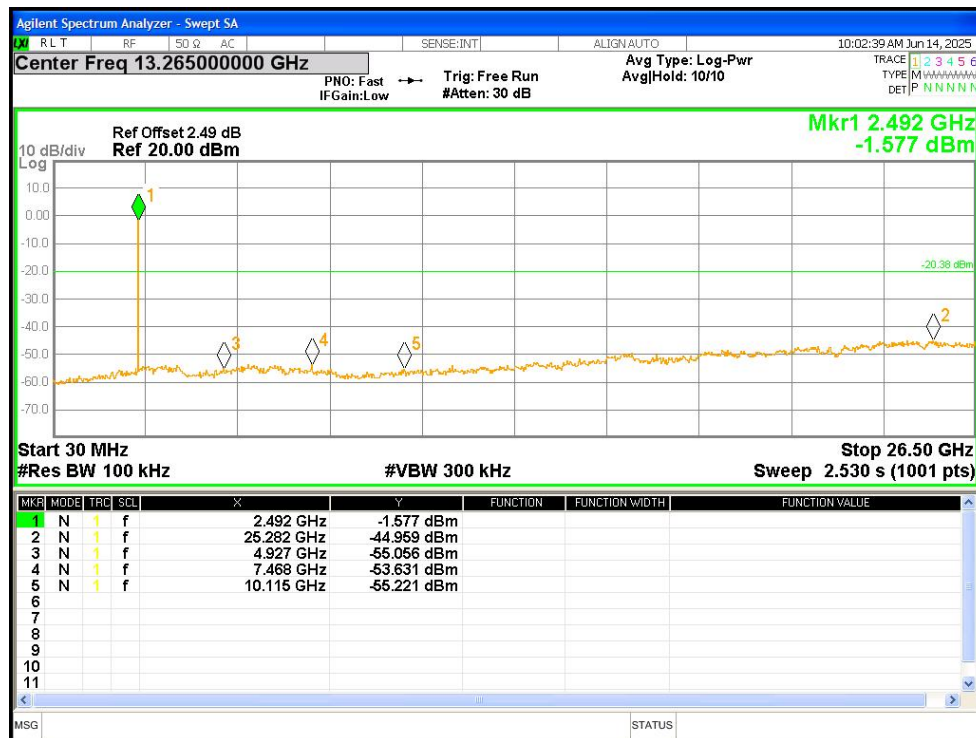
Tx. Spurious NVNT BLE 1M 2480MHz Ant1 Emission

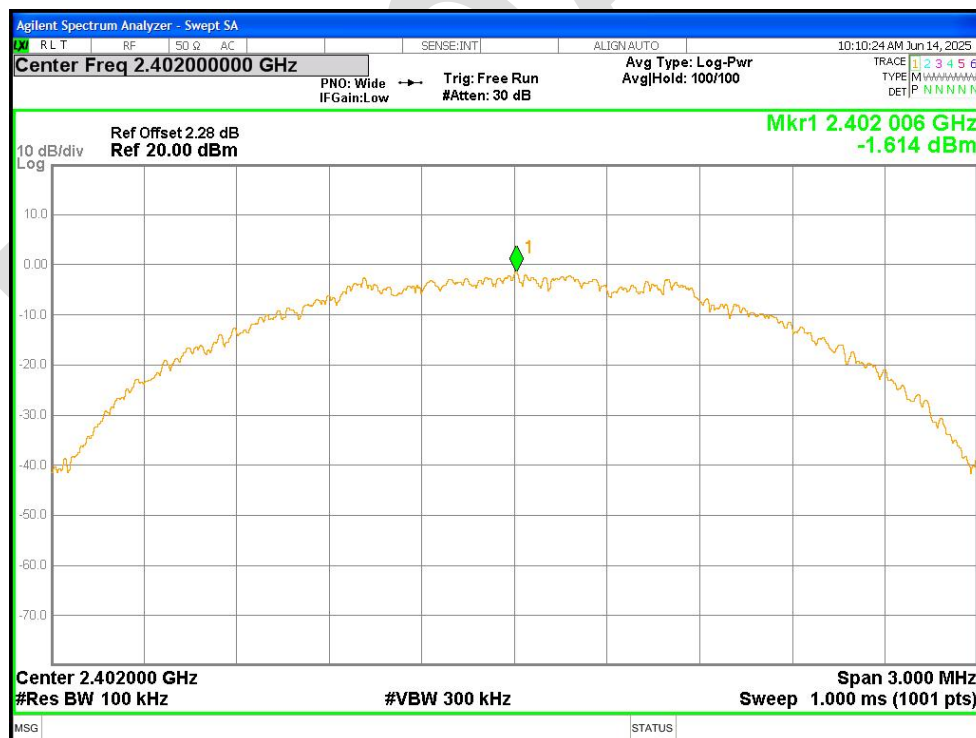
Tx. Spurious NVNT BLE 2M 2402MHz Ant1 Ref

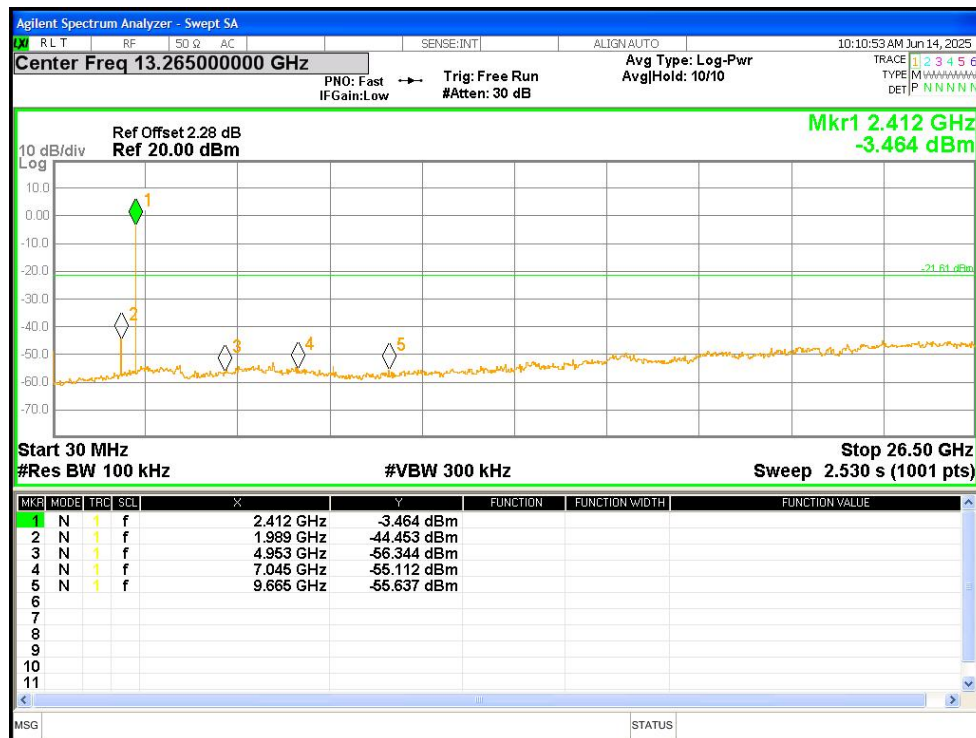
Tx. Spurious NVNT BLE 2M 2402MHz Ant1 Emission

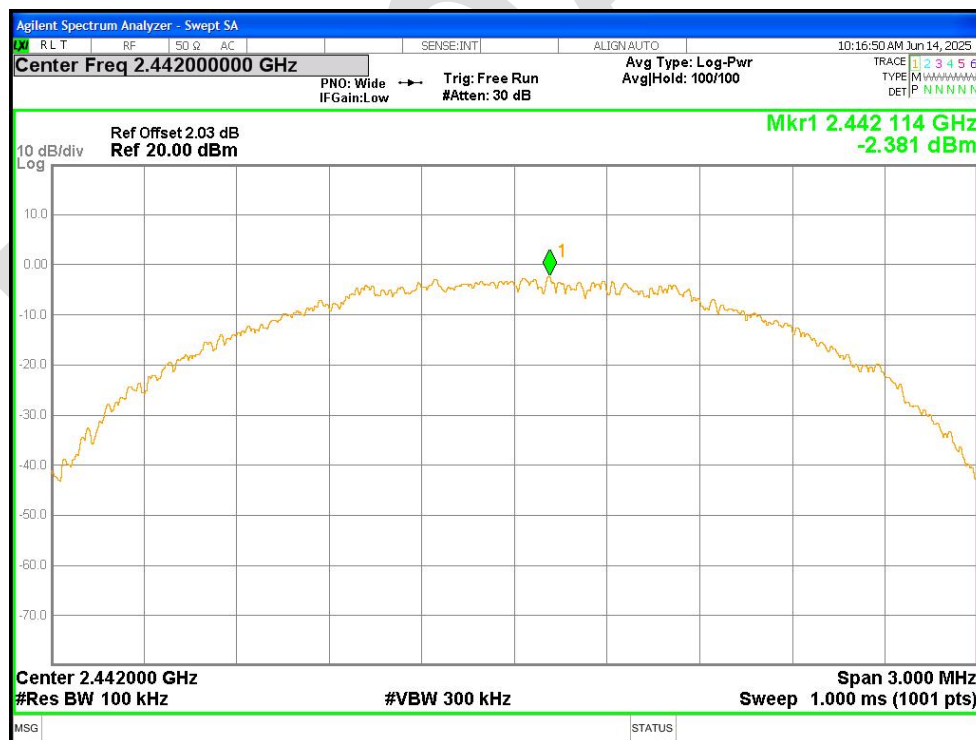
Tx. Spurious NVNT BLE 2M 2442MHz Ant1 Ref

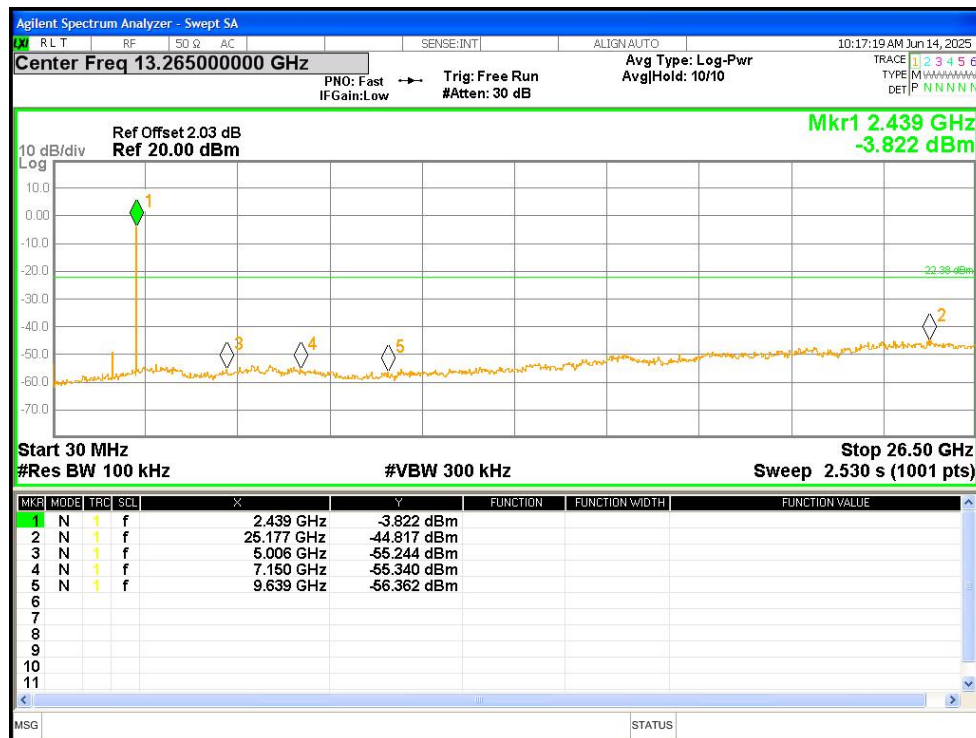
Tx. Spurious NVNT BLE 2M 2442MHz Ant1 Emission

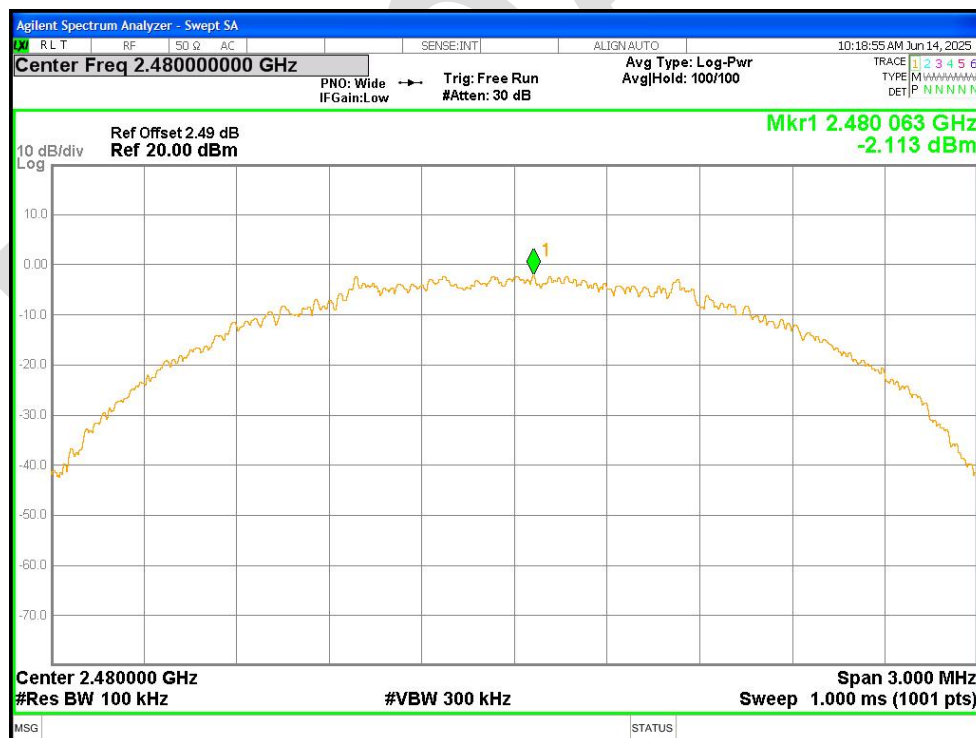
Tx. Spurious NVNT BLE 2M 2480MHz Ant1 Ref

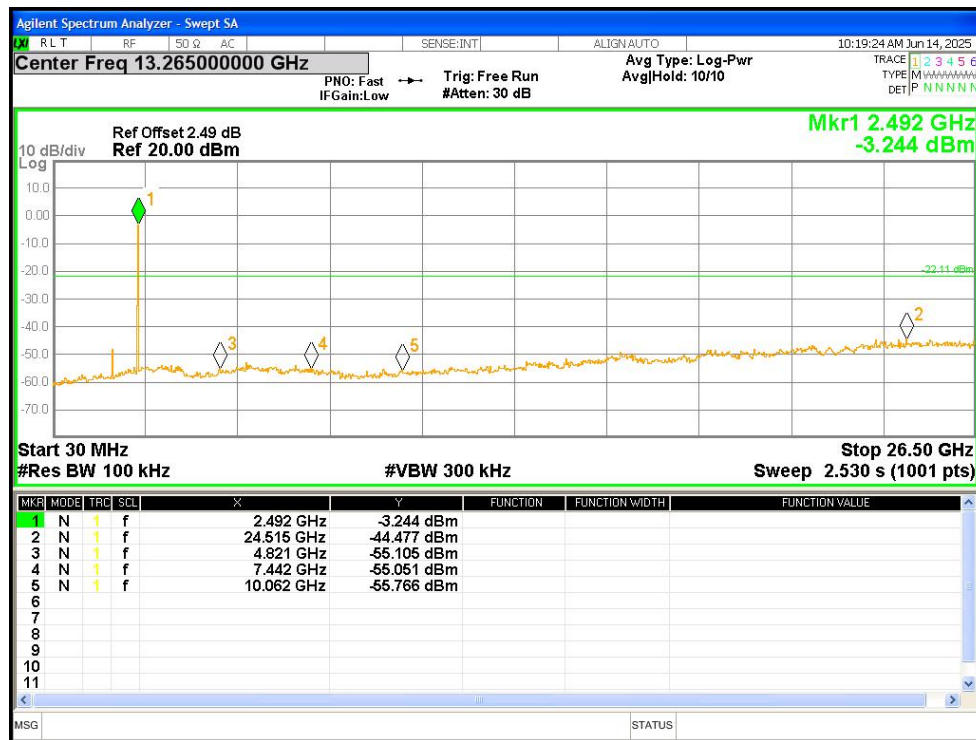
Tx. Spurious NVNT BLE 2M 2480MHz Ant1 Emission

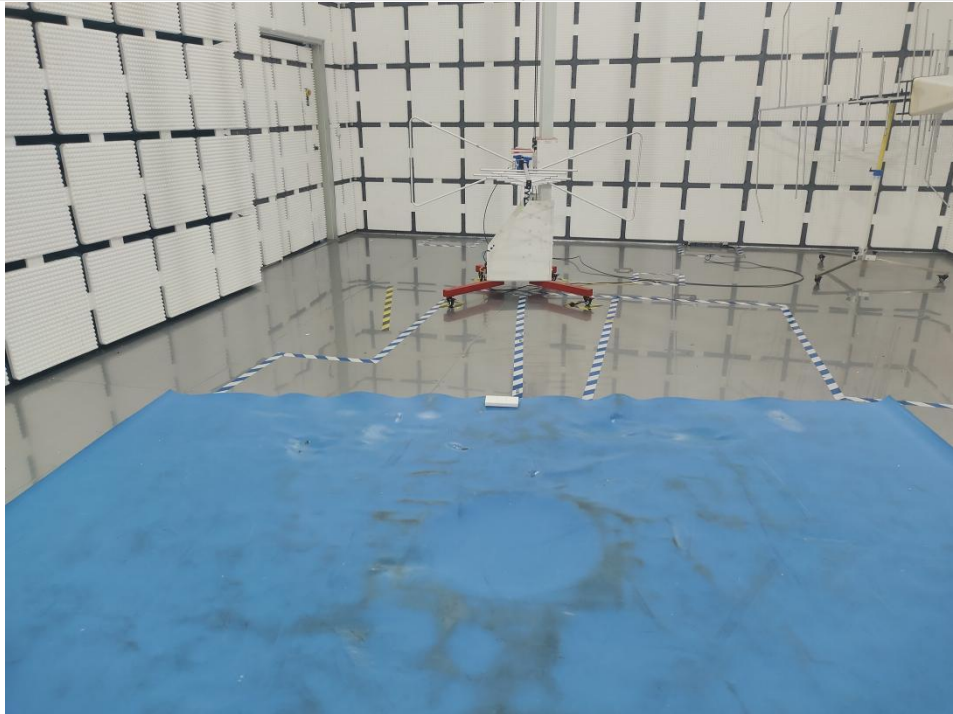
Radiated Emissions (30MHz-1GHz)

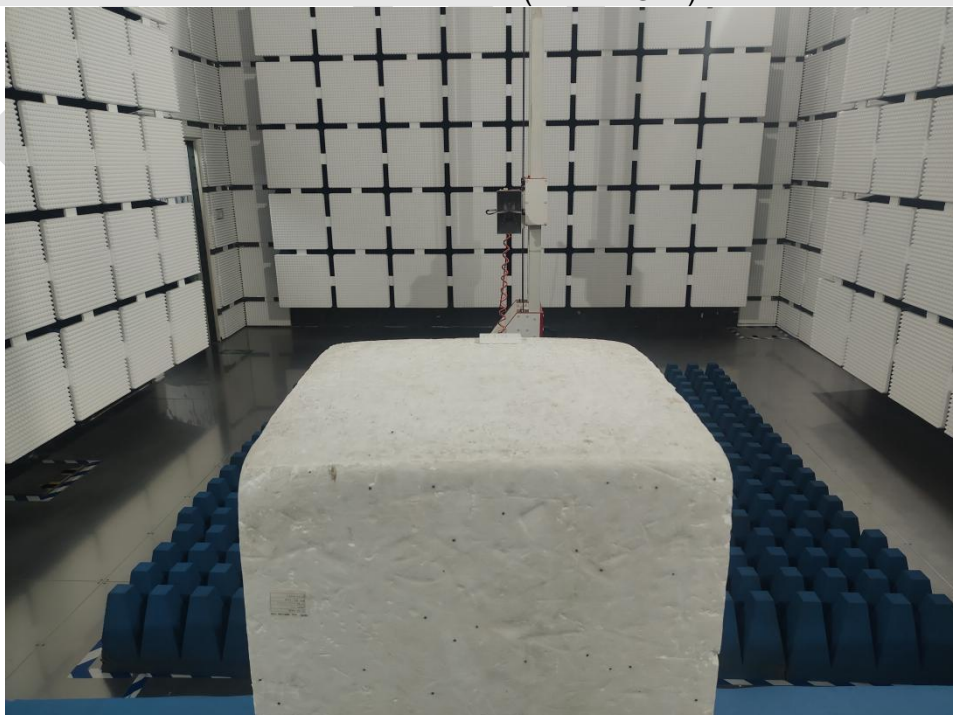
Radiated Emissions (above 1GHz)
