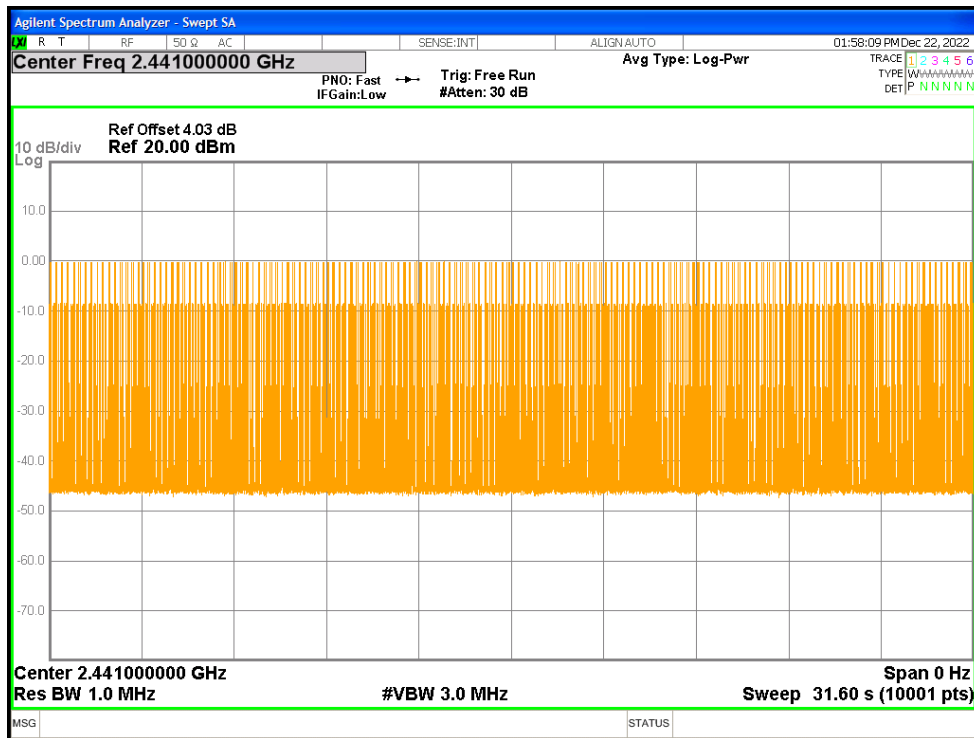
Dwell NVNT 1-DH3 2441MHz Ant1 One Burst

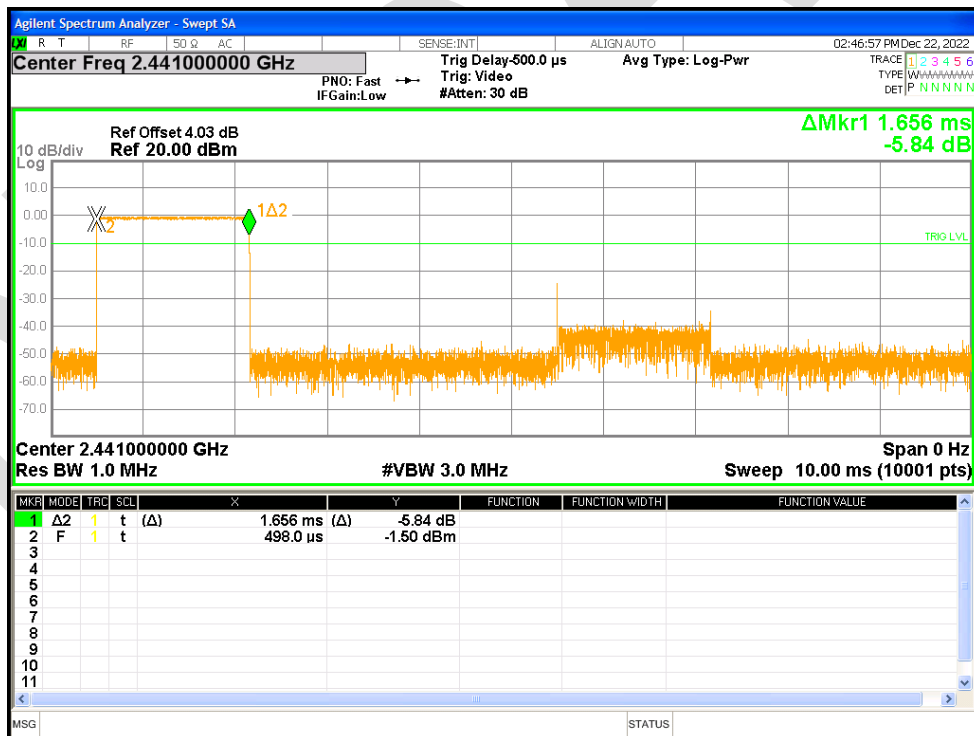
Dwell NVNT 1-DH3 2441MHz Ant1 Accumulated

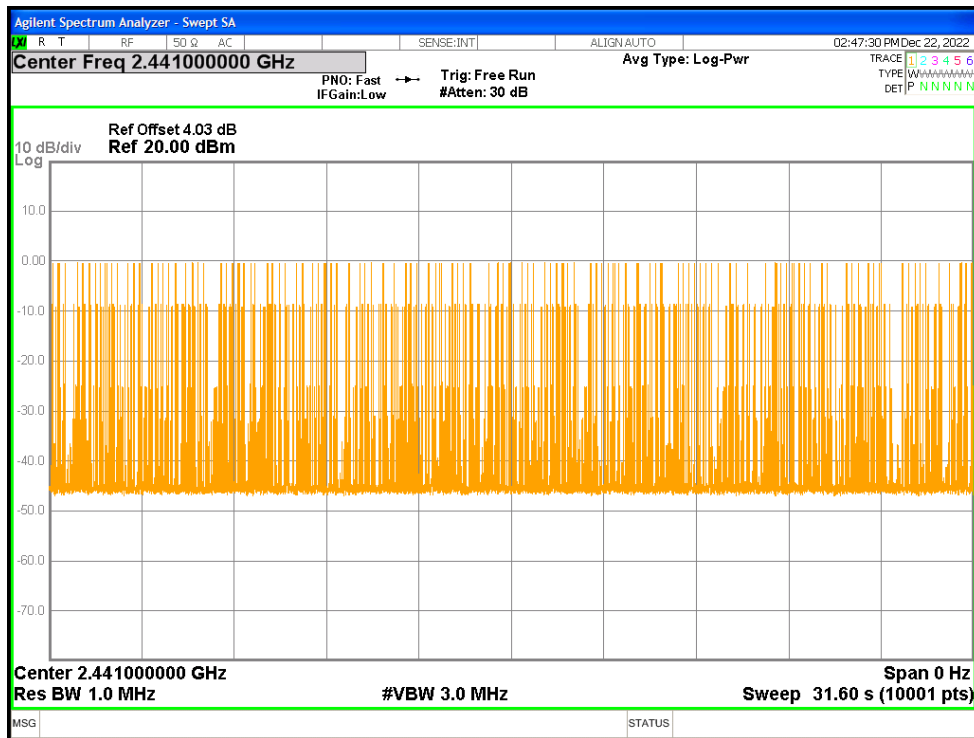
Dwell NVNT 1-DH5 2441MHz Ant1 One Burst

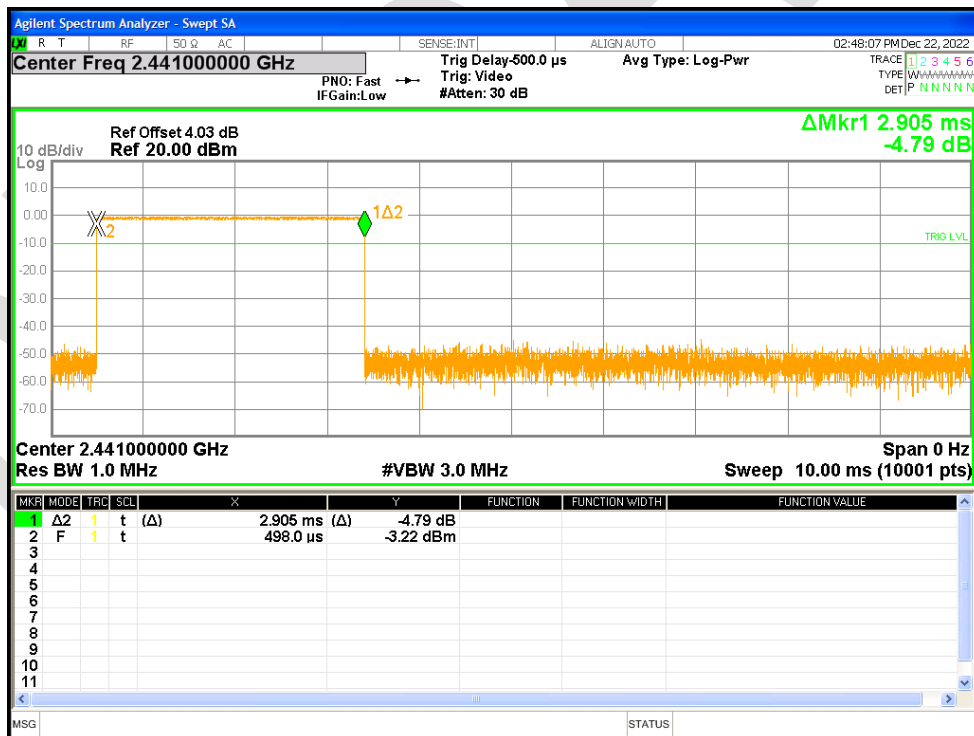
Dwell NVNT 1-DH5 2441MHz Ant1 Accumulated

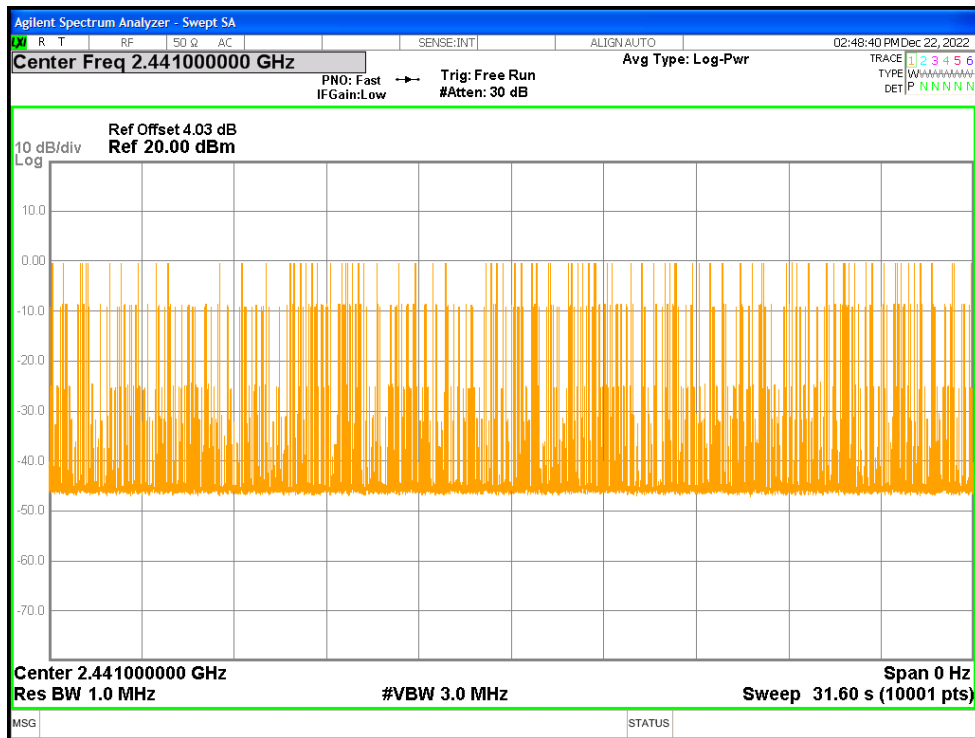
Dwell NVNT 2-DH1 2441MHz Ant1 One Burst

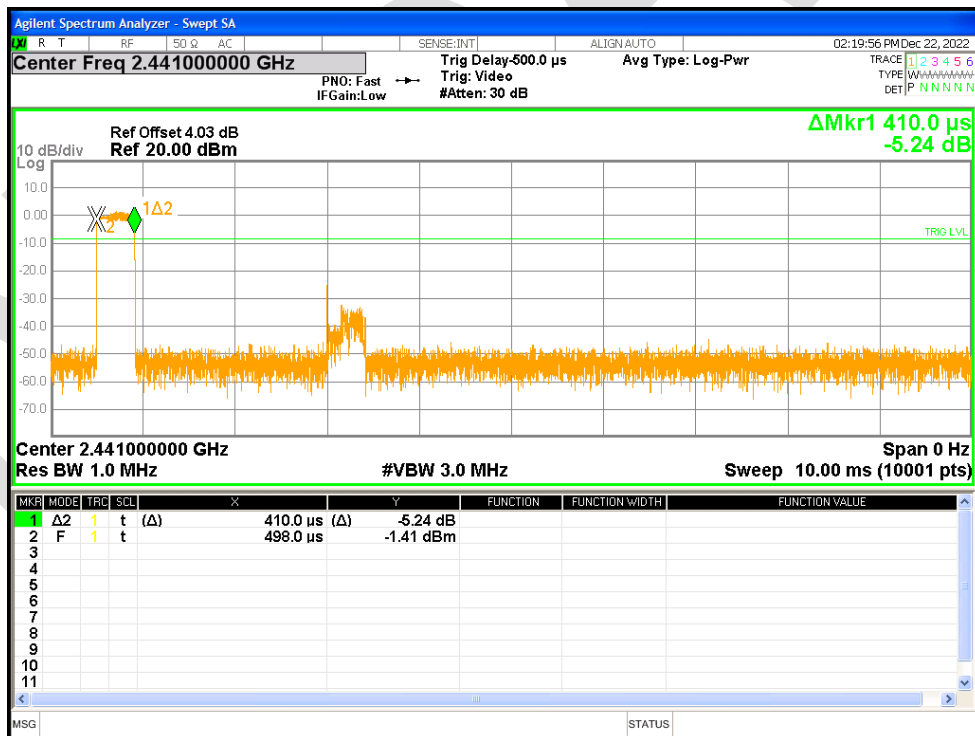
Dwell NVNT 2-DH1 2441MHz Ant1 Accumulated

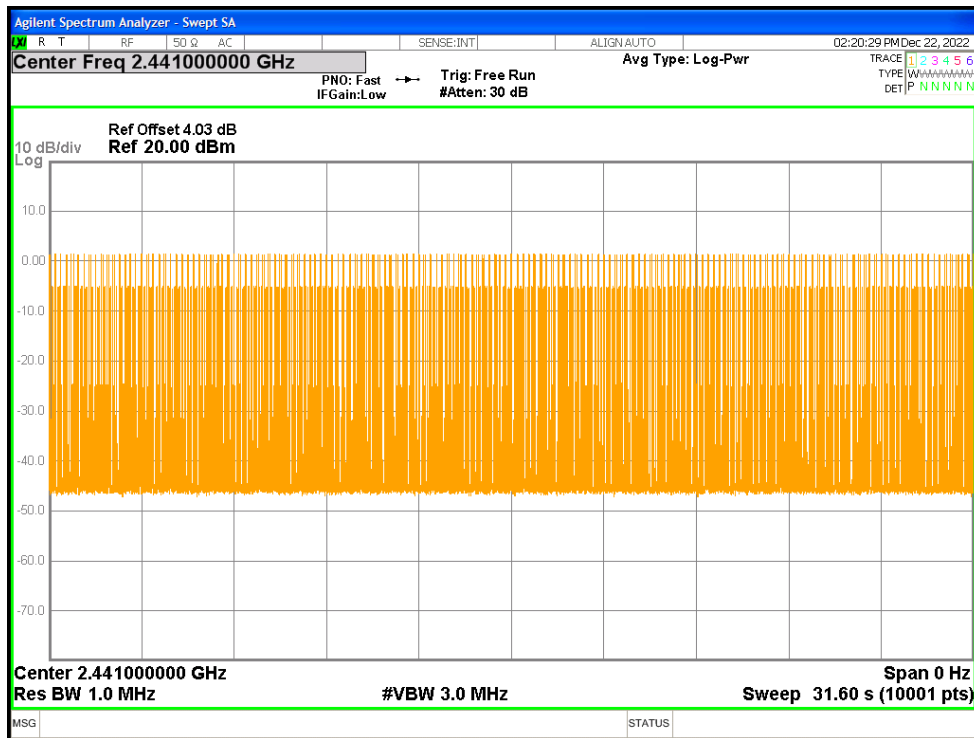
Dwell NVNT 2-DH5 2441MHz Ant1 One Burst

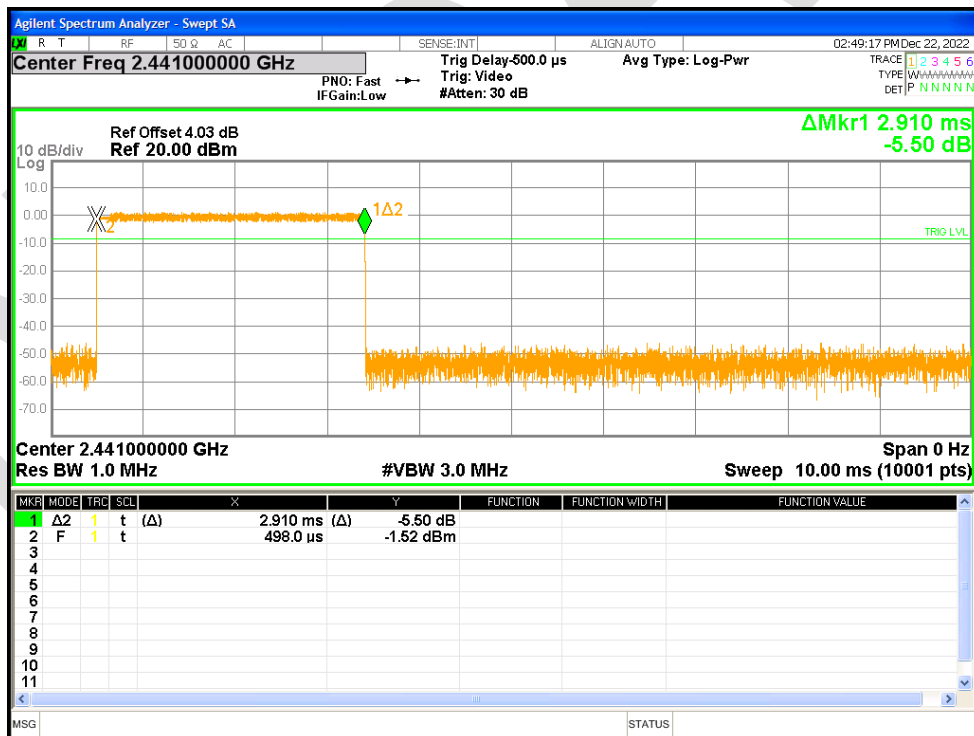
Dwell NVNT 2-DH5 2441MHz Ant1 Accumulated

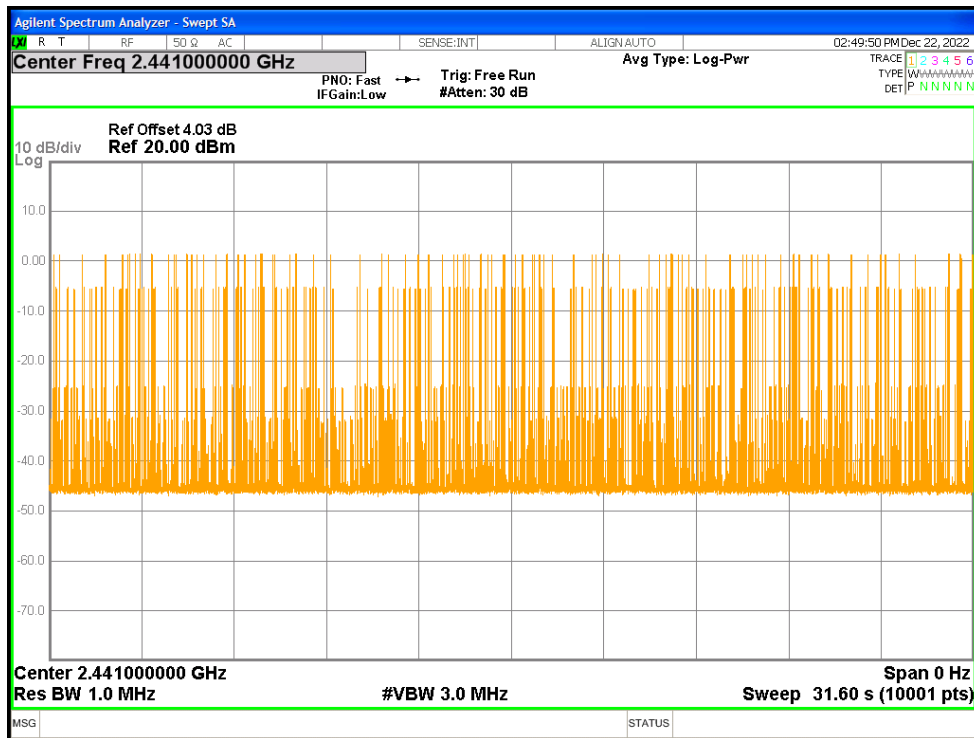
Dwell NVNT 3-DH1 2441MHz Ant1 One Burst

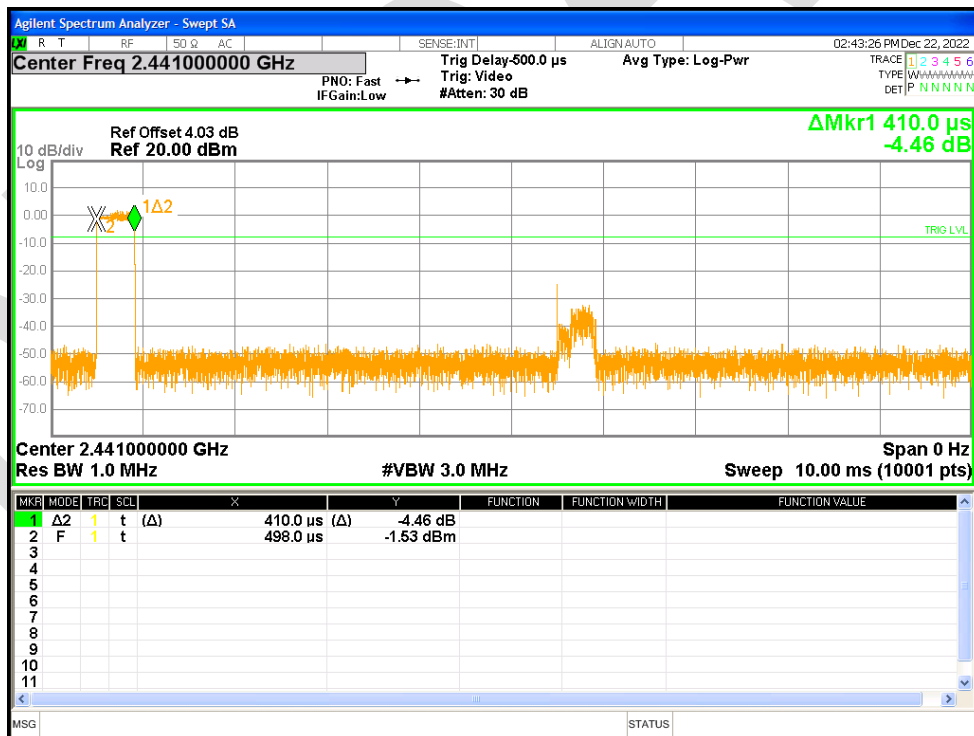
Dwell NVNT 3-DH1 2441MHz Ant1 Accumulated

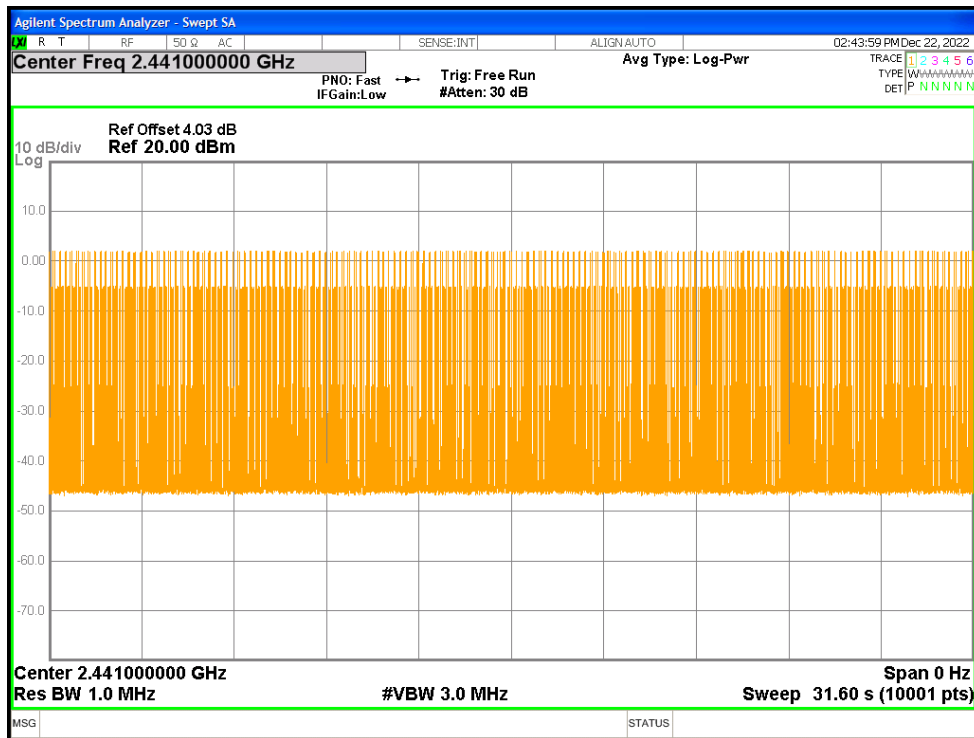
Dwell NVNT 3-DH5 2441MHz Ant1 One Burst

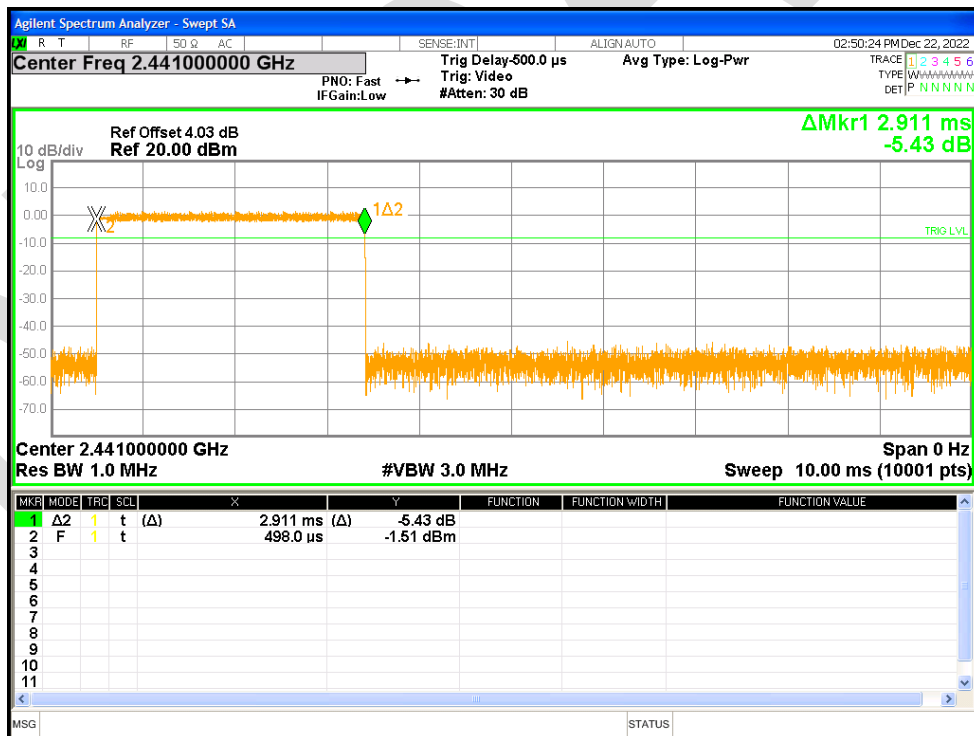
Dwell NVNT 3-DH5 2441MHz Ant1 Accumulated

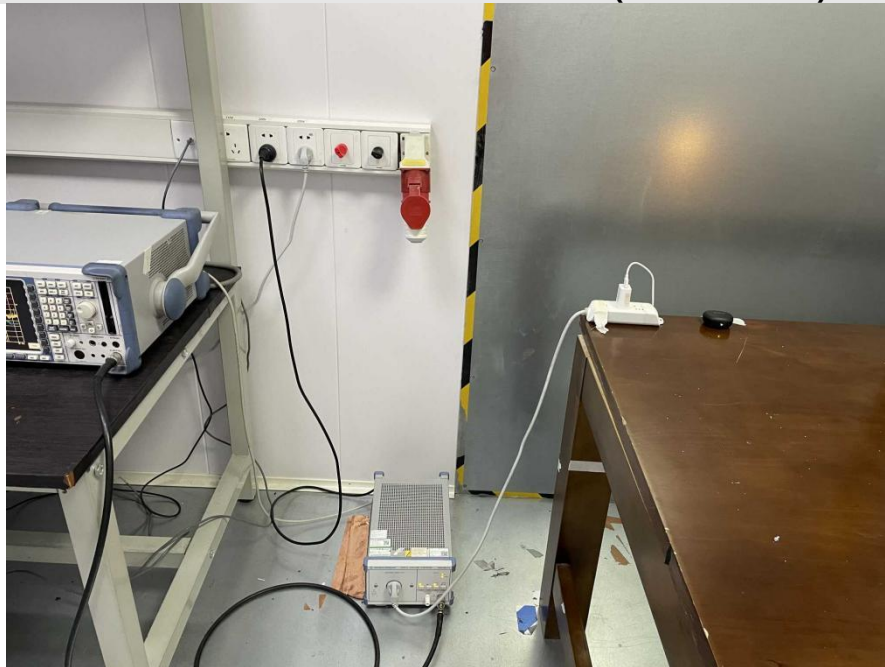
### Conducted Emissions at AC Power Line (150kHz-30MHz)

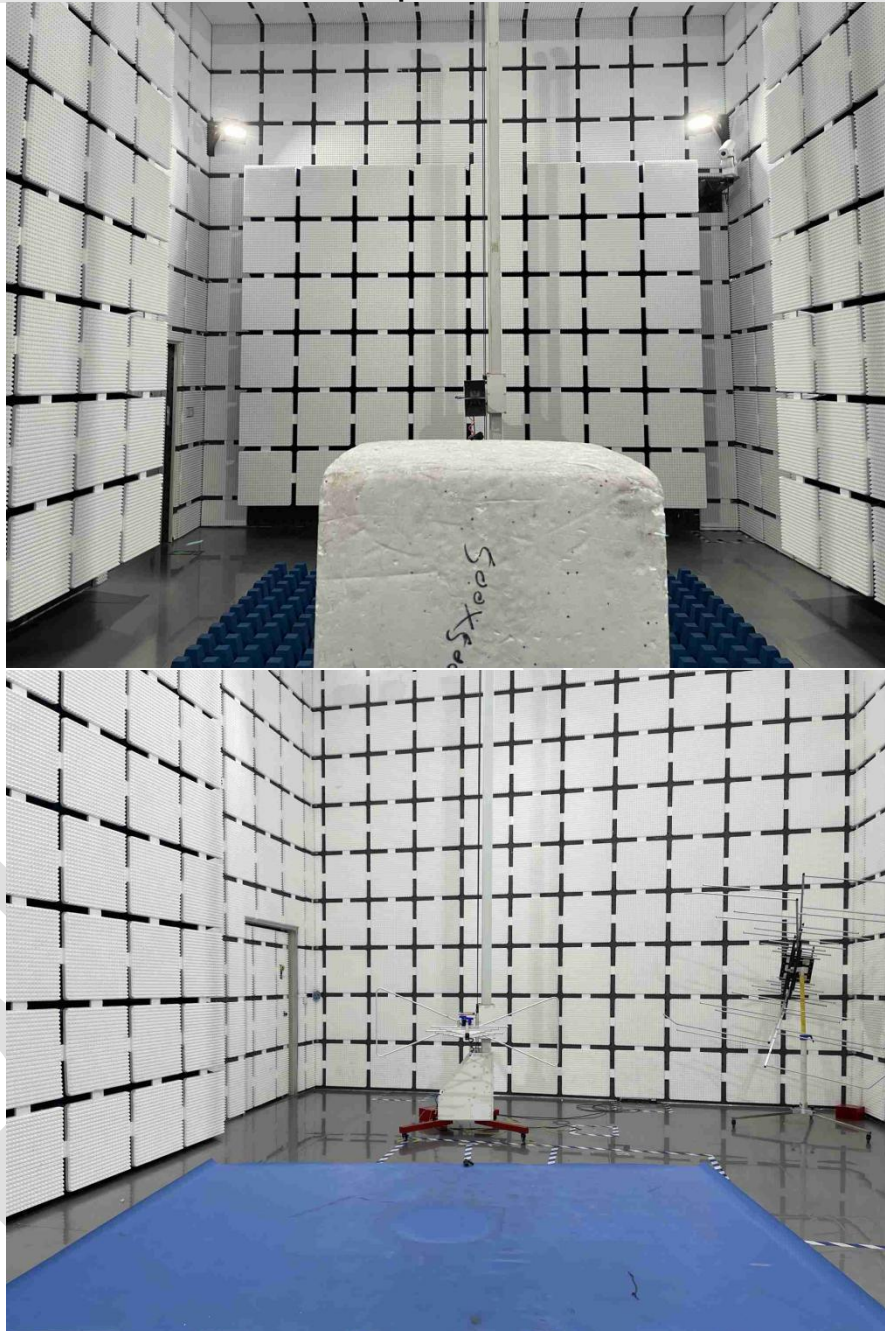
### Radiated Spurious Emissions
