## 7. Form731

## Appendix B: Photographs of Test Setup

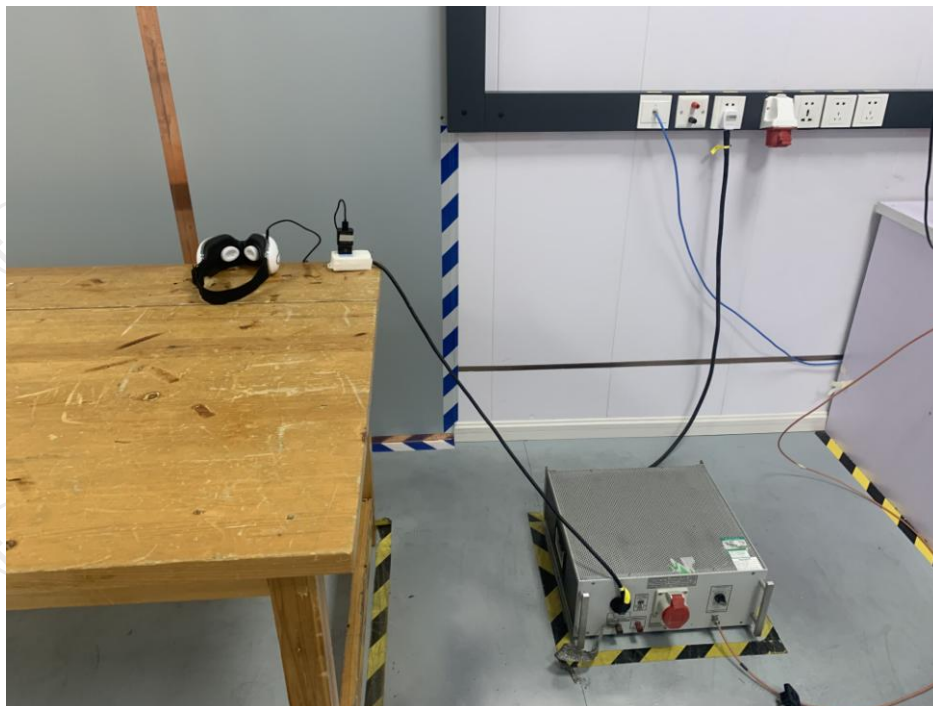
### Conducted Emission
