## 20.6 CONDUCTED RF SPURIOUS EMISSION

Reference to the test report No. BLA-EMC-202309-A1801

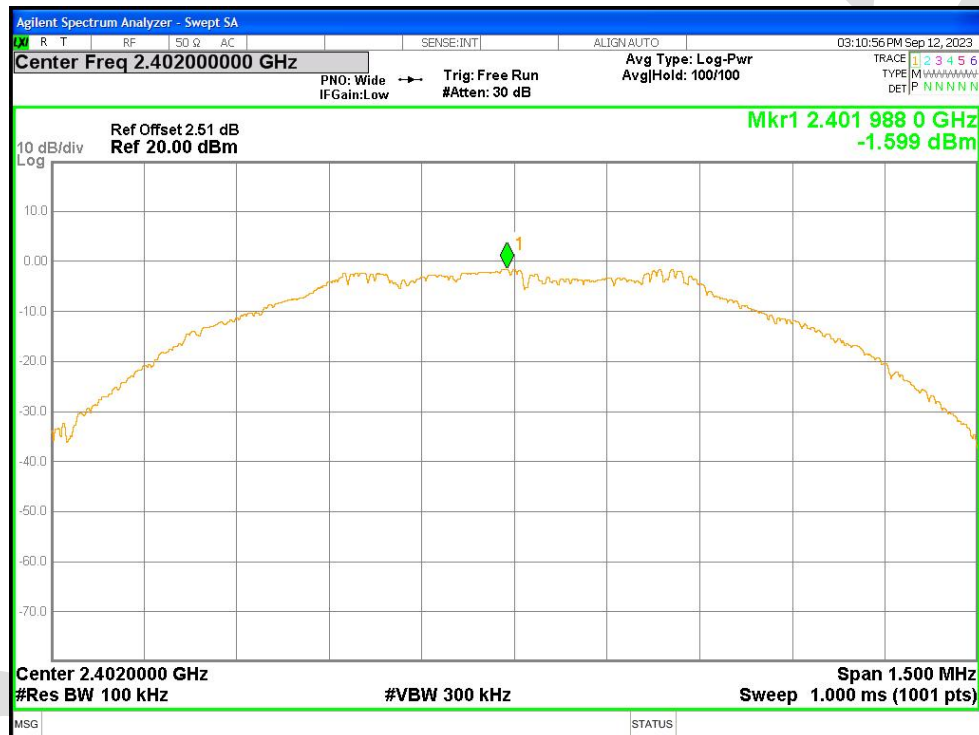
Tx. Spurious NVNT BLE 1M 2402MHz Ant1 Ref

| Condition | Mode | Frequency (MHz) | Antenna | Max Value (dBc) | Limit (dBc) | Verdict |
|---|---|---|---|---|---|---|
| NVNT | BLE 1M | 2402 | Ant1 | -43.36 | -30 | Pass |

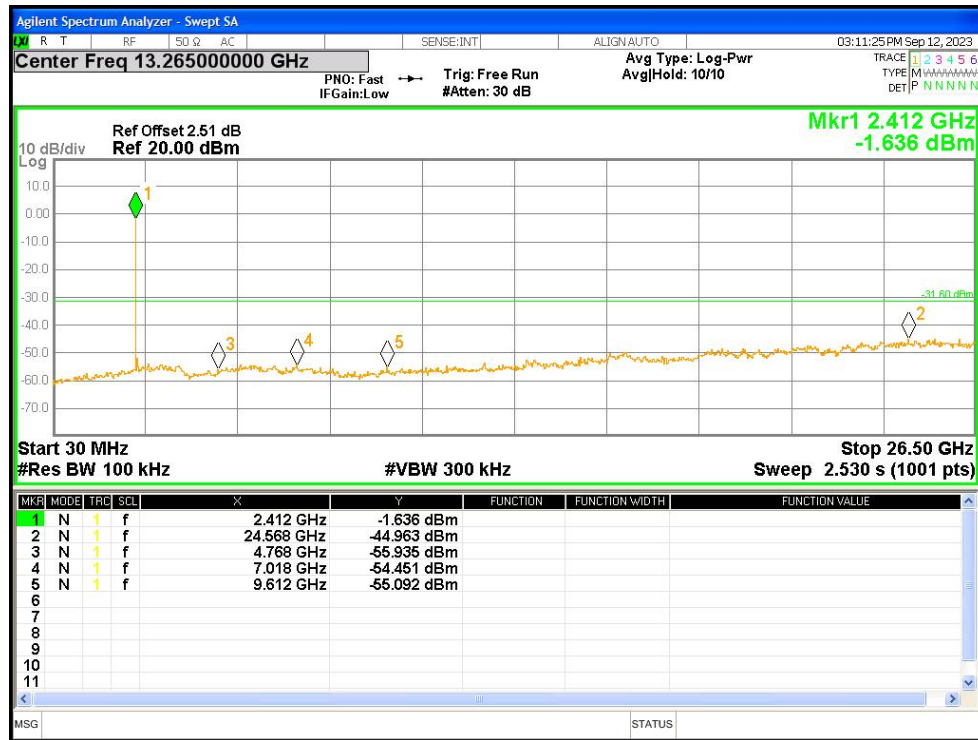
Tx. Spurious NVNT BLE 1M 2402MHz Ant1 Emission

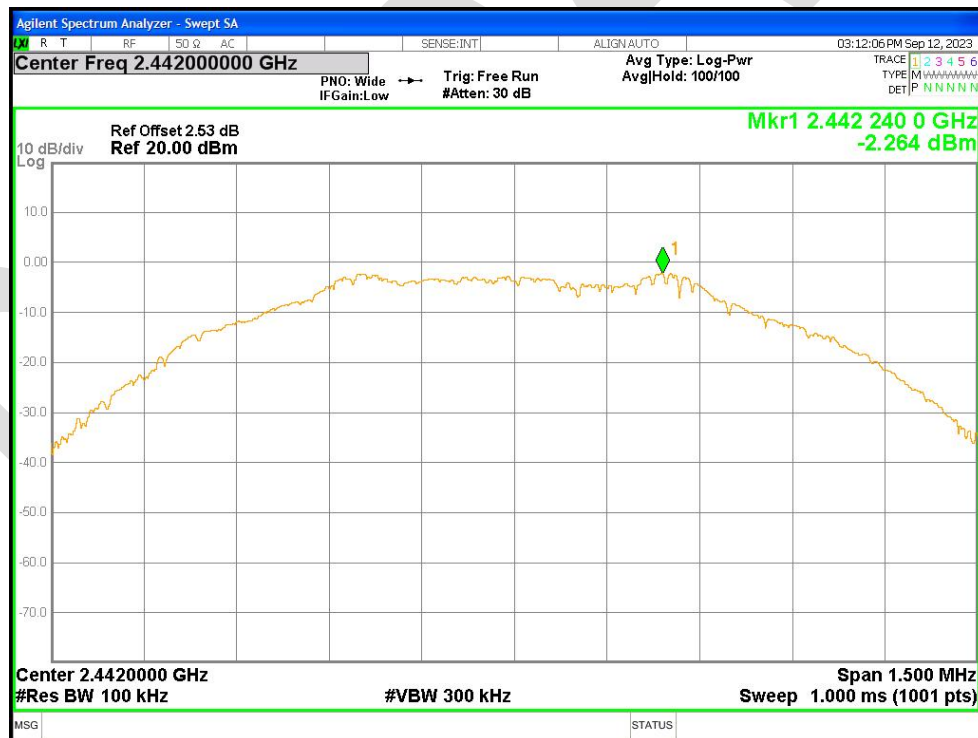
Tx. Spurious NVNT BLE 1M 2442MHz Ant1 Ref

| Condition | Mode | Frequency (MHz) | Antenna | Max Value (dBc) | Limit (dBc) | Verdict |
|---|---|---|---|---|---|---|
| NVNT | BLE 1M | 2442 | Ant1 | -42.39 | -30 | Pass |

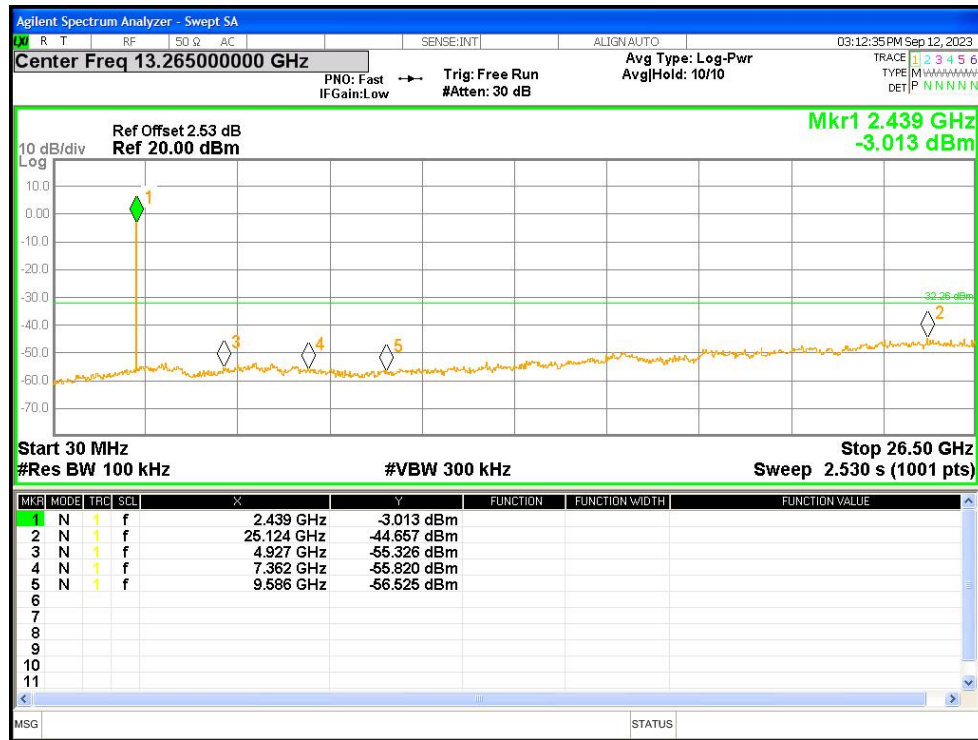
Tx. Spurious NVNT BLE 1M 2442MHz Ant1 Emission

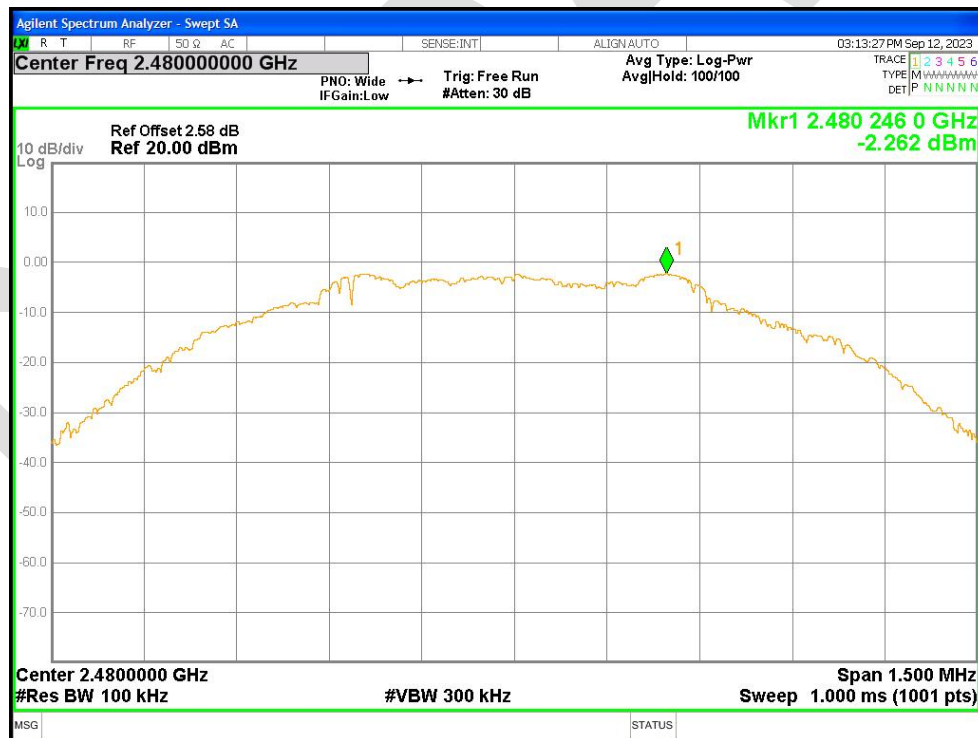
Tx. Spurious NVNT BLE 1M 2480MHz Ant1 Ref

| Condition | Mode | Frequency (MHz) | Antenna | Max Value (dBc) | Limit (dBc) | Verdict |
|---|---|---|---|---|---|---|
| NVNT | BLE 1M | 2480 | Ant1 | -42.98 | -30 | Pass |

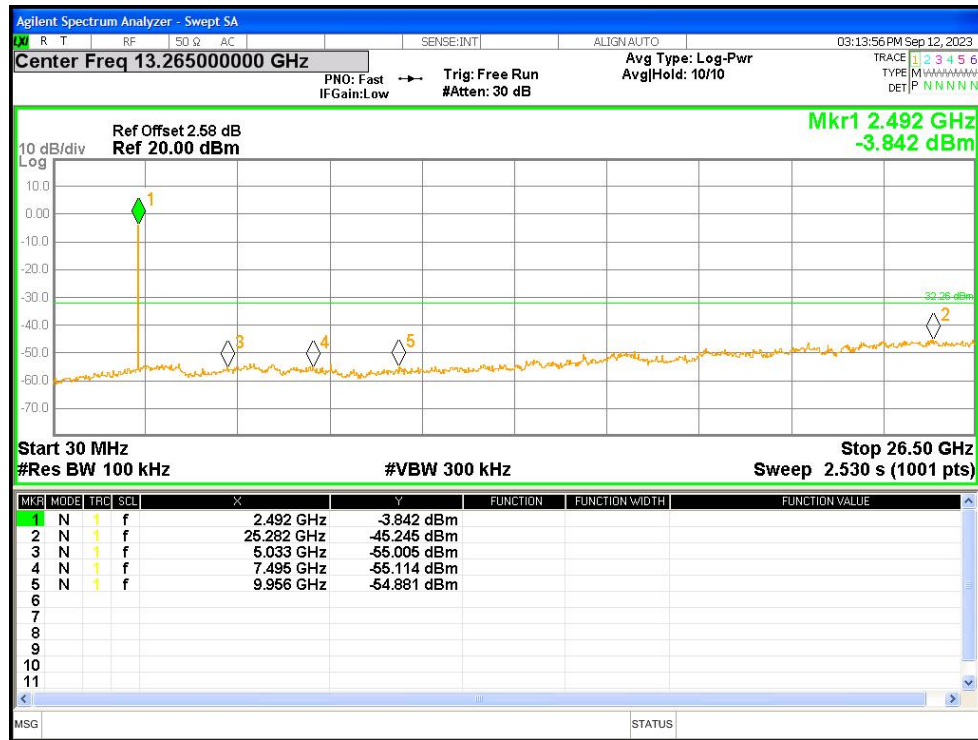
Tx. Spurious NVNT BLE 1M 2480MHz Ant1 Emission

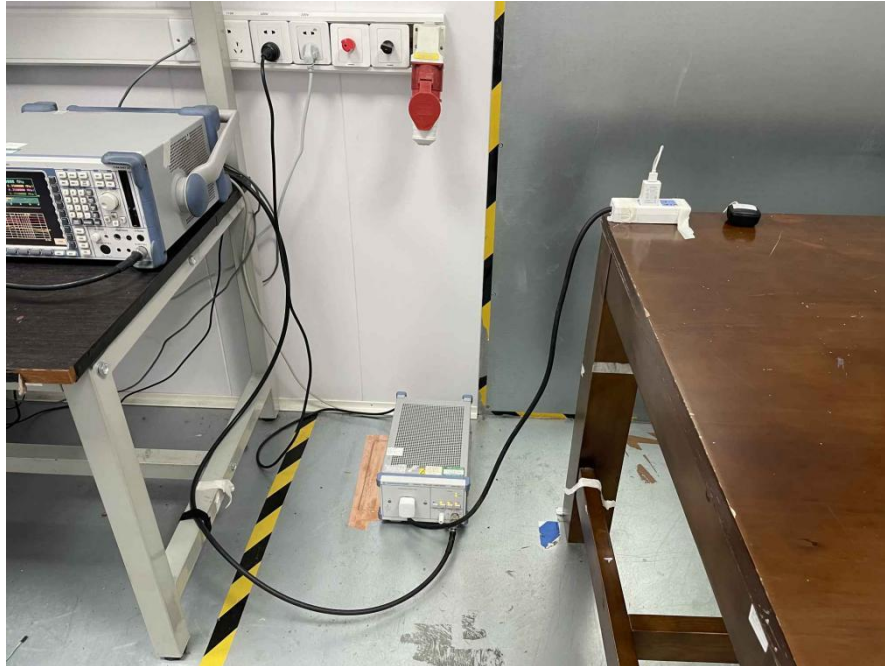
### Conducted Emissions at AC Power Line (150kHz-30MHz)

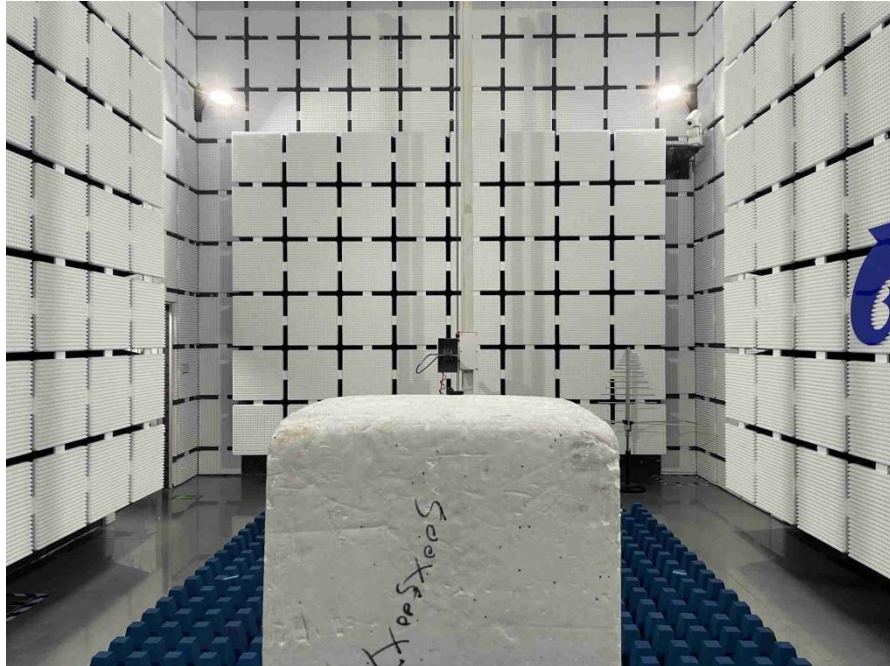
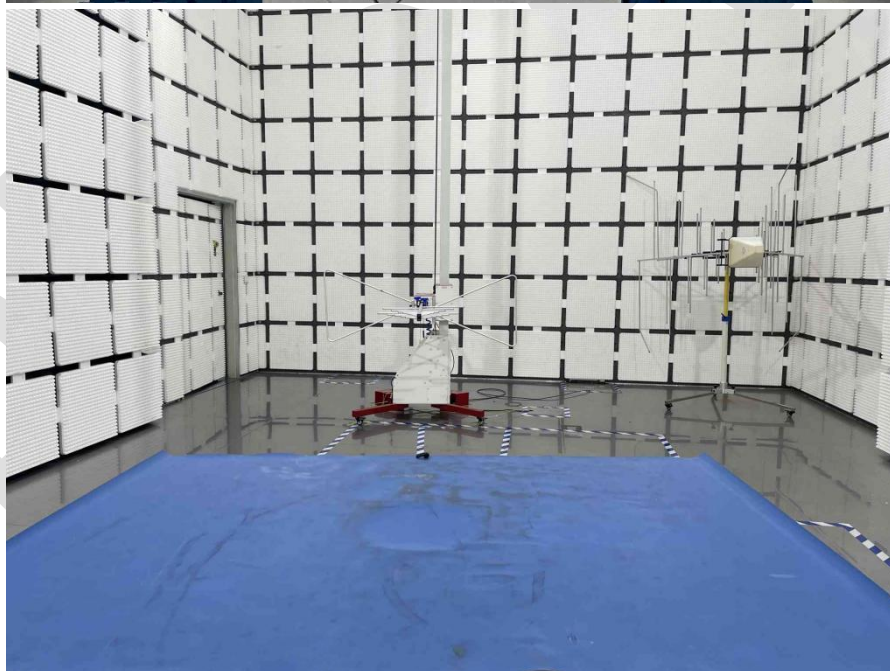
### Radiated Spurious Emissions
