## 6 Photographs of the Test Setup

## 7 Photographs of the EUT

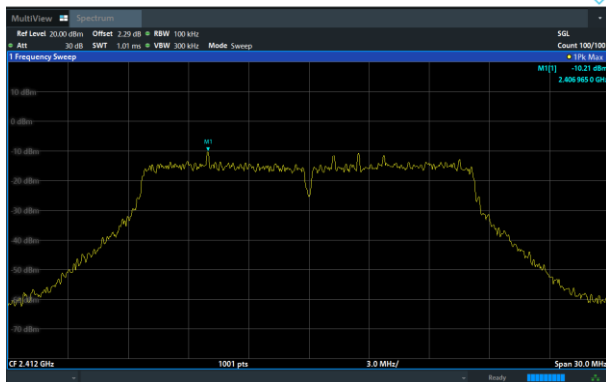
802.11g on Channel 01

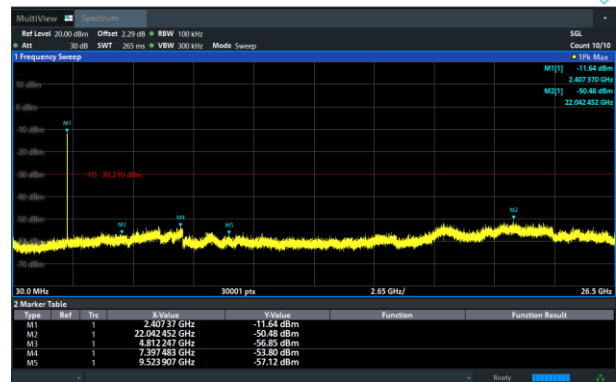
802.11g on Channel 01

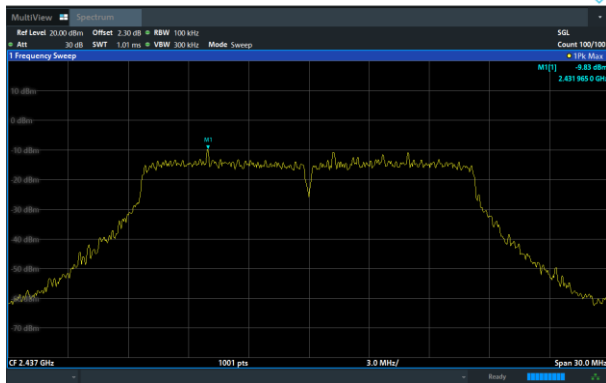
802.11g on Channel 06

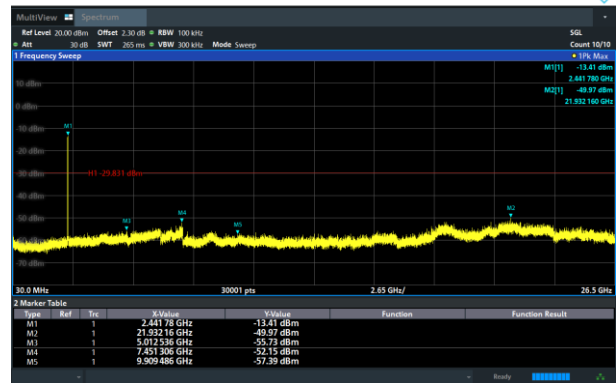
802.11g on Channel 06

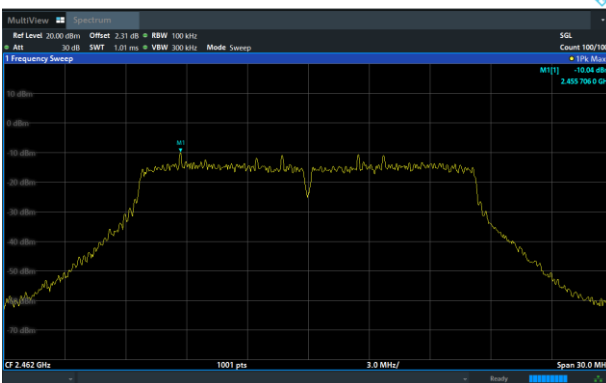
802.11g on Channel 11

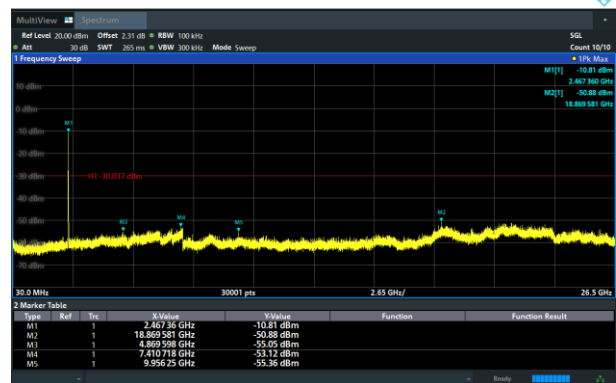
802.11g on Channel 11

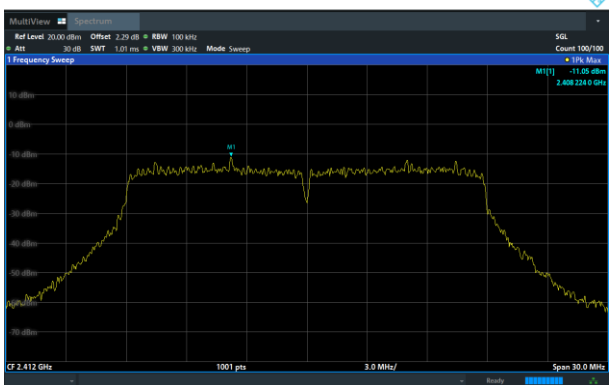
802.11n20 on Channel 01

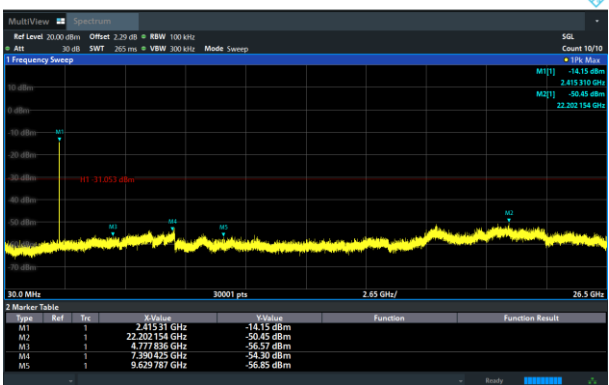
802.11n20 on Channel 01

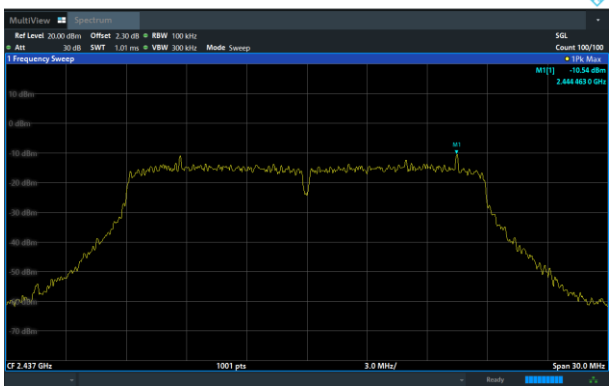
802.11n20 on Channel 06

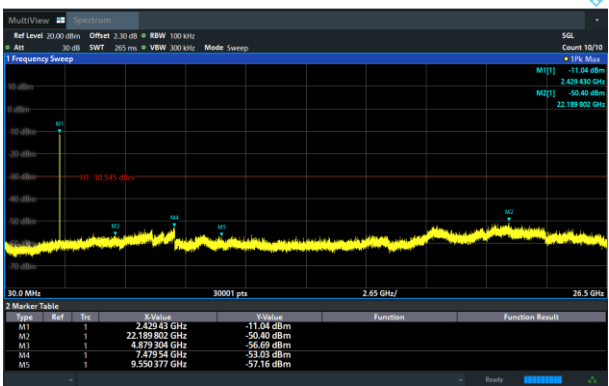
802.11n20 on Channel 06

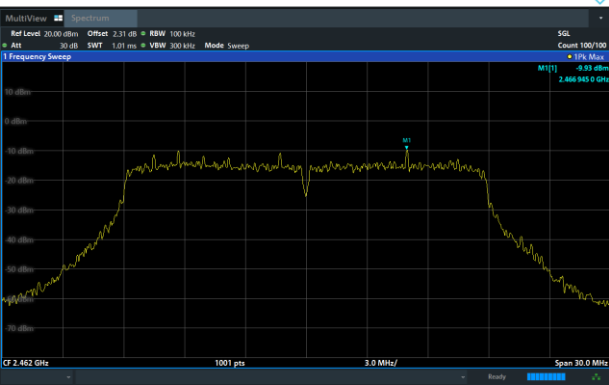
802.11n20 on Channel 11

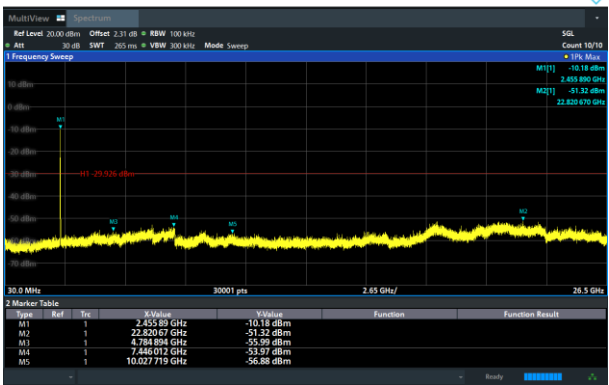
802.11n20 on Channel 11

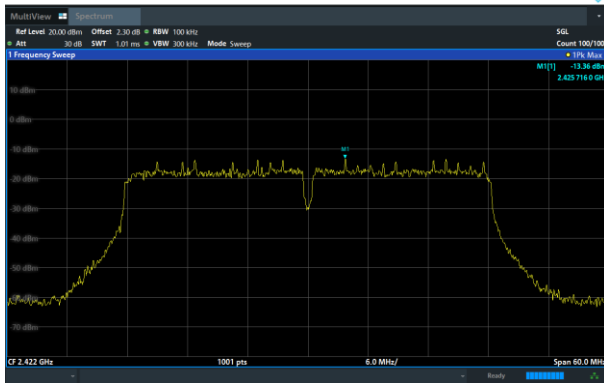
802.11n40 on Channel 03

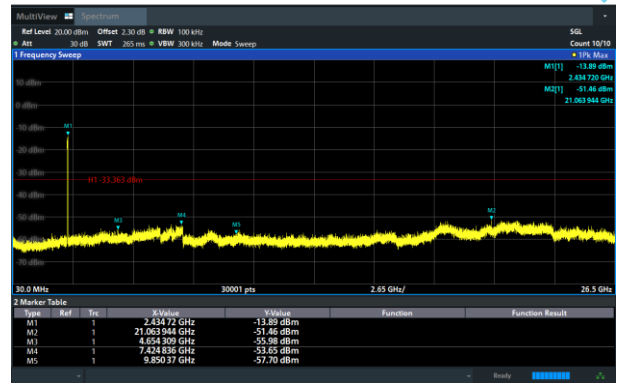
802.11n40 on Channel 03

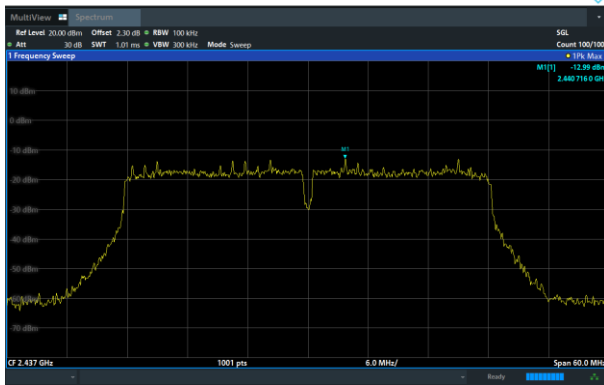
802.11n40 on Channel 06

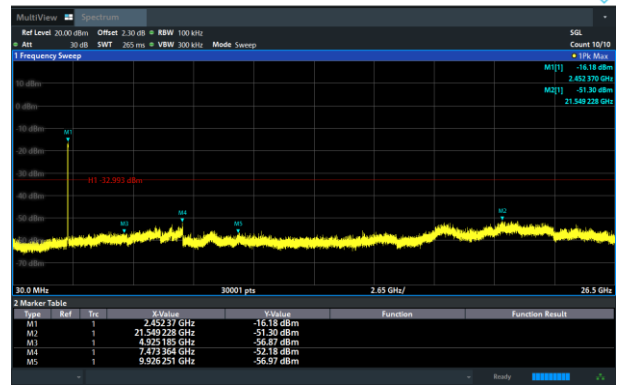
802.11n40 on Channel 06

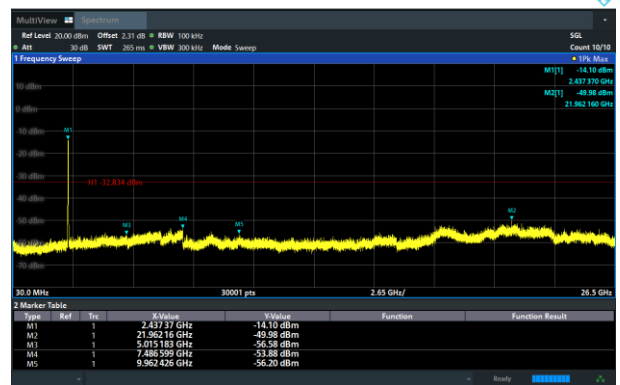
802.11n40 on Channel 09

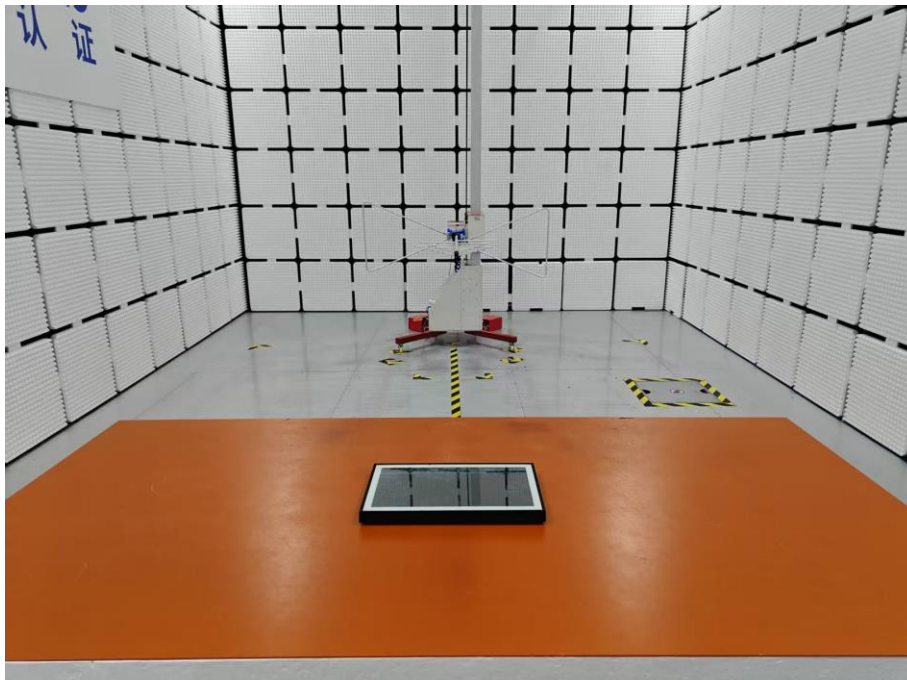
Radiated Emission Below 1GHz

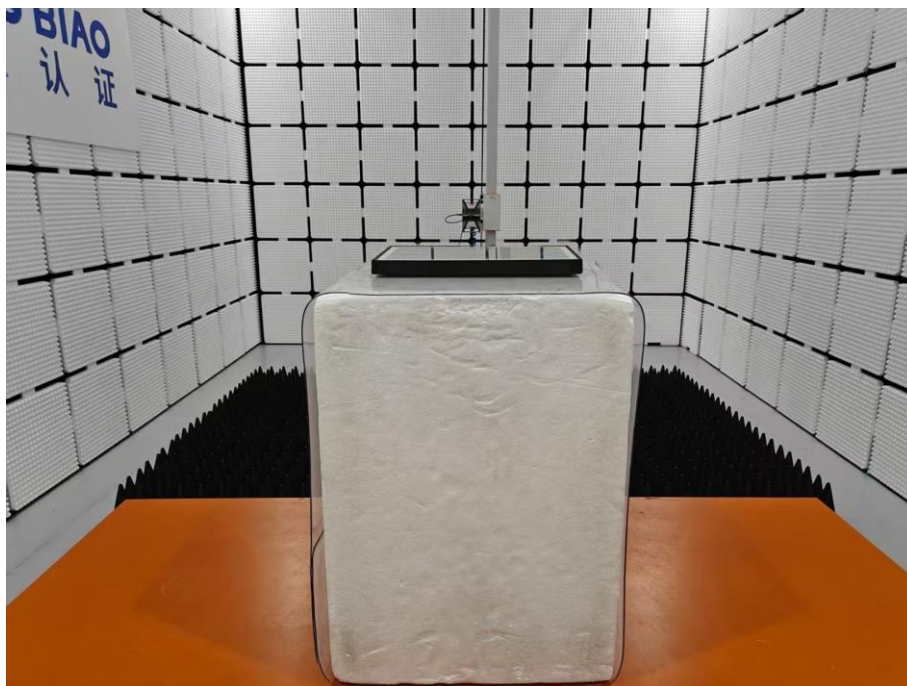
Radiated Emission Above 1GHz

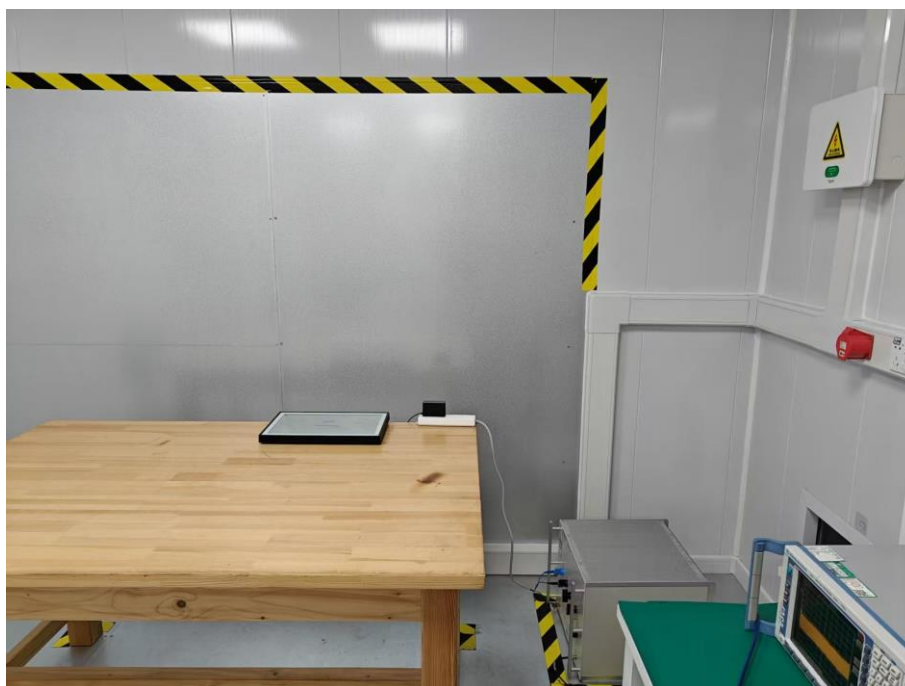
Conducted Emission
