6. Unwanted Emissions In Non-restricted Frequency Bands

Report No.: SZCR250900403901

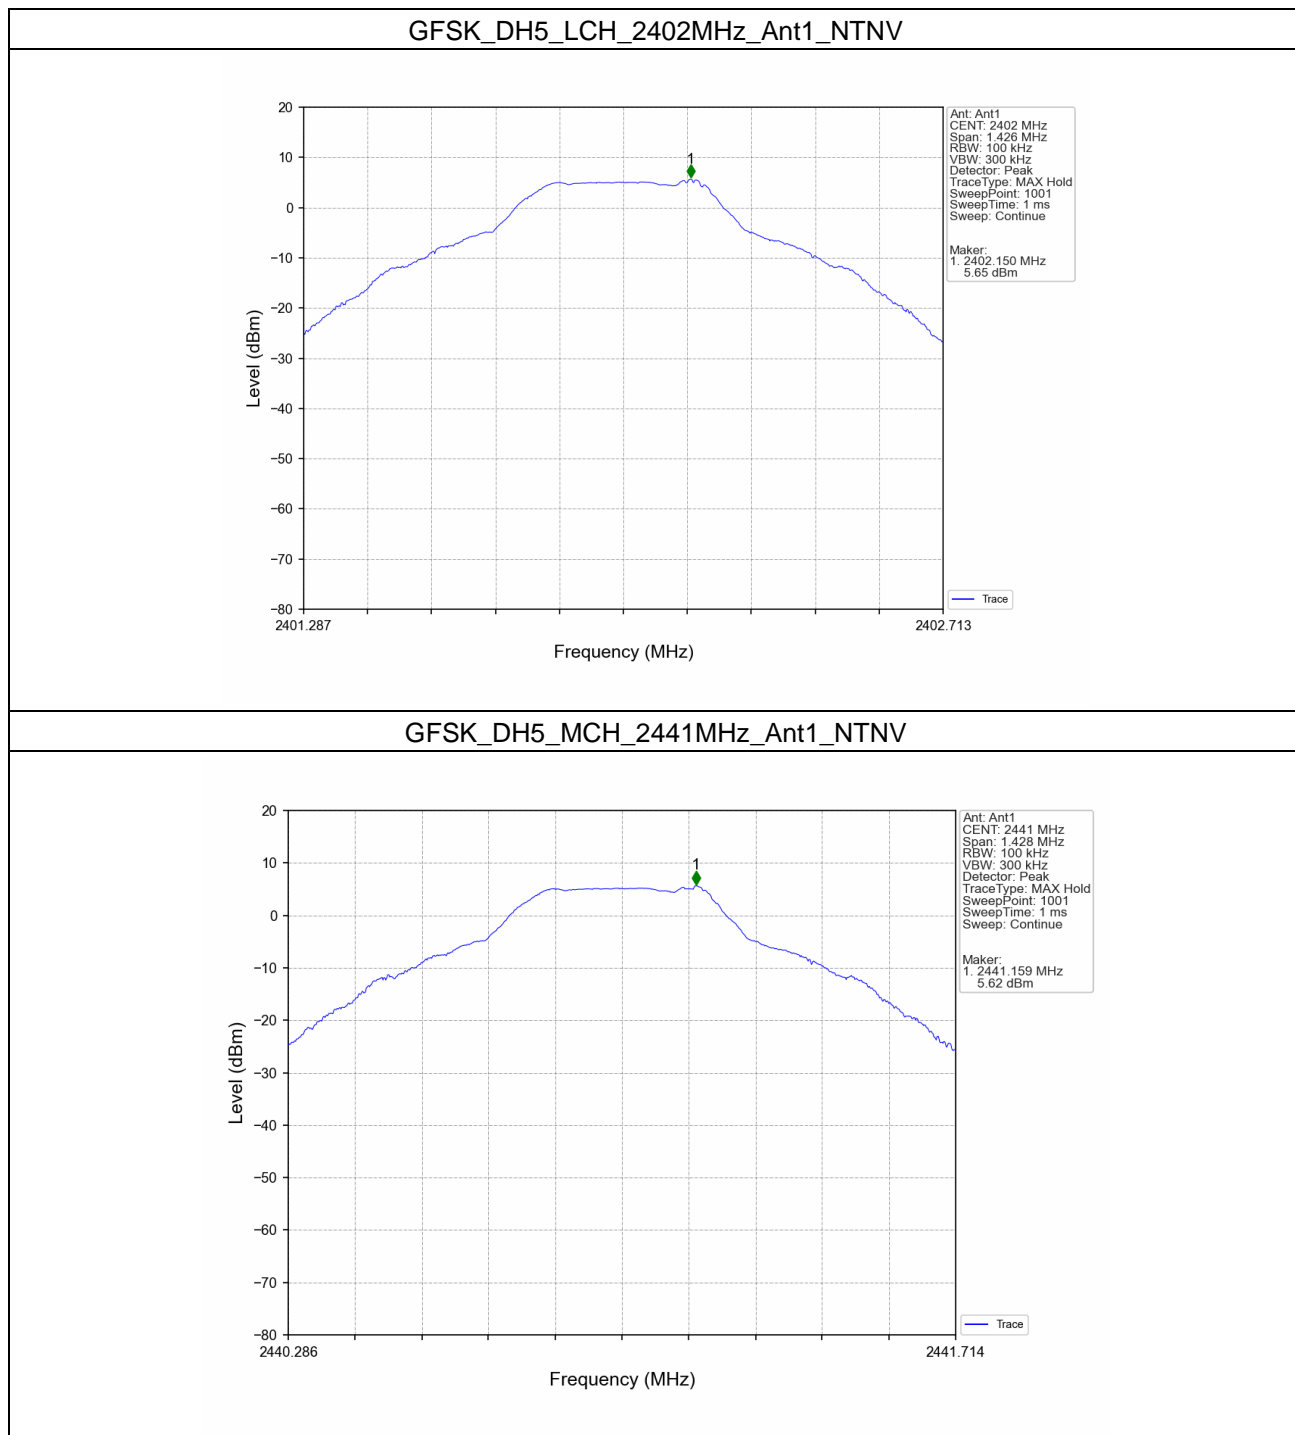
6.2.1 Ref

Mode	TX Type	Frequency (MHz)	Packet Type	ANT	Level of Reference (dBm)
GFSK	SISO	2402	DH5	1	5.65
		2441	DH5	1	5.62
		2480	DH5	1	5.53
Pi/4DQPSK	SISO	2402	2DH5	1	5.49
		2441	2DH5	1	5.62
		2480	2DH5	1	5.50
8DPSK	SISO	2402	3DH5	1	5.63
		2441	3DH5	1	5.72
		2480	3DH5	1	5.61

Note1: Refer to FCC Part 15.247 (d) and ANSI C63.10-2020, the channel contains the maximum PSD level was used to establish the reference level.

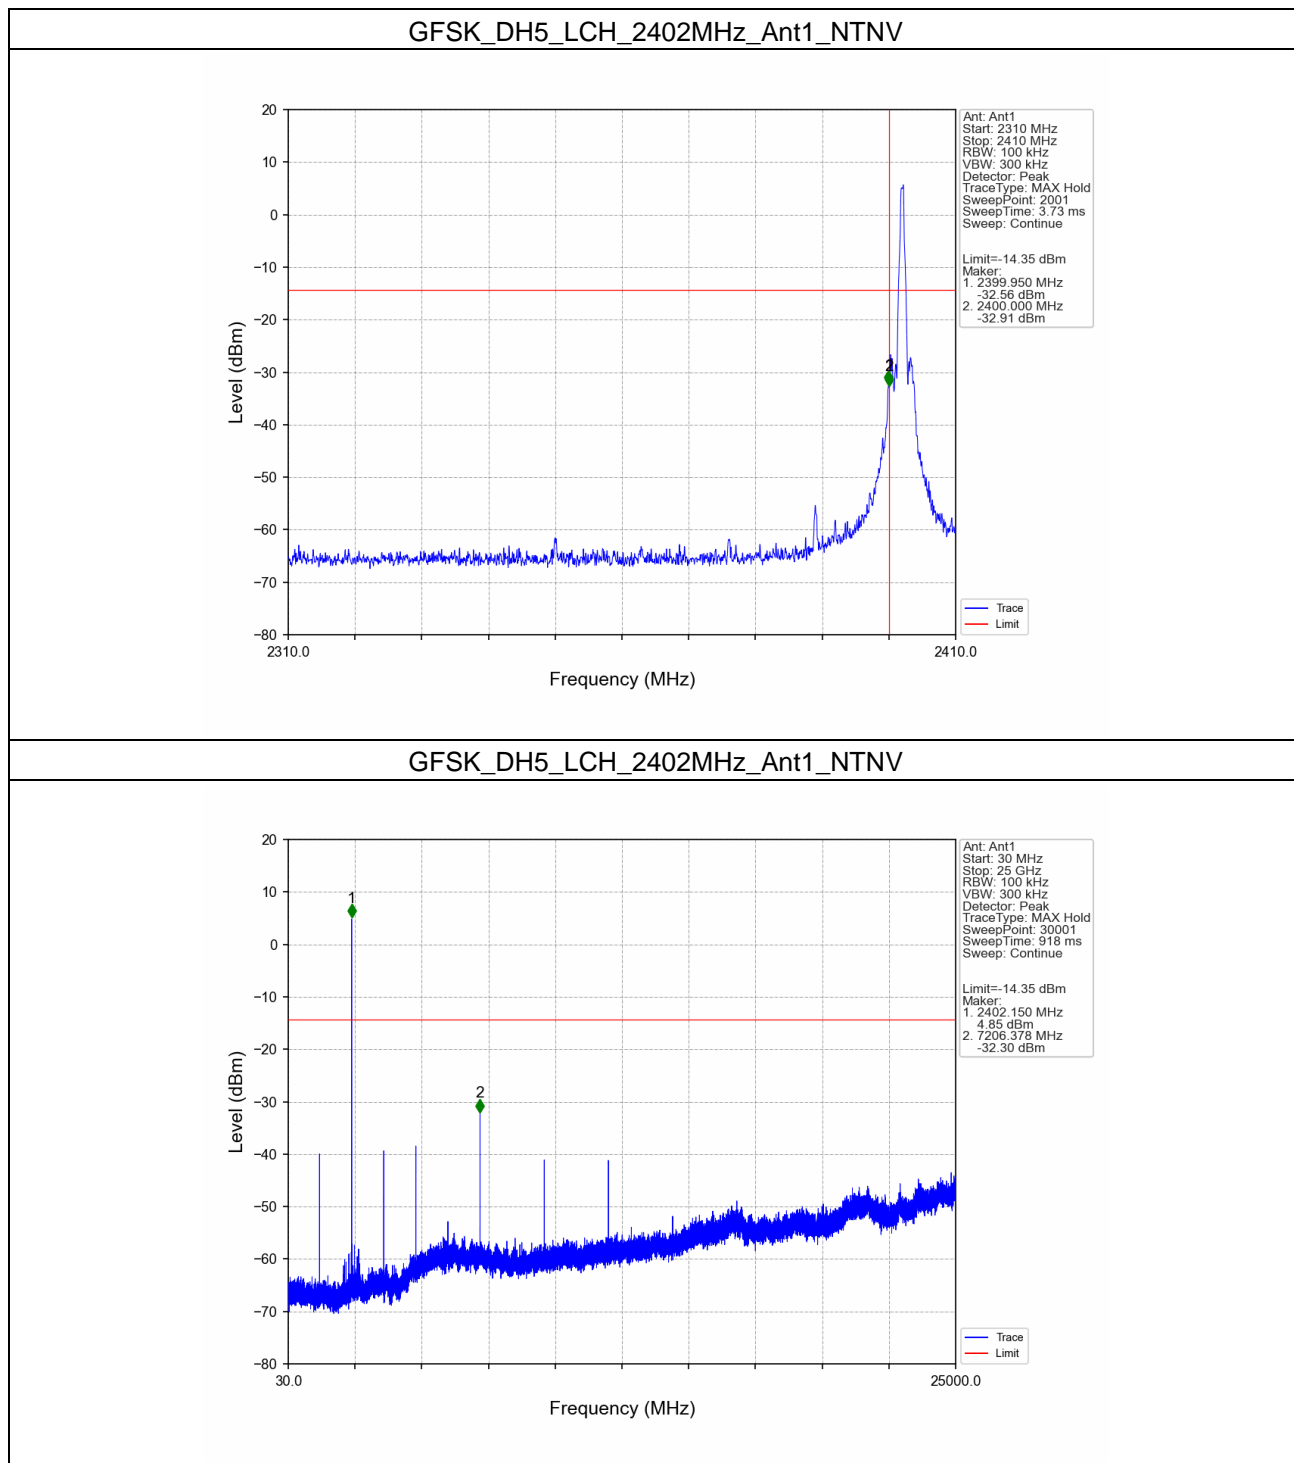
6.2.2 CSE

Mode	TX Type	Frequency (MHz)	Packet Type	ANT	Level of Reference (dBm)	Limit (dBm)	Verdict
GFSK	SISO	2402	DH5	1	5.65	-14.35	Pass
		2441	DH5	1	5.65	-14.35	Pass
		2480	DH5	1	5.65	-14.35	Pass
		HOPP	DH5	1	5.65	-14.35	Pass
					5.65	-14.35	Pass
Pi/4DQPSK	SISO	2402	2DH5	1	5.62	-14.38	Pass
		2441	2DH5	1	5.62	-14.38	Pass
		2480	2DH5	1	5.62	-14.38	Pass
		HOPP	2DH5	1	5.62	-14.38	Pass
					5.62	-14.38	Pass
8DPSK	SISO	2402	3DH5	1	5.72	-14.28	Pass
		2441	3DH5	1	5.72	-14.28	Pass
		2480	3DH5	1	5.72	-14.28	Pass
		HOPP	3DH5	1	5.72	-14.28	Pass
					5.72	-14.28	Pass

Note1: Refer to FCC Part 15.247 (d) and ANSI C63.10-2020, the channel contains the maximum PSD level was used to establish the reference level.
