**Appendix G: Conducted Spurious Emission****Test Result**

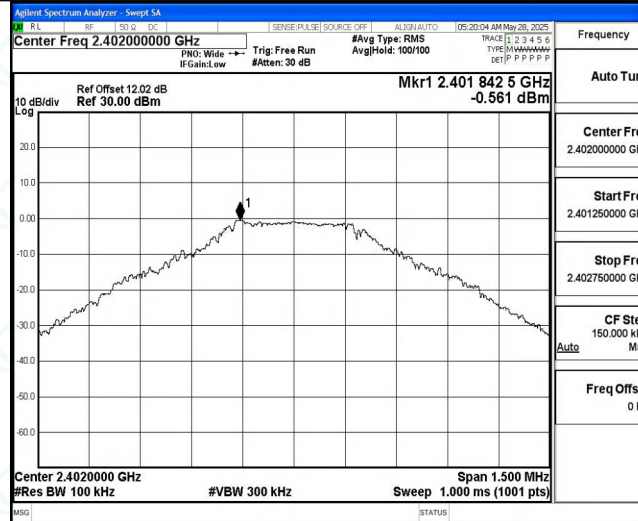
DH5\_Ant1\_2402\_0~Reference

| TestMode | Antenna | Freq(MHz) | FreqRange<br>[MHz] | RefLevel<br>[dBm] | Result<br>[dBm] | Limit<br>[dBm] | Verdict |
|---|---|---|---|---|---|---|---|
| DH5 | Ant1 | 2402 | Reference | -0.56 | -0.56 | --- | PASS |

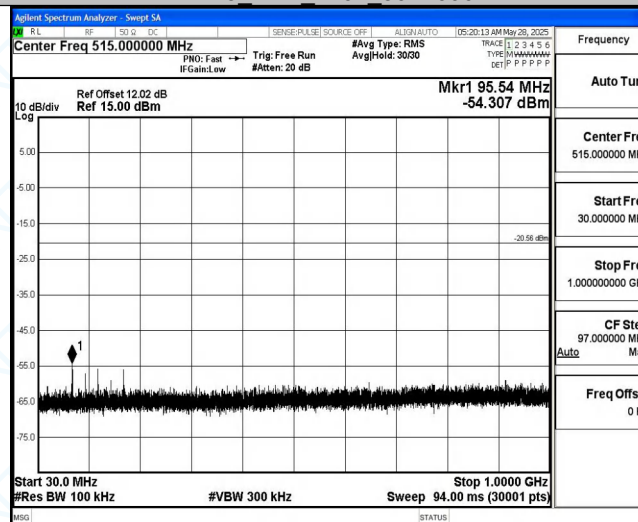
DH5\_Ant1\_2402\_30~1000

| TestMode | Antenna | Freq(MHz) | FreqRange<br>[MHz] | RefLevel<br>[dBm] | Result<br>[dBm] | Limit<br>[dBm] | Verdict |
|---|---|---|---|---|---|---|---|
| | | | 30~1000 | -0.56 | -54.31 | $\leq -20.56$ | PASS |

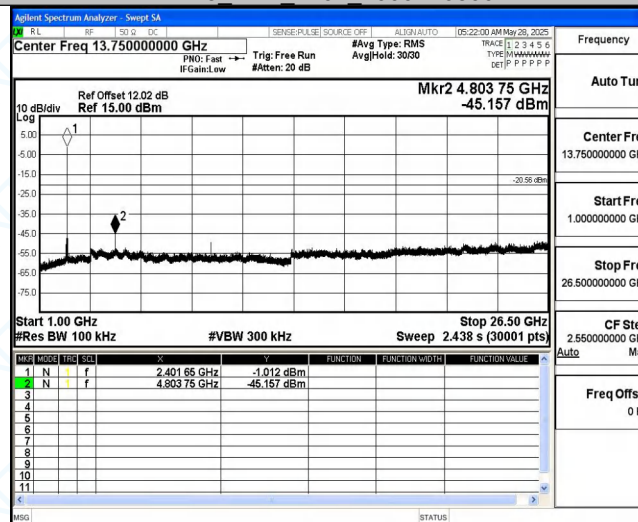
DH5\_Ant1\_2402\_1000~26500

| TestMode | Antenna | Freq(MHz) | FreqRange<br>[MHz] | RefLevel<br>[dBm] | Result<br>[dBm] | Limit<br>[dBm] | Verdict |
|---|---|---|---|---|---|---|---|
| | | | 1000~26500 | -0.56 | -45.16 | $\leq -20.56$ | PASS |

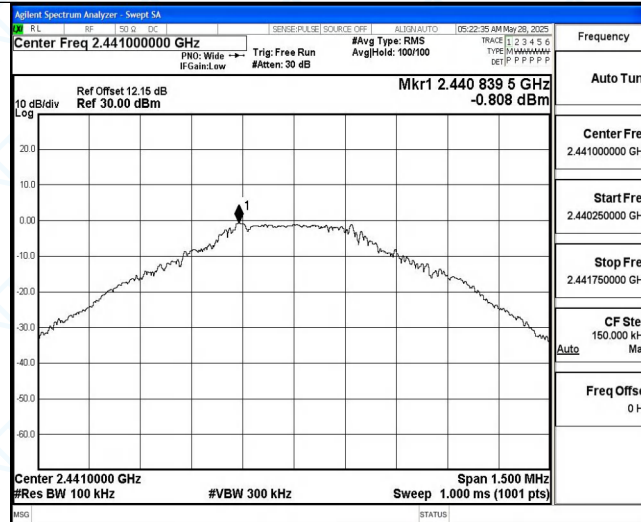
DH5\_Ant1\_2441\_0~Reference

| TestMode | Antenna | Freq(MHz) | FreqRange<br>[MHz] | RefLevel<br>[dBm] | Result<br>[dBm] | Limit<br>[dBm] | Verdict |
|---|---|---|---|---|---|---|---|
| | | 2441 | Reference | -0.81 | -0.81 | --- | PASS |

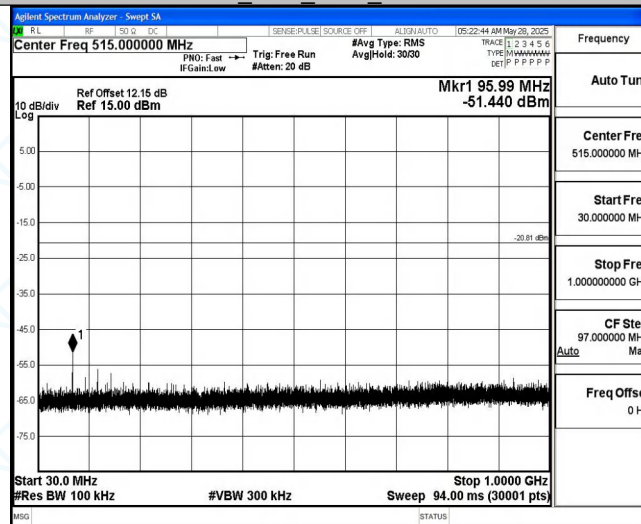
DH5\_Ant1\_2441\_30~1000

| TestMode | Antenna | Freq(MHz) | FreqRange<br>[MHz] | RefLevel<br>[dBm] | Result<br>[dBm] | Limit<br>[dBm] | Verdict |
|---|---|---|---|---|---|---|---|
| | | | 30~1000 | -0.81 | -51.44 | $\leq -20.81$ | PASS |

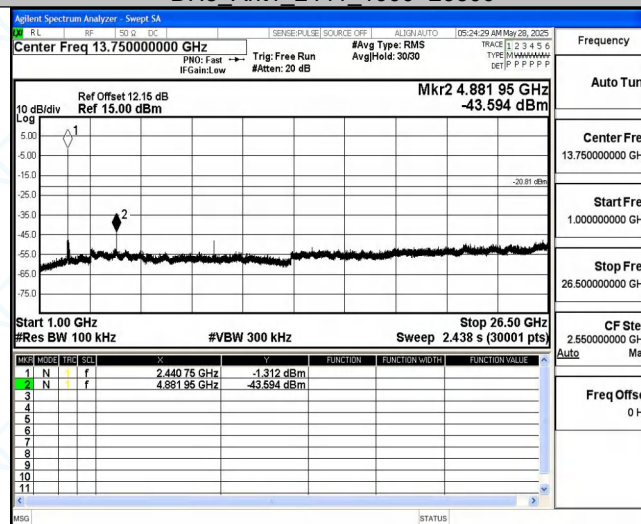
DH5\_Ant1\_2441\_1000~26500

| TestMode | Antenna | Freq(MHz) | FreqRange<br>[MHz] | RefLevel<br>[dBm] | Result<br>[dBm] | Limit<br>[dBm] | Verdict |
|---|---|---|---|---|---|---|---|
| | | | 1000~26500 | -0.81 | -43.59 | $\leq -20.81$ | PASS |

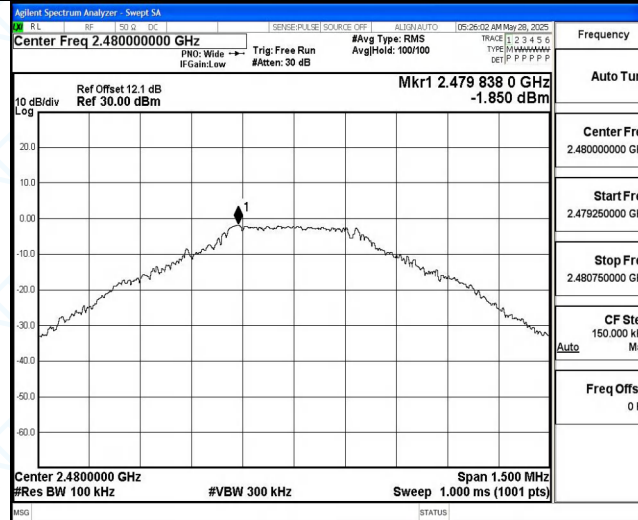
DH5\_Ant1\_2480\_0~Reference

| TestMode | Antenna | Freq(MHz) | FreqRange<br>[MHz] | RefLevel<br>[dBm] | Result<br>[dBm] | Limit<br>[dBm] | Verdict |
|---|---|---|---|---|---|---|---|
| | | 2480 | Reference | -1.85 | -1.85 | --- | PASS |

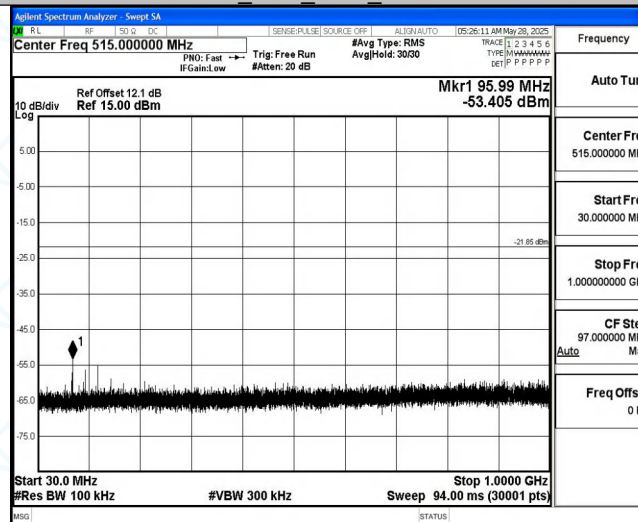
DH5\_Ant1\_2480\_30~1000

| TestMode | Antenna | Freq(MHz) | FreqRange<br>[MHz] | RefLevel<br>[dBm] | Result<br>[dBm] | Limit<br>[dBm] | Verdict |
|---|---|---|---|---|---|---|---|
| | | | 30~1000 | -1.85 | -53.41 | $\leq -21.85$ | PASS |

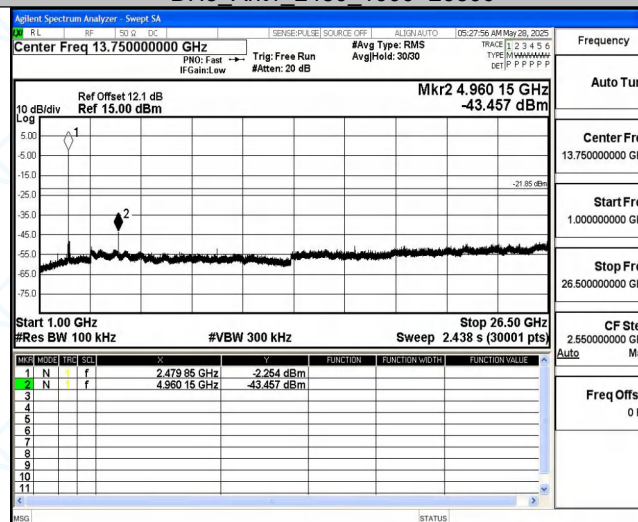
DH5\_Ant1\_2480\_1000~26500

| TestMode | Antenna | Freq(MHz) | FreqRange<br>[MHz] | RefLevel<br>[dBm] | Result<br>[dBm] | Limit<br>[dBm] | Verdict |
|---|---|---|---|---|---|---|---|
| | | | 1000~26500 | -1.85 | -43.46 | $\leq -21.85$ | PASS |

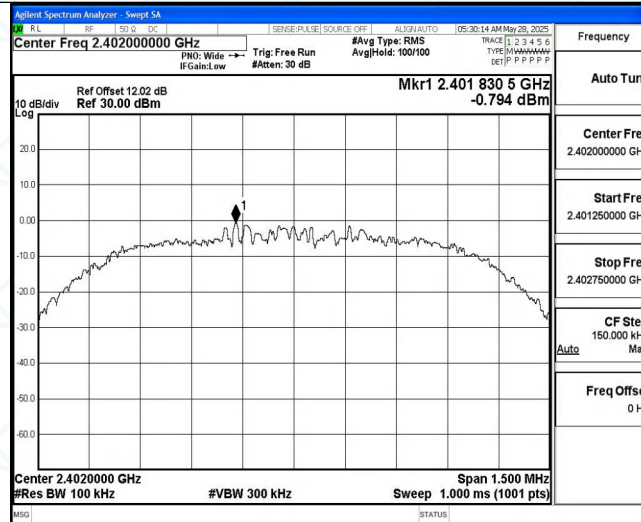
2DH5\_Ant1\_2402\_0~Reference

| TestMode | Antenna | Freq(MHz) | FreqRange<br>[MHz] | RefLevel<br>[dBm] | Result<br>[dBm] | Limit<br>[dBm] | Verdict |
|---|---|---|---|---|---|---|---|
| 2DH5 | Ant1 | 2402 | Reference | -0.79 | -0.79 | --- | PASS |

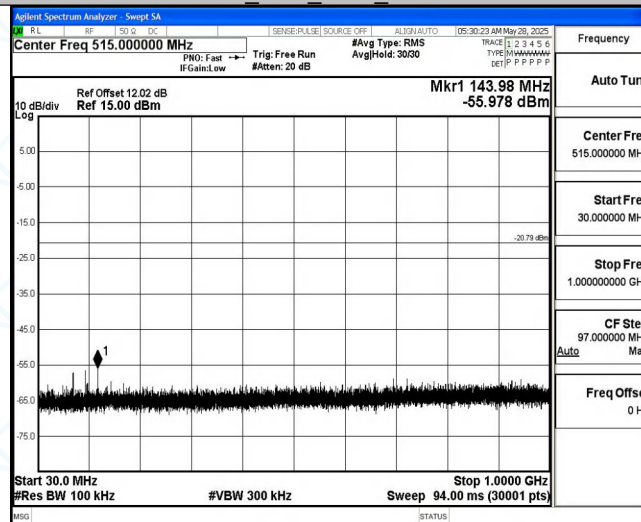
## 2DH5\_Ant1\_2402\_30~1000

| TestMode | Antenna | Freq(MHz) | FreqRange<br>[MHz] | RefLevel<br>[dBm] | Result<br>[dBm] | Limit<br>[dBm] | Verdict |
|---|---|---|---|---|---|---|---|
| | | | 30~1000 | -0.79 | -55.98 | $\leq -20.79$ | PASS |

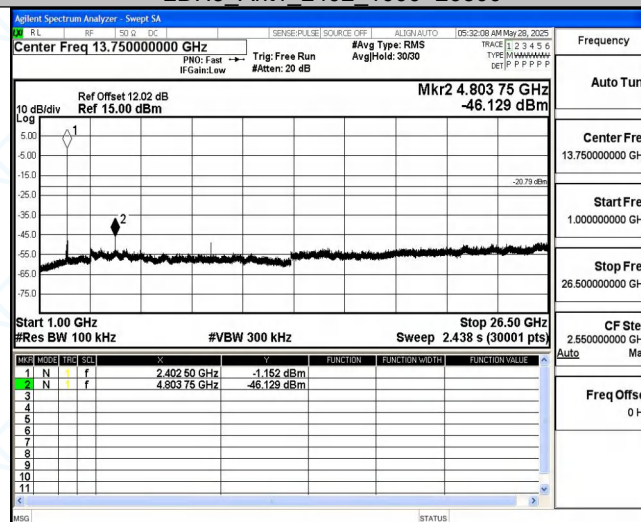
## 2DH5\_Ant1\_2402\_1000~26500

| TestMode | Antenna | Freq(MHz) | FreqRange<br>[MHz] | RefLevel<br>[dBm] | Result<br>[dBm] | Limit<br>[dBm] | Verdict |
|---|---|---|---|---|---|---|---|
| | | | 1000~26500 | -0.79 | -46.13 | $\leq -20.79$ | PASS |

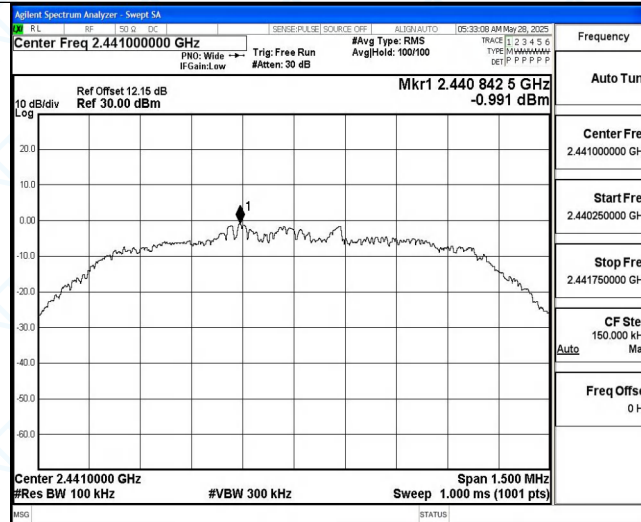
## 2DH5\_Ant1\_2441\_0~Reference

| TestMode | Antenna | Freq(MHz) | FreqRange<br>[MHz] | RefLevel<br>[dBm] | Result<br>[dBm] | Limit<br>[dBm] | Verdict |
|---|---|---|---|---|---|---|---|
| | | 2441 | Reference | -0.99 | -0.99 | --- | PASS |

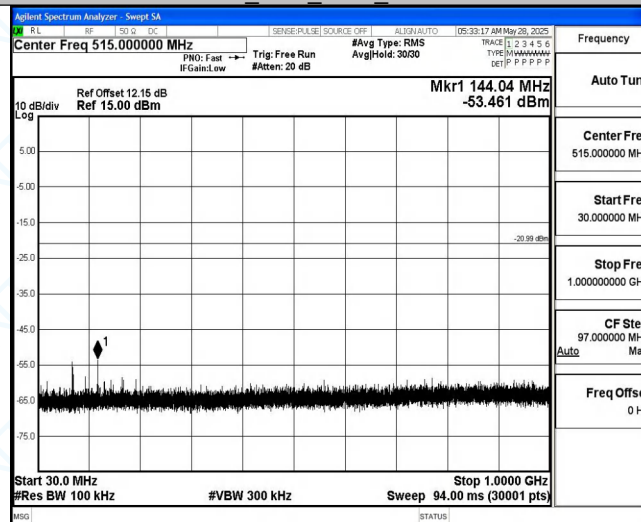
2DH5\_Ant1\_2441\_30~1000

| TestMode | Antenna | Freq(MHz) | FreqRange<br>[MHz] | RefLevel<br>[dBm] | Result<br>[dBm] | Limit<br>[dBm] | Verdict |
|---|---|---|---|---|---|---|---|
| | | | 30~1000 | -0.99 | -53.46 | $\leq -20.99$ | PASS |

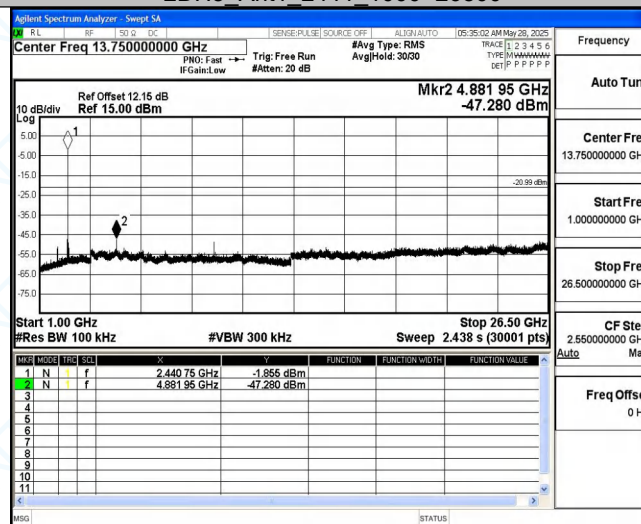
2DH5\_Ant1\_2441\_1000~26500

| TestMode | Antenna | Freq(MHz) | FreqRange<br>[MHz] | RefLevel<br>[dBm] | Result<br>[dBm] | Limit<br>[dBm] | Verdict |
|---|---|---|---|---|---|---|---|
| | | | 1000~26500 | -0.99 | -47.28 | $\leq -20.99$ | PASS |

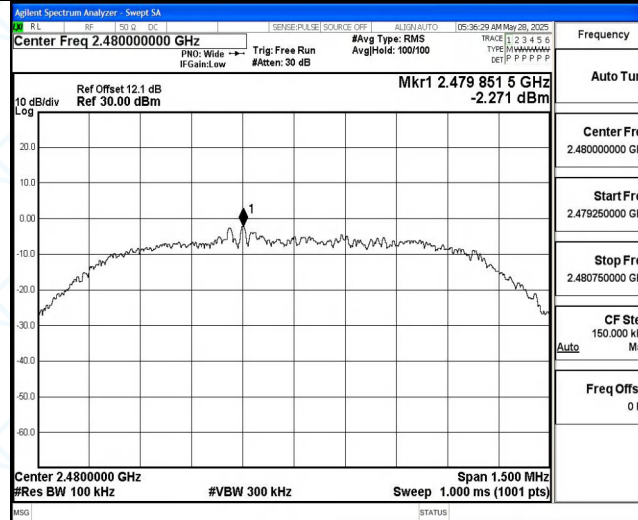
2DH5\_Ant1\_2480\_0~Reference

| TestMode | Antenna | Freq(MHz) | FreqRange<br>[MHz] | RefLevel<br>[dBm] | Result<br>[dBm] | Limit<br>[dBm] | Verdict |
|---|---|---|---|---|---|---|---|
| | | 2480 | Reference | -2.27 | -2.27 | --- | PASS |

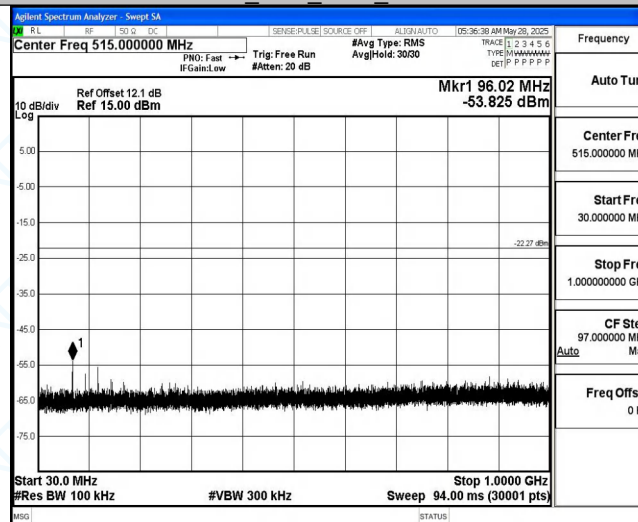
## 2DH5\_Ant1\_2480\_30~1000

| TestMode | Antenna | Freq(MHz) | FreqRange<br>[MHz] | RefLevel<br>[dBm] | Result<br>[dBm] | Limit<br>[dBm] | Verdict |
|---|---|---|---|---|---|---|---|
| | | | 30~1000 | -2.27 | -53.83 | $\leq -22.27$ | PASS |

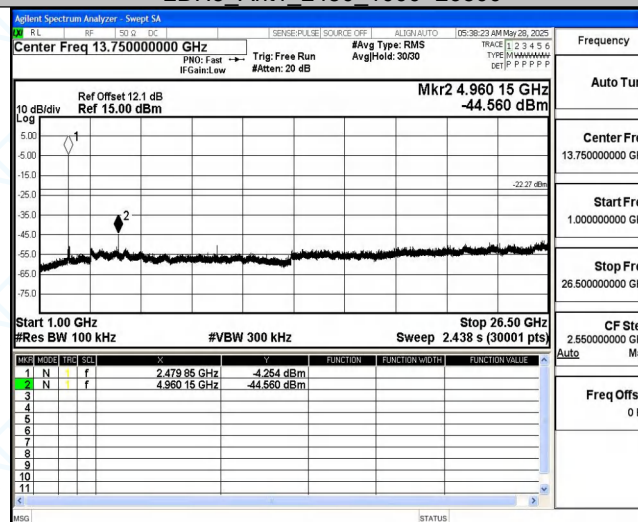
## 2DH5\_Ant1\_2480\_1000~26500

| TestMode | Antenna | Freq(MHz) | FreqRange<br>[MHz] | RefLevel<br>[dBm] | Result<br>[dBm] | Limit<br>[dBm] | Verdict |
|---|---|---|---|---|---|---|---|
| | | | 1000~26500 | -2.27 | -44.56 | $\leq -22.27$ | PASS |

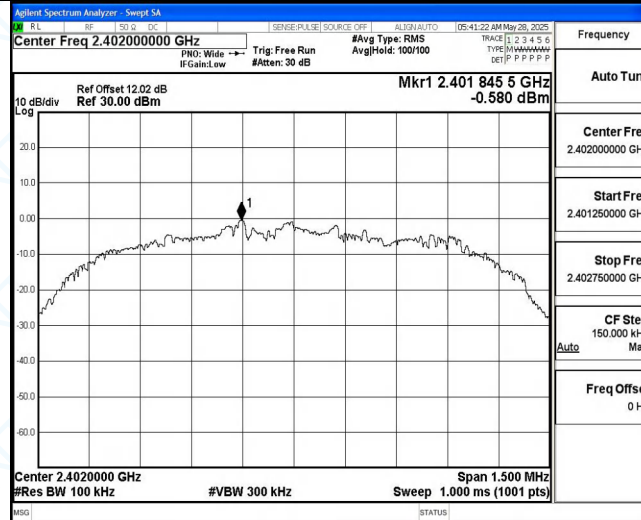
## 3DH5\_Ant1\_2402\_0~Reference

| TestMode | Antenna | Freq(MHz) | FreqRange<br>[MHz] | RefLevel<br>[dBm] | Result<br>[dBm] | Limit<br>[dBm] | Verdict |
|---|---|---|---|---|---|---|---|
| 3DH5 | Ant1 | 2402 | Reference | -0.58 | -0.58 | --- | PASS |

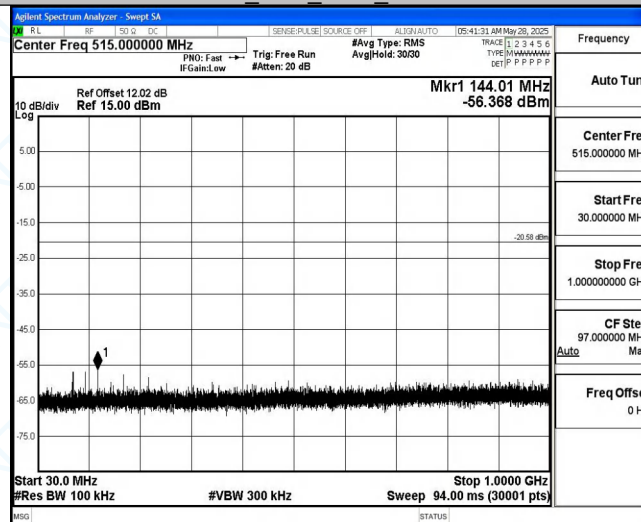
3DH5\_Ant1\_2402\_30~1000

| TestMode | Antenna | Freq(MHz) | FreqRange<br>[MHz] | RefLevel<br>[dBm] | Result<br>[dBm] | Limit<br>[dBm] | Verdict |
|---|---|---|---|---|---|---|---|
| | | | 30~1000 | -0.58 | -56.37 | $\leq -20.58$ | PASS |

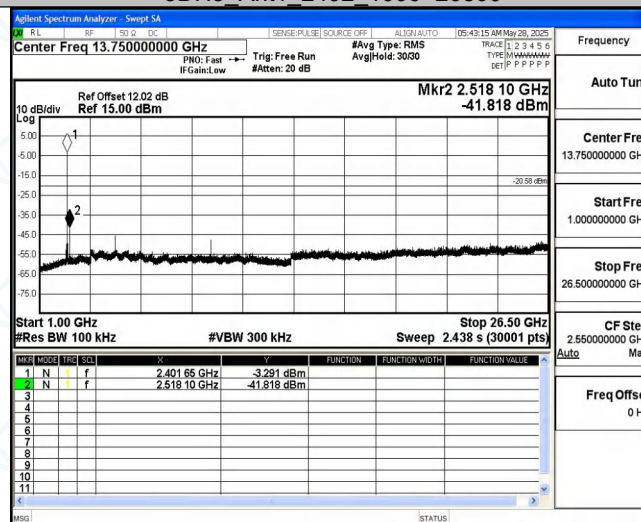
3DH5\_Ant1\_2402\_1000~26500

| TestMode | Antenna | Freq(MHz) | FreqRange<br>[MHz] | RefLevel<br>[dBm] | Result<br>[dBm] | Limit<br>[dBm] | Verdict |
|---|---|---|---|---|---|---|---|
| | | | 1000~26500 | -0.58 | -41.82 | $\leq -20.58$ | PASS |

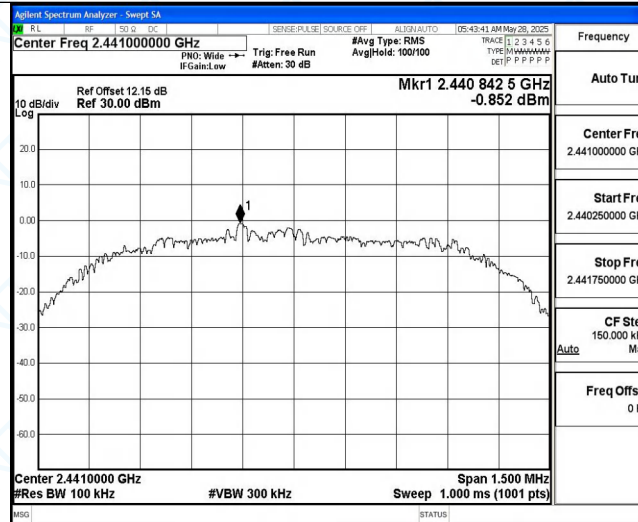
3DH5\_Ant1\_2441\_0~Reference

| TestMode | Antenna | Freq(MHz) | FreqRange<br>[MHz] | RefLevel<br>[dBm] | Result<br>[dBm] | Limit<br>[dBm] | Verdict |
|---|---|---|---|---|---|---|---|
| | | 2441 | Reference | -0.85 | -0.85 | --- | PASS |

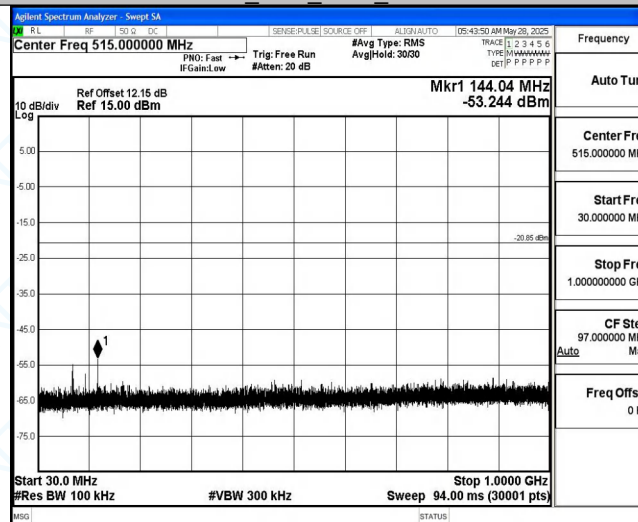
## 3DH5\_Ant1\_2441\_30~1000

| TestMode | Antenna | Freq(MHz) | FreqRange<br>[MHz] | RefLevel<br>[dBm] | Result<br>[dBm] | Limit<br>[dBm] | Verdict |
|---|---|---|---|---|---|---|---|
| | | | 30~1000 | -0.85 | -53.24 | $\leq -20.85$ | PASS |

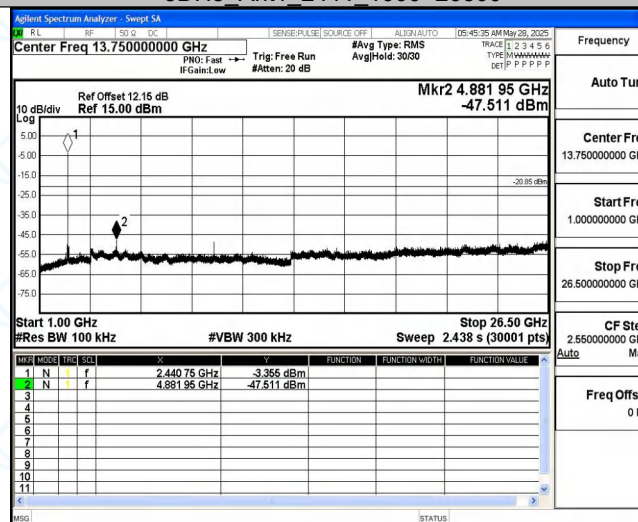
## 3DH5\_Ant1\_2441\_1000~26500

| TestMode | Antenna | Freq(MHz) | FreqRange<br>[MHz] | RefLevel<br>[dBm] | Result<br>[dBm] | Limit<br>[dBm] | Verdict |
|---|---|---|---|---|---|---|---|
| | | | 1000~26500 | -0.85 | -47.51 | $\leq -20.85$ | PASS |

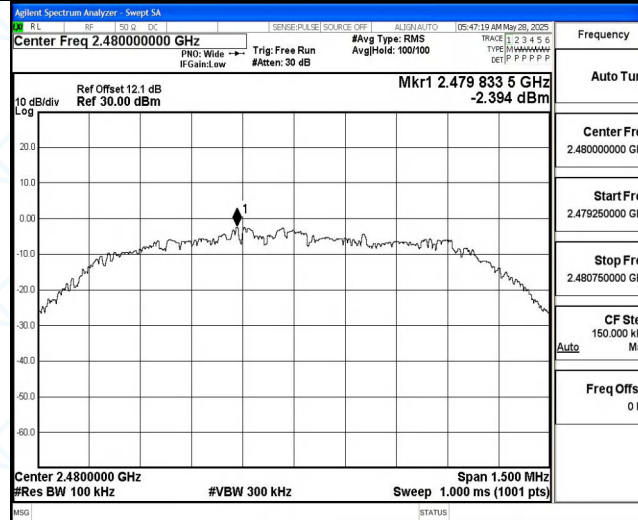
## 3DH5\_Ant1\_2480\_0~Reference

| TestMode | Antenna | Freq(MHz) | FreqRange<br>[MHz] | RefLevel<br>[dBm] | Result<br>[dBm] | Limit<br>[dBm] | Verdict |
|---|---|---|---|---|---|---|---|
| | | 2480 | Reference | -2.39 | -2.39 | --- | PASS |

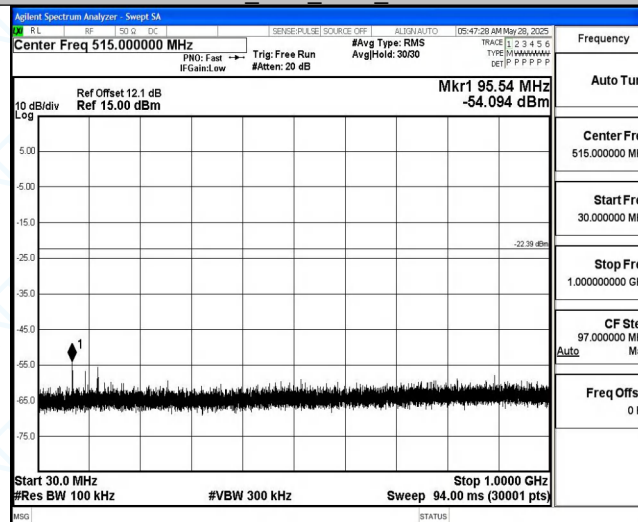
## 3DH5\_Ant1\_2480\_30~1000

| TestMode | Antenna | Freq(MHz) | FreqRange<br>[MHz] | RefLevel<br>[dBm] | Result<br>[dBm] | Limit<br>[dBm] | Verdict |
|---|---|---|---|---|---|---|---|
| | | | 30~1000 | -2.39 | -54.09 | $\leq -22.39$ | PASS |

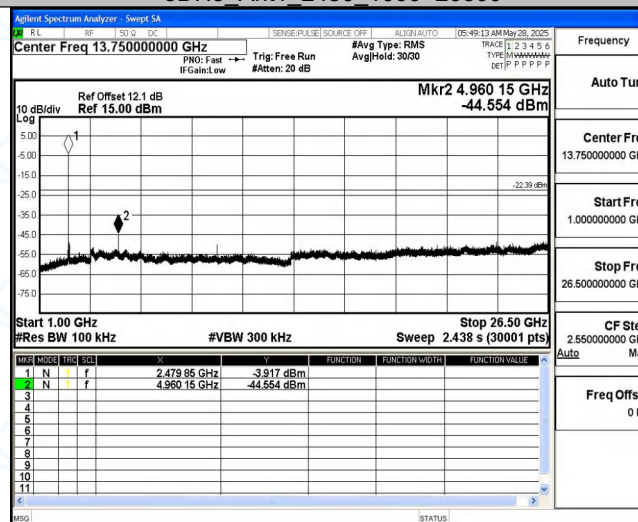
## 3DH5\_Ant1\_2480\_1000~26500

| TestMode | Antenna | Freq(MHz) | FreqRange<br>[MHz] | RefLevel<br>[dBm] | Result<br>[dBm] | Limit<br>[dBm] | Verdict |
|---|---|---|---|---|---|---|---|
| | | | 1000~26500 | -2.39 | -44.55 | $\leq -22.39$ | PASS |
