Statement

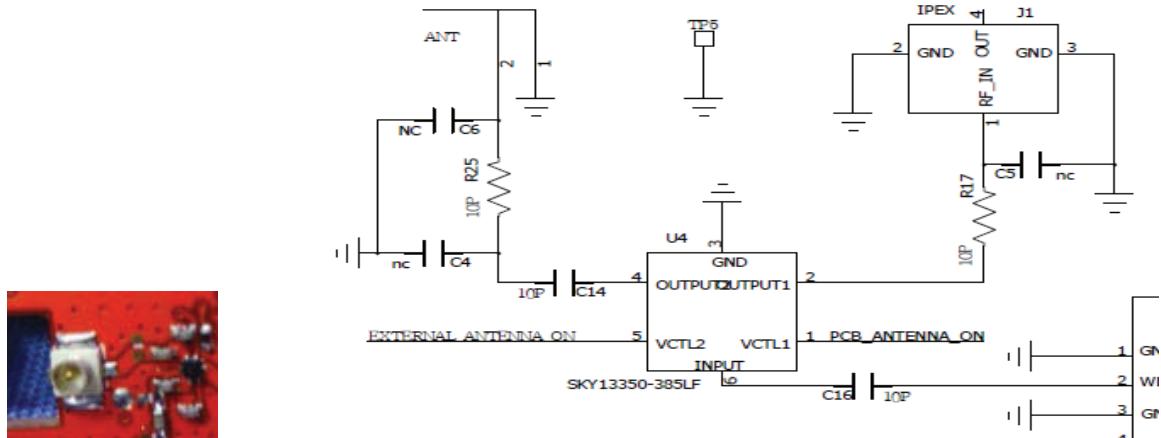
The above diagram shows the connector (J1) is by default disabled by the SKY13350-385LF (U4) switch, therefore, the circuitry is open. During normal operations, there is no signal OUTPUT through the connector (J1) permanently for end product.
