FCC SAR Test Report

Appendix D. Photographs of EUT and Setup

Report No. : SA141128C02

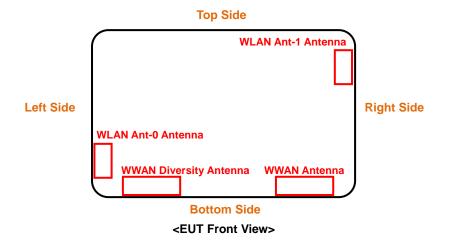
<Antenna Location>

The separation distance for antenna to edge:

Antenna	To Top Side (mm)	To Bottom Side (mm)	To Left Side (mm)	To Right Side (mm)
WWAN	137	0	114	25
WWAN Diversity	137	0	27	129
WLAN Ant-0	104	28	0	207
WLAN Ant-1	10	123	206	0
