# Radiated Emission Measurement

Condition : ETSI EN300\_422-RX\_Spurious

EUT : W6M22405-23507

Test Mode : Rx 607MHz

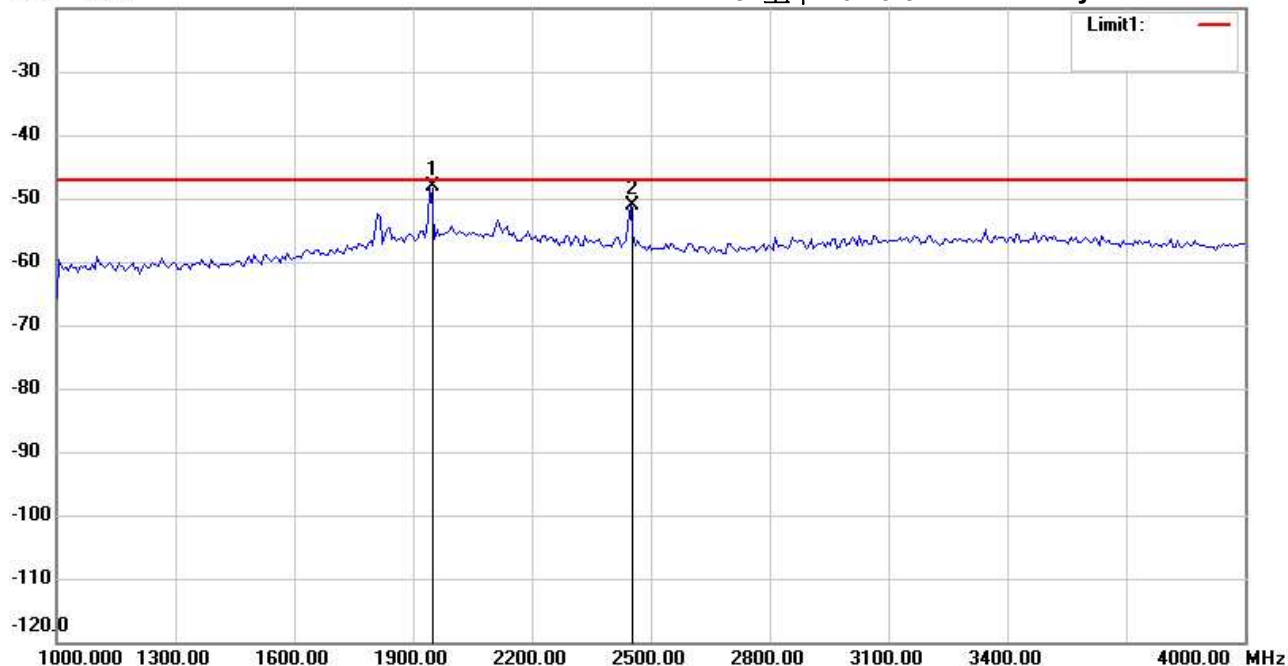
Data : #2

Site : 966A Chamber

Condition : ETSI EN300\_422-RX\_Spurious

Test Mode : Rx 607MHz

Polarization: Vertical

Distance: 3m

| Mk. | Frequency (MHz) | Reading (dBm) | Detector | Corr. factor (dB) | Result (dBm) | Limit (dBm) | Ant.Pos (cm) | Tab.Pos (deg.) | Margin (dB) | Comment |
|---|---|---|---|---|---|---|---|---|---|---|
| * | 1943.888 | -55.79 | peak | 7.75 | -48.04 | -47.00 | 150 | 245 | -1.04 | |
| | 2448.898 | -57.38 | peak | 6.38 | -51.00 | -47.00 | 150 | 305 | -4.00 | |
