## Conducted Spurious Emission for MIMO ANT2

### Test Graphs

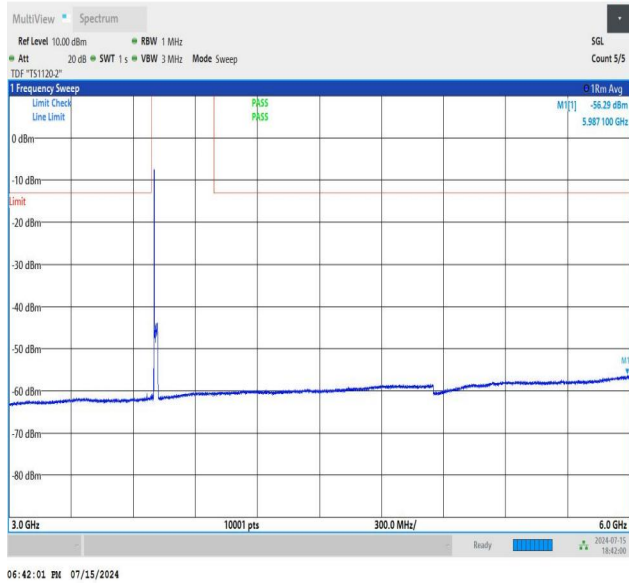
NTNV\_N77-3700-3980\_PC2\_30\_20\_L\_TID2\_NS\_01\_3000\_6000\_#1

**Note:** For UL MIMO mode, the conducted BE/Spurious are tested at single antenna port and add  $10 \cdot \log(\text{NANT})$  according to KDB 662911 D01. The result of the single antenna port test is below the limit by more than 3dB margin, so the results of Ant1+Ant2 also meet the limit requirements.
