## Occupied Bandwidth

### FCC For 90S

#### B26\_1, Normal

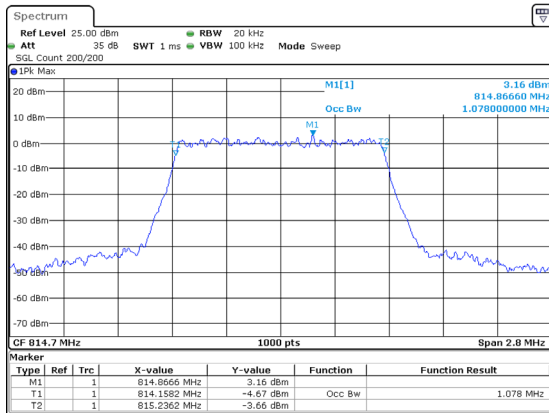
**1.4MHz\_Low\_QPSK\_6@0**

**Occupied Bandwidth**

| Mode | 99% OBW<br>(MHz) | EBW<br>(MHz) |
|---|---|---|
| 1.4MHz_Low_QPSK_6@0 | 1.078 | 1.233 |

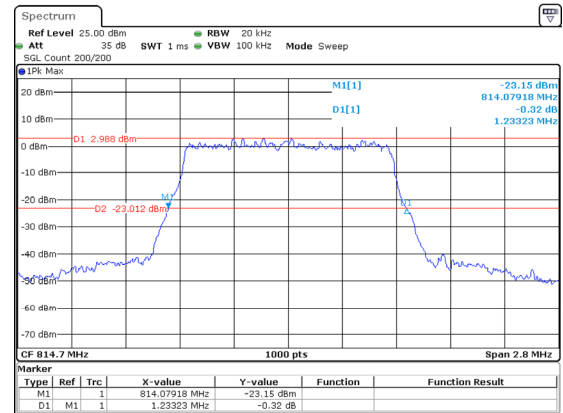
**26dB Bandwidth**

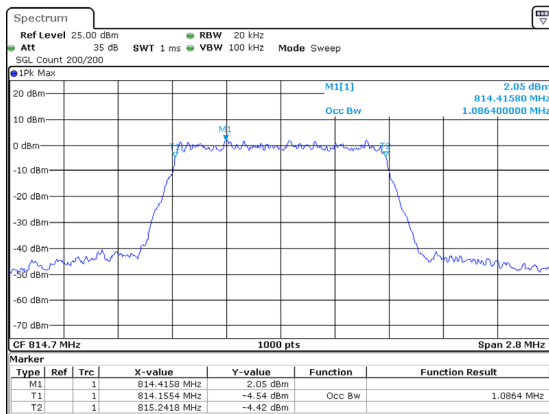
**1.4MHz\_Low\_16QAM\_6@0**

**Occupied Bandwidth**

| Mode | 99% OBW<br>(MHz) | EBW<br>(MHz) |
|---|---|---|
| 1.4MHz_Low_16QAM_6@0 | <b>1.086</b> | 1.264 |

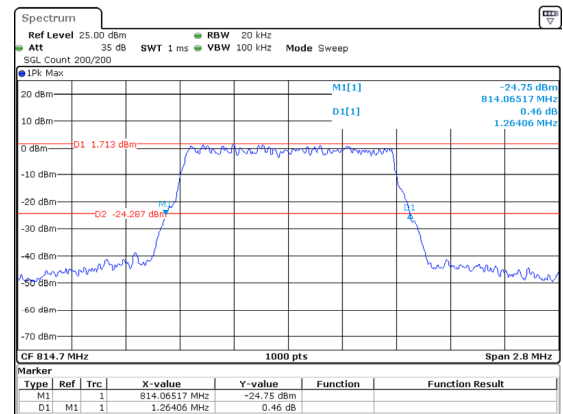
**26dB Bandwidth**

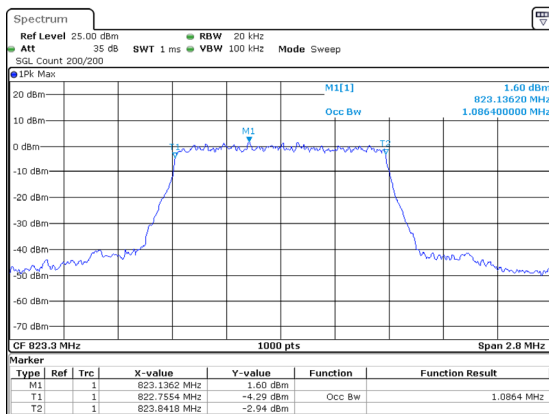
**1.4MHz\_High\_QPSK\_6@0**

**Occupied Bandwidth**

| Mode | 99% OBW<br>(MHz) | EBW<br>(MHz) |
|---|---|---|
| 1.4MHz_High_QPSK_6@0 | <b>1.086</b> | 1.250 |

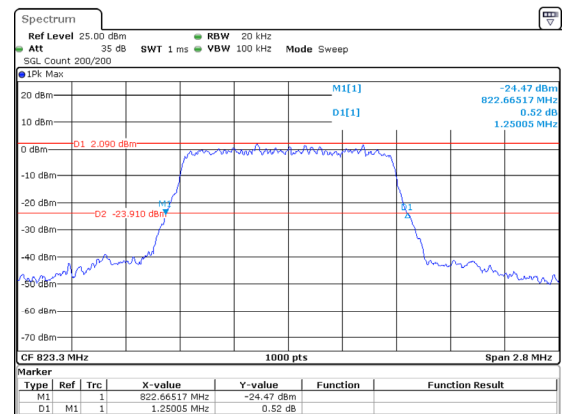
**26dB Bandwidth**

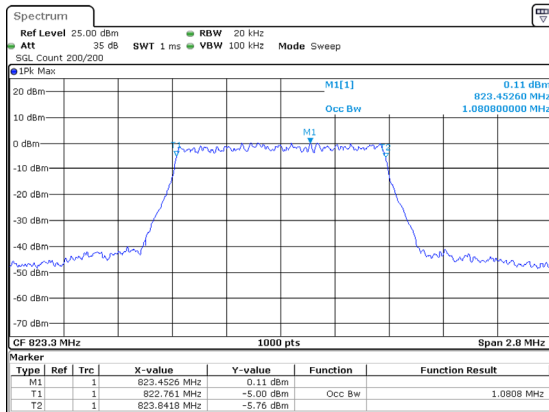
### 1.4MHz\_High\_16QAM\_6@0

#### Occupied Bandwidth

| Mode | 99% OBW<br>(MHz) | EBW<br>(MHz) |
|---|---|---|
| 1.4MHz_High_16QAM_6@0 | 1.081 | 1.270 |

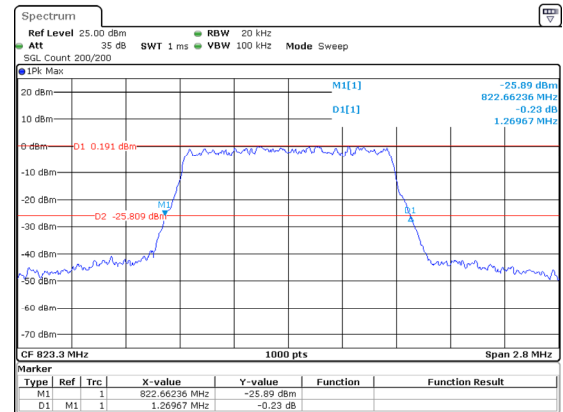
#### 26dB Bandwidth

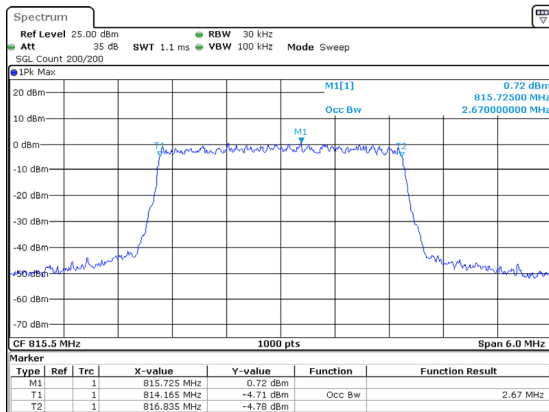
### 3MHz\_Low\_QPSK\_15@0

#### Occupied Bandwidth

| Mode | 99% OBW<br>(MHz) | EBW<br>(MHz) |
|---|---|---|
| 3MHz_Low_QPSK_15@0 | <b>2.670</b> | 2.907 |

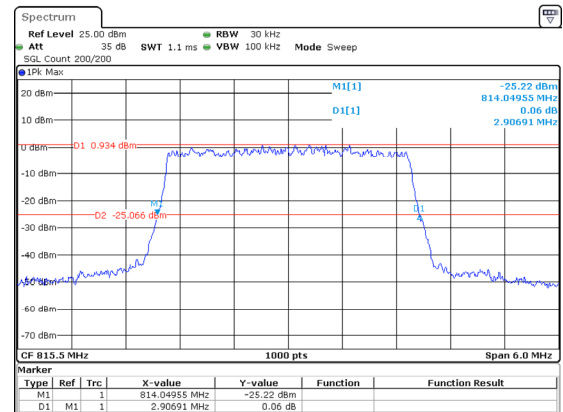
#### 26dB Bandwidth

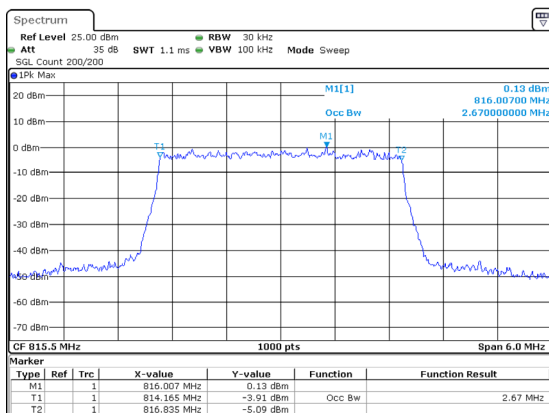
### 3MHz\_Low\_16QAM\_15@0

#### Occupied Bandwidth

| Mode | 99% OBW<br>(MHz) | EBW<br>(MHz) |
|---|---|---|
| 3MHz_Low_16QAM_15@0 | <b>2.670</b> | 2.913 |

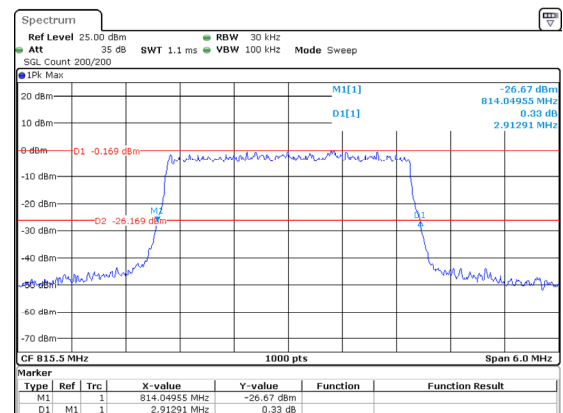
#### 26dB Bandwidth

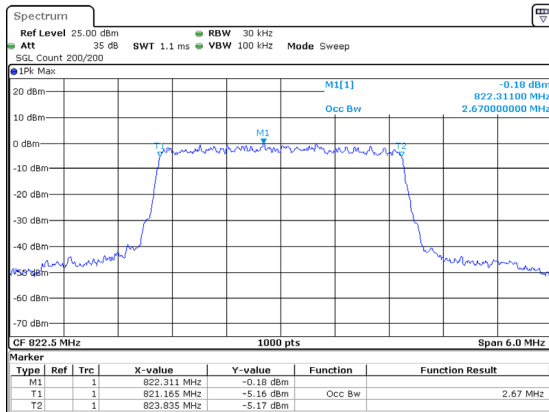
### 3MHz\_High\_QPSK\_15@0

#### Occupied Bandwidth

| Mode | 99% OBW<br>(MHz) | EBW<br>(MHz) |
|---|---|---|
| 3MHz_High_QPSK_15@0 | 2.670 | 2.919 |

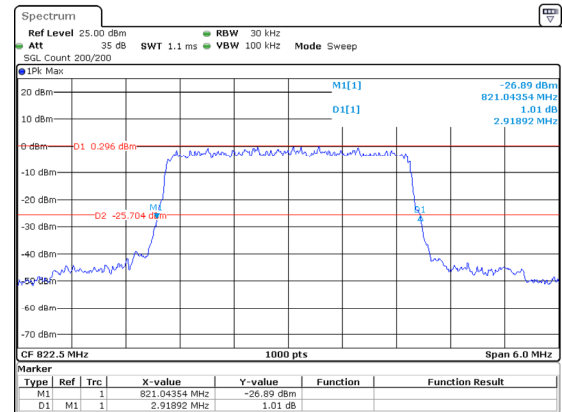
#### 26dB Bandwidth

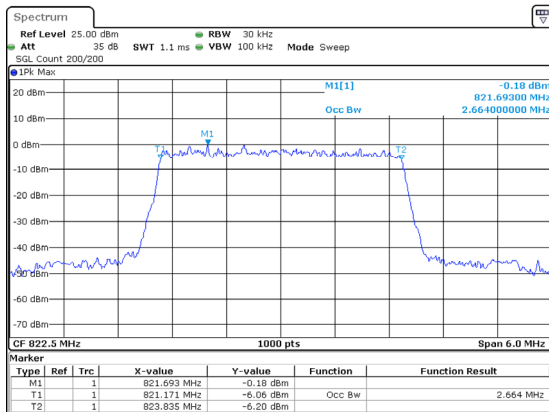
### 3MHz\_High\_16QAM\_15@0

#### Occupied Bandwidth

| Mode | 99% OBW<br>(MHz) | EBW<br>(MHz) |
|---|---|---|
| 3MHz_High_16QAM_15@0 | 2.664 | 2.901 |

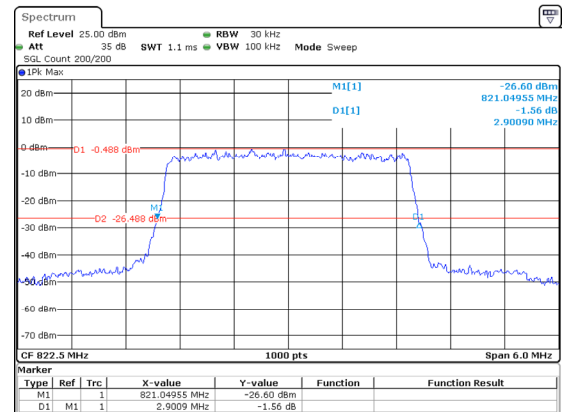
#### 26dB Bandwidth

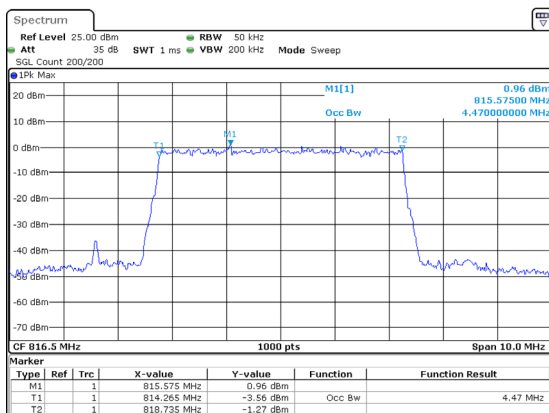
### 5MHz\_Low\_QPSK\_25@0

#### Occupied Bandwidth

| Mode | 99% OBW<br>(MHz) | EBW<br>(MHz) |
|---|---|---|
| 5MHz_Low_QPSK_25@0 | <b>4.470</b> | 4.845 |

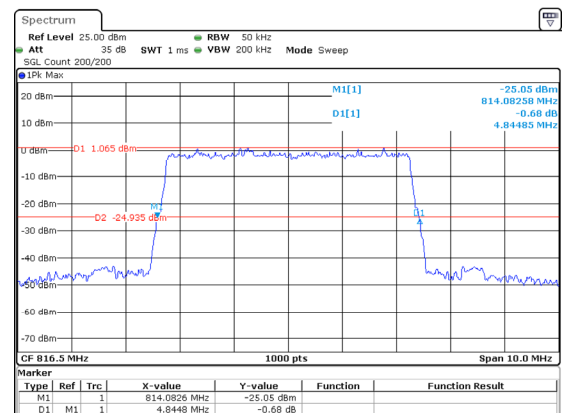
#### 26dB Bandwidth

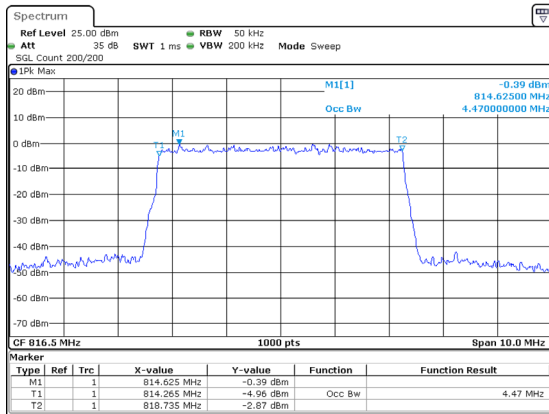
## 5MHz\_Low\_16QAM\_25@0

### Occupied Bandwidth

| Mode | 99% OBW<br>(MHz) | EBW<br>(MHz) |
|---|---|---|
| 5MHz_Low_16QAM_25@0 | <b>4.470</b> | 4.825 |

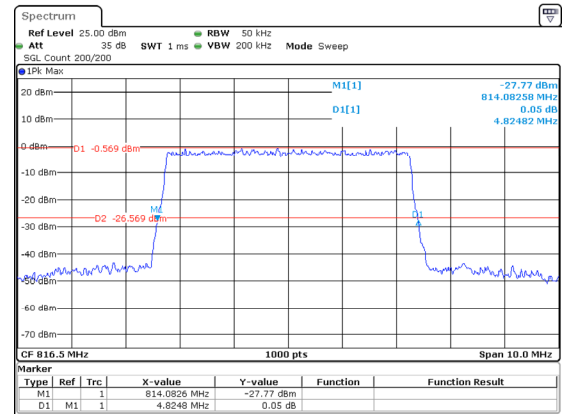
### 26dB Bandwidth

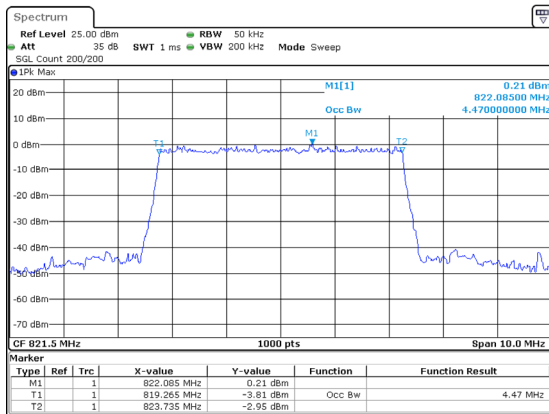
## 5MHz\_High\_QPSK\_25@0

### Occupied Bandwidth

| Mode | 99% OBW<br>(MHz) | EBW<br>(MHz) |
|---|---|---|
| 5MHz_High_QPSK_25@0 | 4.470 | 4.805 |

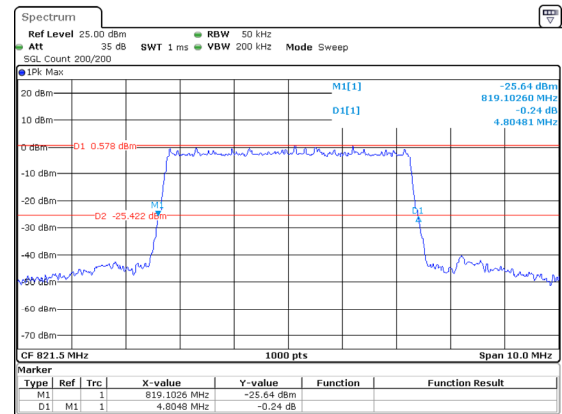
### 26dB Bandwidth

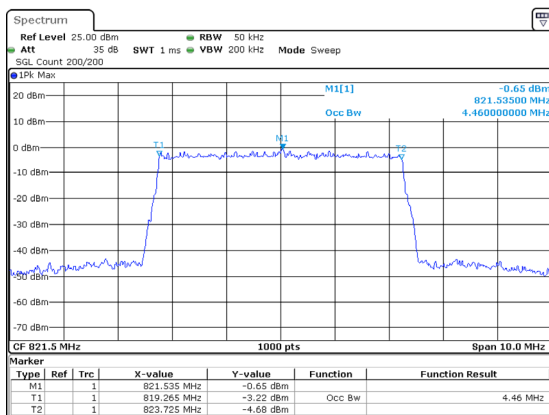
## 5MHz\_High\_16QAM\_25@0

### Occupied Bandwidth

| Mode | 99% OBW<br>(MHz) | EBW<br>(MHz) |
|---|---|---|
| 5MHz_High_16QAM_25@0 | 4.460 | 4.795 |

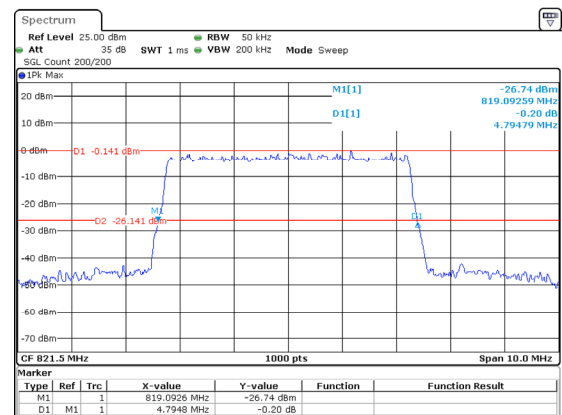
### 26dB Bandwidth

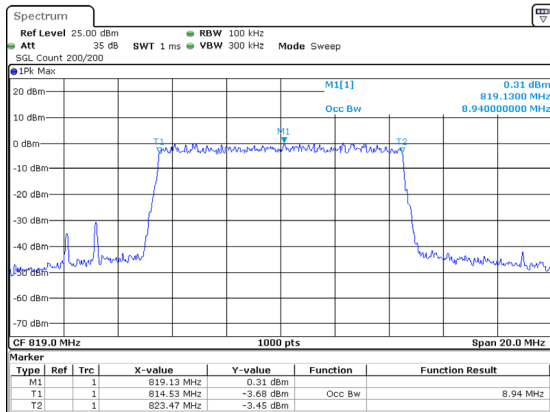
## 10MHz\_Low\_QPSK\_50@0

### Occupied Bandwidth

| Mode | 99% OBW<br>(MHz) | EBW<br>(MHz) |
|---|---|---|
| 10MHz_Low_QPSK_50@0 | <b>8.940</b> | 9.610 |

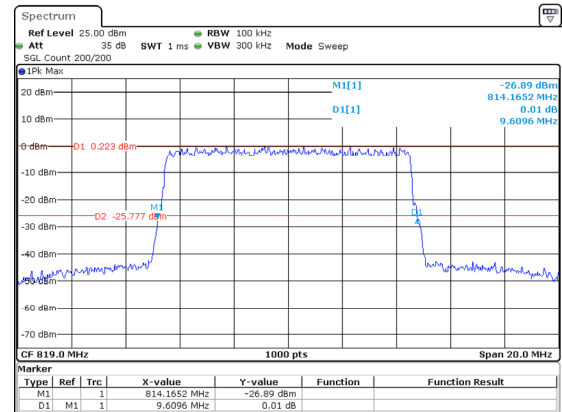
### 26dB Bandwidth

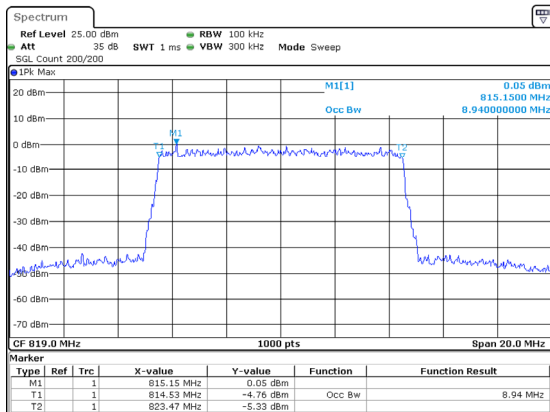
## 10MHz\_Low\_16QAM\_50@0

### Occupied Bandwidth

| Mode | 99% OBW<br>(MHz) | EBW<br>(MHz) |
|---|---|---|
| 10MHz_Low_16QAM_50@0 | <b>8.940</b> | 9.510 |

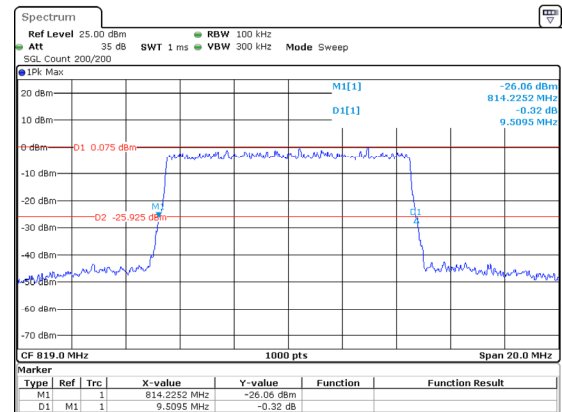
### 26dB Bandwidth

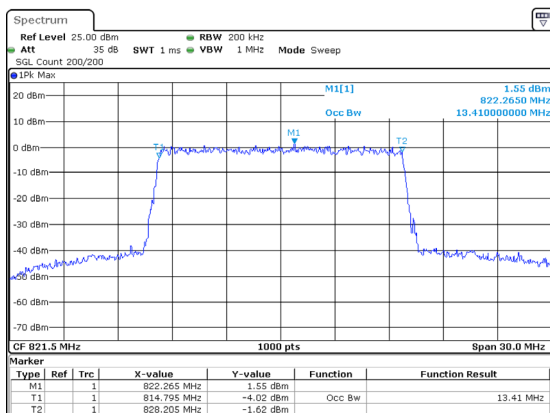
## 15MHz\_Low\_QPSK\_75@0

### Occupied Bandwidth

| Mode | 99% OBW<br>(MHz) | EBW<br>(MHz) |
|---|---|---|
| 15MHz_Low_QPSK_75@0 | <b>13.410</b> | 14.384 |

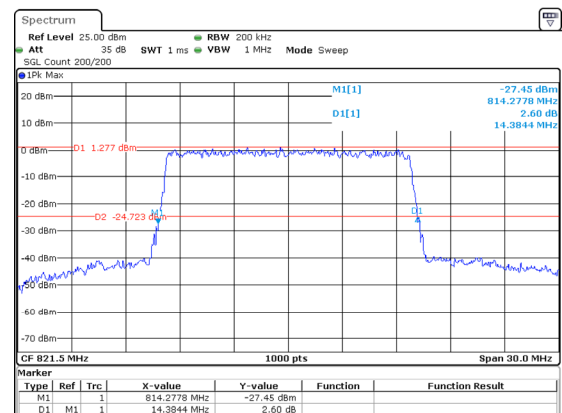
### 26dB Bandwidth

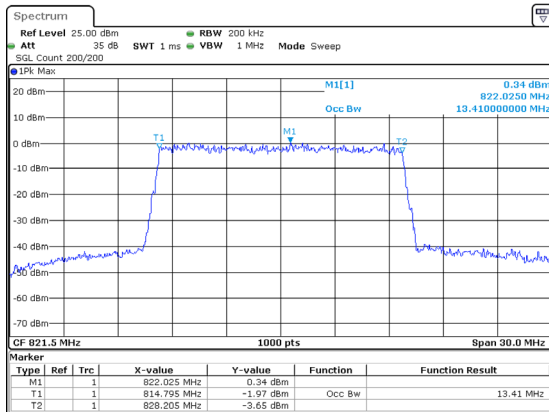
## 15MHz\_Low\_16QAM\_75@0

### Occupied Bandwidth

| Mode | 99% OBW<br>(MHz) | EBW<br>(MHz) |
|---|---|---|
| 15MHz_Low_16QAM_75@0 | <b>13.410</b> | 14.324 |

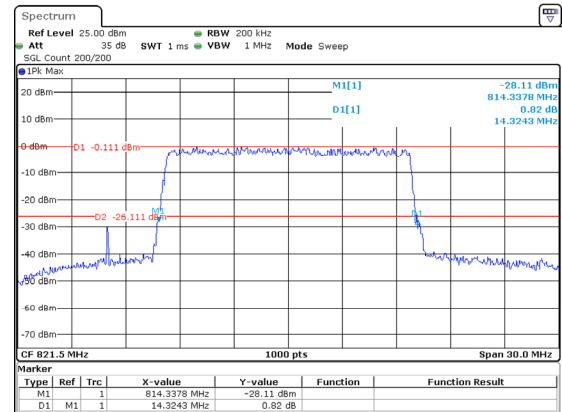
### 26dB Bandwidth

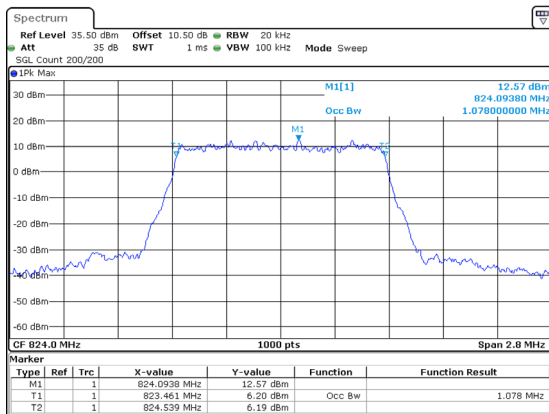
## 1.4MHz\_Middle\_QPSK\_6@0

### Occupied Bandwidth

| Mode | 99% OBW<br>(MHz) | EBW<br>(MHz) |
|---|---|---|
| 1.4MHz_Middle_QPSK_6@0 | <b>1.078</b> | 1.233 |

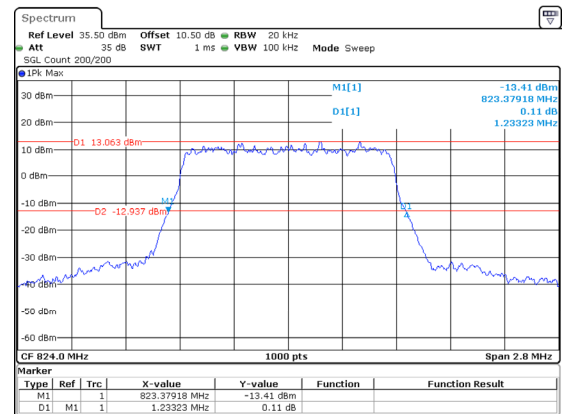
### 26dB Bandwidth

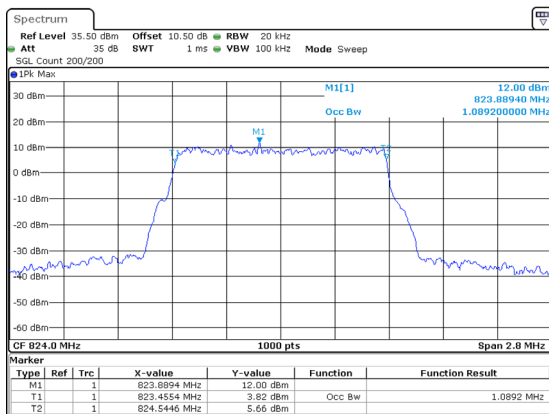
## 1.4MHz\_Middle\_16QAM\_6@0

### Occupied Bandwidth

| Mode | 99% OBW<br>(MHz) | EBW<br>(MHz) |
|---|---|---|
| 1.4MHz_Middle_16QAM_6@0 | <b>1.089</b> | 1.267 |

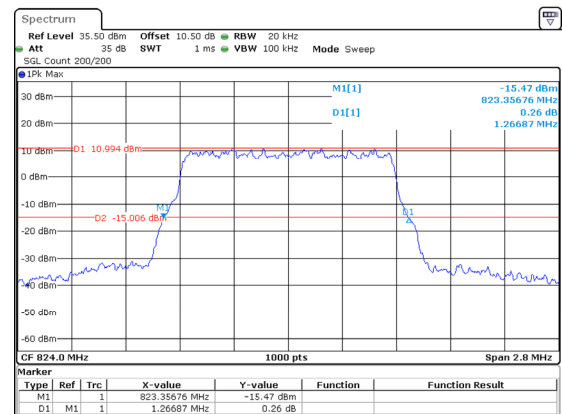
### 26dB Bandwidth

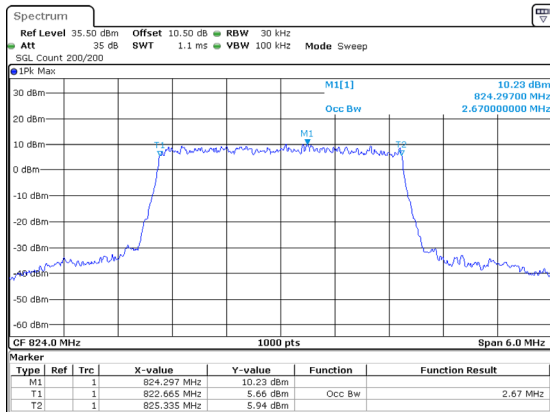
### 3MHz\_Middle\_QPSK\_15@0

#### Occupied Bandwidth

| Mode | 99% OBW<br>(MHz) | EBW<br>(MHz) |
|---|---|---|
| 3MHz_Middle_QPSK_15@0 | <b>2.670</b> | 2.919 |

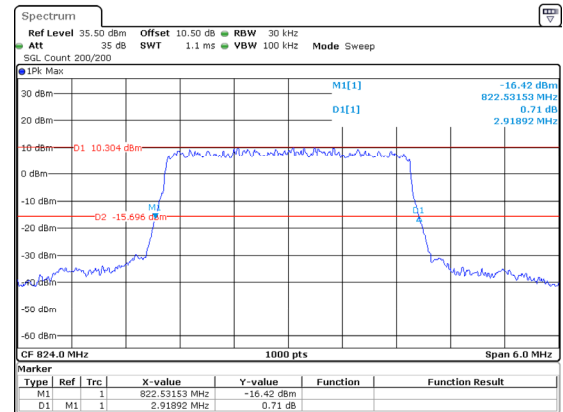
#### 26dB Bandwidth

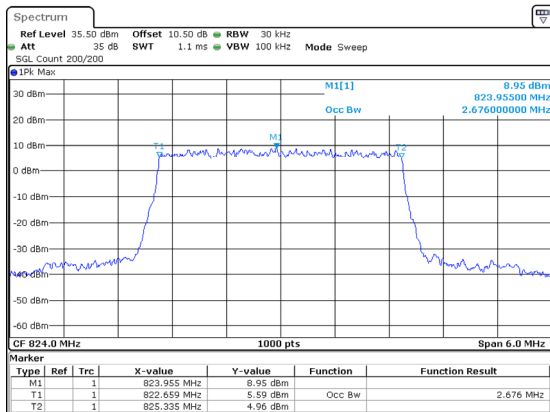
### 3MHz\_Middle\_16QAM\_15@0

#### Occupied Bandwidth

| Mode | 99% OBW<br>(MHz) | EBW<br>(MHz) |
|---|---|---|
| 3MHz_Middle_16QAM_15@0 | <b>2.676</b> | 2.931 |

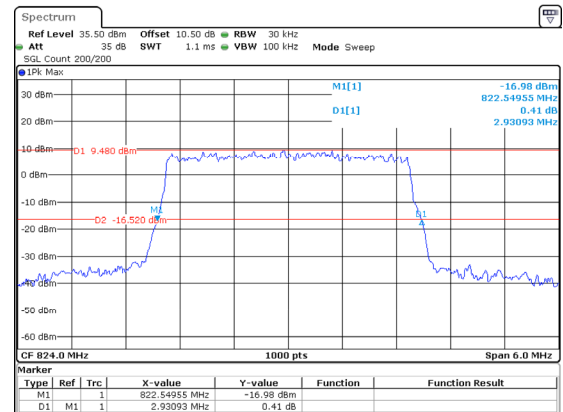
#### 26dB Bandwidth

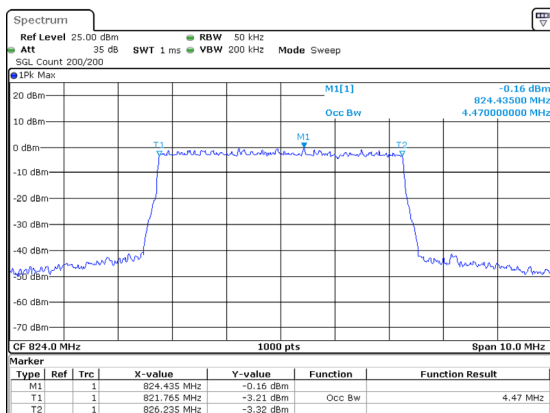
### 5MHz\_Middle\_QPSK\_25@0

#### Occupied Bandwidth

| Mode | 99% OBW<br>(MHz) | EBW<br>(MHz) |
|---|---|---|
| 5MHz_Middle_QPSK_25@0 | <b>4.470</b> | 4.785 |

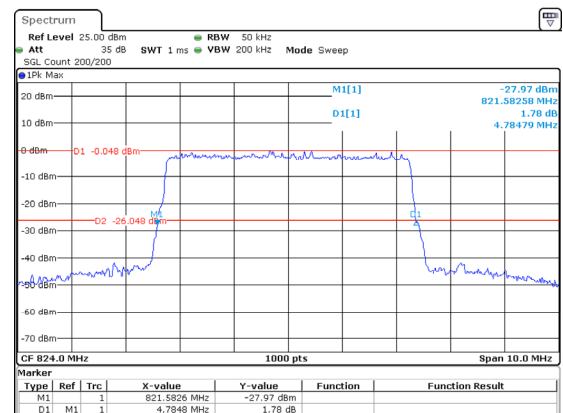
#### 26dB Bandwidth

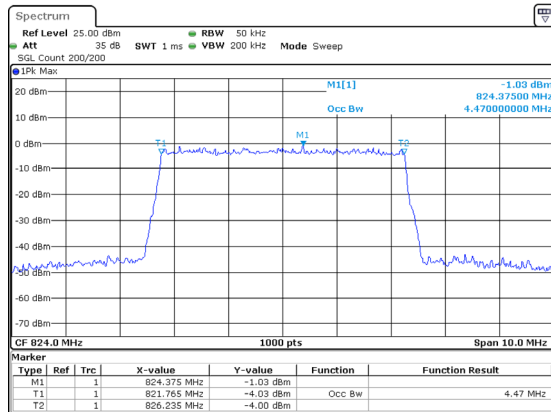
## 5MHz\_Middle\_16QAM\_25@0

### Occupied Bandwidth

| Mode | 99% OBW<br>(MHz) | EBW<br>(MHz) |
|---|---|---|
| 5MHz_Middle_16QAM_25@0 | <b>4.470</b> | 4.835 |

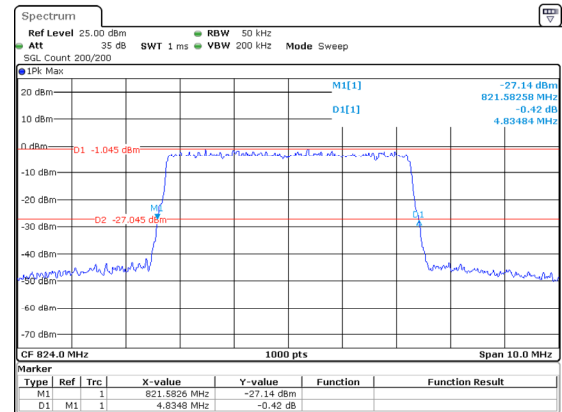
### 26dB Bandwidth

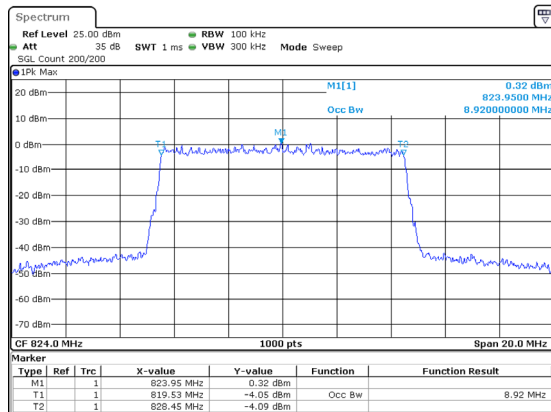
## 10MHz\_Middle\_QPSK\_50@0

### Occupied Bandwidth

| Mode | 99% OBW<br>(MHz) | EBW<br>(MHz) |
|---|---|---|
| 10MHz_Middle_QPSK_50@0 | <b>8.920</b> | 9.610 |

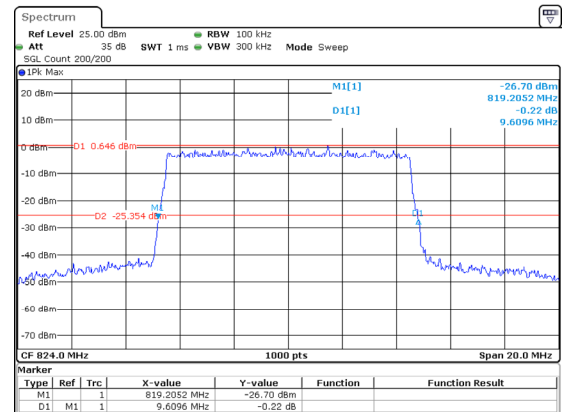
### 26dB Bandwidth

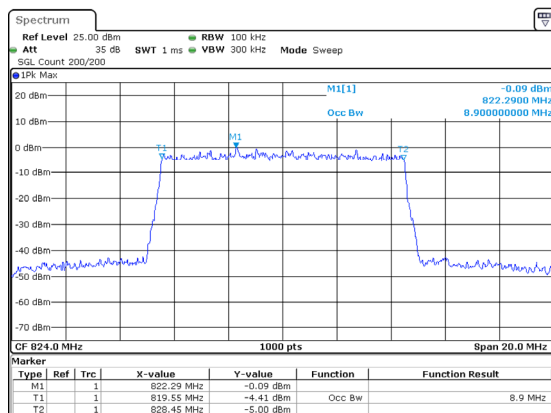
## 10MHz\_Middle\_16QAM\_50@0

### Occupied Bandwidth

| Mode | 99% OBW<br>(MHz) | EBW<br>(MHz) |
|---|---|---|
| 10MHz_Middle_16QAM_50@0 | <b>8.900</b> | 9.570 |

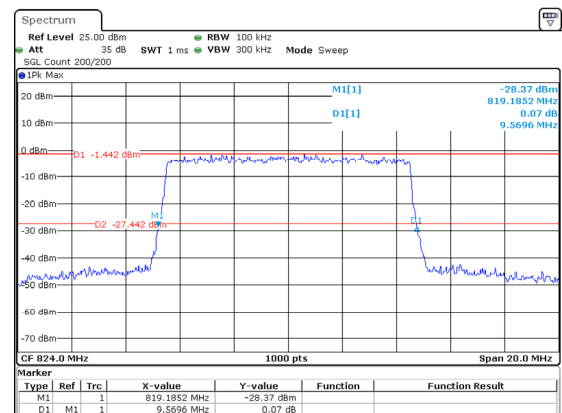
### 26dB Bandwidth

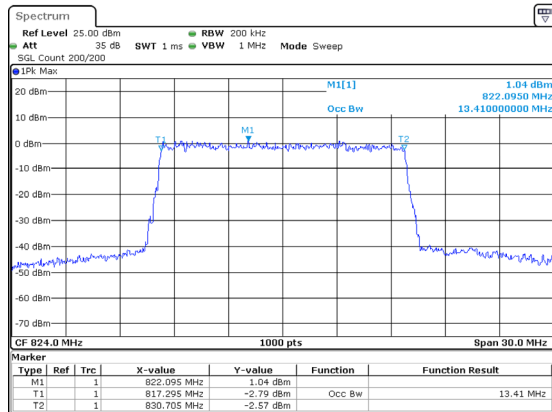
## 15MHz\_Middle\_QPSK\_75@0

### Occupied Bandwidth

| Mode | 99% OBW<br>(MHz) | EBW<br>(MHz) |
|---|---|---|
| 15MHz_Middle_QPSK_75@0 | <b>13.410</b> | 14.444 |

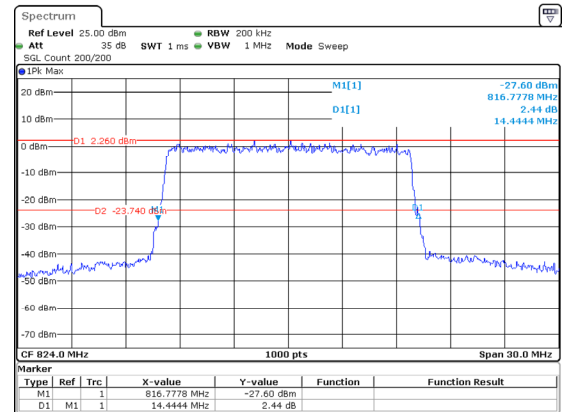
### 26dB Bandwidth

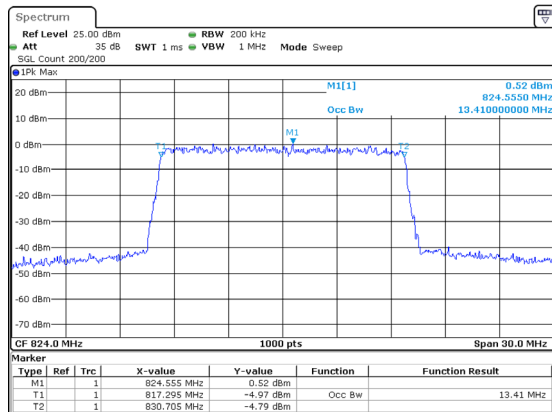
## 15MHz\_Middle\_16QAM\_75@0

### Occupied Bandwidth

| Mode | 99% OBW<br>(MHz) | EBW<br>(MHz) |
|---|---|---|
| 15MHz_Middle_16QAM_75@0 | <b>13.410</b> | 14.414 |

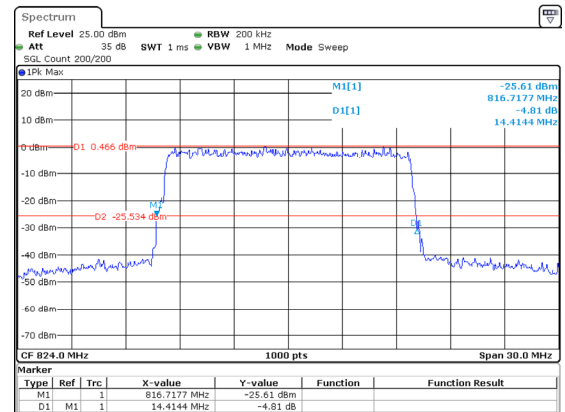
### 26dB Bandwidth
