## 9 PHOTOGRAPHS OF TEST SETUP

Test model No.: RM110

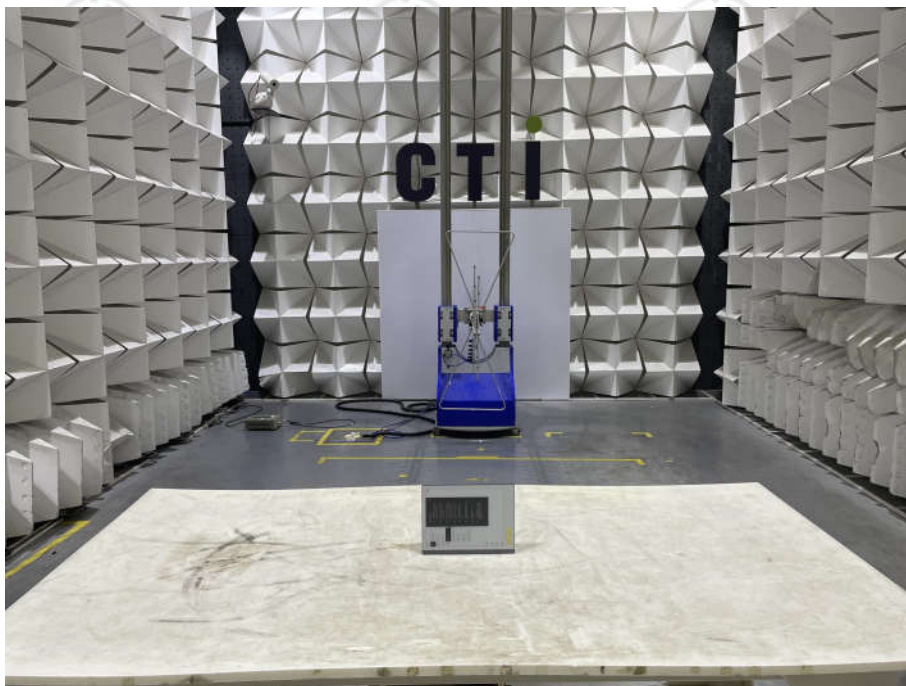
**Radiated spurious emission Test Setup-1(Below 1GHz)**

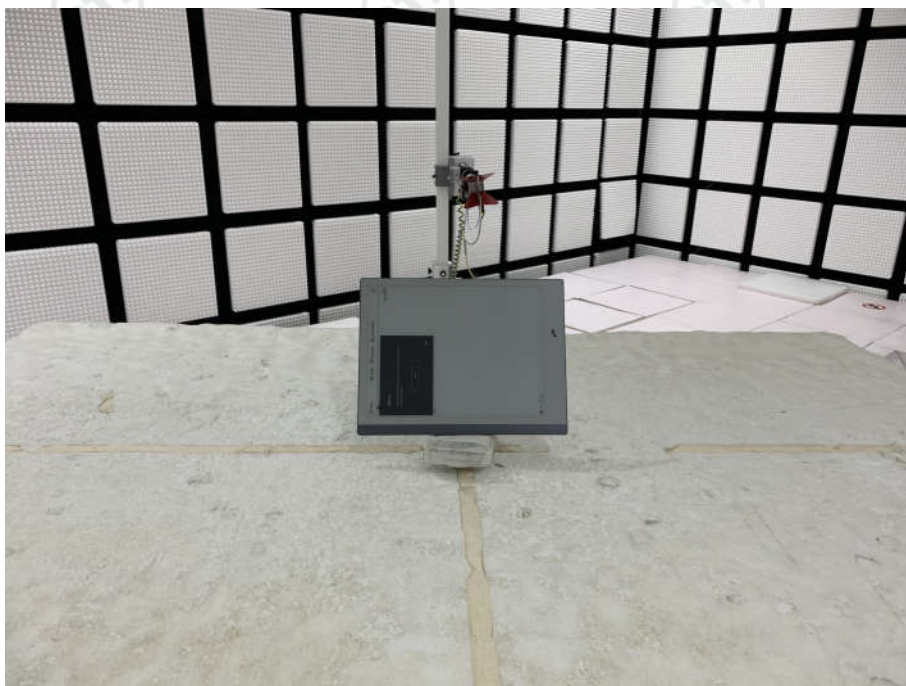
**Radiated spurious emission Test Setup-2(Above 1GHz)**

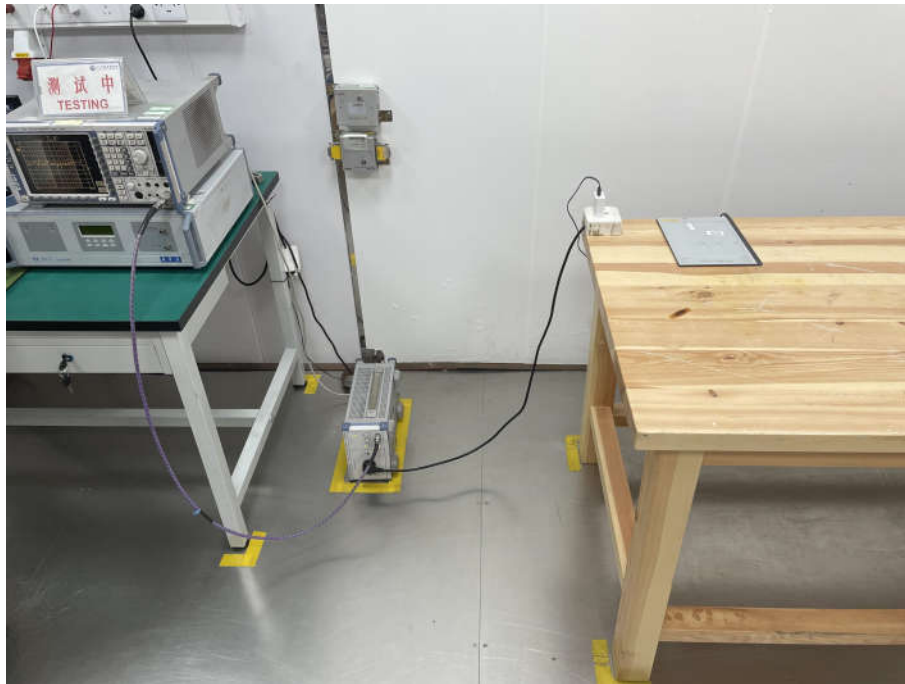
**Conducted emission Test Setup**

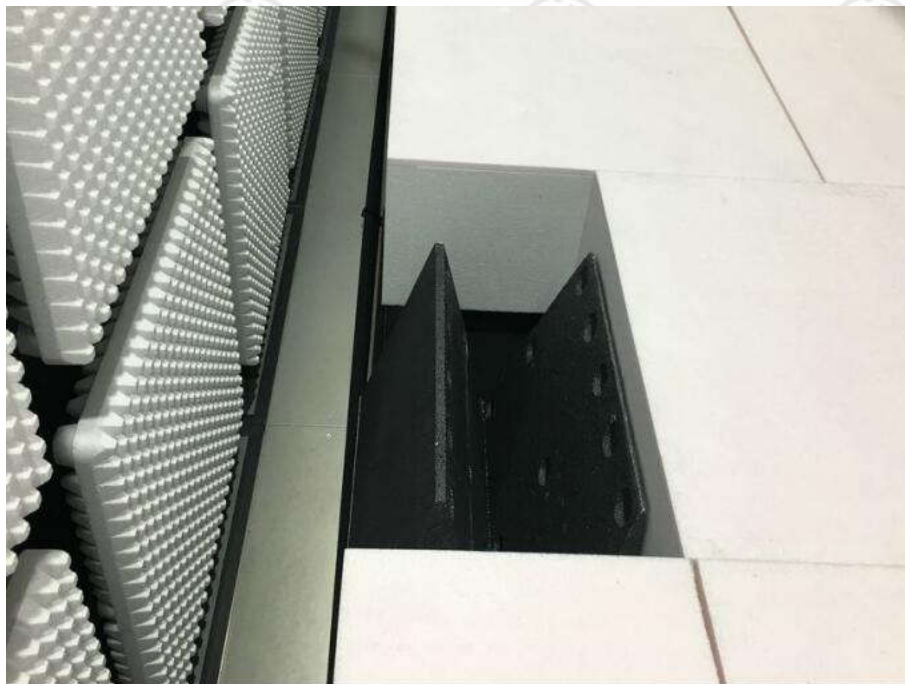
**Radiated spurious emission Test Setup-3(Above 1GHz)**  
**There are absorbing materials under the ground.**
