## 7.5 Band Edge

## 7.6 Conducted RF Spurious Emission

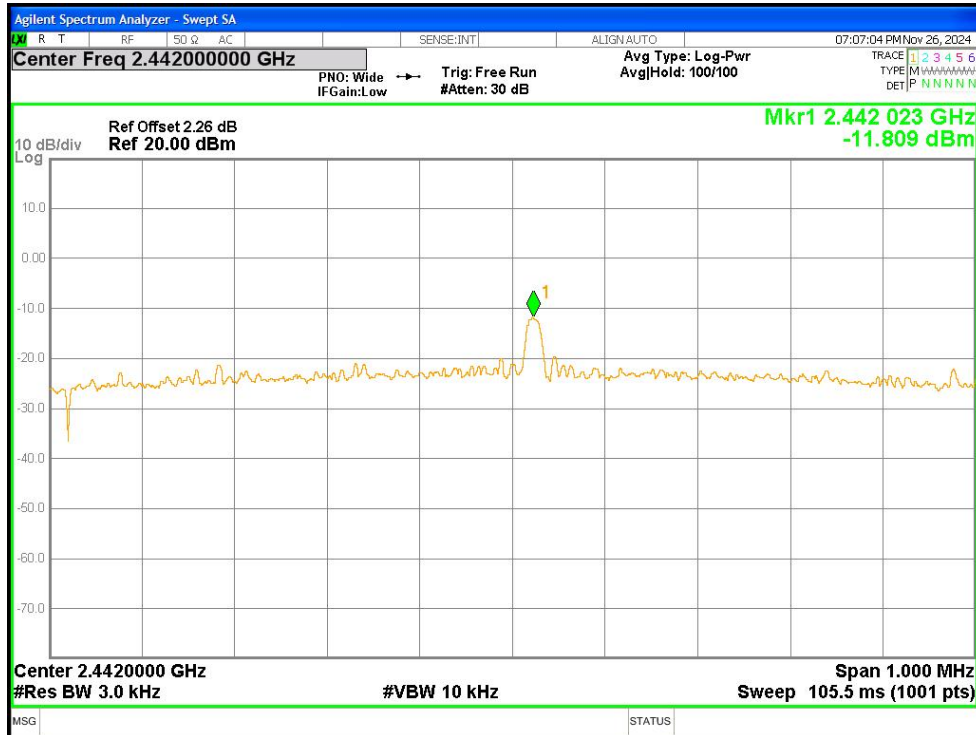
PSD NVNT BLE 2M 2442MHz Ant1

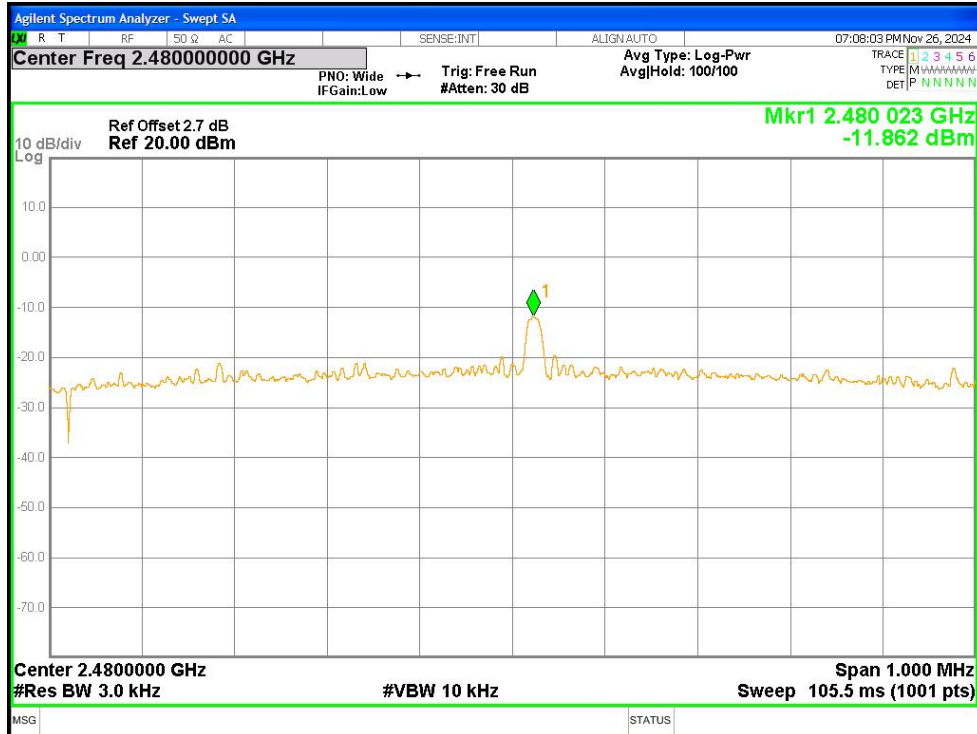
PSD NVNT BLE 2M 2480MHz Ant1

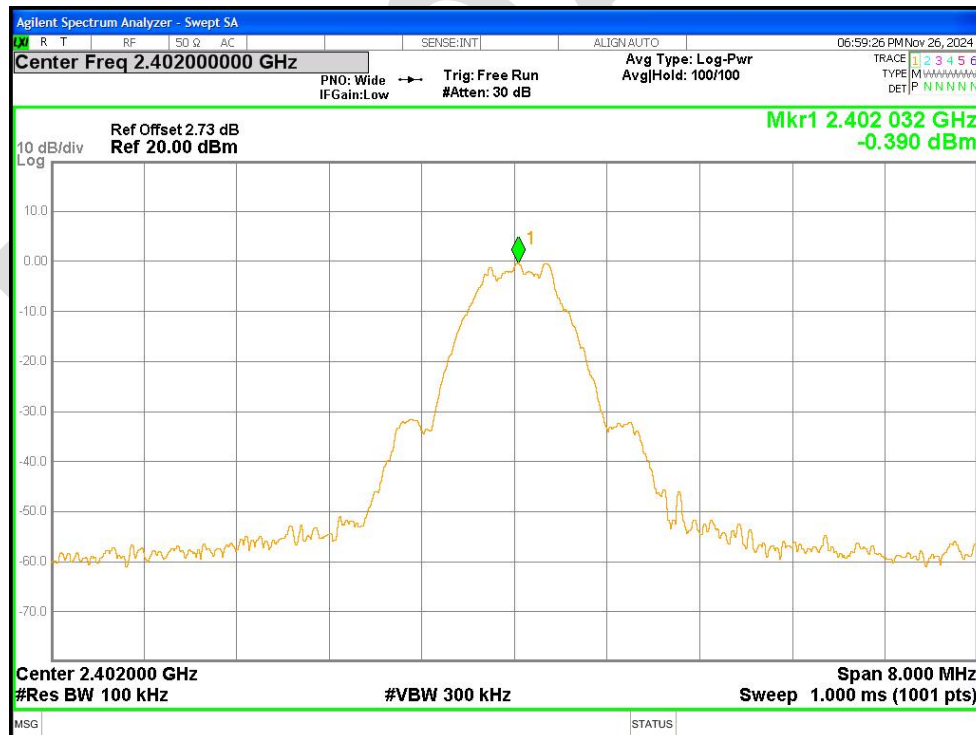
Band Edge NVNT BLE 1M 2402MHz Ant1 Ref

| Condition | Mode | Frequency (MHz) | Antenna | Max Value (dBc) | Limit (dBc) | Verdict |
|---|---|---|---|---|---|---|
| NVNT | BLE 1M | 2402 | Ant1 | -54.62 | -20 | Pass |

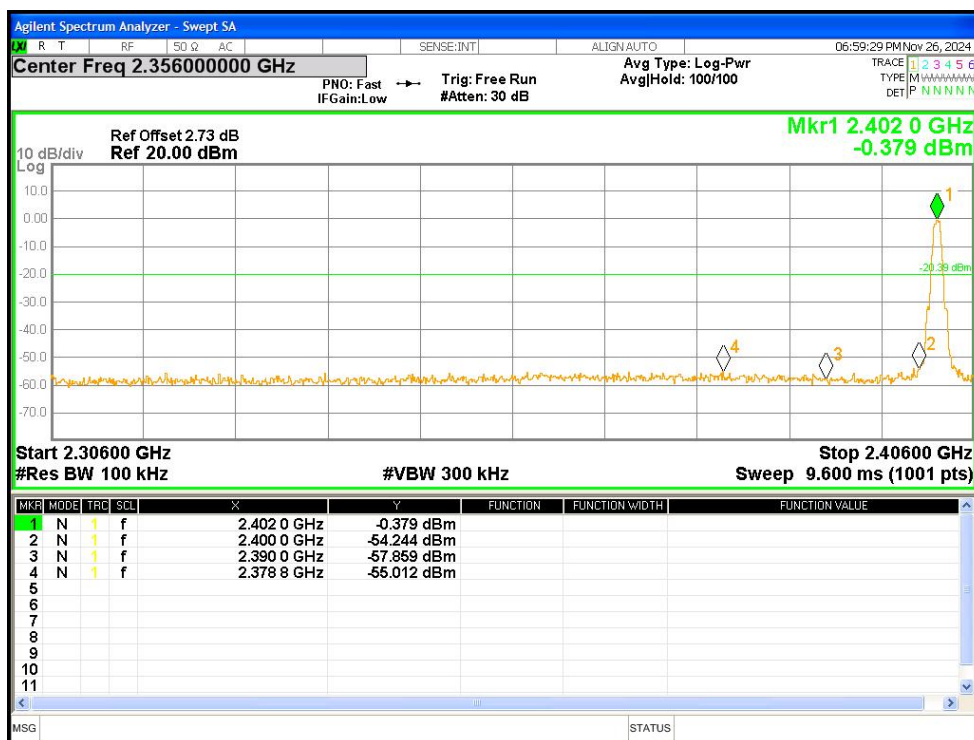
Band Edge NVNT BLE 1M 2402MHz Ant1 Emission

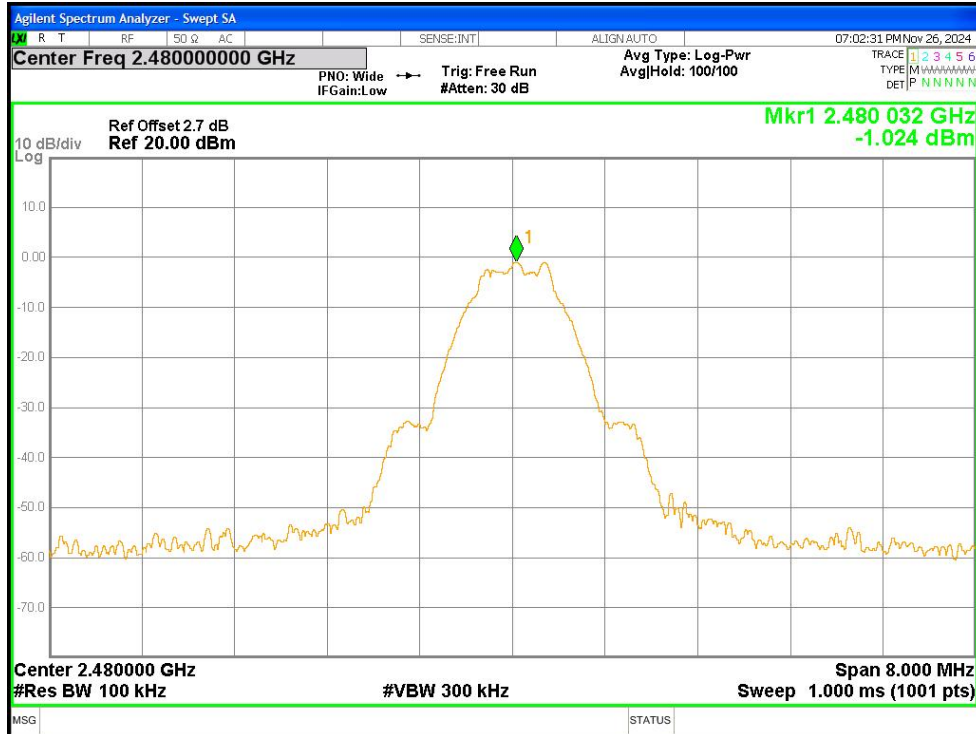
Band Edge NVNT BLE 1M 2480MHz Ant1 Ref

| Condition | Mode | Frequency (MHz) | Antenna | Max Value (dBc) | Limit (dBc) | Verdict |
|---|---|---|---|---|---|---|
| NVNT | BLE 1M | 2480 | Ant1 | -52.66 | -20 | Pass |

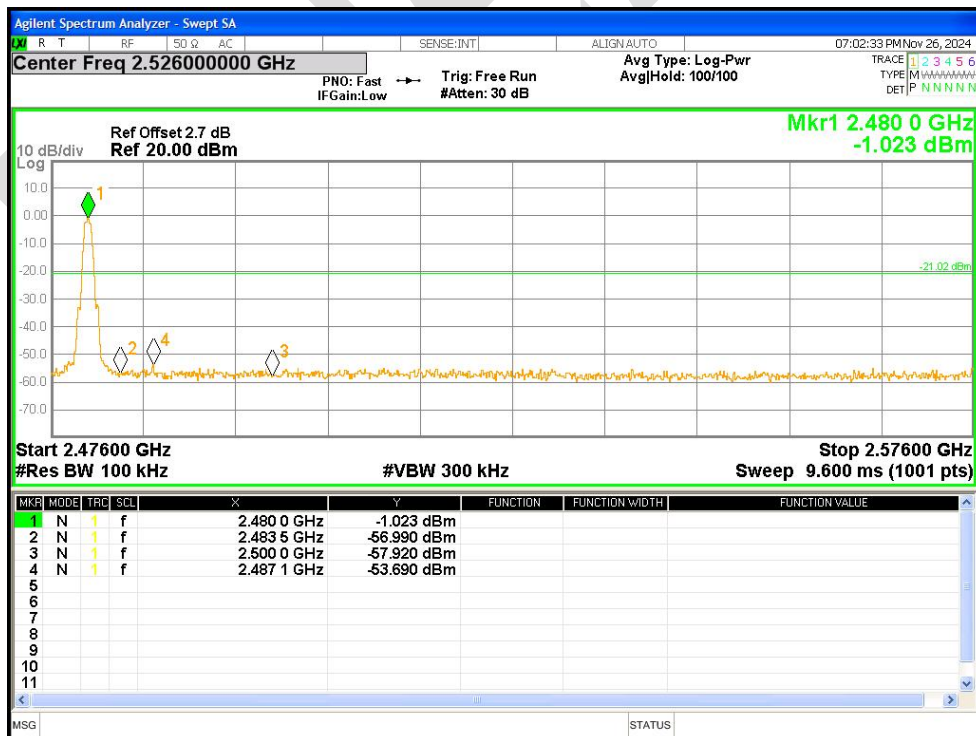
Band Edge NVNT BLE 1M 2480MHz Ant1 Emission

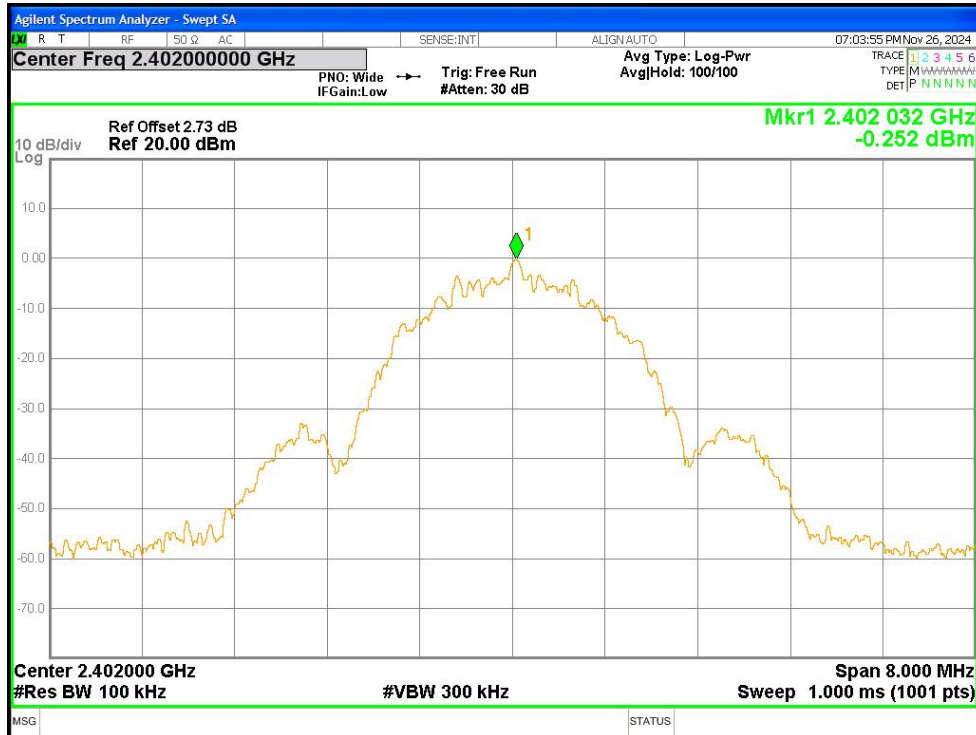
Band Edge NVNT BLE 2M 2402MHz Ant1 Ref

| Condition | Mode | Frequency (MHz) | Antenna | Max Value (dBc) | Limit (dBc) | Verdict |
|---|---|---|---|---|---|---|
| NVNT | BLE 2M | 2402 | Ant1 | -53.4 | -20 | Pass |

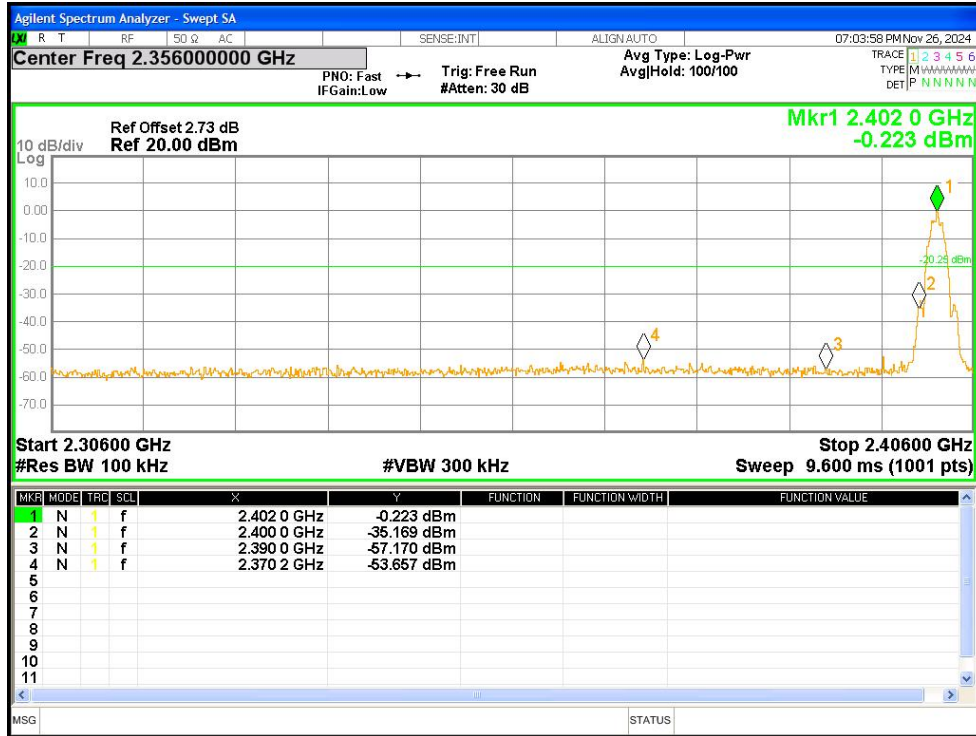
Band Edge NVNT BLE 2M 2402MHz Ant1 Emission

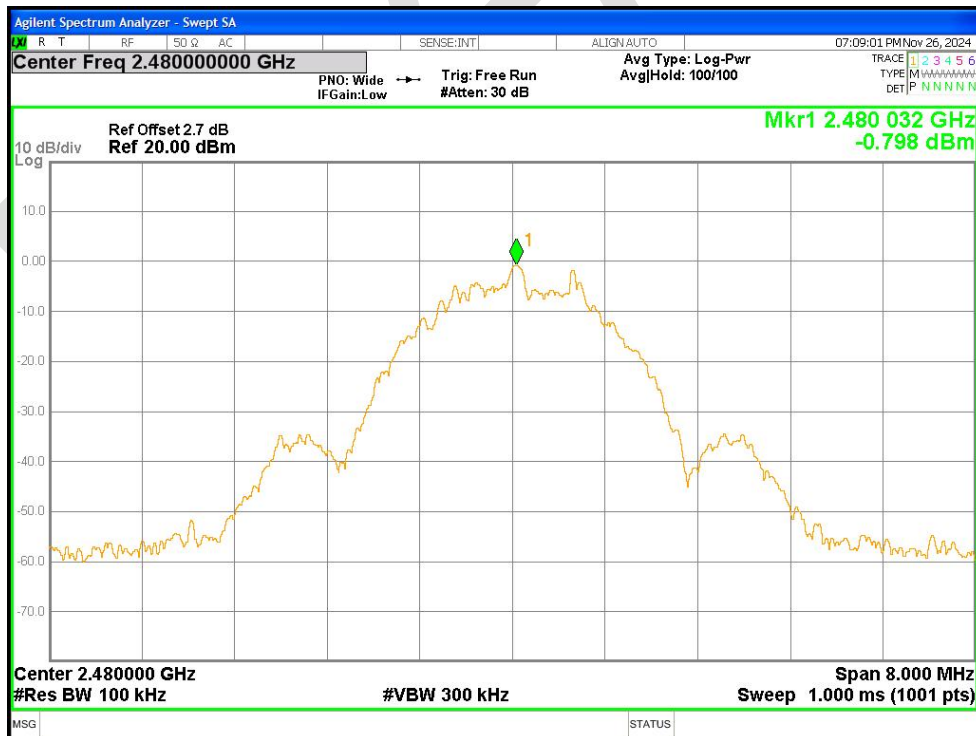
Band Edge NVNT BLE 2M 2480MHz Ant1 Ref

| Condition | Mode | Frequency (MHz) | Antenna | Max Value (dBc) | Limit (dBc) | Verdict |
|---|---|---|---|---|---|---|
| NVNT | BLE 2M | 2480 | Ant1 | -50.81 | -20 | Pass |

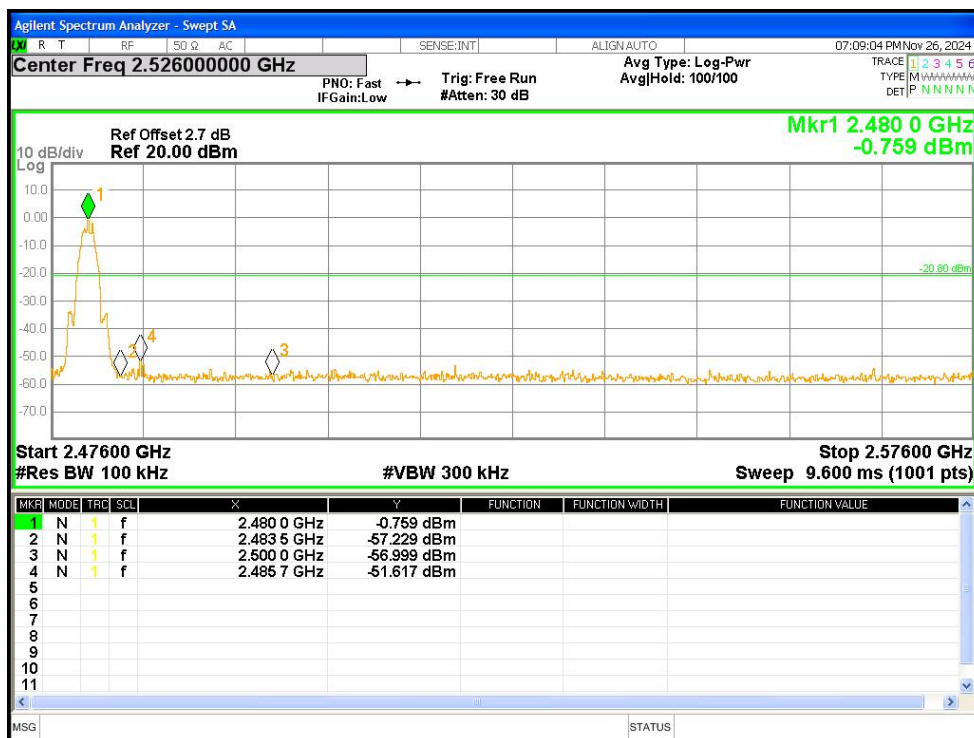
Band Edge NVNT BLE 2M 2480MHz Ant1 Emission

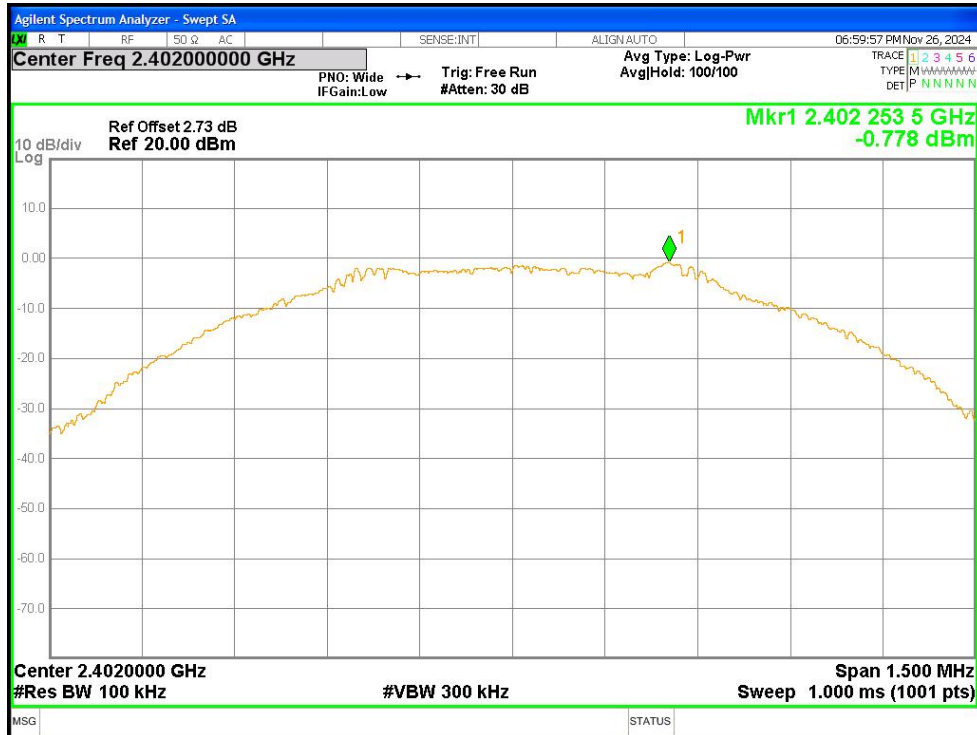
Tx. Spurious NVNT BLE 1M 2402MHz Ant1 Ref

| Condition | Mode | Frequency (MHz) | Antenna | Max Value (dBc) | Limit (dBc) | Verdict |
|---|---|---|---|---|---|---|
| NVNT | BLE 1M | 2402 | Ant1 | -43.96 | -20 | Pass |

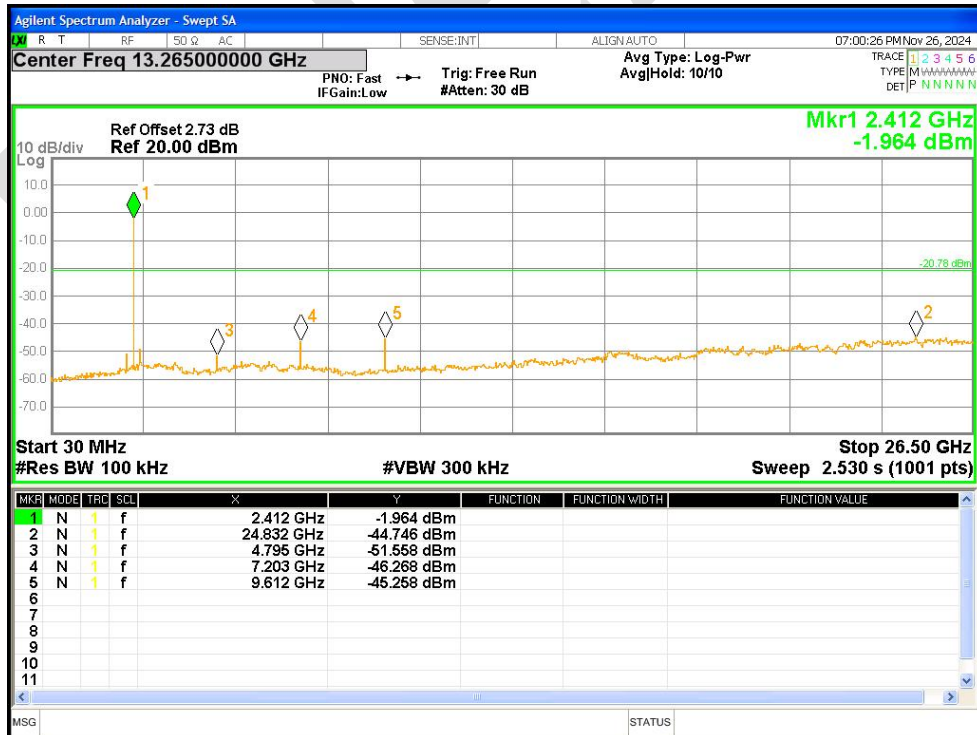
Tx. Spurious NVNT BLE 1M 2402MHz Ant1 Emission

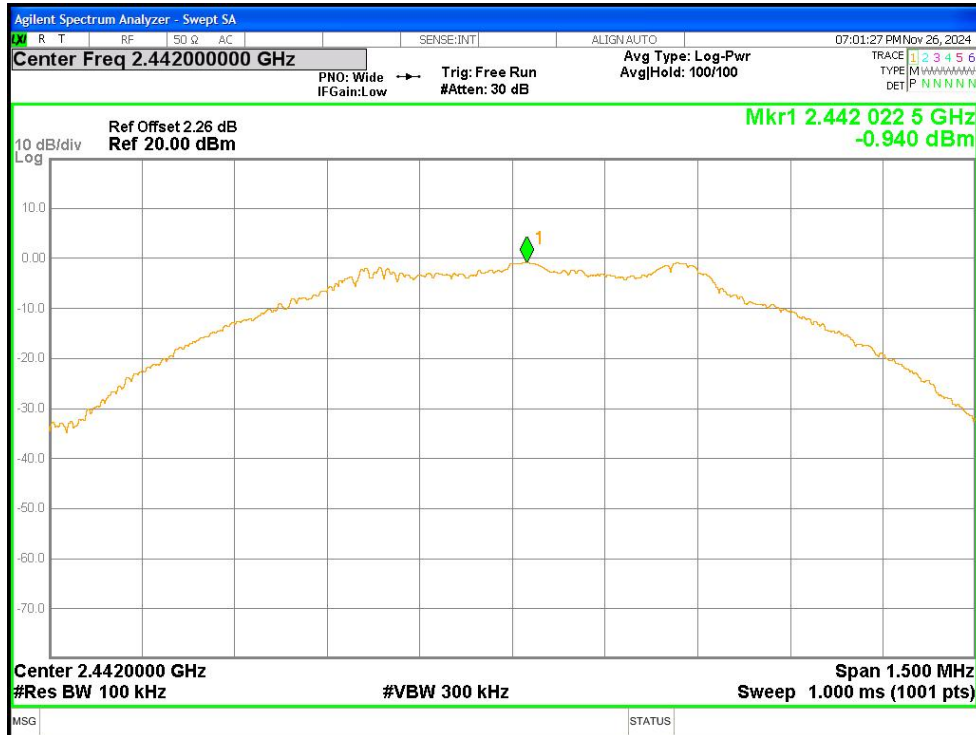
Tx. Spurious NVNT BLE 1M 2442MHz Ant1 Ref

| Condition | Mode | Frequency (MHz) | Antenna | Max Value (dBc) | Limit (dBc) | Verdict |
|---|---|---|---|---|---|---|
| NVNT | BLE 1M | 2442 | Ant1 | -44.72 | -20 | Pass |

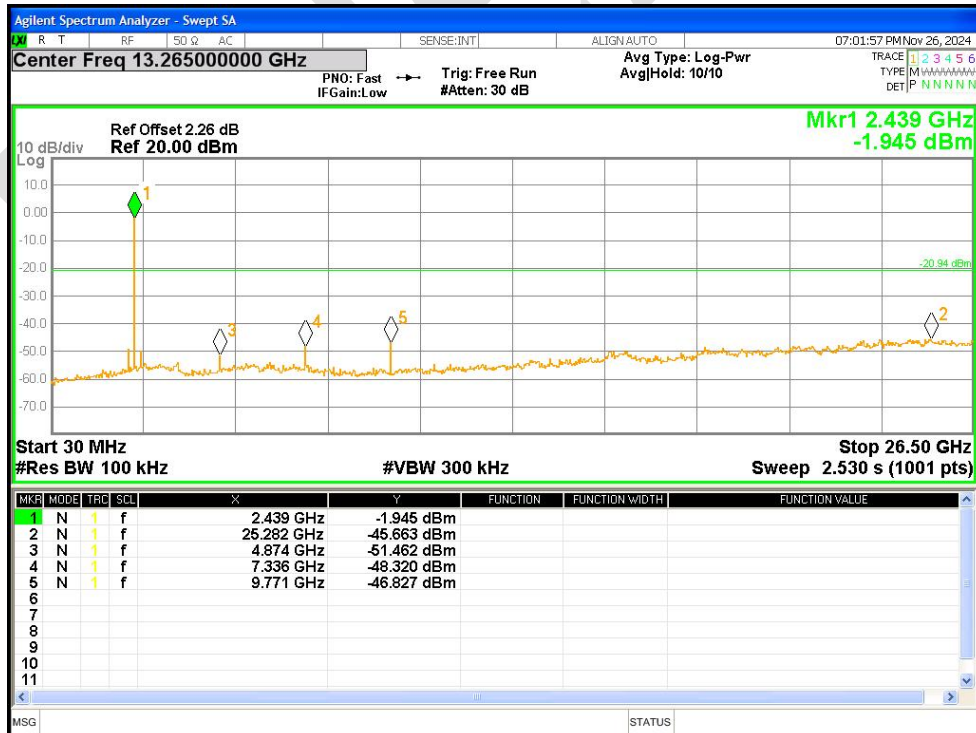
Tx. Spurious NVNT BLE 1M 2442MHz Ant1 Emission

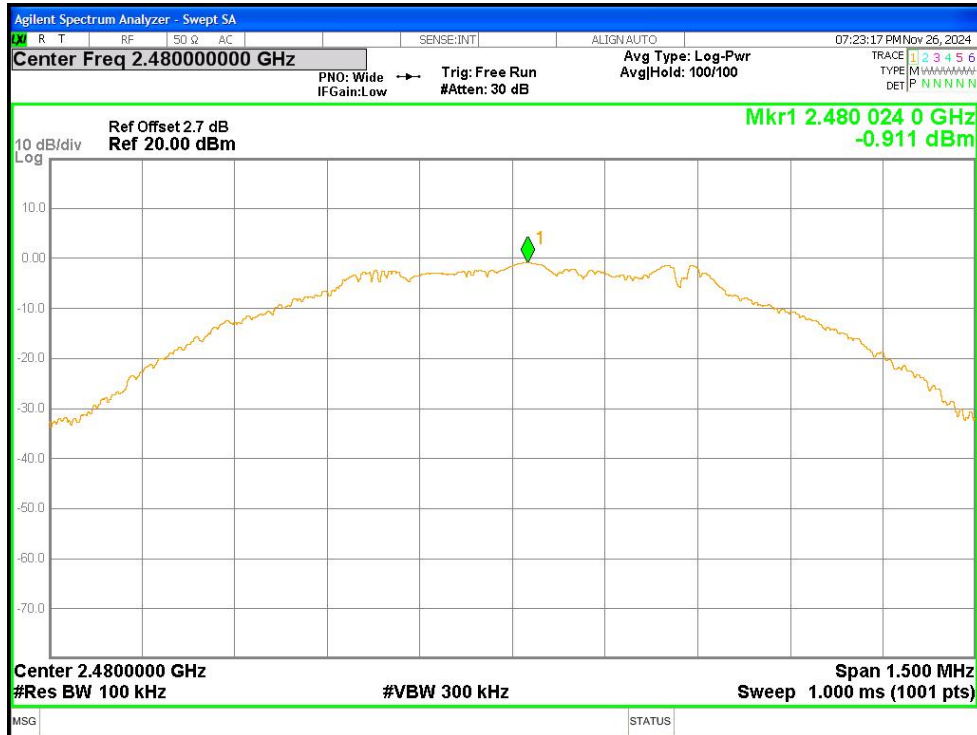
Tx. Spurious NVNT BLE 1M 2480MHz Ant1 Ref

| Condition | Mode | Frequency (MHz) | Antenna | Max Value (dBc) | Limit (dBc) | Verdict |
|---|---|---|---|---|---|---|
| NVNT | BLE 1M | 2480 | Ant1 | -43.36 | -20 | Pass |

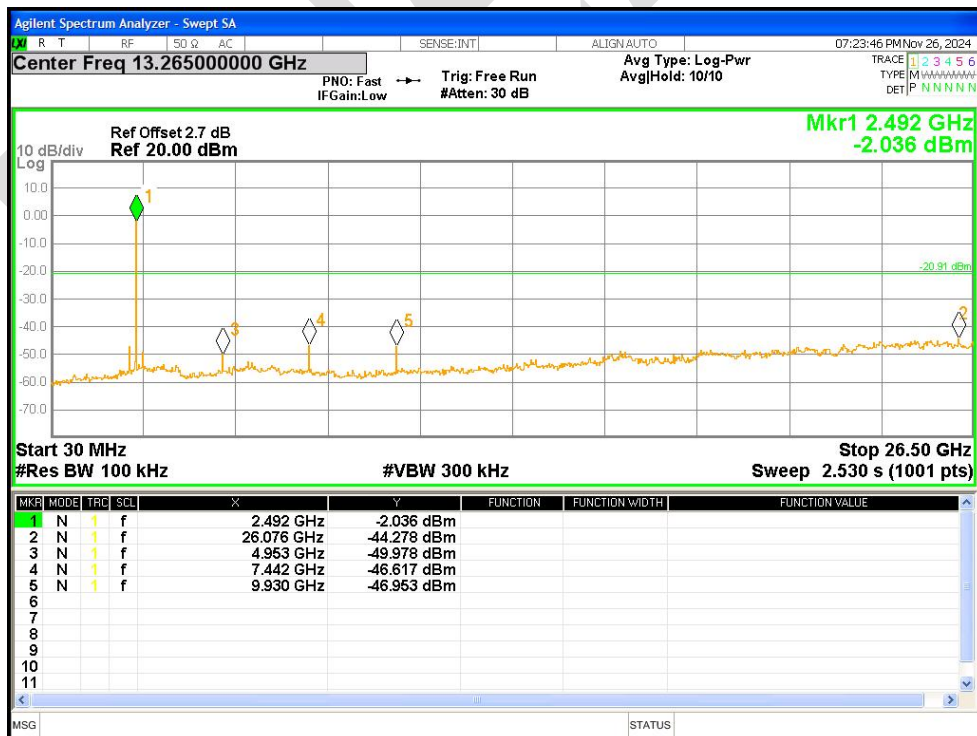
Tx. Spurious NVNT BLE 1M 2480MHz Ant1 Emission

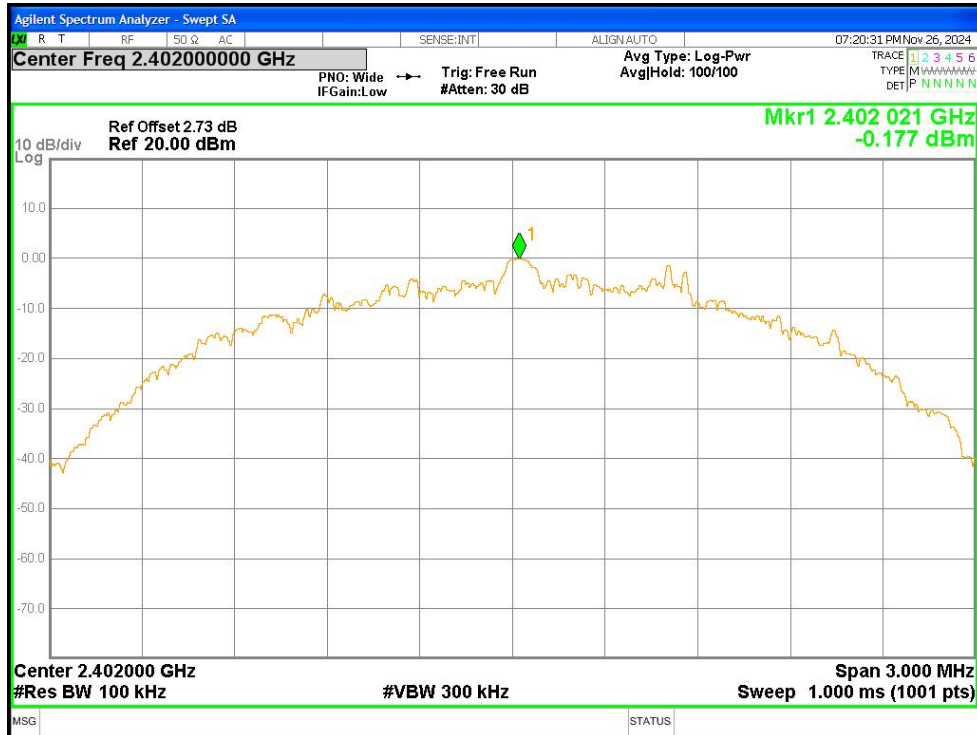
Tx. Spurious NVNT BLE 2M 2402MHz Ant1 Ref

| Condition | Mode | Frequency (MHz) | Antenna | Max Value (dBc) | Limit (dBc) | Verdict |
|---|---|---|---|---|---|---|
| NVNT | BLE 2M | 2402 | Ant1 | -44.09 | -20 | Pass |

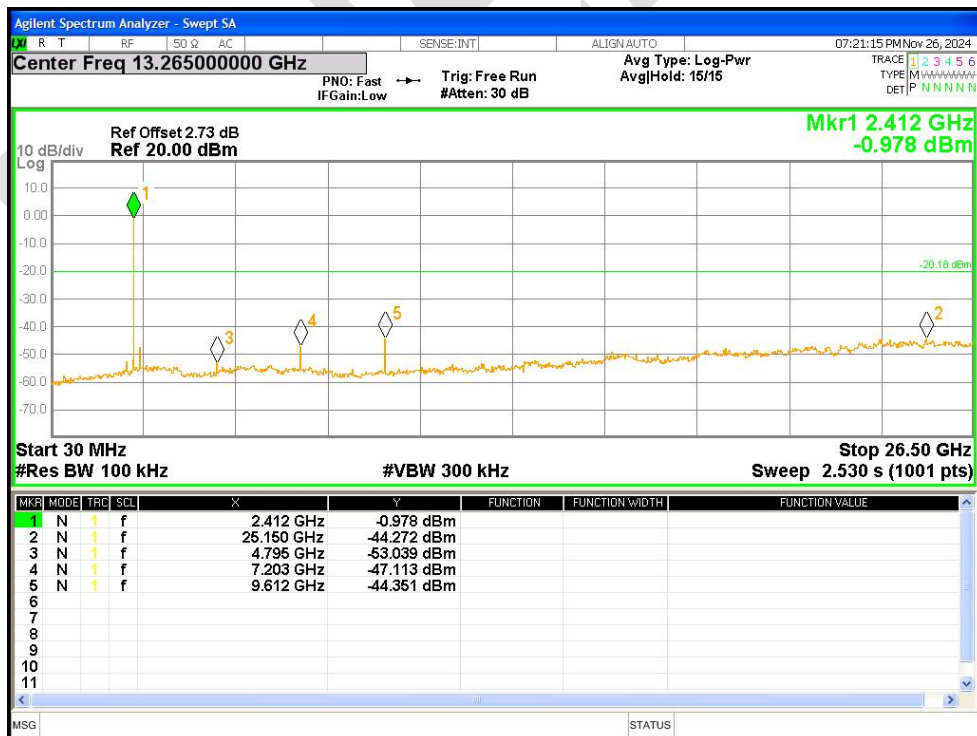
Tx. Spurious NVNT BLE 2M 2402MHz Ant1 Emission

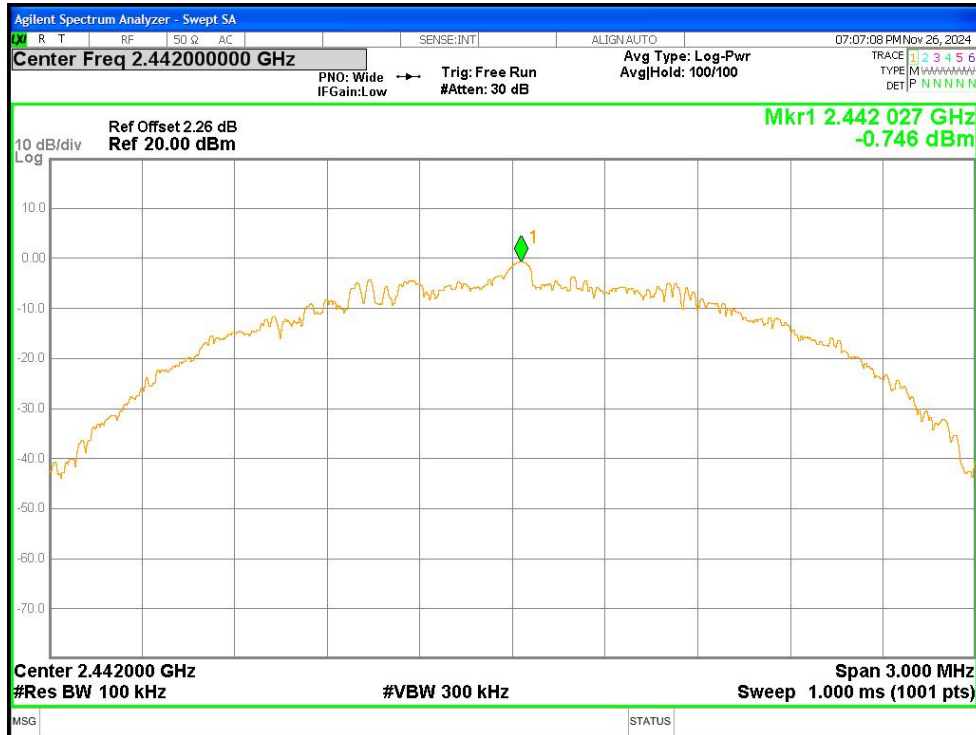
Tx. Spurious NVNT BLE 2M 2442MHz Ant1 Ref

| Condition | Mode | Frequency (MHz) | Antenna | Max Value (dBc) | Limit (dBc) | Verdict |
|---|---|---|---|---|---|---|
| NVNT | BLE 2M | 2442 | Ant1 | -44.4 | -20 | Pass |

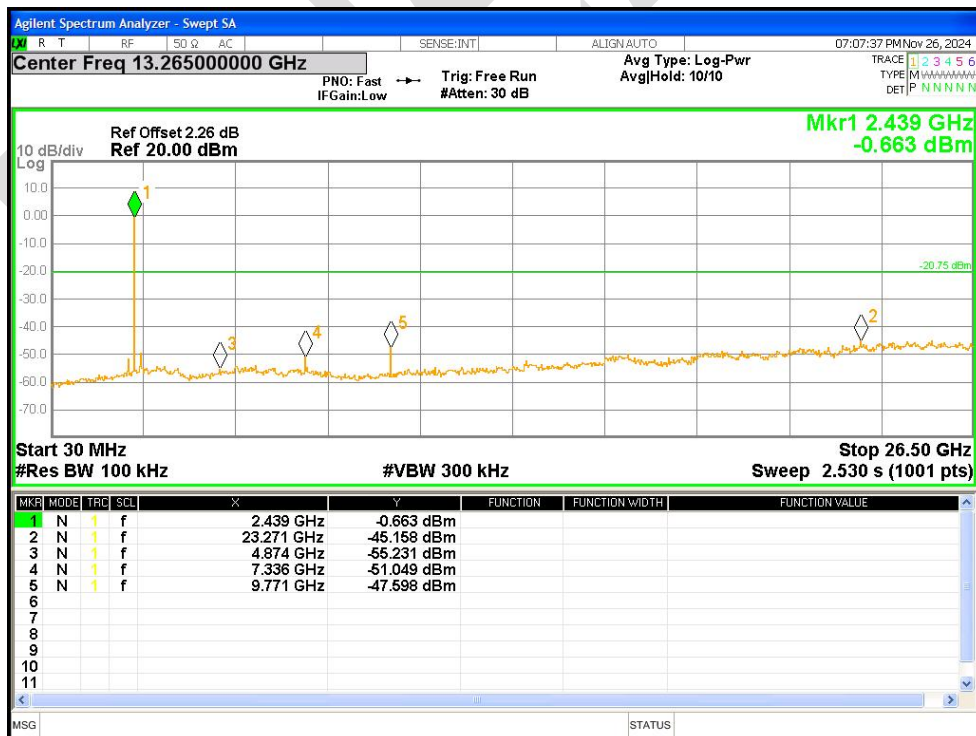
Tx. Spurious NVNT BLE 2M 2442MHz Ant1 Emission

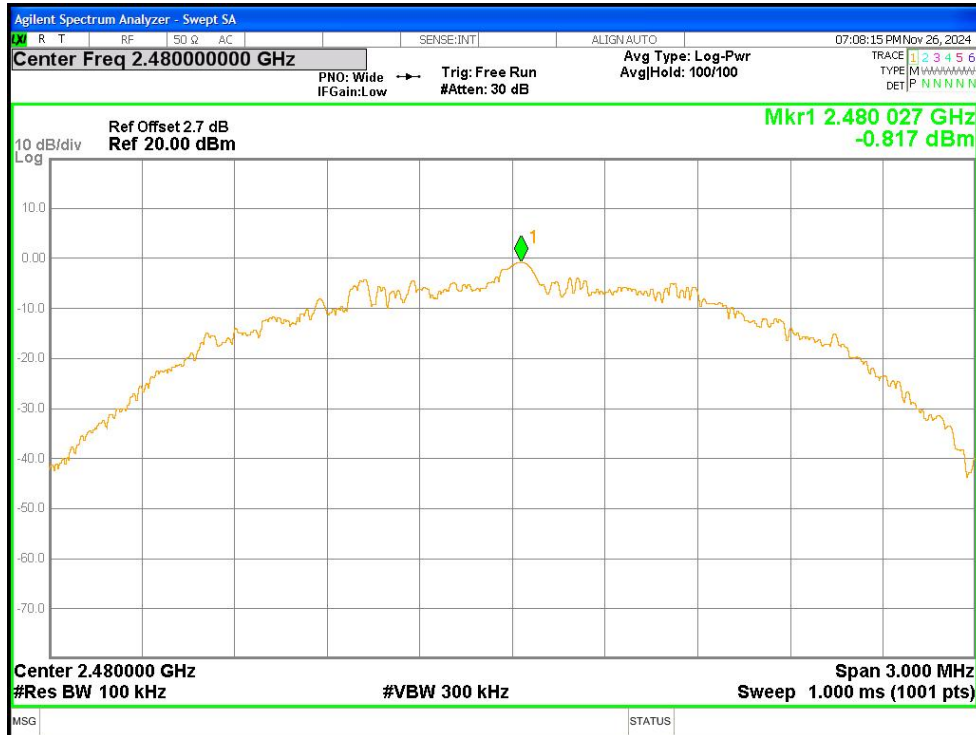
Tx. Spurious NVNT BLE 2M 2480MHz Ant1 Ref

| Condition | Mode | Frequency (MHz) | Antenna | Max Value (dBc) | Limit (dBc) | Verdict |
|---|---|---|---|---|---|---|
| NVNT | BLE 2M | 2480 | Ant1 | -43.89 | -20 | Pass |

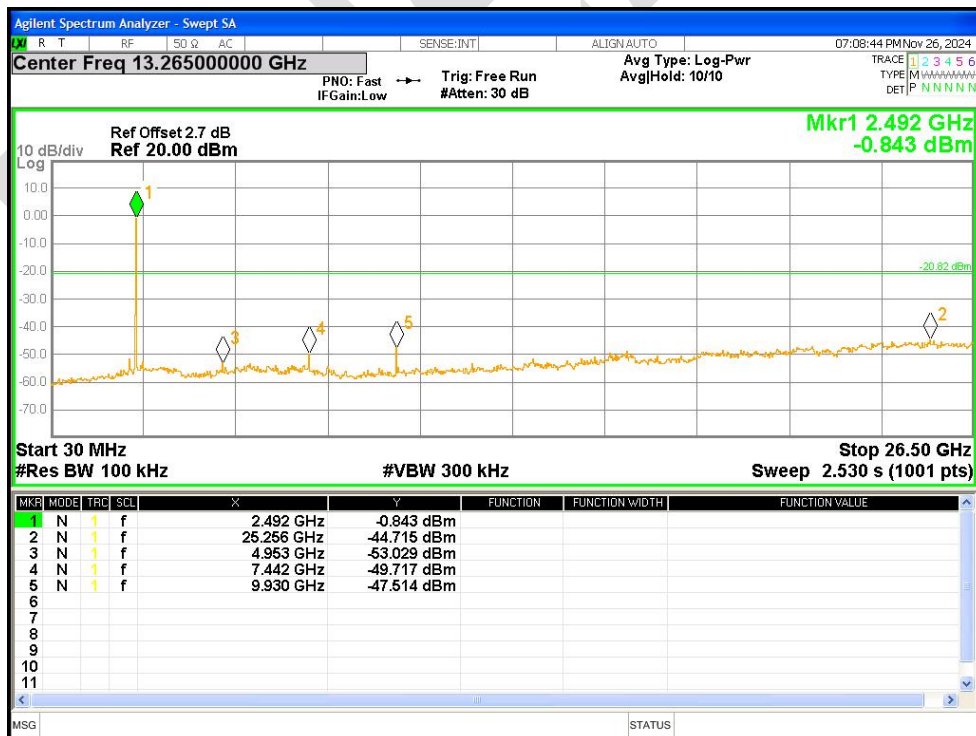
Tx. Spurious NVNT BLE 2M 2480MHz Ant1 Emission

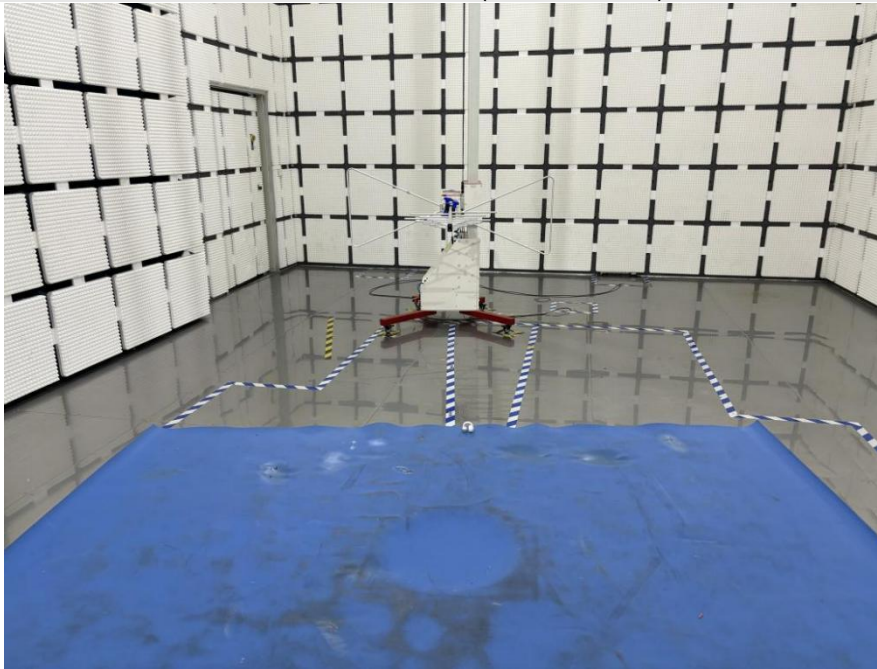
Radiated Emissions (30MHz-1GHz)

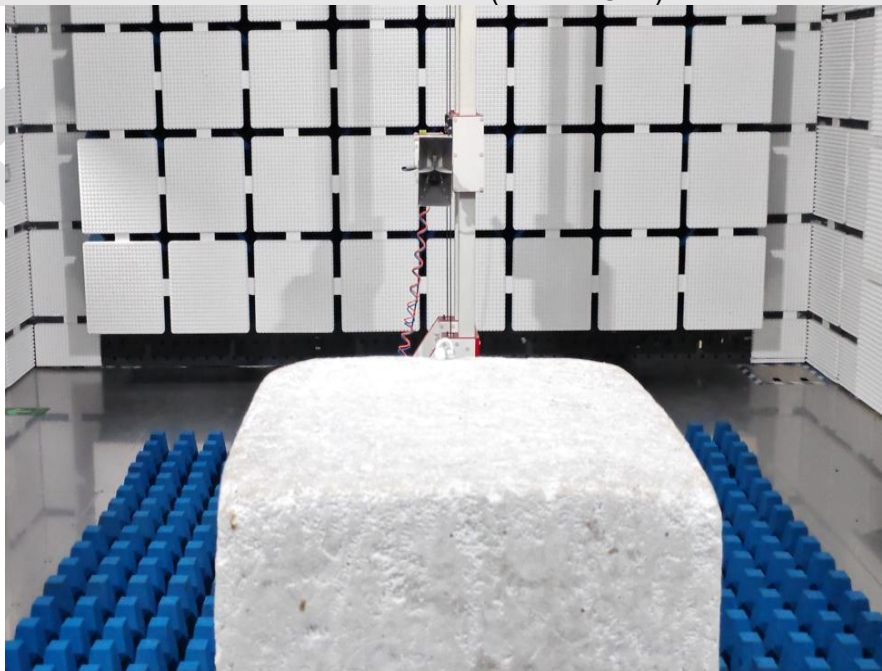
Radiated Emissions (above 1GHz)
