## 7.5Band Edge

## 7.6 Conducted RF Spurious Emission

## Appendix B: photographs of test setup

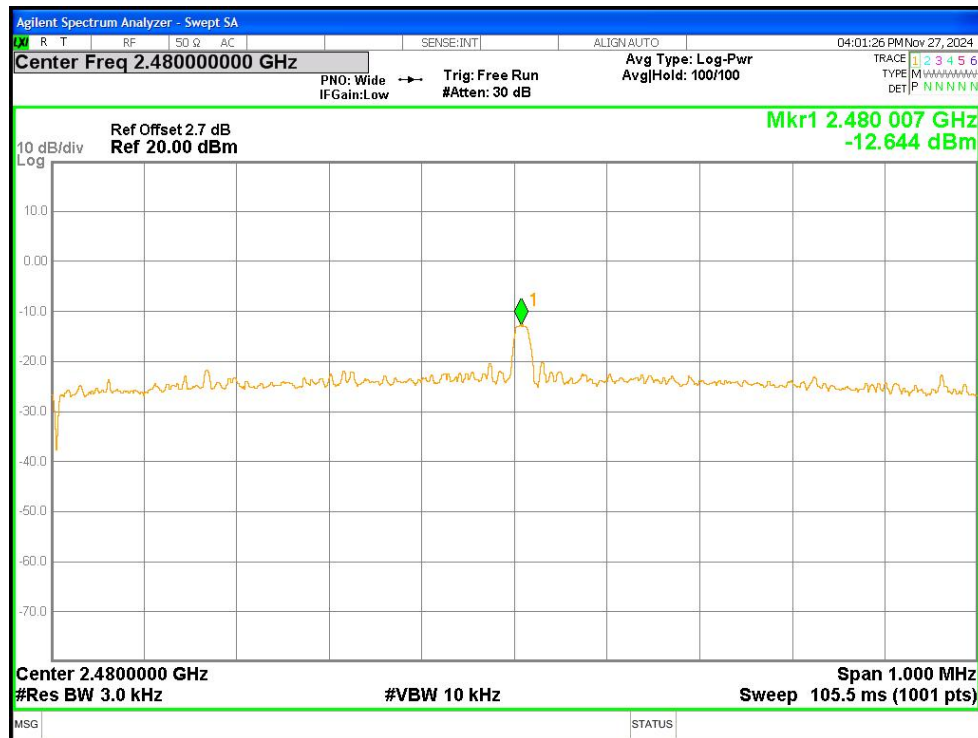
PSD NVNT BLE 2M 2480MHz Ant1

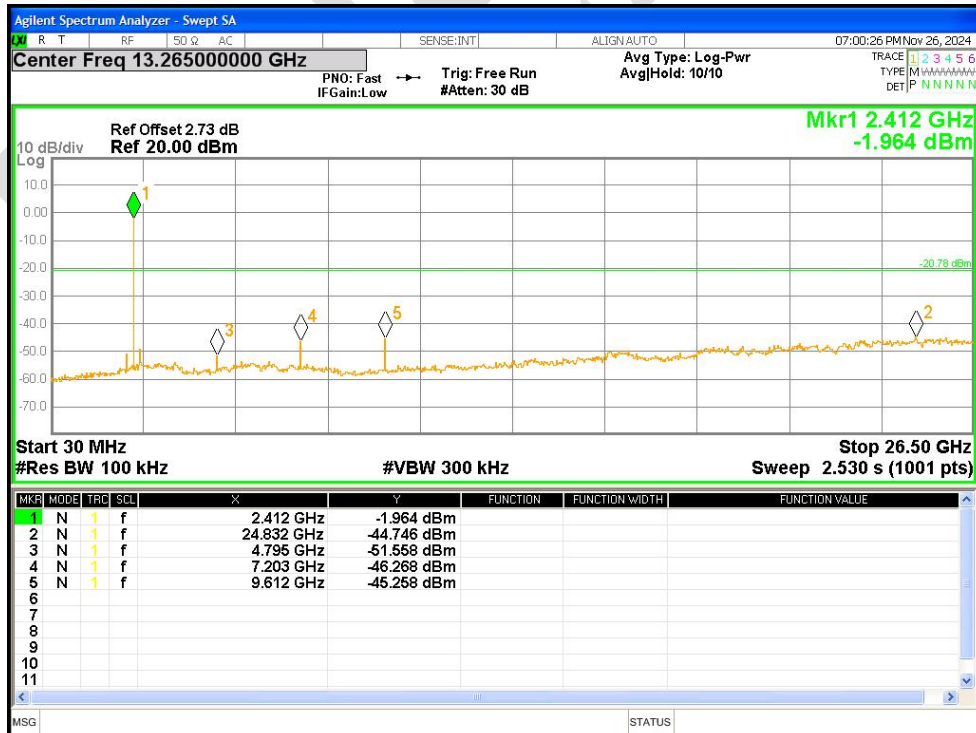
Tx. Spurious NVNT BLE 1M 2402MHz Ant1 Emission

| Condition | Mode | Frequency (MHz) | Antenna | Max Value (dBc) | Limit (dBc) | Verdict |
|---|---|---|---|---|---|---|
| NVNT | BLE 1M | 2402 | Ant1 | -43.96 | -20 | Pass |
