# Radiated Emission Measurement

Condition : FCC\_part 15 RE-Class C\_Above 1GHz\_PK

EUT : W6M22311-23090

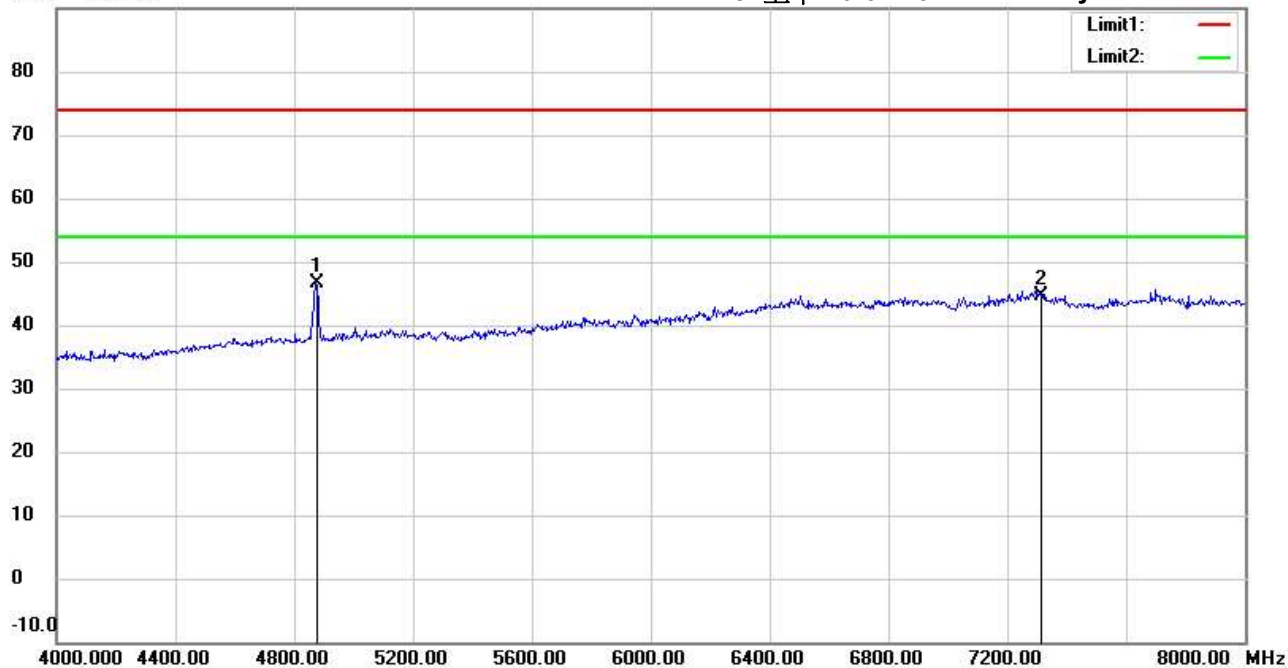
Test Mode : TX 802.11g CH6

Polarization: **Horizontal**

| Mk. | Frequency (MHz) | Reading (dBuV) | Detector | Corr. factor (dB/m) | Result (dBuV/m) | Limit (dBuV/m) | Ant.Pos (cm) | Tab.Pos (deg.) | Margin (dB) | Comment |
|---|---|---|---|---|---|---|---|---|---|---|
| * | 4874.000 | 41.51 | peak | 5.21 | 46.72 | 74.00 | 150 | 22 | -27.28 | |
| | 7311.000 | 32.98 | peak | 11.70 | 44.68 | 74.00 | 150 | 270 | -29.32 | |

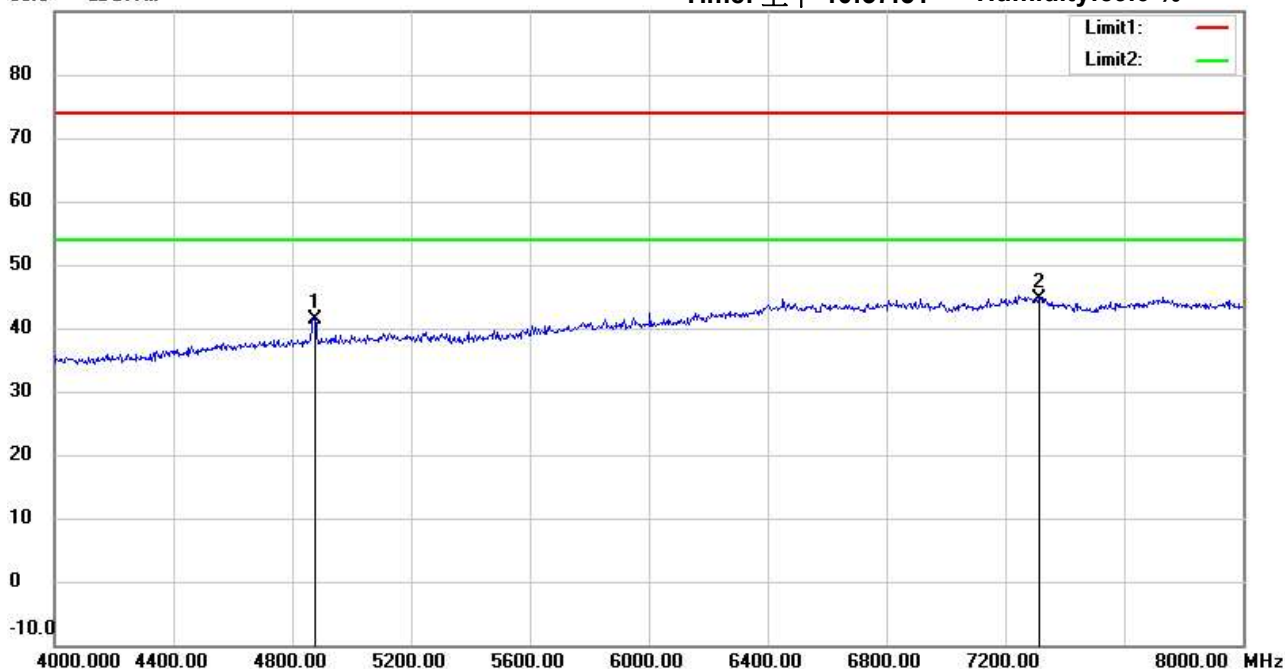
Test Mode : TX 802.11g CH6

Polarization: Vertical

| Mk. | Frequency (MHz) | Reading (dBuV) | Detector | Corr. factor (dB/m) | Result (dBuV/m) | Limit (dBuV/m) | Ant.Pos (cm) | Tab.Pos (deg.) | Margin (dB) | Comment |
|---|---|---|---|---|---|---|---|---|---|---|
| | 4876.000 | 36.22 | peak | 5.22 | 41.44 | 74.00 | 150 | 125 | -32.56 | |
| * | 7311.000 | 32.91 | peak | 11.70 | 44.61 | 74.00 | 150 | 130 | -29.39 | |

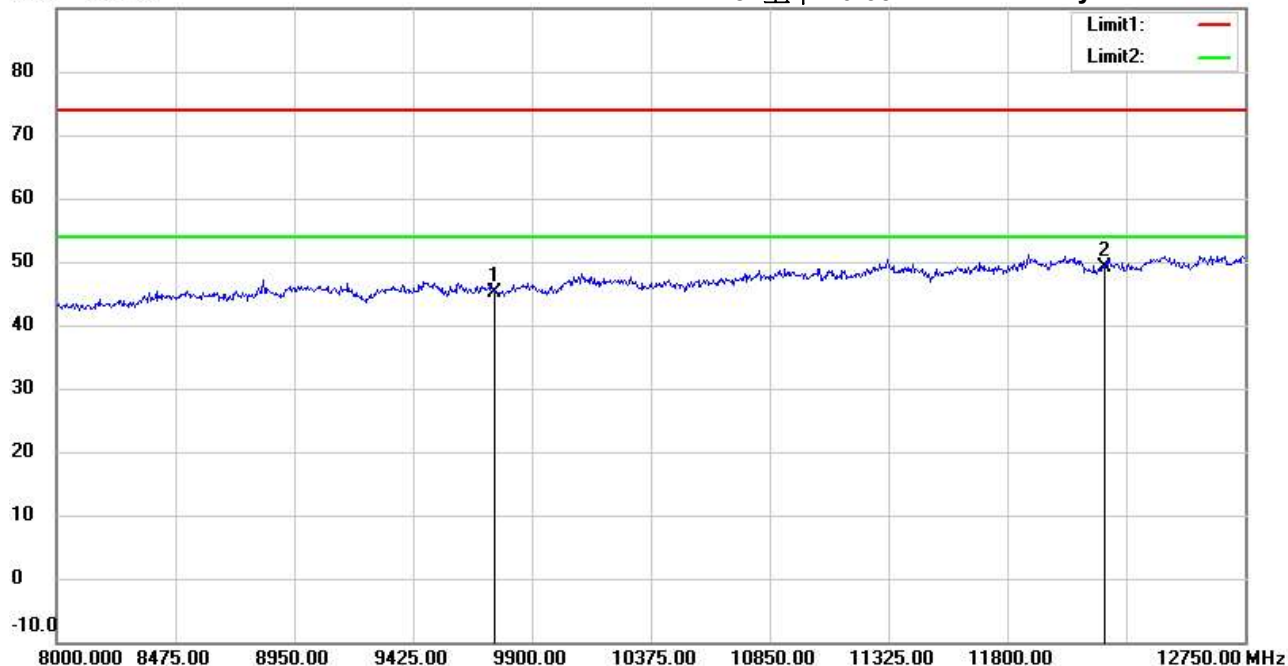
Test Mode : TX 802.11g CH6

Polarization: **Horizontal**

| Mk. | Frequency (MHz) | Reading (dBuV) | Detector | Corr. factor (dB/m) | Result (dBuV/m) | Limit (dBuV/m) | Ant.Pos (cm) | Tab.Pos (deg.) | Margin (dB) | Comment |
|---|---|---|---|---|---|---|---|---|---|---|
| | 9748.000 | 31.53 | peak | 13.70 | 45.23 | 74.00 | 150 | 21 | -28.77 | |
| * | 12185.000 | 32.22 | peak | 17.02 | 49.24 | 74.00 | 150 | 301 | -24.76 | |

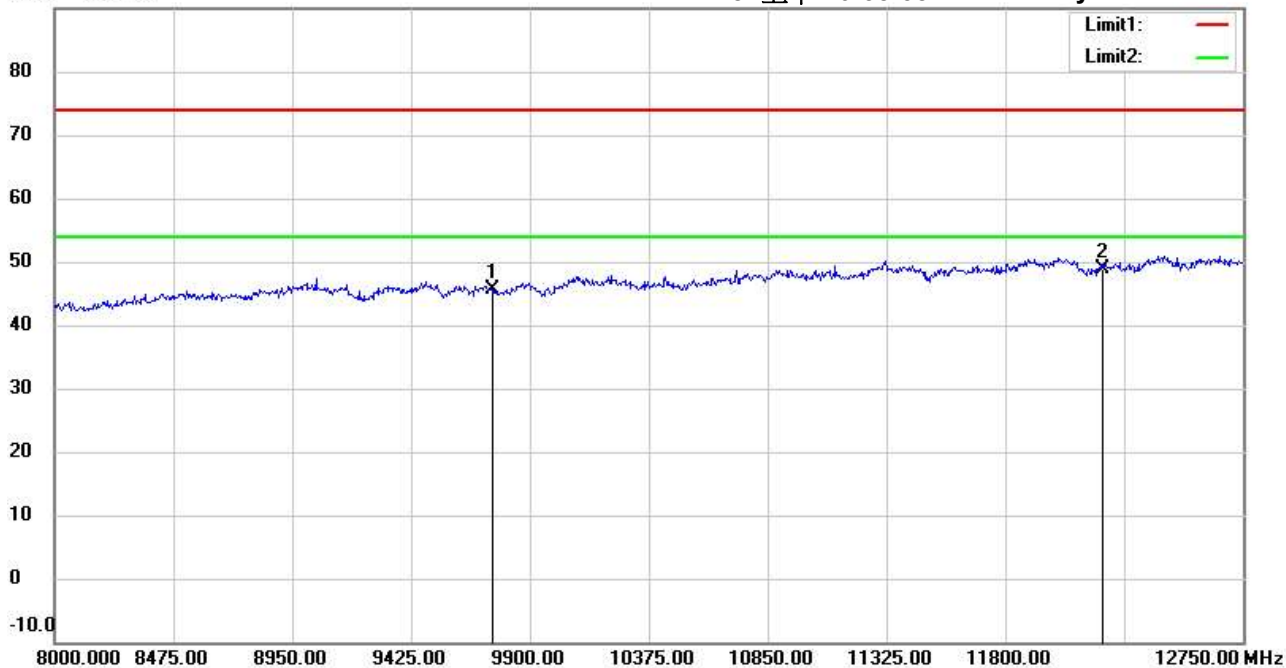
Test Mode : TX 802.11g CH6

Polarization: Vertical

| Mk. | Frequency (MHz) | Reading (dBuV) | Detector | Corr. factor (dB/m) | Result (dBuV/m) | Limit (dBuV/m) | Ant.Pos (cm) | Tab.Pos (deg.) | Margin (dB) | Comment |
|---|---|---|---|---|---|---|---|---|---|---|
| | 9748.000 | 32.02 | peak | 13.70 | 45.72 | 74.00 | 150 | 98 | -28.28 | |
| * | 12185.000 | 31.74 | peak | 17.02 | 48.76 | 74.00 | 150 | 81 | -25.24 | |

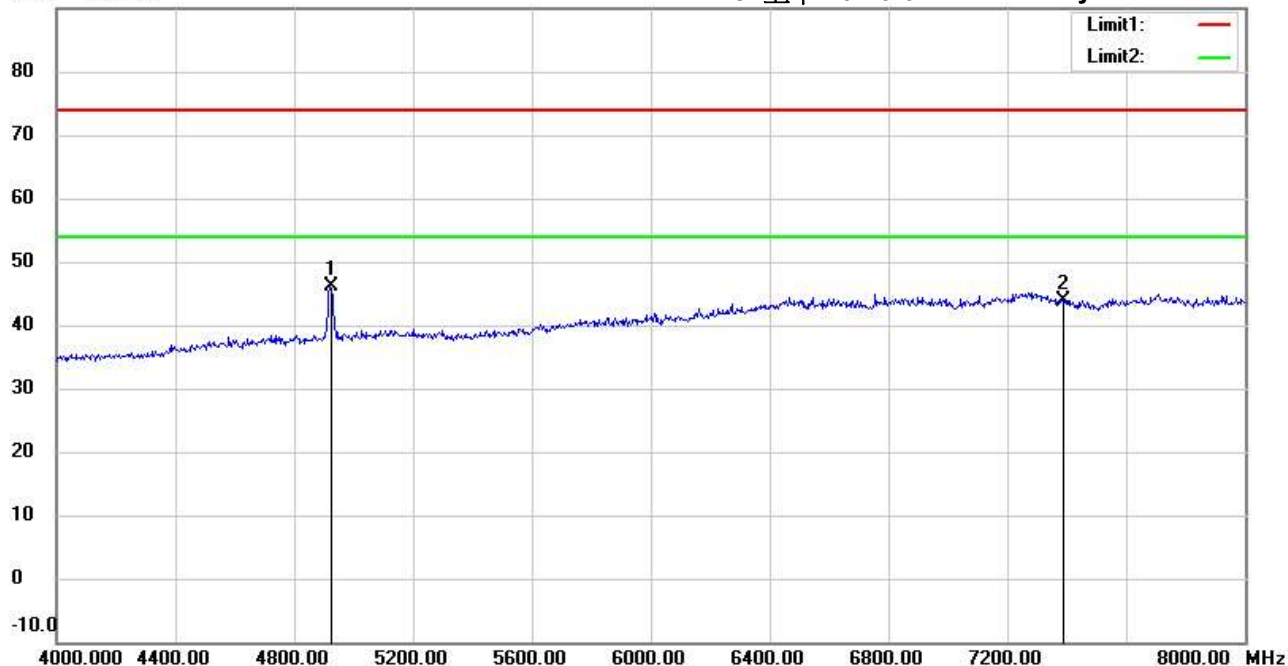
Test Mode : TX 802.11g CH11

Polarization: **Horizontal**

| Mk. | Frequency (MHz) | Reading (dBuV) | Detector | Corr. factor (dB/m) | Result (dBuV/m) | Limit (dBuV/m) | Ant.Pos (cm) | Tab.Pos (deg.) | Margin (dB) | Comment |
|---|---|---|---|---|---|---|---|---|---|---|
| * | 4922.000 | 40.80 | peak | 5.37 | 46.17 | 74.00 | 150 | 24 | -27.83 | |
| | 7386.000 | 32.53 | peak | 11.39 | 43.92 | 74.00 | 150 | 26 | -30.08 | |

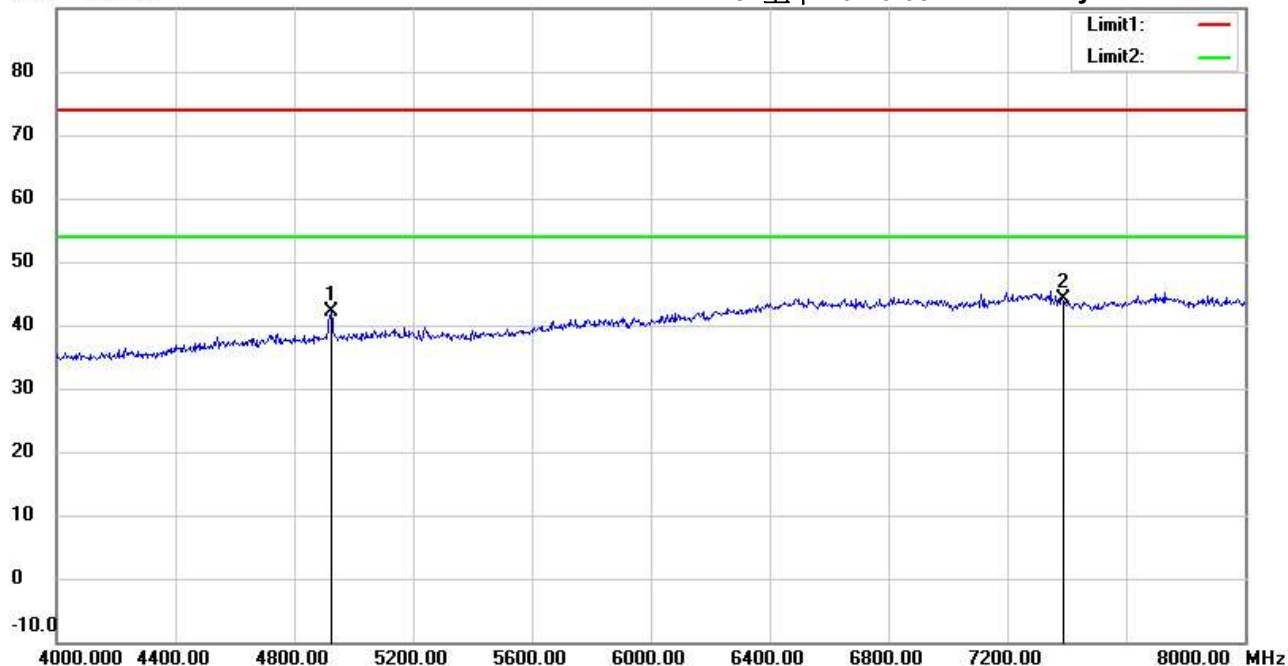
Test Mode : TX 802.11g CH11

Polarization: Vertical

| Mk. | Frequency (MHz) | Reading (dBuV) | Detector | Corr. factor (dB/m) | Result (dBuV/m) | Limit (dBuV/m) | Ant.Pos (cm) | Tab.Pos (deg.) | Margin (dB) | Comment |
|---|---|---|---|---|---|---|---|---|---|---|
| | 4924.000 | 36.69 | peak | 5.38 | 42.07 | 74.00 | 150 | 268 | -31.93 | |
| * | 7386.000 | 32.76 | peak | 11.39 | 44.15 | 74.00 | 150 | 216 | -29.85 | |

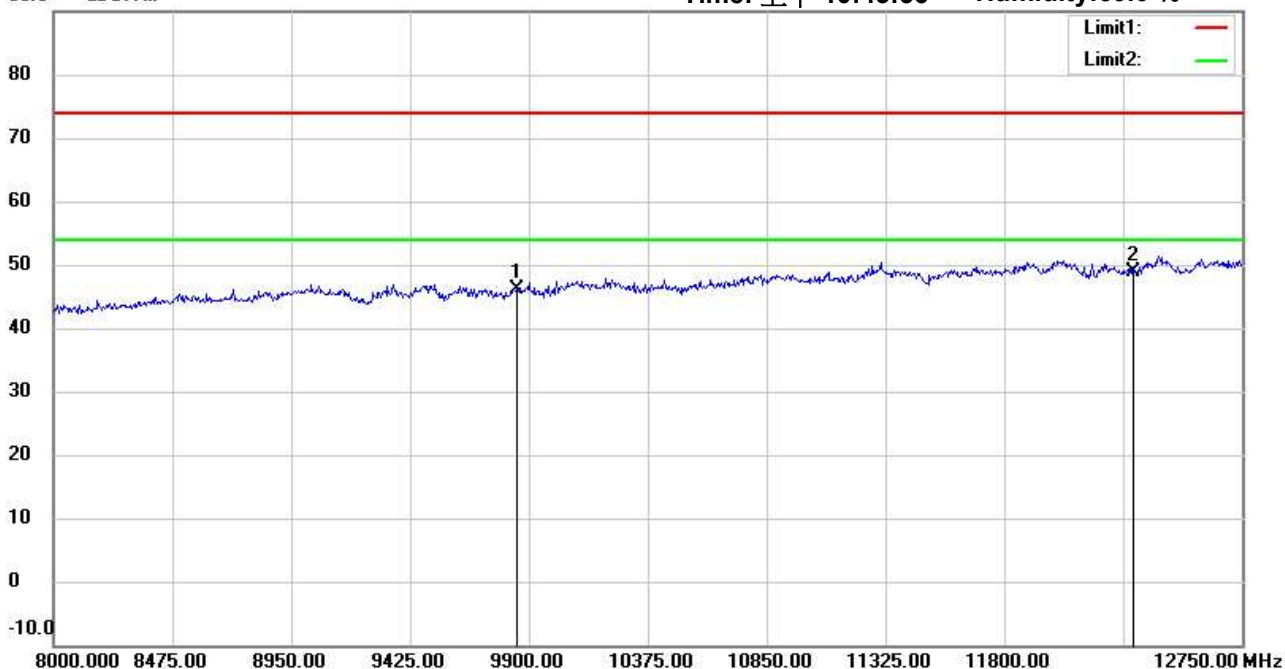
Test Mode : TX 802.11g CH11

Polarization: **Horizontal**

| Mk. | Frequency (MHz) | Reading (dBuV) | Detector | Corr. factor (dB/m) | Result (dBuV/m) | Limit (dBuV/m) | Ant.Pos (cm) | Tab.Pos (deg.) | Margin (dB) | Comment |
|---|---|---|---|---|---|---|---|---|---|---|
| | 9848.000 | 32.24 | peak | 13.97 | 46.21 | 74.00 | 150 | 254 | -27.79 | |
| * | 12310.000 | 32.28 | peak | 16.62 | 48.90 | 74.00 | 150 | 355 | -25.10 | |

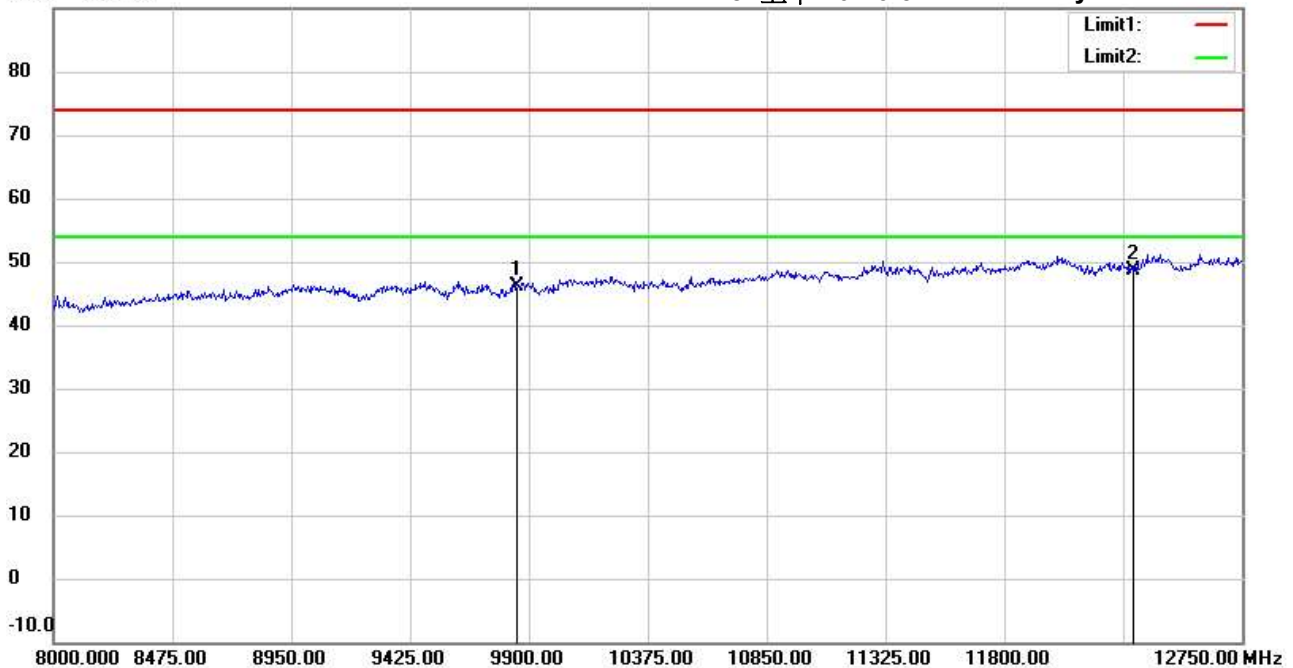
Test Mode : TX 802.11g CH11

Polarization: Vertical

| Mk. | Frequency (MHz) | Reading (dBuV) | Detector | Corr. factor (dB/m) | Result (dBuV/m) | Limit (dBuV/m) | Ant.Pos (cm) | Tab.Pos (deg.) | Margin (dB) | Comment |
|---|---|---|---|---|---|---|---|---|---|---|
| | 9848.000 | 32.22 | peak | 13.97 | 46.19 | 74.00 | 150 | 257 | -27.81 | |
| * | 12310.000 | 31.96 | peak | 16.62 | 48.58 | 74.00 | 150 | 51 | -25.42 | |

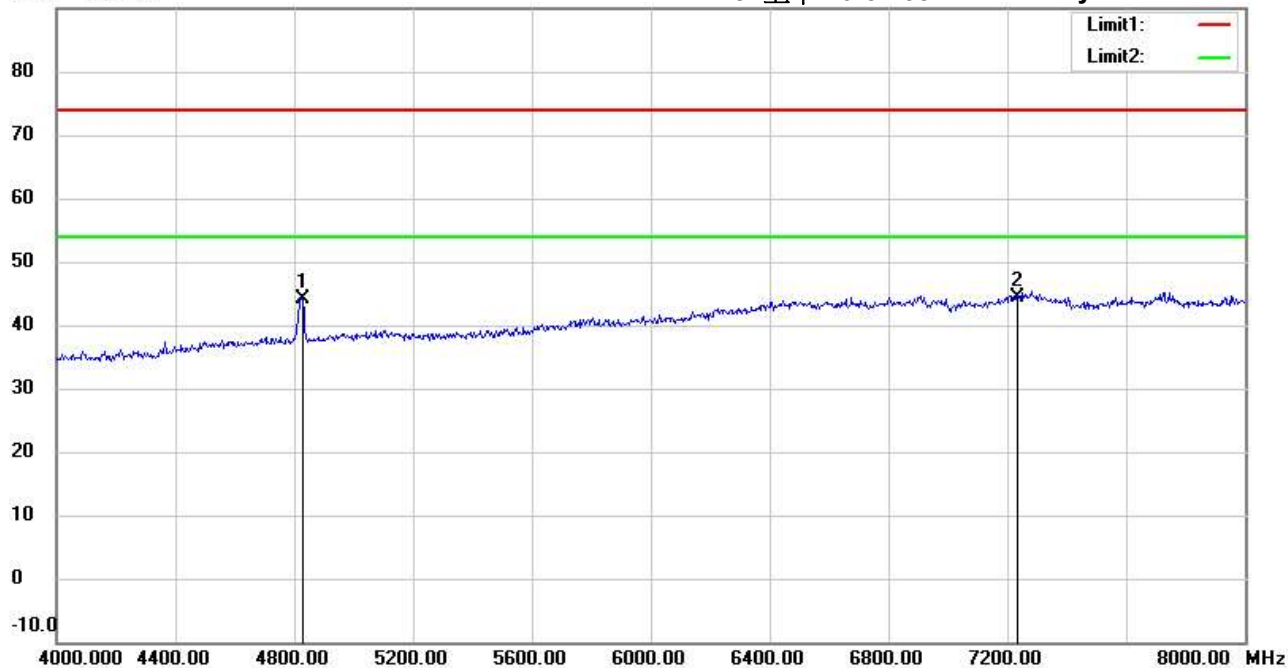
Test Mode : TX 802.11n20 CH1

Polarization: **Horizontal**

| Mk. | Frequency (MHz) | Reading (dBuV) | Detector | Corr. factor (dB/m) | Result (dBuV/m) | Limit (dBuV/m) | Ant.Pos (cm) | Tab.Pos (deg.) | Margin (dB) | Comment |
|---|---|---|---|---|---|---|---|---|---|---|
| | 4826.000 | 39.05 | peak | 5.09 | 44.14 | 74.00 | 150 | 30 | -29.86 | |
| * | 7236.000 | 32.84 | peak | 11.50 | 44.34 | 74.00 | 150 | 305 | -29.66 | |

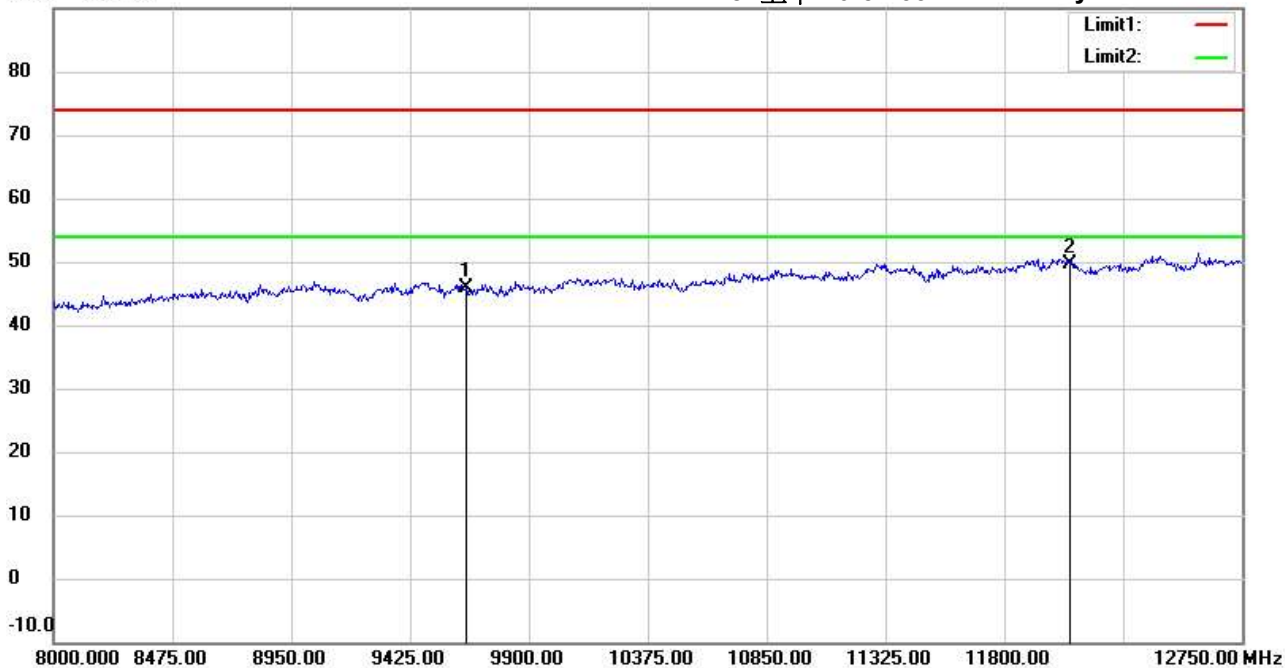
Test Mode : TX 802.11n20 CH1

Polarization: **Horizontal**

| Mk. | Frequency (MHz) | Reading (dBuV) | Detector | Corr. factor (dB/m) | Result (dBuV/m) | Limit (dBuV/m) | Ant.Pos (cm) | Tab.Pos (deg.) | Margin (dB) | Comment |
|---|---|---|---|---|---|---|---|---|---|---|
| | 9648.000 | 32.47 | peak | 13.44 | 45.91 | 74.00 | 150 | 32 | -28.09 | |
| * | 12060.000 | 32.65 | peak | 17.10 | 49.75 | 74.00 | 150 | 11 | -24.25 | |
