# Radiated Emission Measurement

Condition : FCC\_part 15 RE-Class C\_Above 1GHz\_PK

EUT : W6M22311-23090

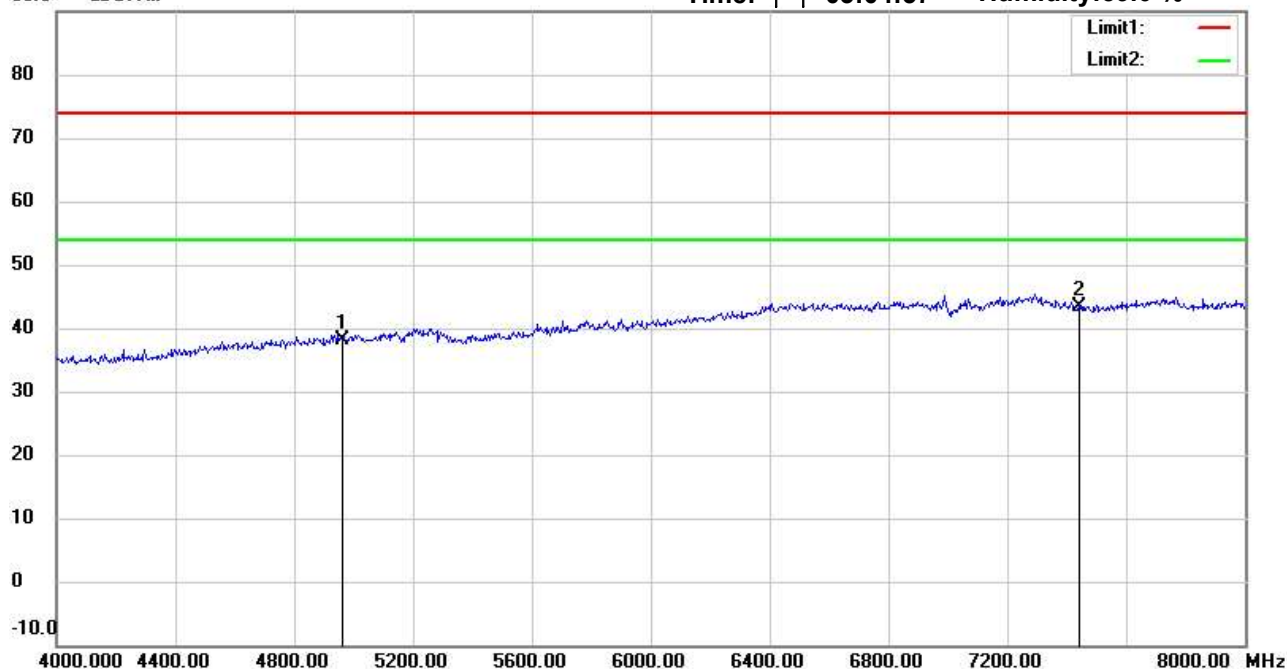
Data : #7

Test Mode : TX 2480MHz

Polarization: Vertical

| Mk. | Frequency (MHz) | Reading (dBuV) | Detector | Corr. factor (dB/m) | Result (dBuV/m) | Limit (dBuV/m) | Ant.Pos (cm) | Tab.Pos (deg.) | Margin (dB) | Comment |
|---|---|---|---|---|---|---|---|---|---|---|
| | 4960.000 | 32.53 | peak | 5.53 | 38.06 | 74.00 | 150 | 14 | -35.94 | |
| * | 7440.000 | 31.93 | peak | 11.41 | 43.34 | 74.00 | 150 | 323 | -30.66 | |

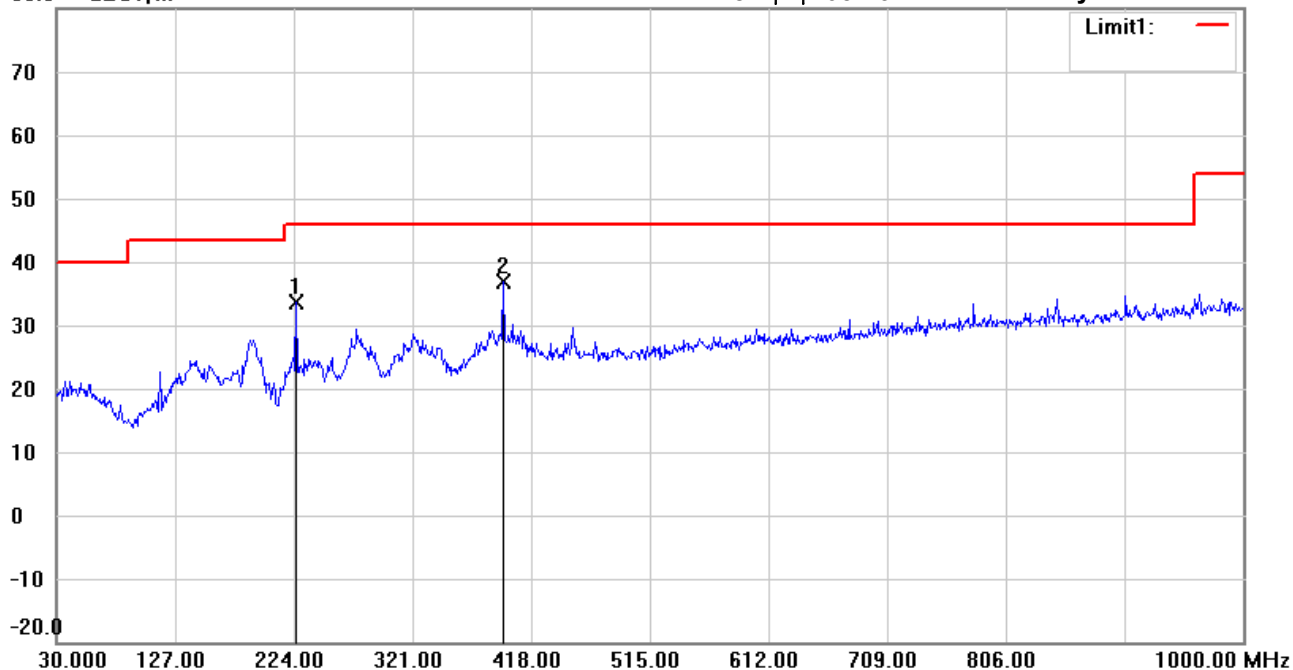
File : 1\_BLE(1M)\_TX 2402MHz Data : #1

Condition : FCC\_part 15 RE-Class C\_30-1000MHz

Polarization: *Horizontal*

Test Mode : TX 2402MHz

| Mk. | Frequency (MHz) | Reading (dBuV) | Detector | Corr. factor (dB/m) | Result (dBuV/m) | Limit (dBuV/m) | Ant.Pos (cm) | Tab.Pos (deg.) | Margin (dB) | Comment |
|---|---|---|---|---|---|---|---|---|---|---|
| | 225.9400 | 47.68 | peak | -14.13 | 33.55 | 46.00 | 100 | 358 | -12.45 | |
| * | 395.2050 | 45.64 | peak | -8.85 | 36.79 | 46.00 | 100 | 337 | -9.21 | |

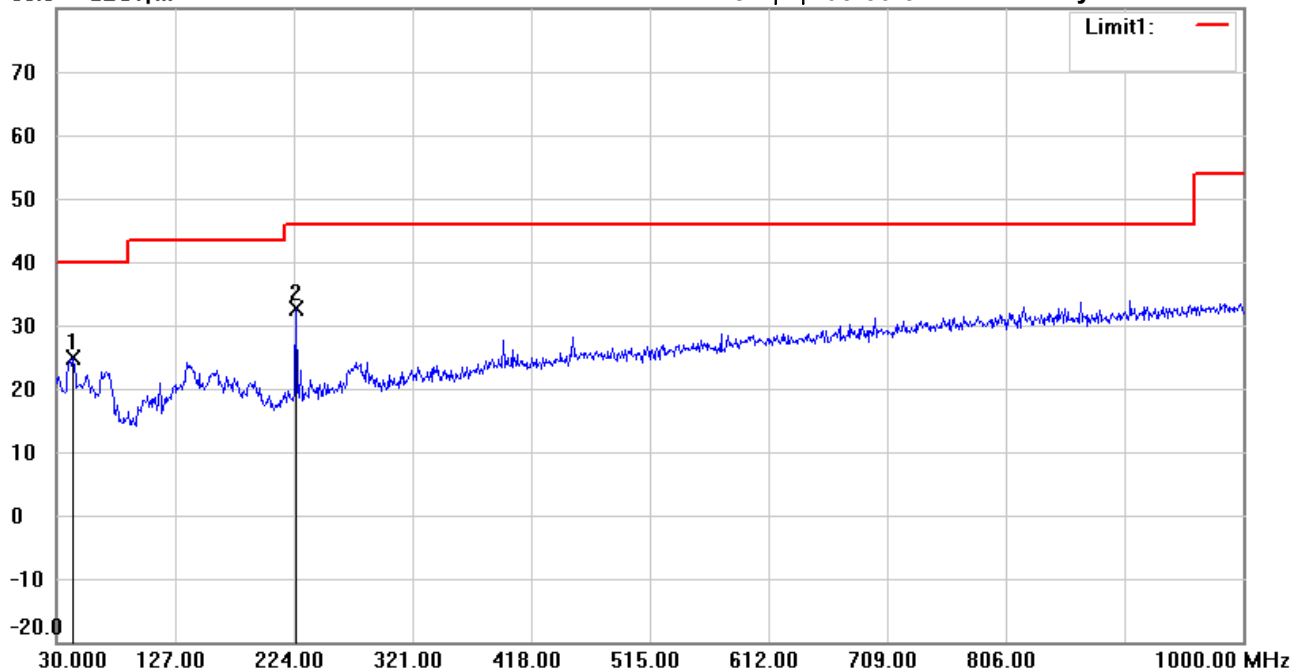
File : 1\_BLE(1M)\_TX 2402MHz Data : #2

Condition : FCC\_part 15 RE-Class C\_30-1000MHz

Test Mode : TX 2402MHz

Polarization: Vertical

| Mk. | Frequency (MHz) | Reading (dBuV) | Detector | Corr. factor (dB/m) | Result (dBuV/m) | Limit (dBuV/m) | Ant.Pos (cm) | Tab.Pos (deg.) | Margin (dB) | Comment |
|---|---|---|---|---|---|---|---|---|---|---|
| | 43.5800 | 37.26 | peak | -12.44 | 24.82 | 40.00 | 100 | 339 | -15.18 | |
| * | 225.9400 | 46.85 | peak | -14.13 | 32.72 | 46.00 | 100 | 37 | -13.28 | |

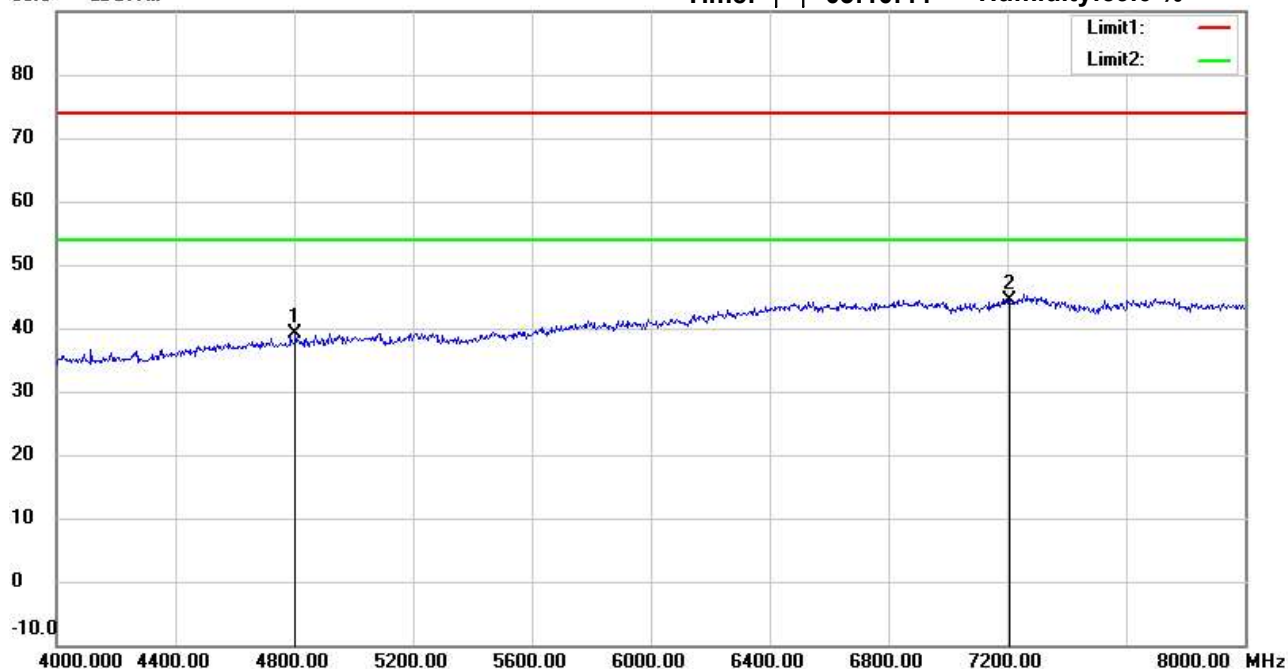
Data :#2

Condition : FCC\_part 15 RE-Class C\_Above 1GHz\_PK

Test Mode : TX 2402MHz

Polarization: **Horizontal**

| Mk. | Frequency (MHz) | Reading (dBuV) | Detector | Corr. factor (dB/m) | Result (dBuV/m) | Limit (dBuV/m) | Ant.Pos (cm) | Tab.Pos (deg.) | Margin (dB) | Comment |
|---|---|---|---|---|---|---|---|---|---|---|
| | 4804.000 | 34.02 | peak | 5.03 | 39.05 | 74.00 | 150 | 36 | -34.95 | |
| * | 7206.000 | 32.90 | peak | 11.38 | 44.28 | 74.00 | 150 | 210 | -29.72 | |

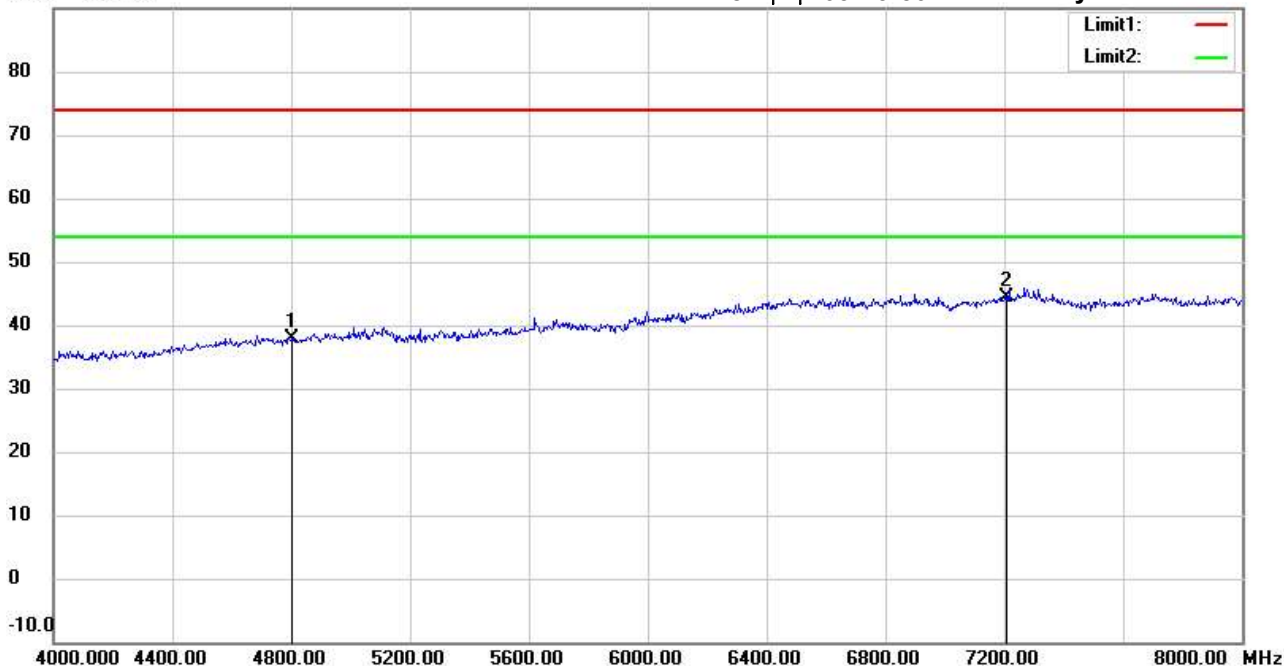
Data :#7

Condition : FCC\_part 15 RE-Class C\_Above 1GHz\_PK

Test Mode : TX 2402MHz

Polarization: Vertical

| Mk. | Frequency (MHz) | Reading (dBuV) | Detector | Corr. factor (dB/m) | Result (dBuV/m) | Limit (dBuV/m) | Ant.Pos (cm) | Tab.Pos (deg.) | Margin (dB) | Comment |
|---|---|---|---|---|---|---|---|---|---|---|
| | 4804.000 | 32.82 | peak | 5.03 | 37.85 | 74.00 | 150 | 10 | -36.15 | |
| * | 7206.000 | 33.07 | peak | 11.38 | 44.45 | 74.00 | 150 | 119 | -29.55 | |

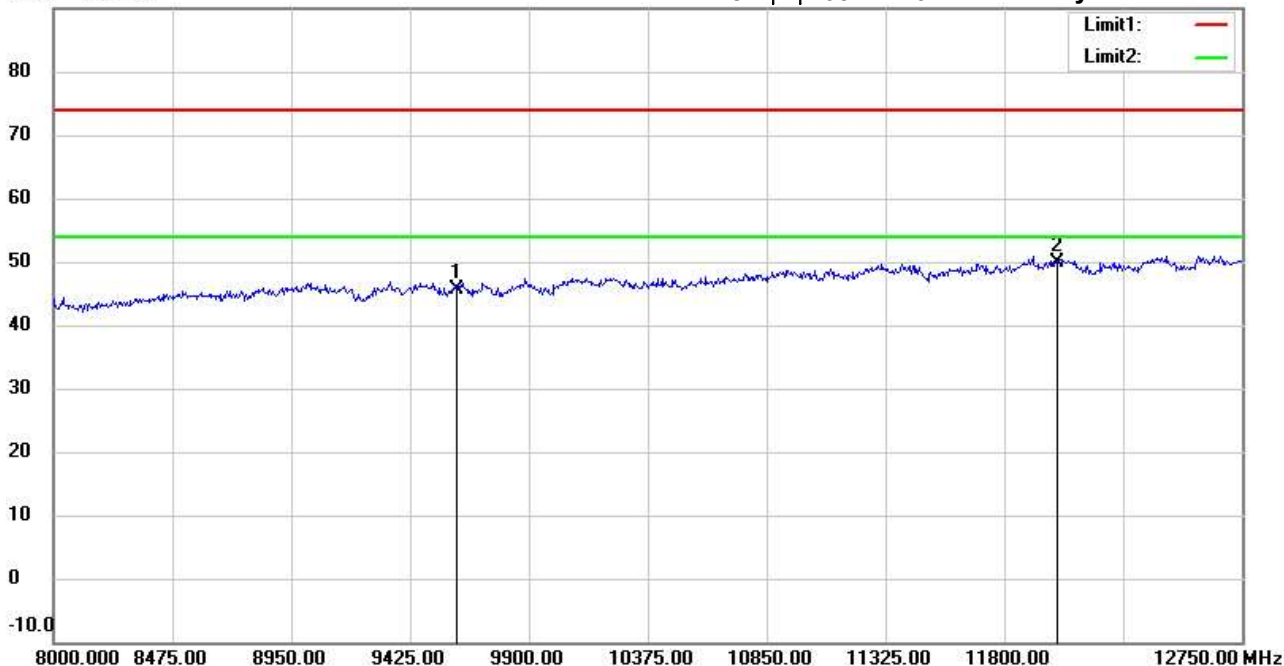
Data : #3

Condition : FCC\_part 15 RE-Class C\_Above 1GHz\_PK

Test Mode : TX 2402MHz

Polarization: **Horizontal**

| Mk. | Frequency (MHz) | Reading (dBuV) | Detector | Corr. factor (dB/m) | Result (dBuV/m) | Limit (dBuV/m) | Ant.Pos (cm) | Tab.Pos (deg.) | Margin (dB) | Comment |
|---|---|---|---|---|---|---|---|---|---|---|
| | 9608.000 | 32.12 | peak | 13.39 | 45.51 | 74.00 | 150 | 284 | -28.49 | |
| * | 12010.000 | 32.51 | peak | 17.28 | 49.79 | 74.00 | 150 | 5 | -24.21 | |

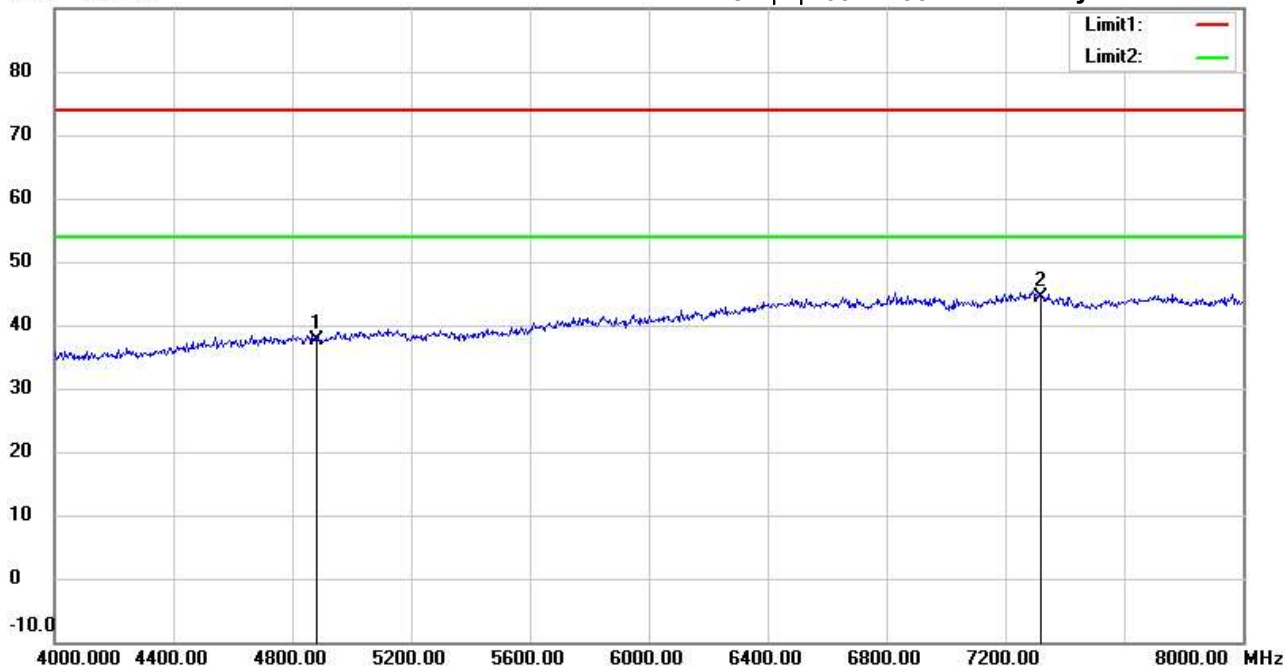
Data :#7

Condition : FCC\_part 15 RE-Class C\_Above 1GHz\_PK

Test Mode : TX 2440MHz

Polarization: **Vertical**

| Mk. | Frequency (MHz) | Reading (dBuV) | Detector | Corr. factor (dB/m) | Result (dBuV/m) | Limit (dBuV/m) | Ant.Pos (cm) | Tab.Pos (deg.) | Margin (dB) | Comment |
|---|---|---|---|---|---|---|---|---|---|---|
| | 4880.000 | 32.50 | peak | 5.23 | 37.73 | 74.00 | 150 | 158 | -36.27 | |
| * | 7320.000 | 32.74 | peak | 11.67 | 44.41 | 74.00 | 150 | 243 | -29.59 | |

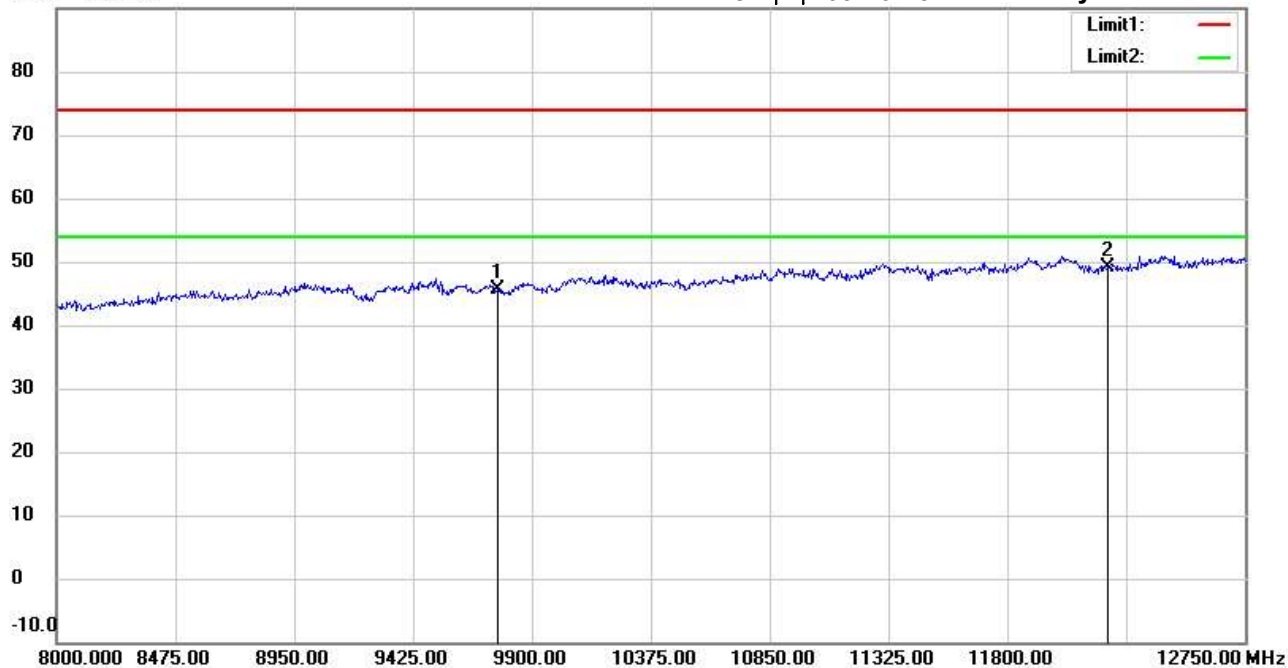
Data : #3

Condition : FCC\_part 15 RE-Class C\_Above 1GHz\_PK

Test Mode : TX 2440MHz

Polarization: **Horizontal**

| Mk. | Frequency (MHz) | Reading (dBuV) | Detector | Corr. factor (dB/m) | Result (dBuV/m) | Limit (dBuV/m) | Ant.Pos (cm) | Tab.Pos (deg.) | Margin (dB) | Comment |
|---|---|---|---|---|---|---|---|---|---|---|
| | 9760.000 | 31.85 | peak | 13.75 | 45.60 | 74.00 | 150 | 211 | -28.40 | |
| * | 12200.000 | 32.14 | peak | 17.03 | 49.17 | 74.00 | 150 | 315 | -24.83 | |
