## **RADIO TEST REPORT**

**Product** : **Payment Terminal**

**Model Name** : **M020**

**Test Regulation** : **FCC 47 CFR Part 15 Subpart C (Section 15.225)**

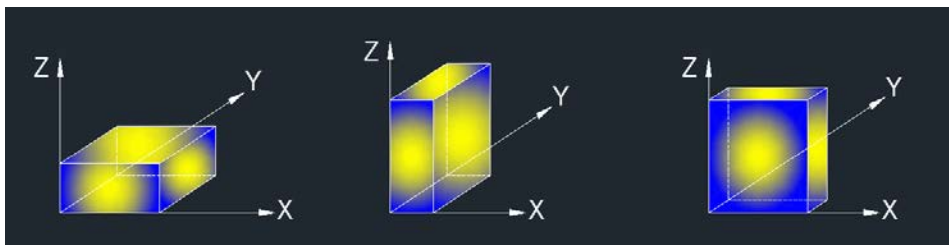
X axis, Y axis, Z axis positions:

The fundamental of the EUT was investigated in three orthogonal axes X/Y/Z, it was determined that Z axis were worst-case . Therefore, all final radiated testing was performed with the EUT in Z axis.

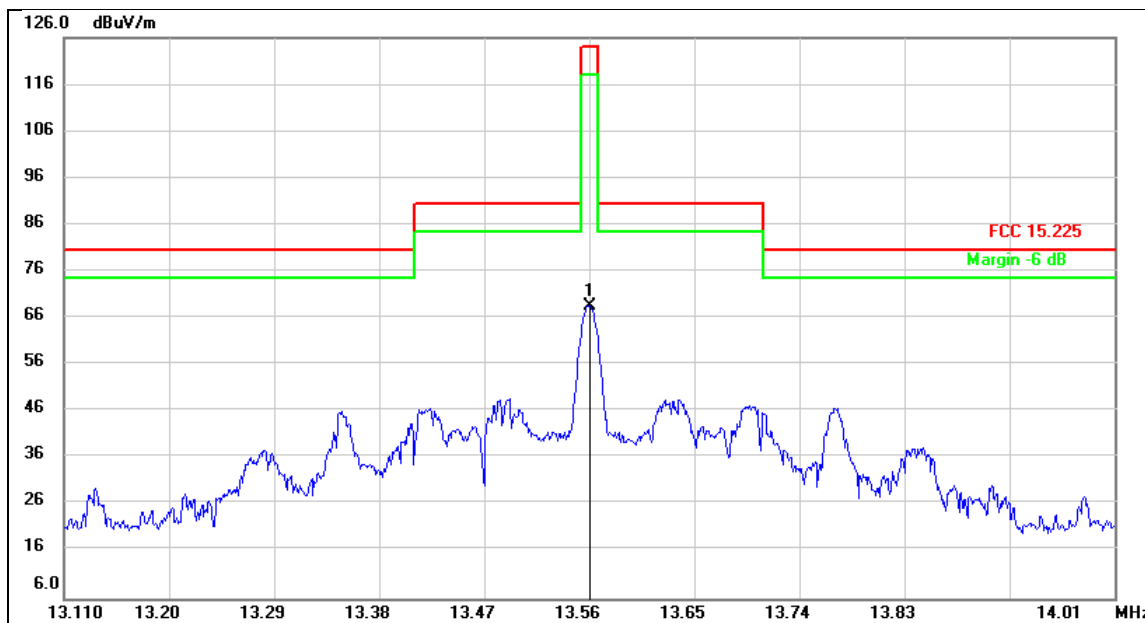
### Spectrum Mask 0 Degree

| No. | Frequency<br>(MHz) | Reading<br>(dBuV/m) | Correct<br>dB/m | Result<br>(dBuV/m) | Limit<br>(dBuV/m) | Margin<br>(dB) | Remark |
| 1 | 13.5601 | 57.18 | 11.45 | 68.63 | 124.00 | -55.37 | peak |

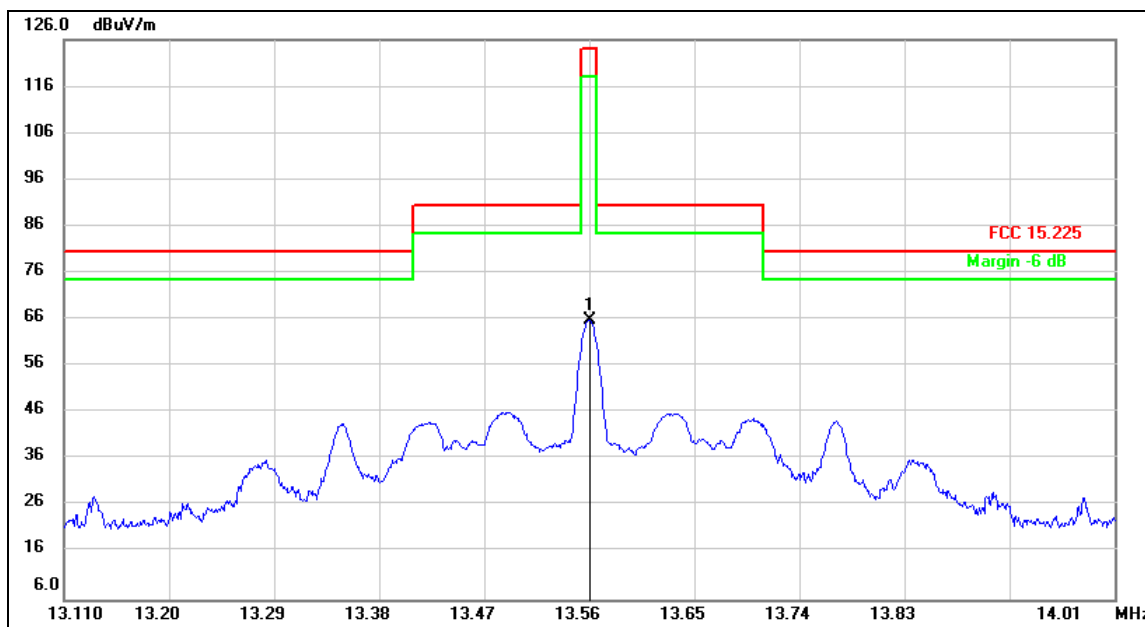
### Spectrum Mask 90 Degree

| No. | Frequency<br>(MHz) | Reading<br>(dBuV/m) | Correct<br>dB/m | Result<br>(dBuV/m) | Limit<br>(dBuV/m) | Margin<br>(dB) | Remark |
| 1 | 13.5601 | 54.35 | 11.45 | 65.80 | 124.00 | -58.20 | peak |

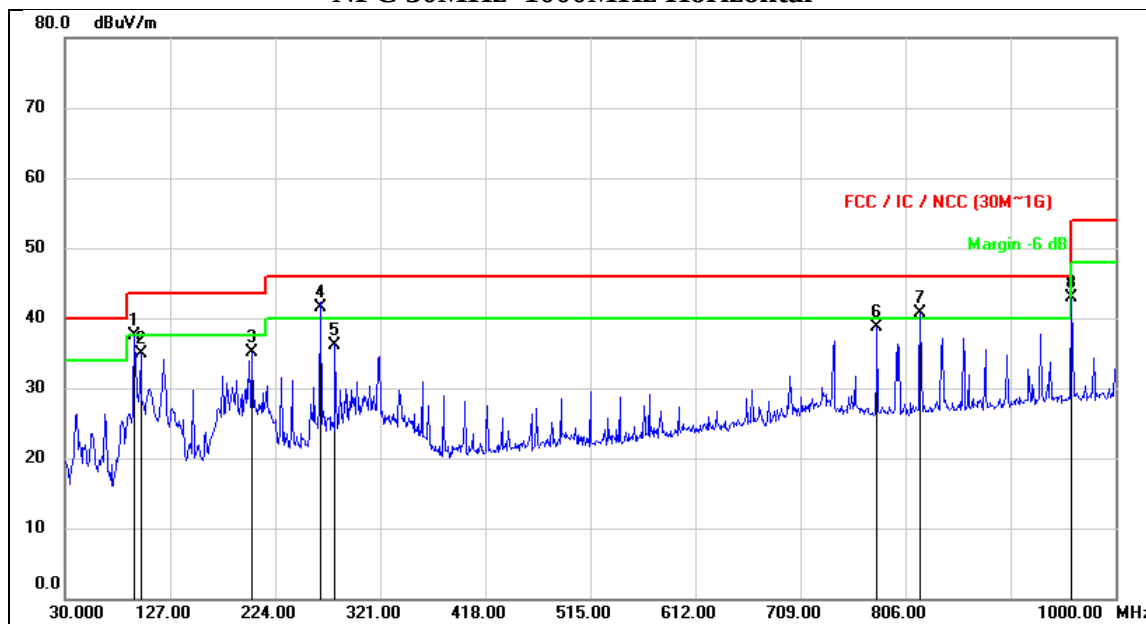
### NFC 30MHz~1000MHz Horizontal

| No. | Frequency<br>(MHz) | Reading<br>(dBuV/m) | Correct<br>dB/m | Result<br>(dBuV/m) | Limit<br>(dBuV/m) | Margin<br>(dB) | Remark |
| 1 | 94.8930 | 58.60 | -21.09 | 37.51 | 43.50 | -5.99 | peak |

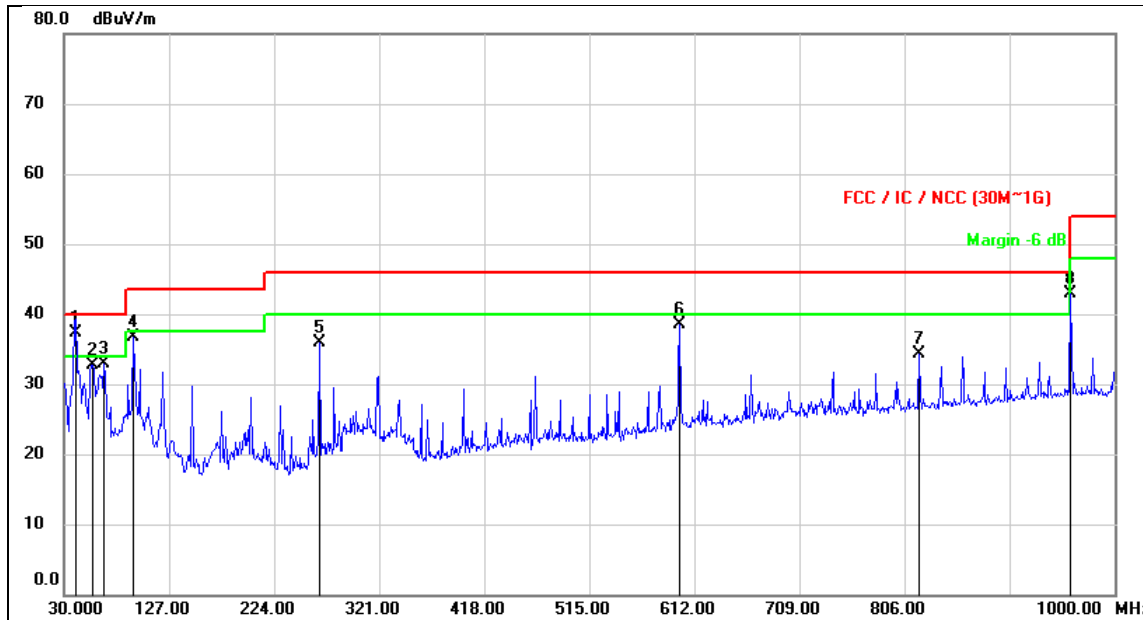
### NFC 30MHz~1000MHz Vertical

| No. | Frequency (MHz) | Reading (dBuV/m) | Correct dB/m | Result (dBuV/m) | Limit (dBuV/m) | Margin (dB) | Remark |
| 1 | 40.6699 | 52.95 | -15.72 | 37.23 | 40.00 | -2.77 | QP |

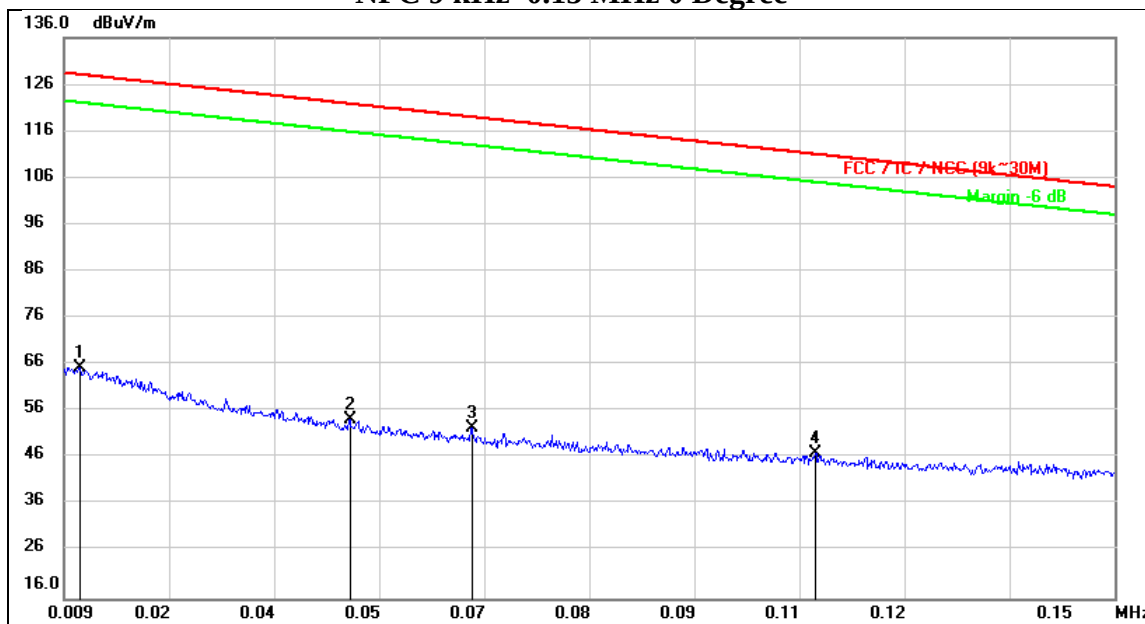
### NFC 9 kHz~0.15 MHz 0 Degree

| No. | Frequency<br>(KHz) | Reading<br>(dBuV/m) | Correct<br>dB/m | Result<br>(dBuV/m) | Limit<br>(dBuV/m) | Margin<br>(dB) | Remark |
| 1 | 0.0111 | 46.14 | 19.32 | 65.46 | 128.12 | -62.66 | peak |

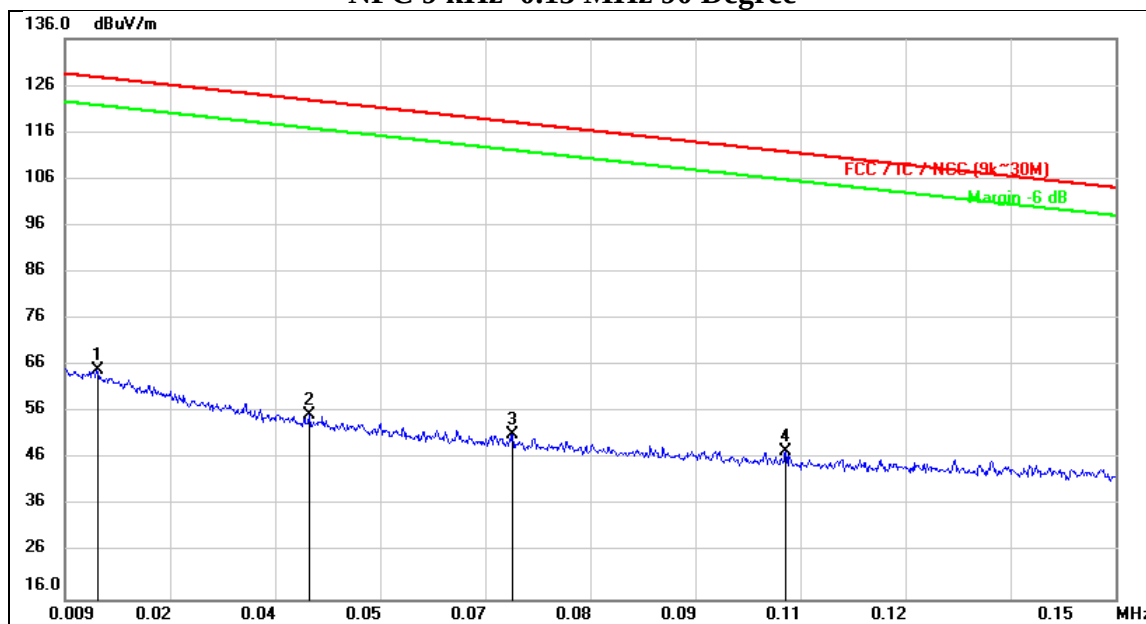
### NFC 9 kHz~0.15 MHz 90 Degree

| No. | Frequency<br>(KHz) | Reading<br>(dBuV/m) | Correct<br>dB/m | Result<br>(dBuV/m) | Limit<br>(dBuV/m) | Margin<br>(dB) | Remark |
| 1 | 0.0134 | 46.42 | 18.70 | 65.12 | 127.74 | -62.62 | peak |

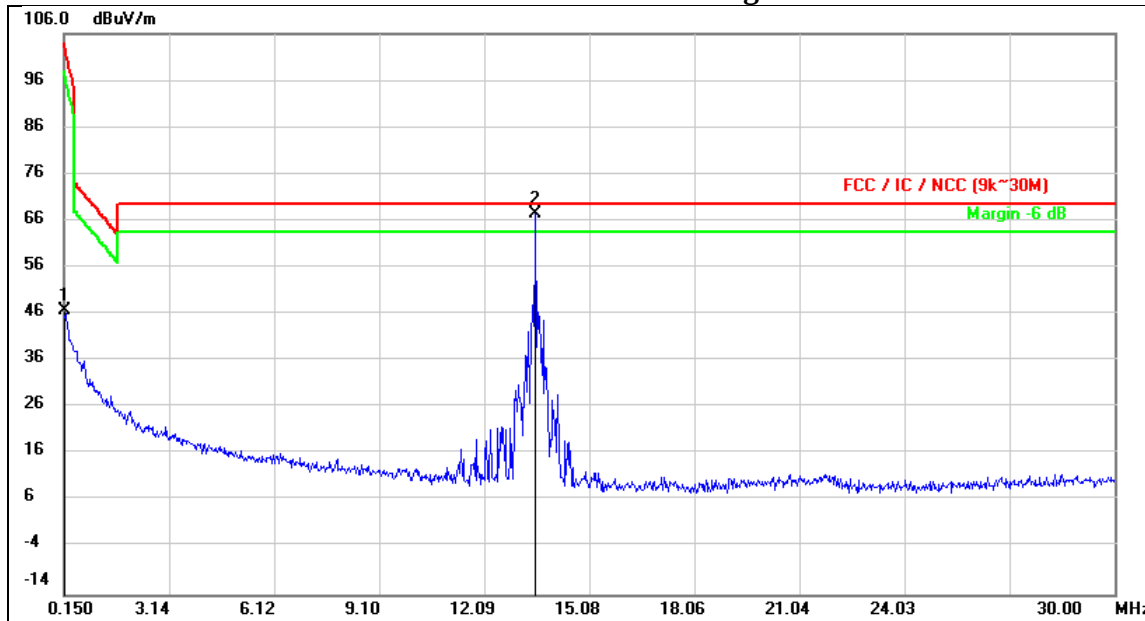
### NFC 0.15 MHz~30 MHz 0 Degree

| No. | Frequency<br>(MHz) | Reading<br>(dBuV/m) | Correct<br>dB/m | Result<br>(dBuV/m) | Limit<br>(dBuV/m) | Margin<br>(dB) | Remark |
| 1 | 0.1688 | 34.98 | 11.80 | 46.78 | 103.53 | -56.75 | peak |

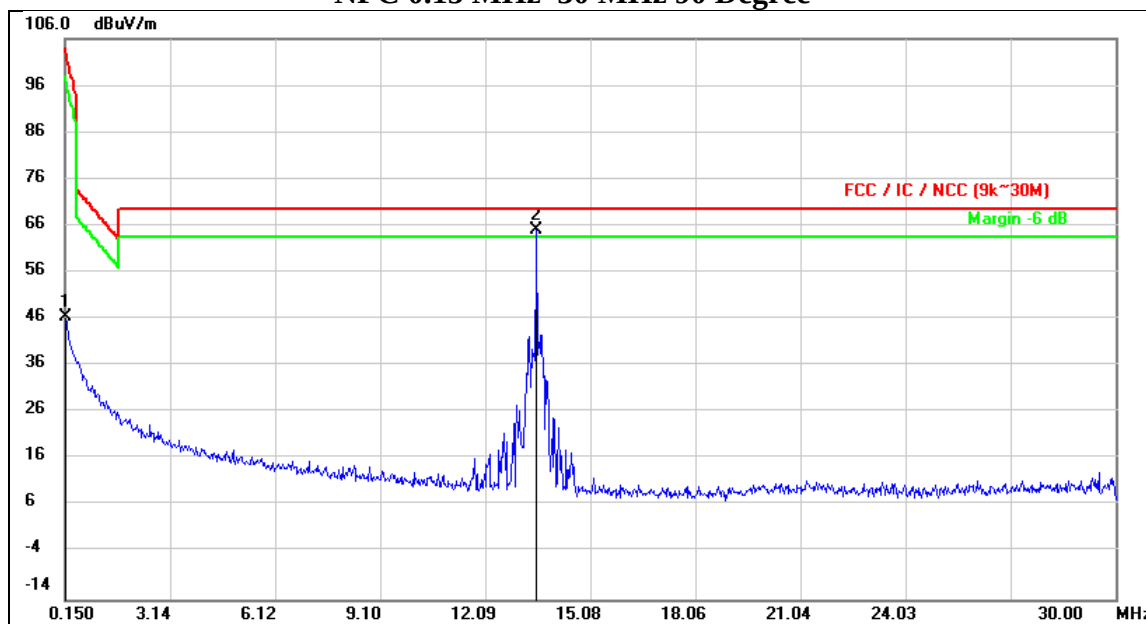
### NFC 0.15 MHz~30 MHz 90 Degree

| No. | Frequency<br>(MHz) | Reading<br>(dBuV/m) | Correct<br>dB/m | Result<br>(dBuV/m) | Limit<br>(dBuV/m) | Margin<br>(dB) | Remark |
| 1 | 0.1508 | 34.74 | 11.81 | 46.55 | 104.08 | -57.53 | peak |

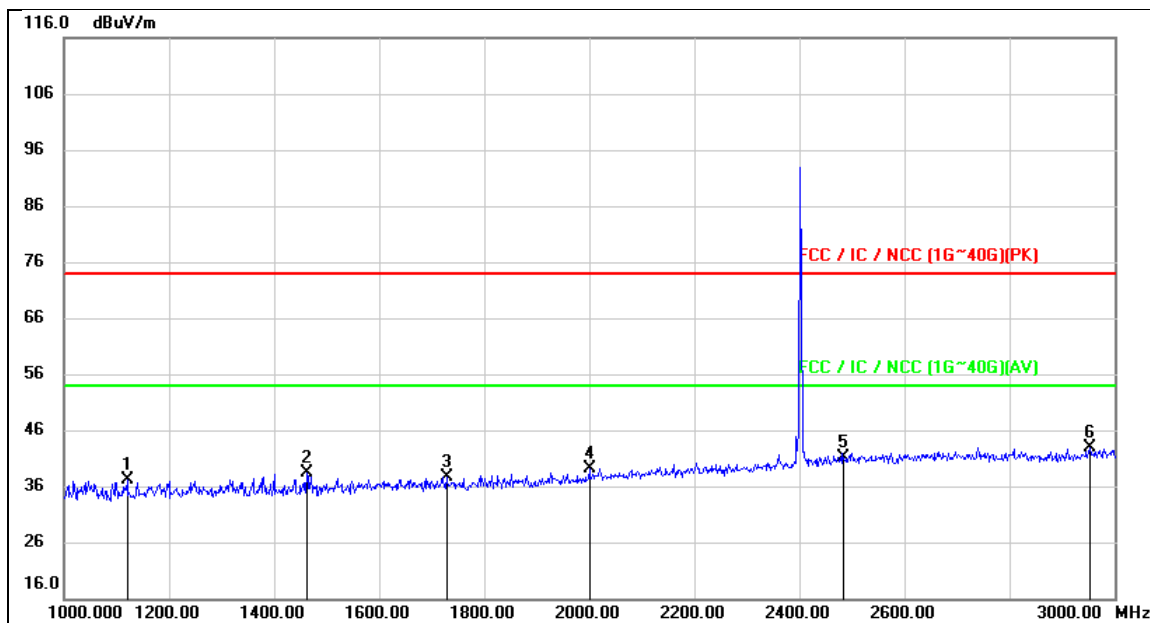
### Spurious Emission 1-3GHz Horizontal

| No. | Frequency<br>(MHz) | Reading<br>(dBuV/m) | Correct<br>dB/m | Result<br>(dBuV/m) | Limit<br>(dBuV/m) | Margin<br>(dB) | Remark |
| 1 | 1120.467 | 49.75 | -12.72 | 37.03 | 74.00 | -36.97 | peak |

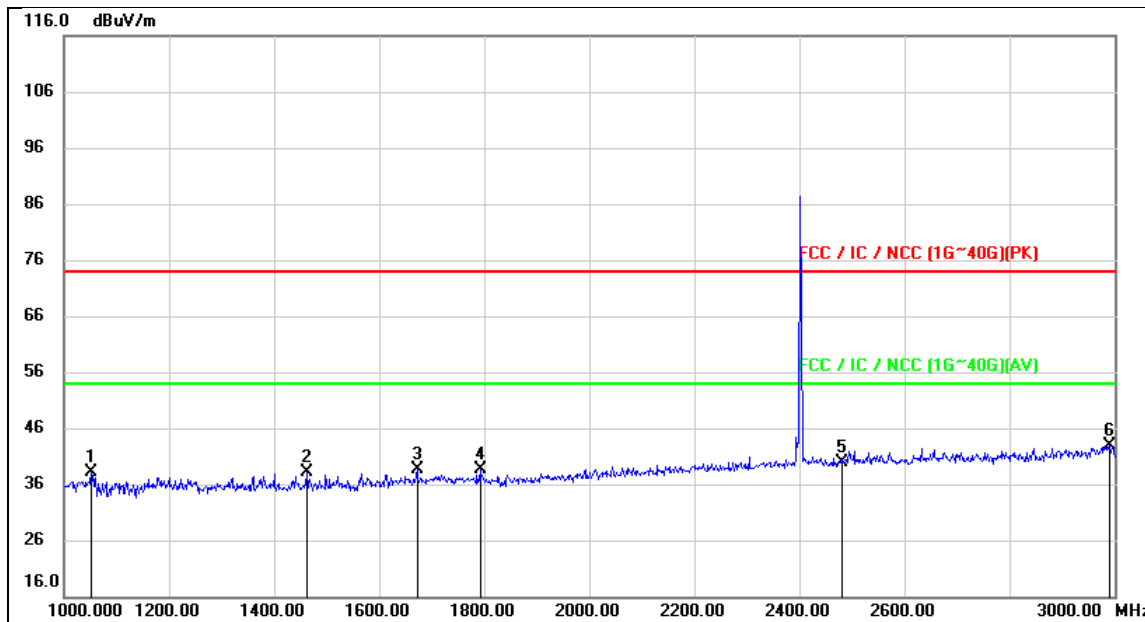
### Spurious Emission 1-3GHz Vertical

| No. | Frequency<br>(MHz) | Reading<br>(dBuV/m) | Correct<br>dB/m | Result<br>(dBuV/m) | Limit<br>(dBuV/m) | Margin<br>(dB) | Remark |
| 1 | 1053.600 | 51.20 | -12.97 | 38.23 | 74.00 | -35.77 | peak |

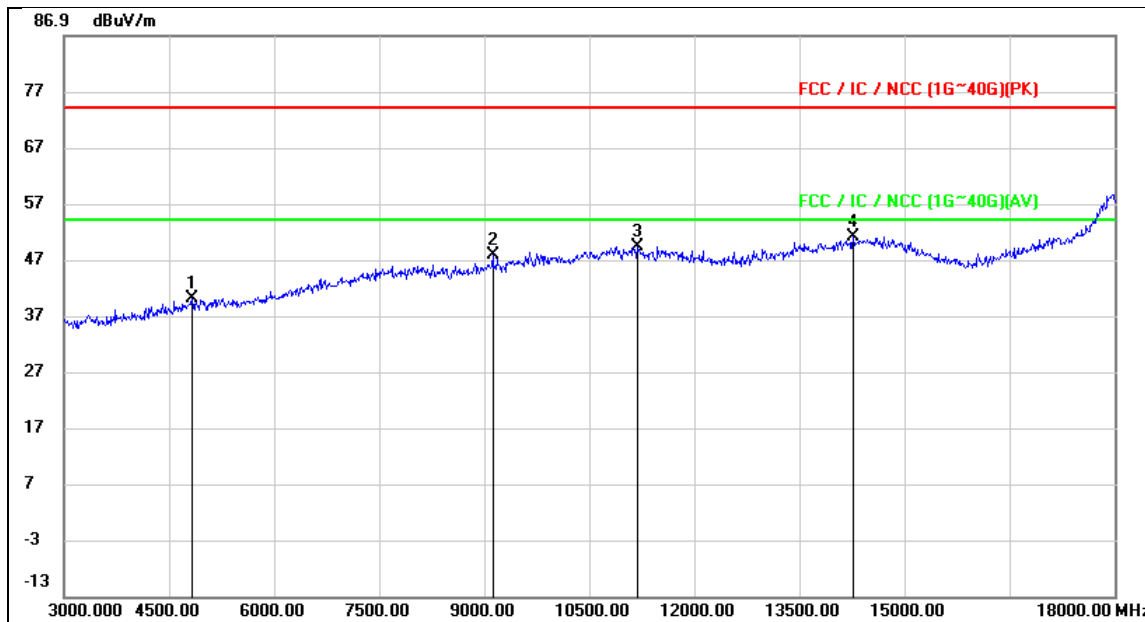
### Spurious Emission 3-18GHz Horizontal

| No. | Frequency<br>(MHz) | Reading<br>(dBuV/m) | Correct<br>dB/m | Result<br>(dBuV/m) | Limit<br>(dBuV/m) | Margin<br>(dB) | Remark |
| 1 | 4833.500 | 43.42 | -3.47 | 39.95 | 74.00 | -34.05 | peak |

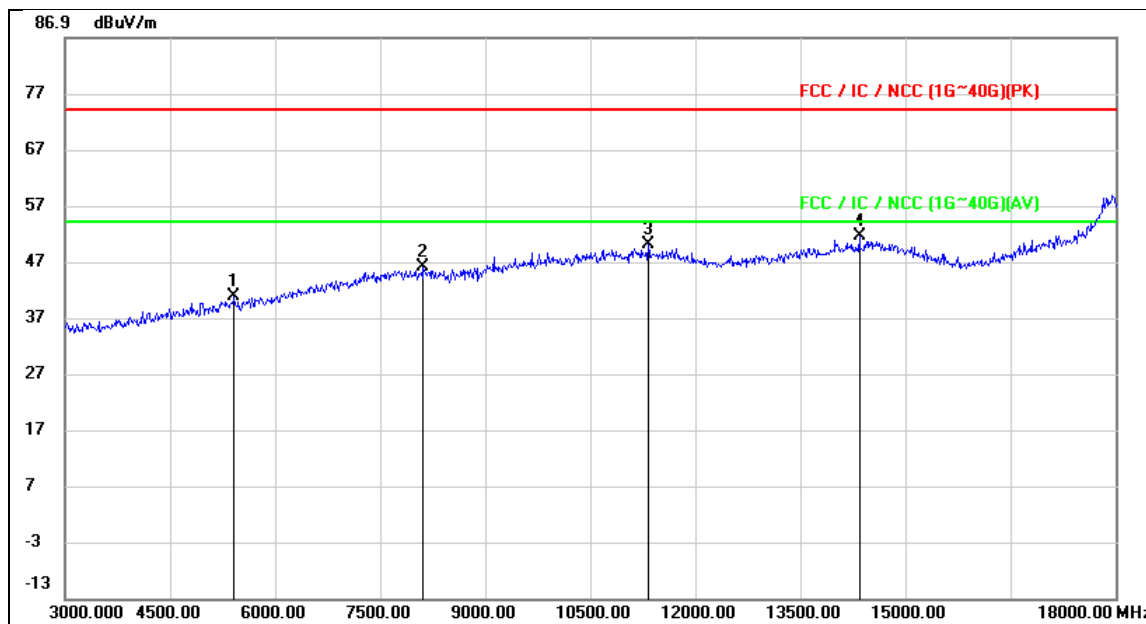
### Spurious Emission 3-18GHz Vertical

| No. | Frequency<br>(MHz) | Reading<br>(dBuV/m) | Correct<br>dB/m | Result<br>(dBuV/m) | Limit<br>(dBuV/m) | Margin<br>(dB) | Remark |
| 1 | 5422.000 | 43.45 | -2.76 | 40.69 | 74.00 | -33.31 | peak |

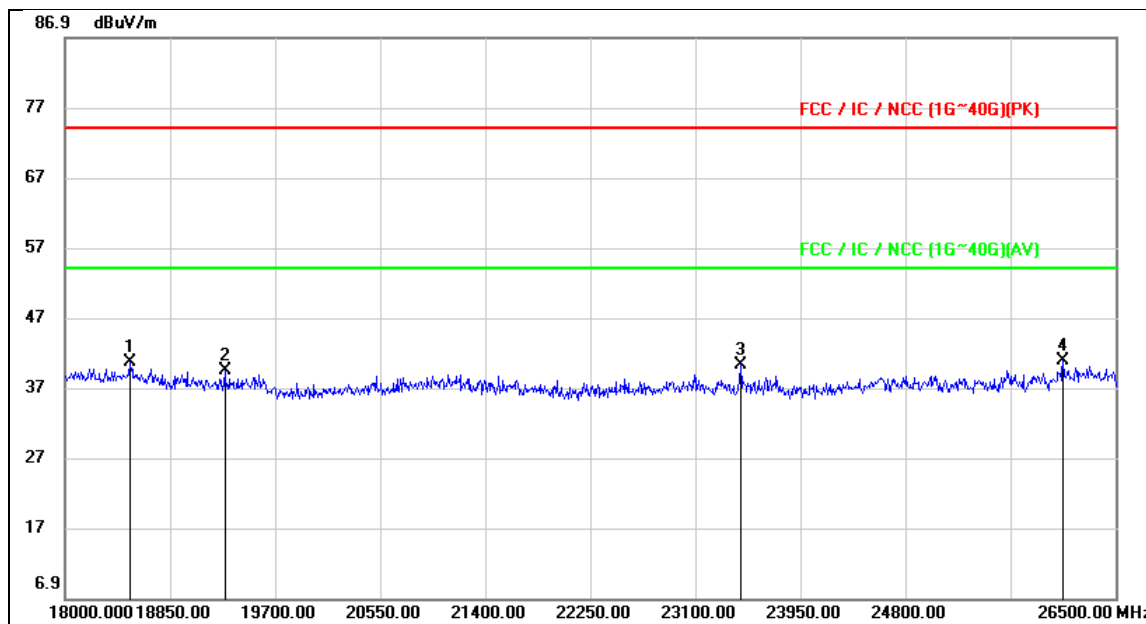
### Spurious Emission 18-25GHz Horizontal

| No. | Frequency<br>(MHz) | Reading<br>(dBuV/m) | Correct<br>dB/m | Result<br>(dBuV/m) | Limit<br>(dBuV/m) | Margin<br>(dB) | Remark |
| 1 | 18534.650 | 42.98 | -2.45 | 40.53 | 74.00 | -33.47 | peak |

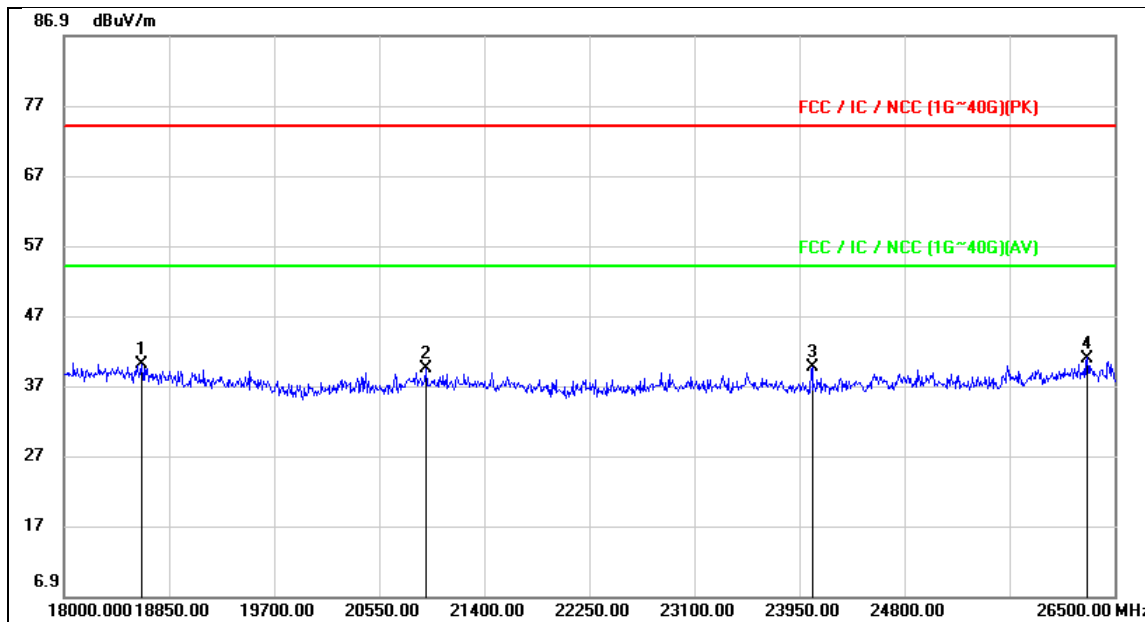
### Spurious Emission 18-25GHz Vertical

| No. | Frequency<br>(MHz) | Reading<br>(dBuV/m) | Correct<br>dB/m | Result<br>(dBuV/m) | Limit<br>(dBuV/m) | Margin<br>(dB) | Remark |
| 1 | 18631.833 | 42.51 | -2.54 | 39.97 | 74.00 | -34.03 | peak |

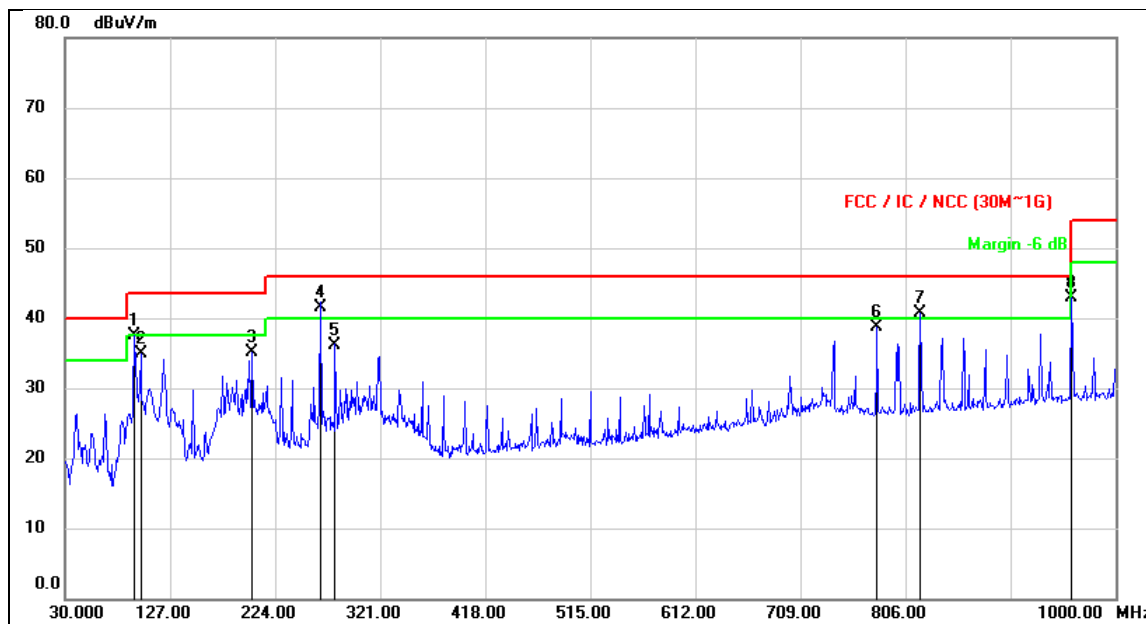
### Spurious Emission 30-1000MHz Horizontal

| No. | Frequency<br>(MHz) | Reading<br>(dBuV/m) | Correct<br>dB/m | Result<br>(dBuV/m) | Limit<br>(dBuV/m) | Margin<br>(dB) | Remark |
| 1 | 94.8930 | 58.60 | -21.09 | 37.51 | 43.50 | -5.99 | peak |

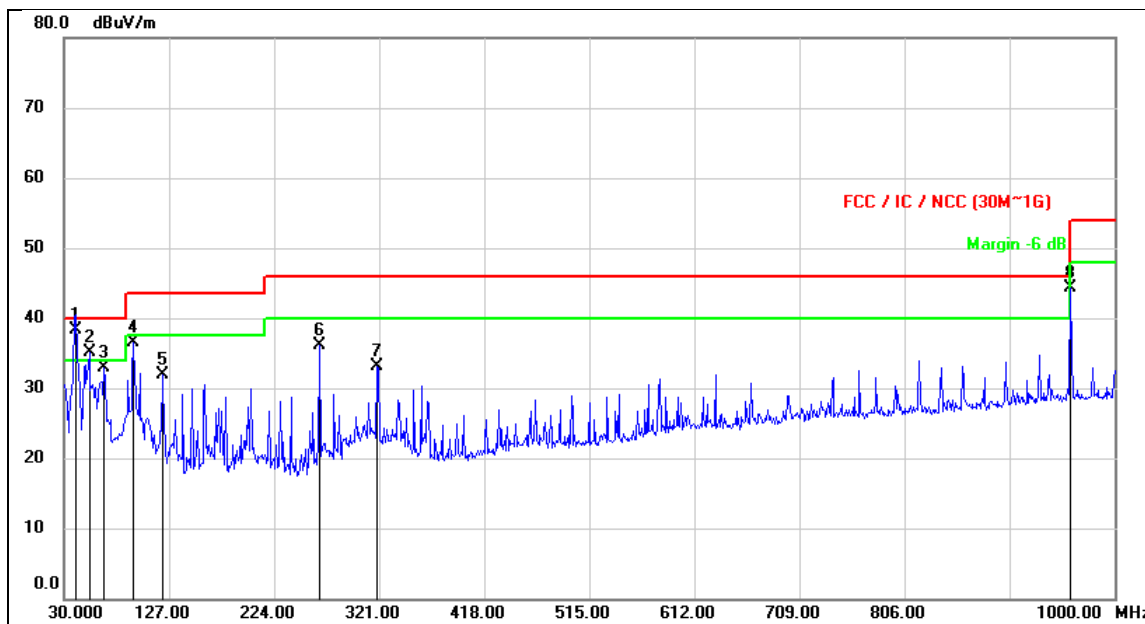
### Spurious Emission 30-1000MHz Vertical

| No. | Frequency<br>(MHz) | Reading<br>(dBuV/m) | Correct<br>dB/m | Result<br>(dBuV/m) | Limit<br>(dBuV/m) | Margin<br>(dB) | Remark |
| 1 | 40.6699 | 54.07 | -15.72 | 38.35 | 40.00 | -1.65 | QP |

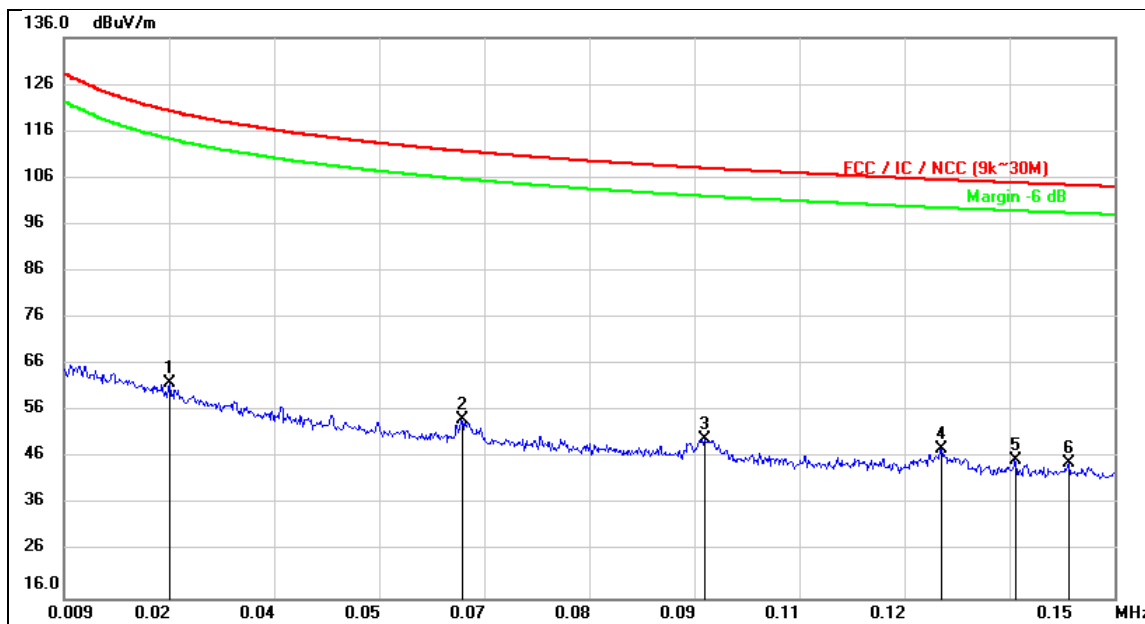
### Spurious Emission Worst case 9-150kHz 0°

| No. | Frequency<br>(KHz) | Reading<br>(dBuV/m) | Correct<br>dB/m | Result<br>(dBuV/m) | Limit<br>(dBuV/m) | Margin<br>(dB) | Remark |
| 1 | 0.0232 | 45.85 | 16.20 | 62.05 | 120.34 | -58.29 | peak |

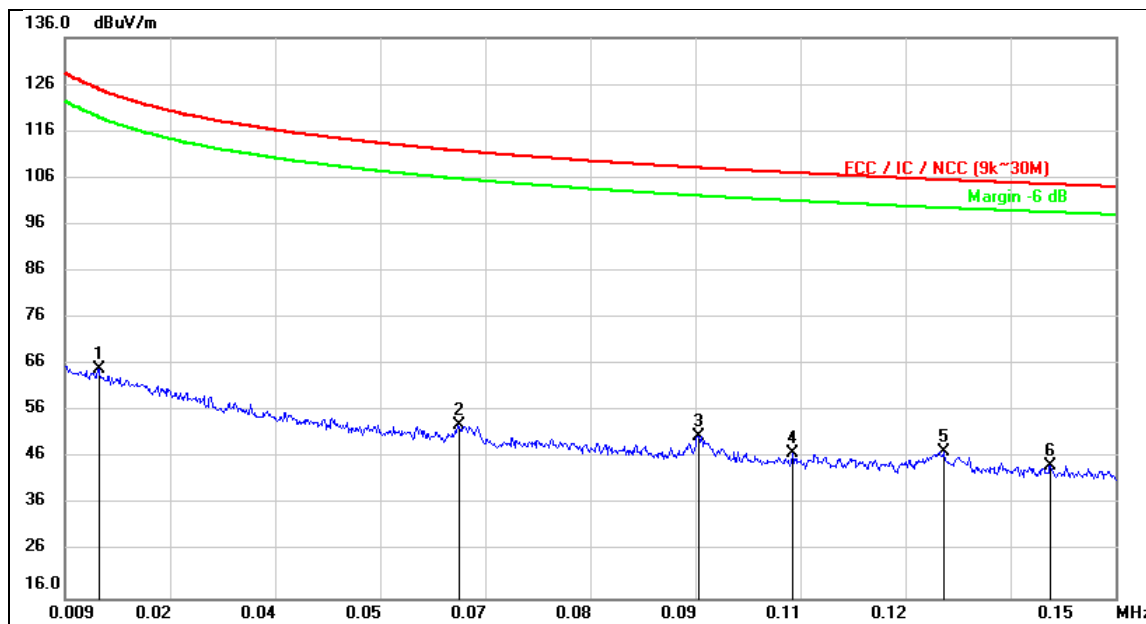
### Spurious Emission Worst case 9-150kHz 90°

| No. | Frequency (KHz) | Reading (dBuV/m) | Correct dB/m | Result (dBuV/m) | Limit (dBuV/m) | Margin (dB) | Remark |
| 1 | 0.0135 | 46.23 | 18.79 | 65.02 | 125.09 | -60.07 | peak |

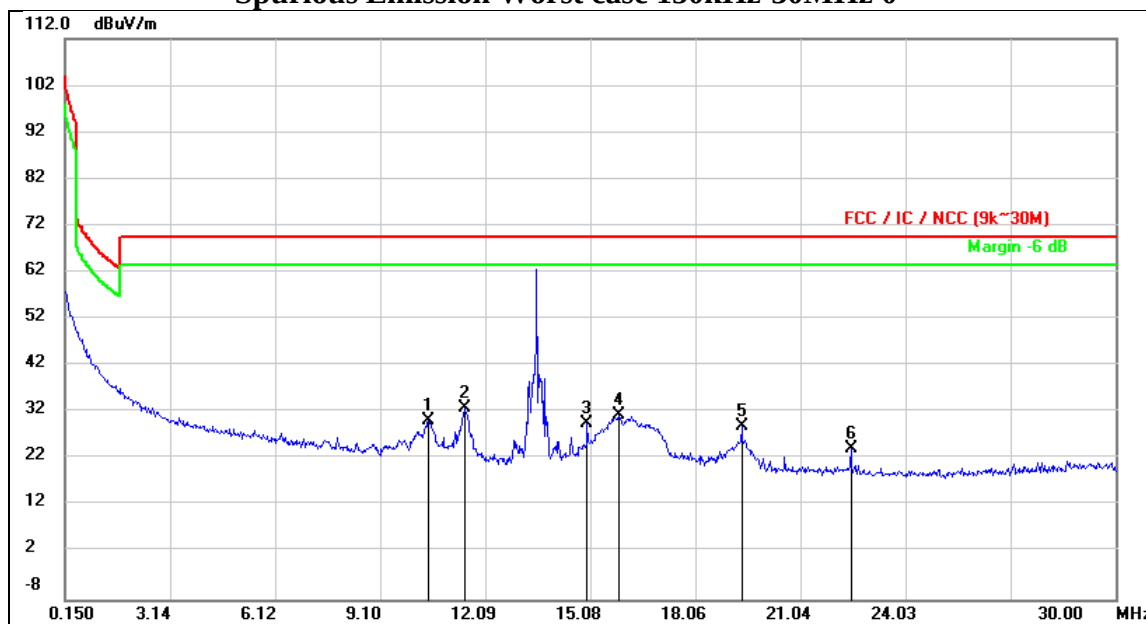
### Spurious Emission Worst case 150kHz-30MHz 0°

| No. | Frequency<br>(MHz) | Reading<br>(dBuV/m) | Correct<br>dB/m | Result<br>(dBuV/m) | Limit<br>(dBuV/m) | Margin<br>(dB) | Remark |
| 1 | 10.5079 | 18.58 | 11.64 | 30.22 | 69.54 | -39.32 | peak |

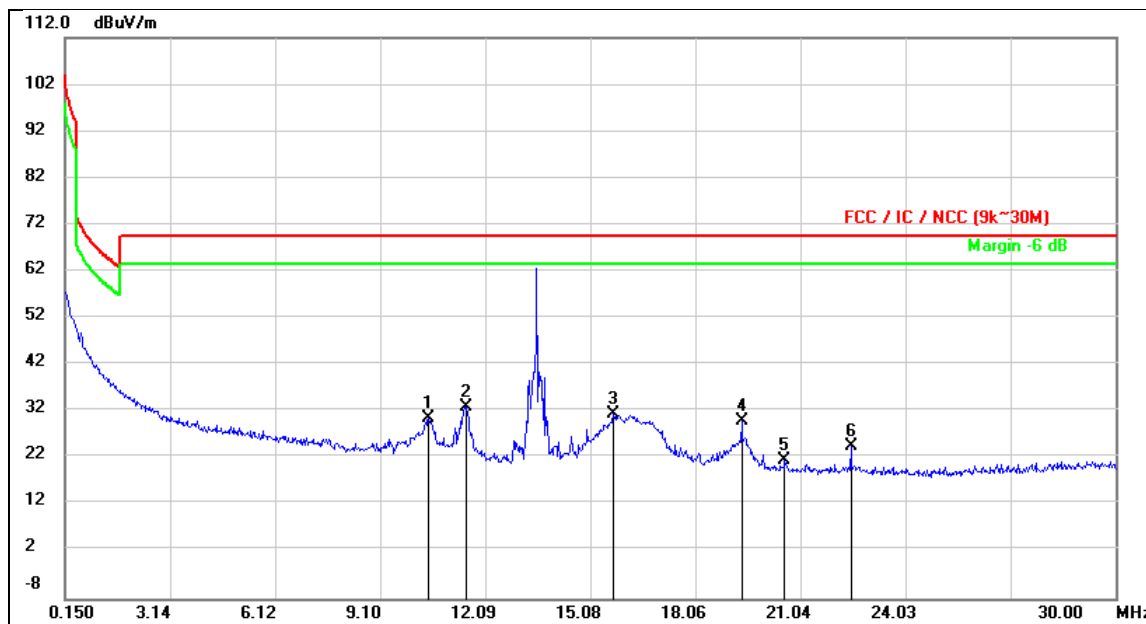
### Spurious Emission Worst case 150kHz-30MHz 90°

| No. | Frequency<br>(MHz) | Reading<br>(dBuV/m) | Correct<br>dB/m | Result<br>(dBuV/m) | Limit<br>(dBuV/m) | Margin<br>(dB) | Remark |
| 1 | 10.5000 | 18.98 | 11.64 | 30.62 | 69.54 | -38.92 | peak |

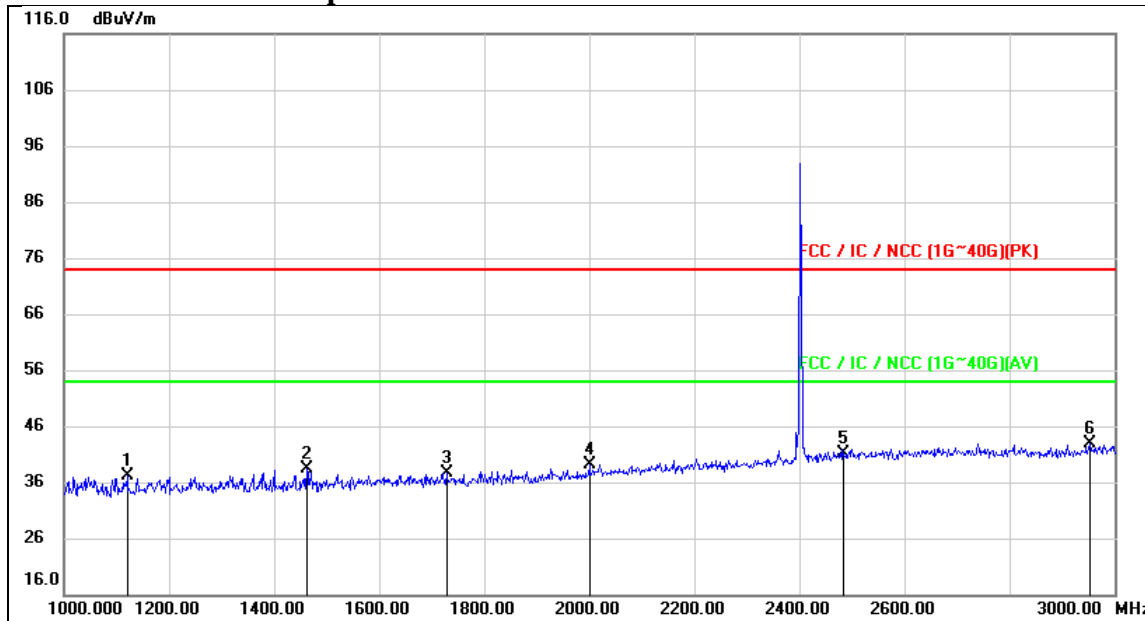
**Co-location (BT + NFC)  
Spurious Emission 1-3GHz Horizontal**

| No. | Frequency<br>(MHz) | Reading<br>(dBuV/m) | Correct<br>dB/m | Result<br>(dBuV/m) | Limit<br>(dBuV/m) | Margin<br>(dB) | Remark |
| 1 | 1120.467 | 49.75 | -12.72 | 37.03 | 74.00 | -36.97 | peak |

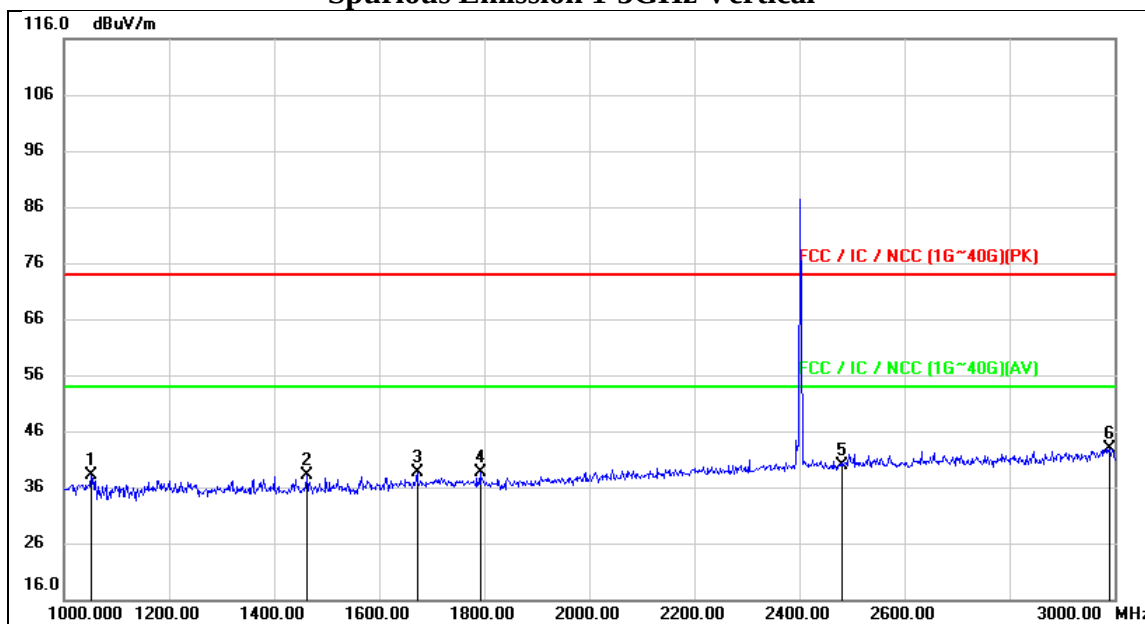
### Spurious Emission 1-3GHz Vertical

| No. | Frequency<br>(MHz) | Reading<br>(dBuV/m) | Correct<br>dB/m | Result<br>(dBuV/m) | Limit<br>(dBuV/m) | Margin<br>(dB) | Remark |
| 1 | 1053.600 | 51.20 | -12.97 | 38.23 | 74.00 | -35.77 | peak |

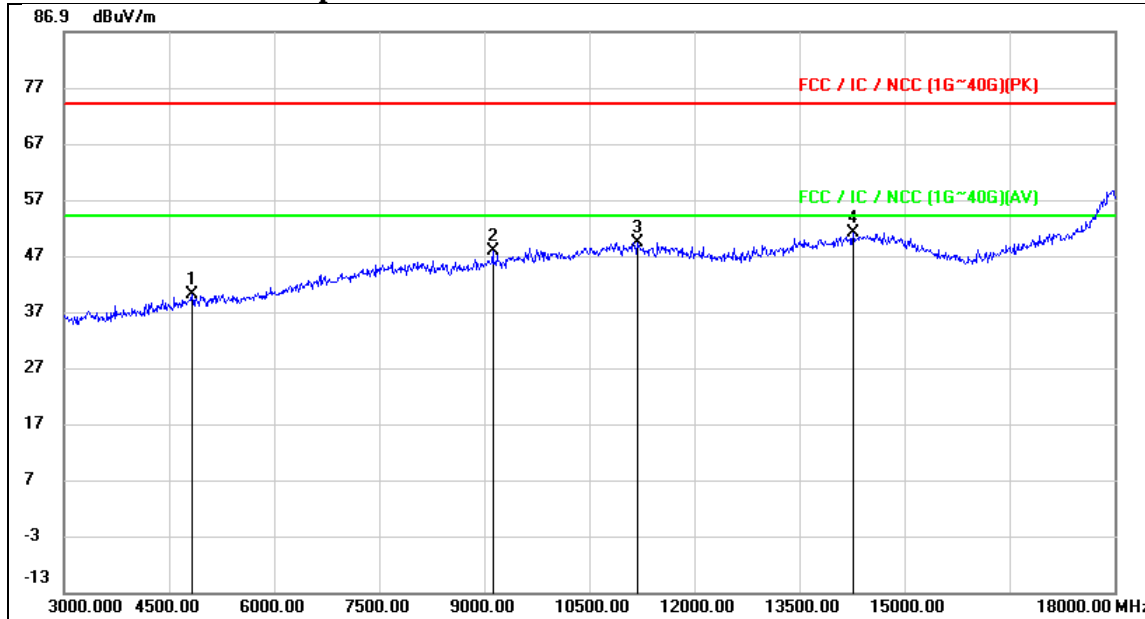
### Spurious Emission 3-18GHz Horizontal

| No. | Frequency<br>(MHz) | Reading<br>(dBuV/m) | Correct<br>dB/m | Result<br>(dBuV/m) | Limit<br>(dBuV/m) | Margin<br>(dB) | Remark |
| 1 | 4833.500 | 43.42 | -3.47 | 39.95 | 74.00 | -34.05 | peak |

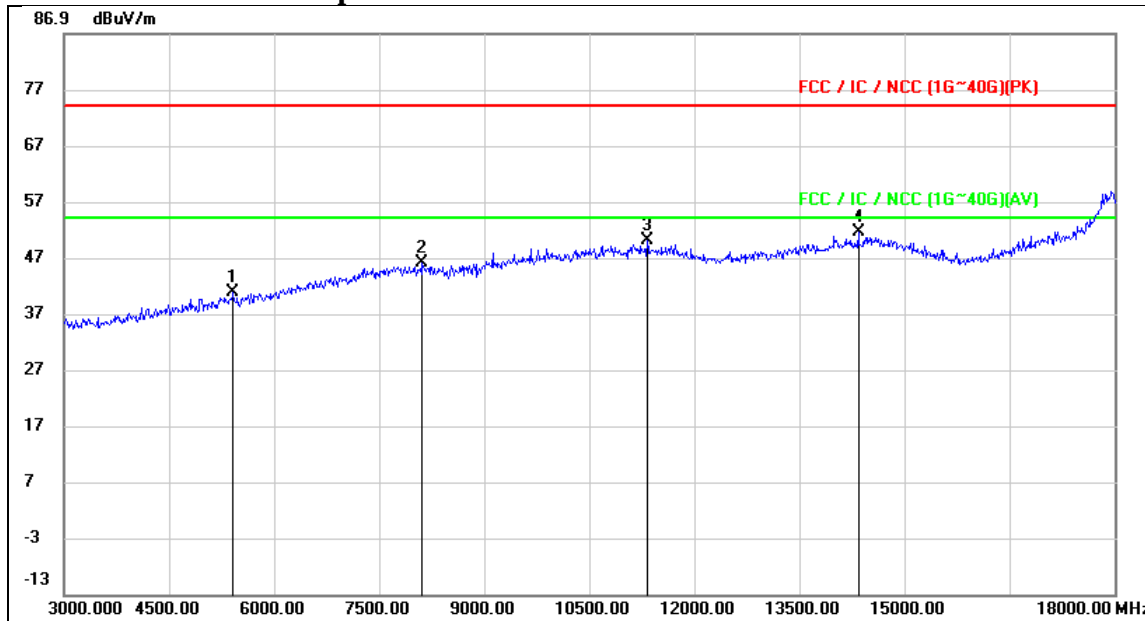
### Spurious Emission 3-18GHz Vertical

| No. | Frequency<br>(MHz) | Reading<br>(dBuV/m) | Correct<br>dB/m | Result<br>(dBuV/m) | Limit<br>(dBuV/m) | Margin<br>(dB) | Remark |
| 1 | 5422.000 | 43.45 | -2.76 | 40.69 | 74.00 | -33.31 | peak |

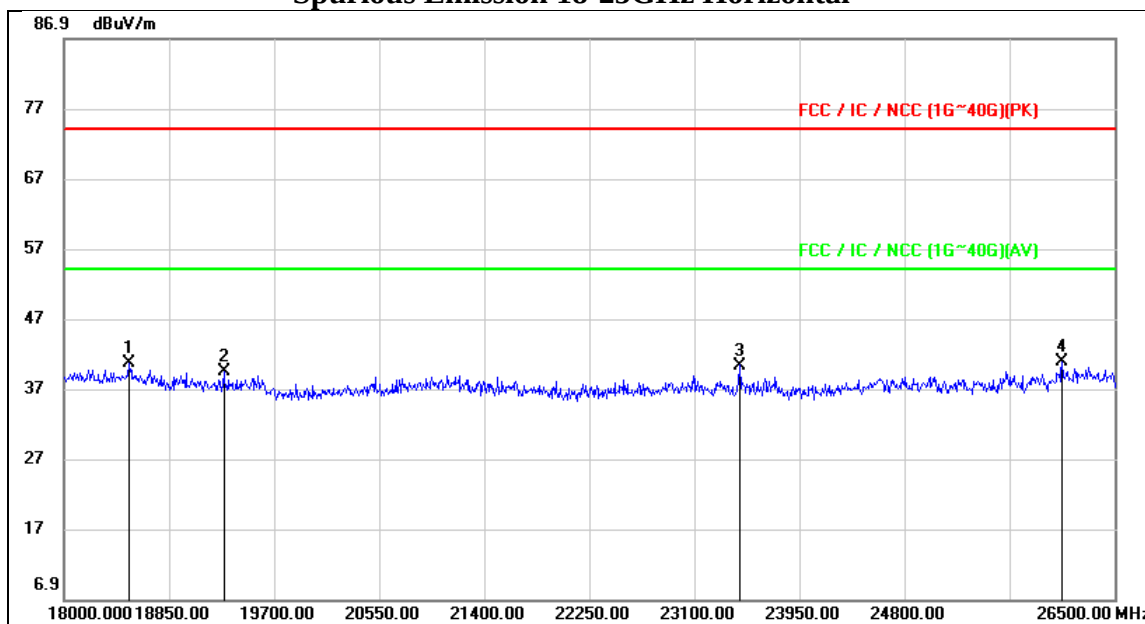
### Spurious Emission 18-25GHz Horizontal

| No. | Frequency<br>(MHz) | Reading<br>(dBuV/m) | Correct<br>dB/m | Result<br>(dBuV/m) | Limit<br>(dBuV/m) | Margin<br>(dB) | Remark |
| 1 | 18534.650 | 42.98 | -2.45 | 40.53 | 74.00 | -33.47 | peak |

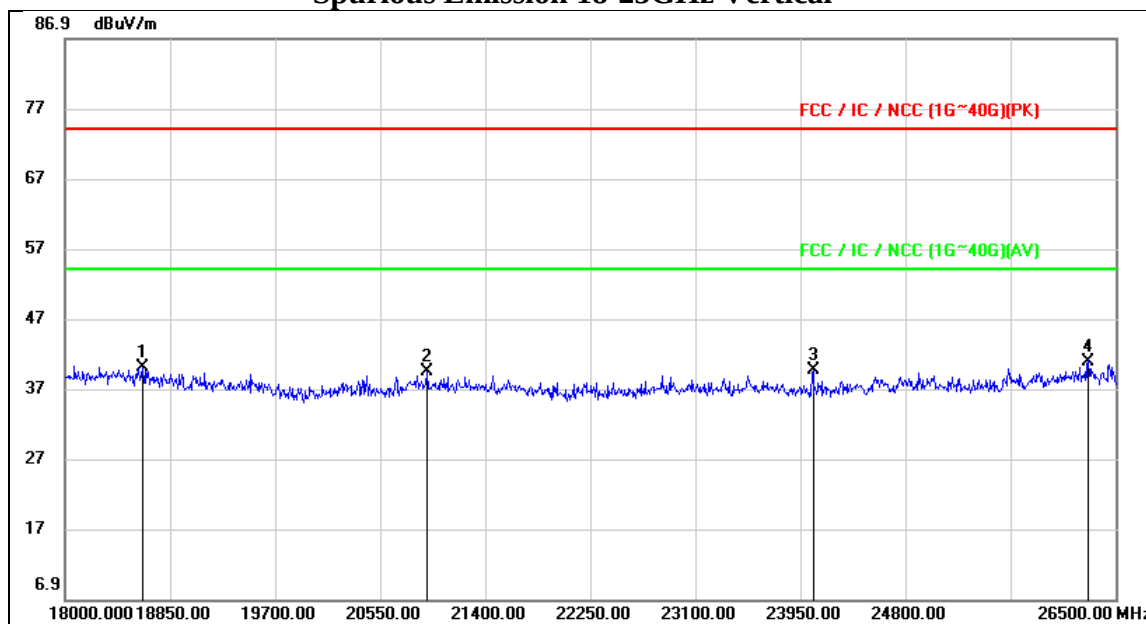
### Spurious Emission 18-25GHz Vertical

| No. | Frequency<br>(MHz) | Reading<br>(dBuV/m) | Correct<br>dB/m | Result<br>(dBuV/m) | Limit<br>(dBuV/m) | Margin<br>(dB) | Remark |
| 1 | 18631.833 | 42.51 | -2.54 | 39.97 | 74.00 | -34.03 | peak |

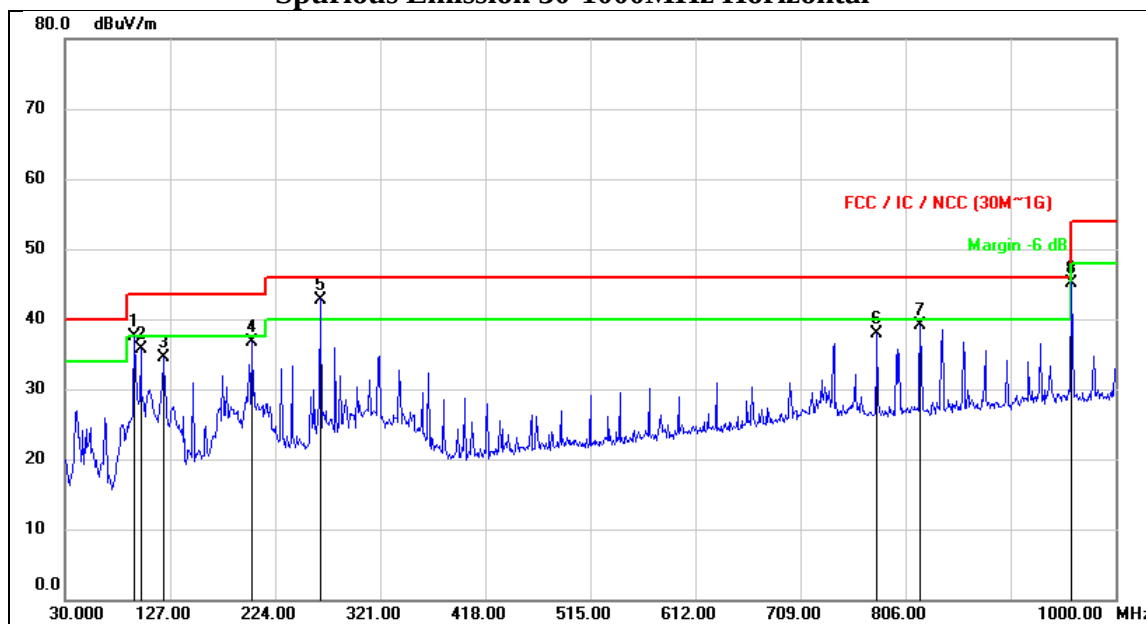
### Spurious Emission 30-1000MHz Horizontal

| No. | Frequency<br>(MHz) | Reading<br>(dBuV/m) | Correct<br>dB/m | Result<br>(dBuV/m) | Limit<br>(dBuV/m) | Margin<br>(dB) | Remark |
| 1 | 94.8930 | 58.60 | -21.09 | 37.51 | 43.50 | -5.99 | peak |

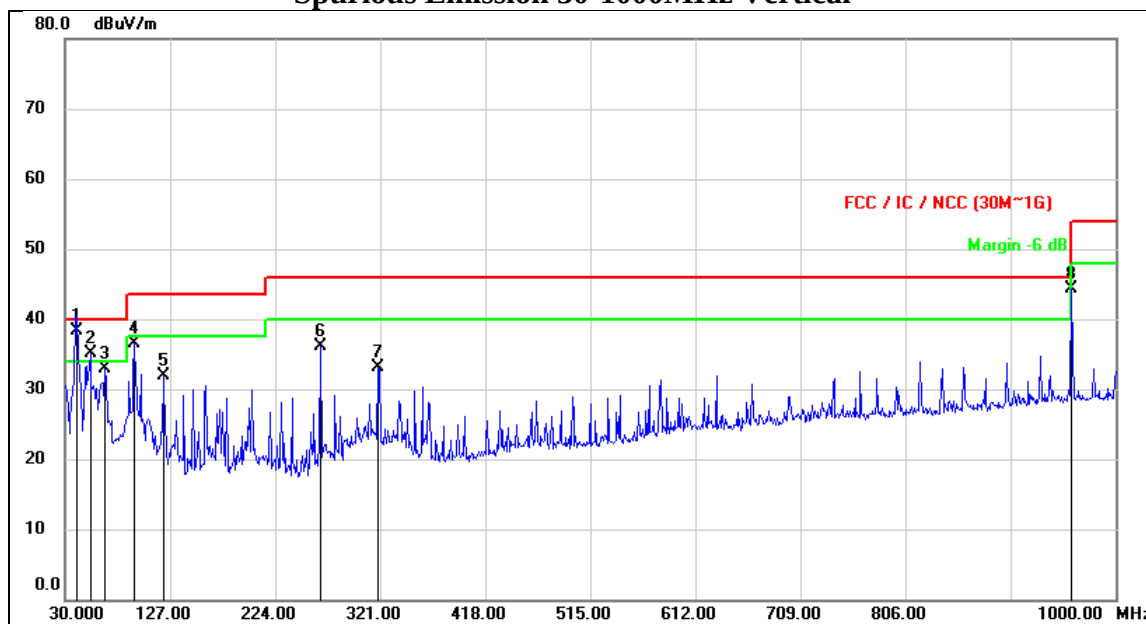
### Spurious Emission 30-1000MHz Vertical

| No. | Frequency<br>(MHz) | Reading<br>(dBuV/m) | Correct<br>dB/m | Result<br>(dBuV/m) | Limit<br>(dBuV/m) | Margin<br>(dB) | Remark |
| 1 | 40.6699 | 54.07 | -15.72 | 38.35 | 40.00 | -1.65 | QP |

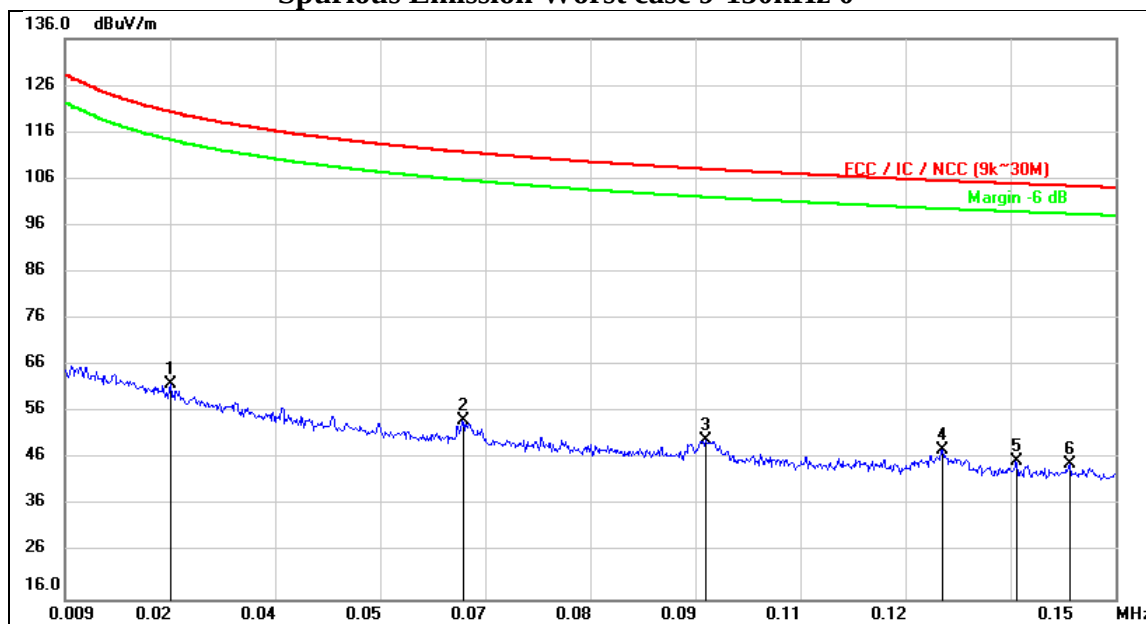
### Spurious Emission Worst case 9-150kHz 0°

| No. | Frequency<br>(KHz) | Reading<br>(dBuV/m) | Correct<br>dB/m | Result<br>(dBuV/m) | Limit<br>(dBuV/m) | Margin<br>(dB) | Remark |
| 1 | 0.0232 | 45.85 | 16.20 | 62.05 | 120.34 | -58.29 | peak |
