## **RADIO TEST REPORT**

**Product** : **Payment Terminal**

**Model Name** : **M020**

**Test Regulation** : **FCC 47 CFR Part 15 Subpart C (Section 15.225)**

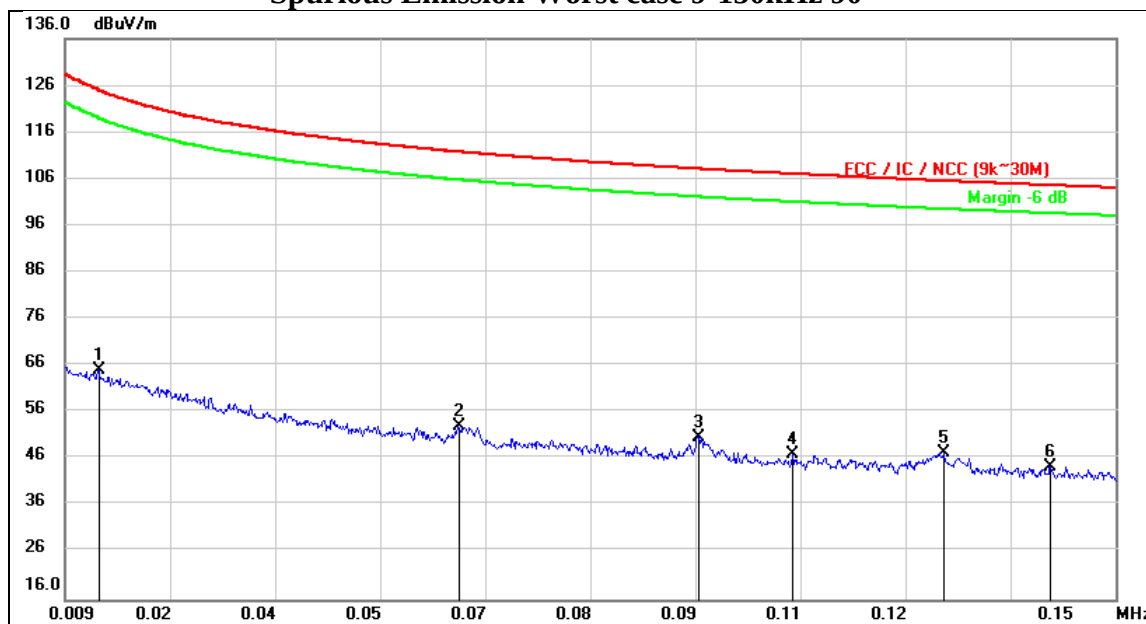
### Spurious Emission Worst case 9-150kHz 90°

| No. | Frequency<br>(KHz) | Reading<br>(dBuV/m) | Correct<br>dB/m | Result<br>(dBuV/m) | Limit<br>(dBuV/m) | Margin<br>(dB) | Remark |
| 1 | 0.0135 | 46.23 | 18.79 | 65.02 | 125.09 | -60.07 | peak |

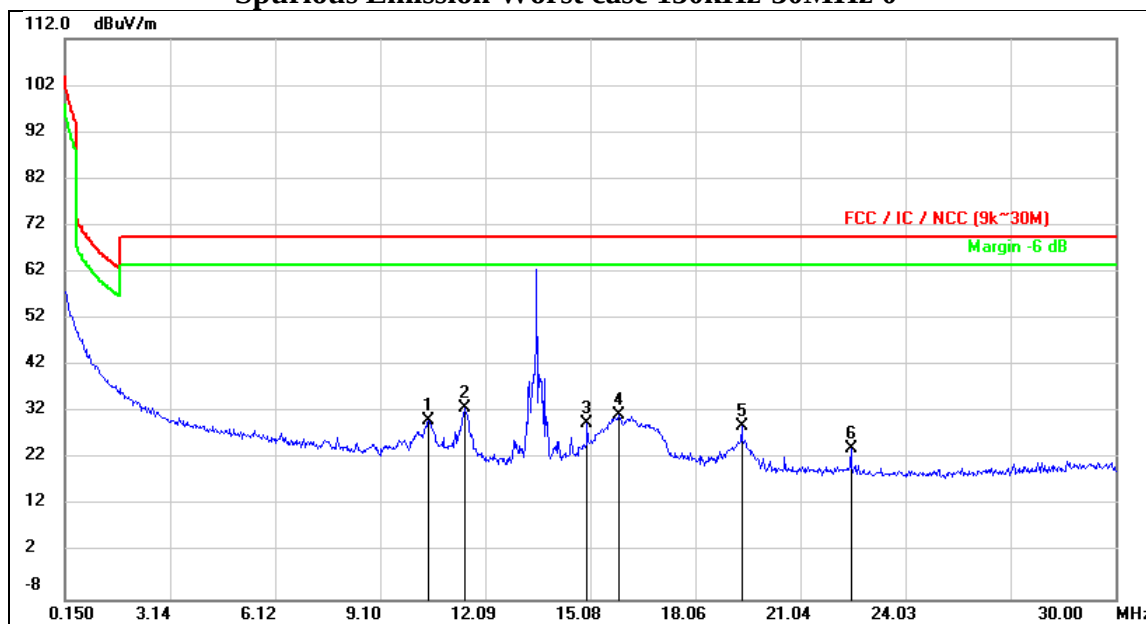
### Spurious Emission Worst case 150kHz-30MHz 0°

| No. | Frequency<br>(MHz) | Reading<br>(dBuV/m) | Correct<br>dB/m | Result<br>(dBuV/m) | Limit<br>(dBuV/m) | Margin<br>(dB) | Remark |
| 1 | 10.5079 | 18.58 | 11.64 | 30.22 | 69.54 | -39.32 | peak |

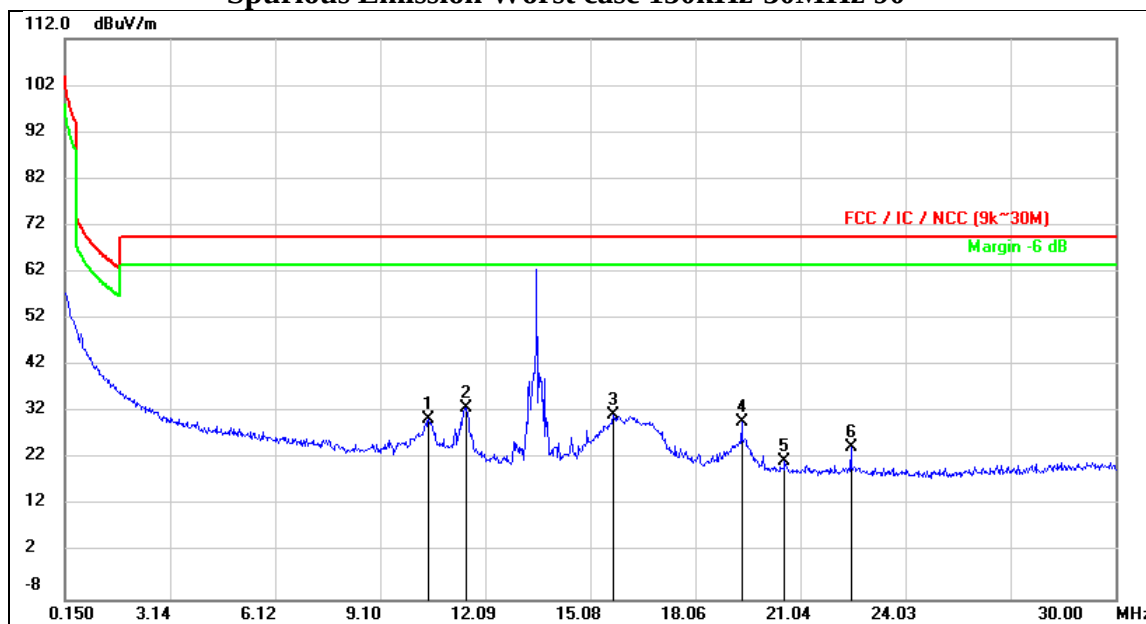
### Spurious Emission Worst case 150kHz-30MHz 90°

| No. | Frequency<br>(MHz) | Reading<br>(dBuV/m) | Correct<br>dB/m | Result<br>(dBuV/m) | Limit<br>(dBuV/m) | Margin<br>(dB) | Remark |
| 1 | 10.5000 | 18.98 | 11.64 | 30.62 | 69.54 | -38.92 | peak |

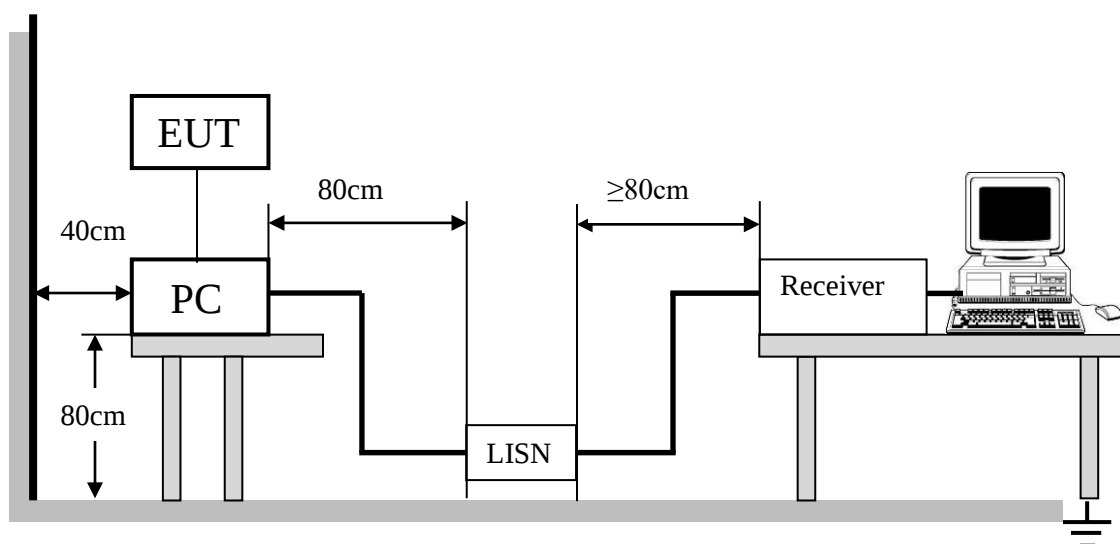
### Test Procedures

The EUT was put on a table of non-conducting material that was 80cm high. The vertical conducting wall of shielding was located 40cm to the rear of the EUT. The power line of the EUT was connected to the AC mains through a Artificial Mains Network (A.M.N.). A EMI Measurement Receiver (R&S Test Receiver ESR3) was used to test the emissions from both sides of AC line. According to the requirements in Section 6.2 of ANSI C63.10 - 2013. Conducted emissions from the EUT measured in the frequency range between 0.15 MHz and 30MHz using CISPR Quasi-Peak and average detector mode. The bandwidth of EMI test receiver was set at 9kHz.

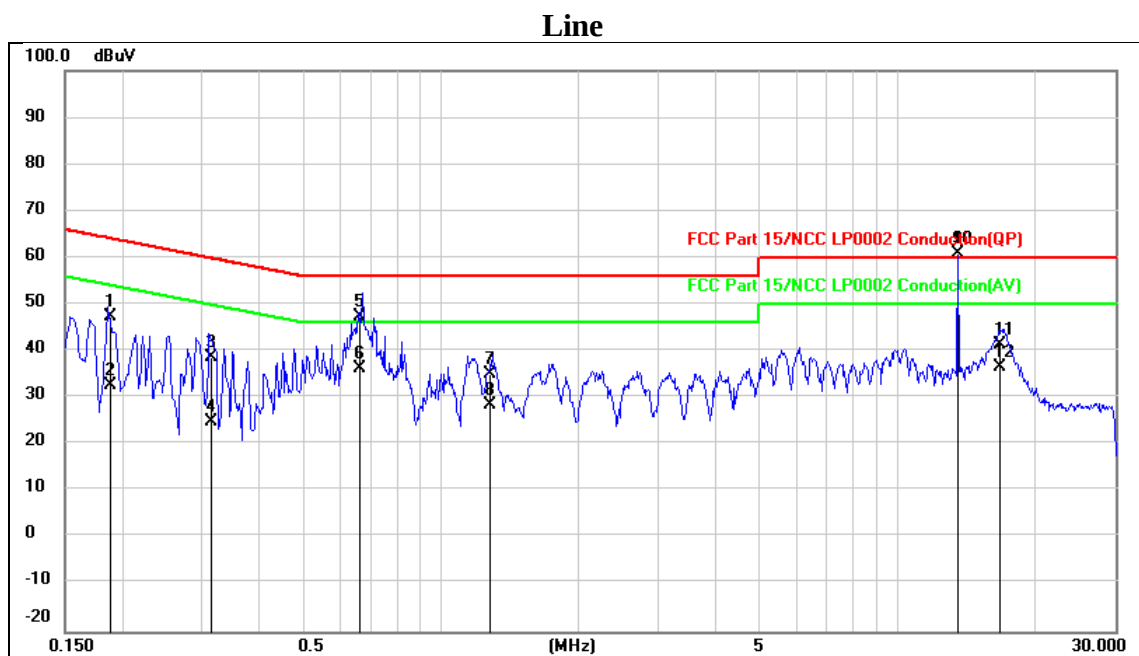
Perform the AC power-line conducted tests with the NFC antenna connected to determine compliance.

| No. | Frequency<br>(MHz) | Reading<br>(dBuV) | Correct<br>dB | Result<br>(dBuV) | Limit<br>(dBuV) | Margin<br>(dB) | Remark |
| 1 | 0.1889 | 27.64 | 19.58 | 47.22 | 64.08 | -16.86 | QP |

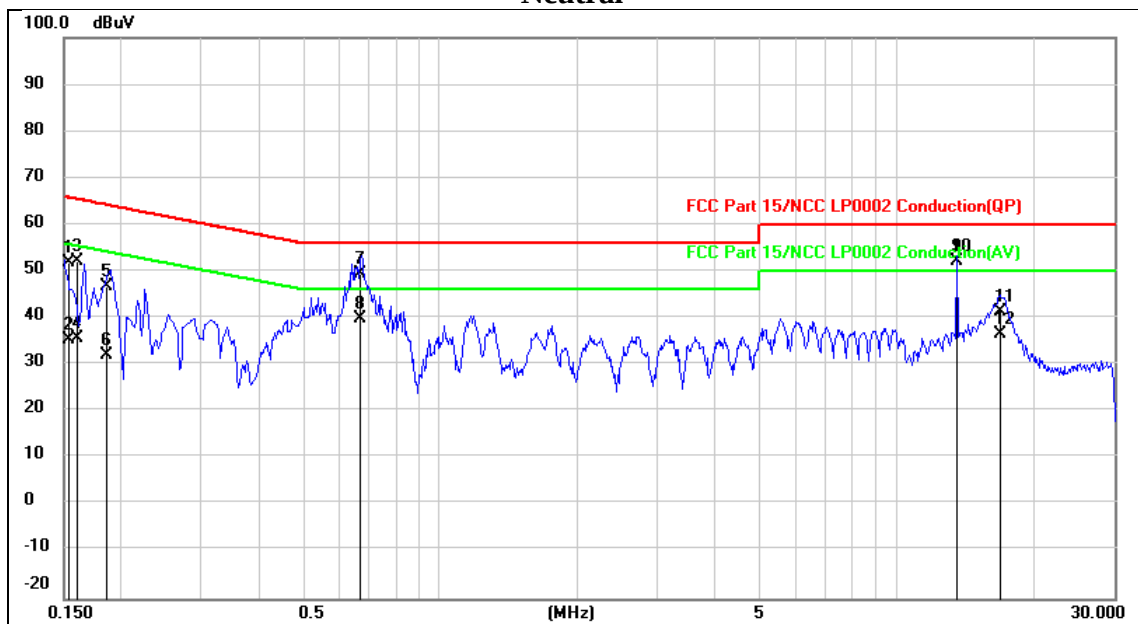
### Neutral

| No. | Frequency<br>(MHz) | Reading<br>(dBuV) | Correct<br>dB | Result<br>(dBuV) | Limit<br>(dBuV) | Margin<br>(dB) | Remark |
| 1 | 0.1536 | 32.29 | 19.59 | 51.88 | 65.80 | -13.92 | QP |

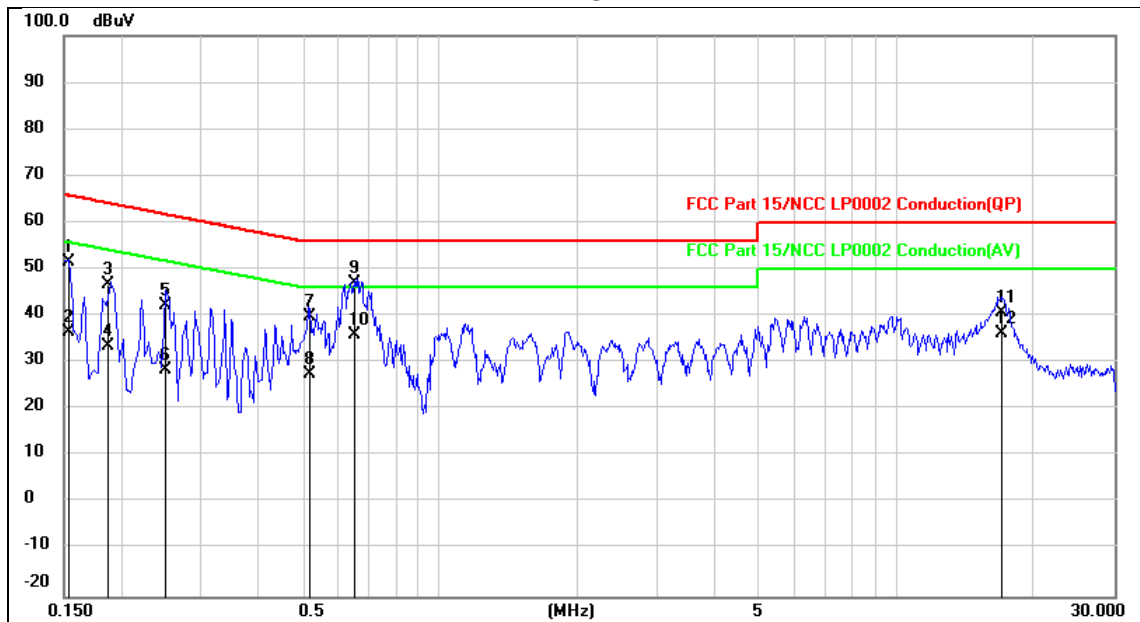
### Line

Retest with a dummy load in lieu of the NFC antenna to determine compliance.

| No. | Frequency<br>(MHz) | Reading<br>(dBuV) | Correct<br>dB | Result<br>(dBuV) | Limit<br>(dBuV) | Margin<br>(dB) | Remark |
| 1 | 0.1541 | 32.09 | 19.57 | 51.66 | 65.78 | -14.12 | QP |

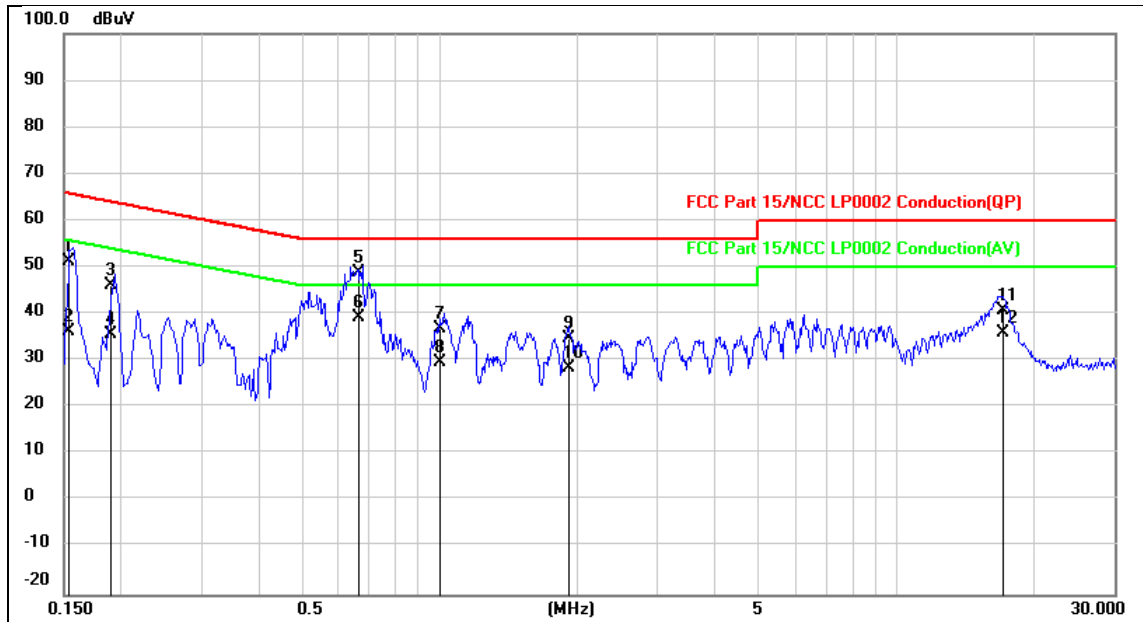
### Neutral

| No. | Frequency<br>(MHz) | Reading<br>(dBuV) | Correct<br>dB | Result<br>(dBuV) | Limit<br>(dBuV) | Margin<br>(dB) | Remark |
| 1 | 0.1536 | 31.77 | 19.59 | 51.36 | 65.80 | -14.44 | QP |

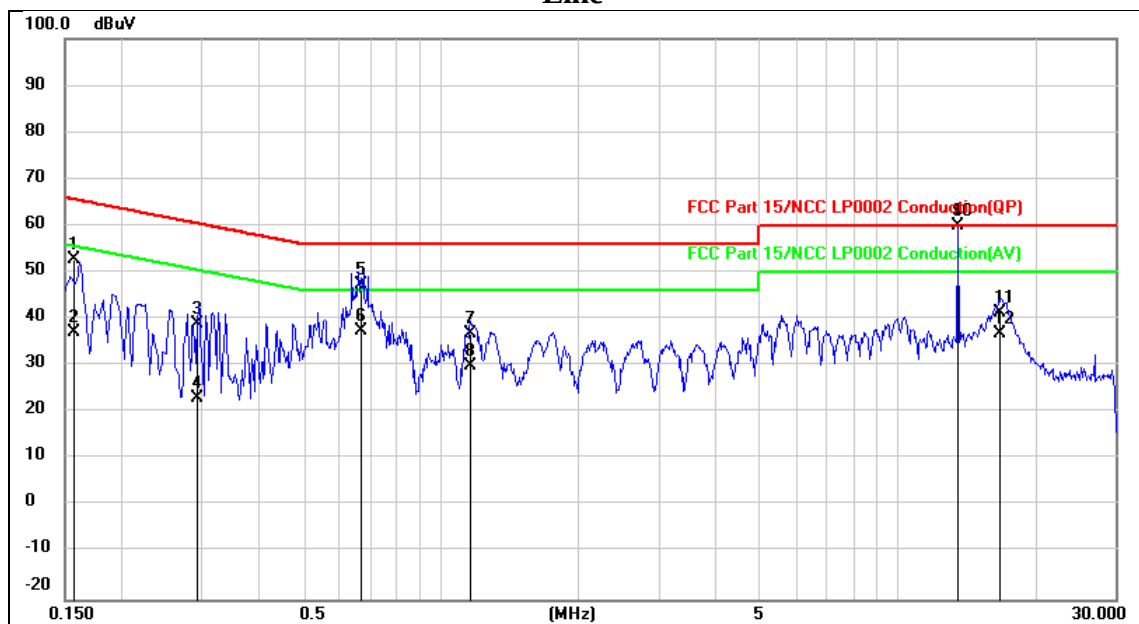
### Line

Perform the AC power-line conducted tests with the NFC antenna connected to determine compliance.

| No. | Frequency<br>(MHz) | Reading<br>(dBuV) | Correct<br>dB | Result<br>(dBuV) | Limit<br>(dBuV) | Margin<br>(dB) | Remark |
| 1 | 0.1570 | 33.12 | 19.57 | 52.69 | 65.62 | -12.93 | QP |

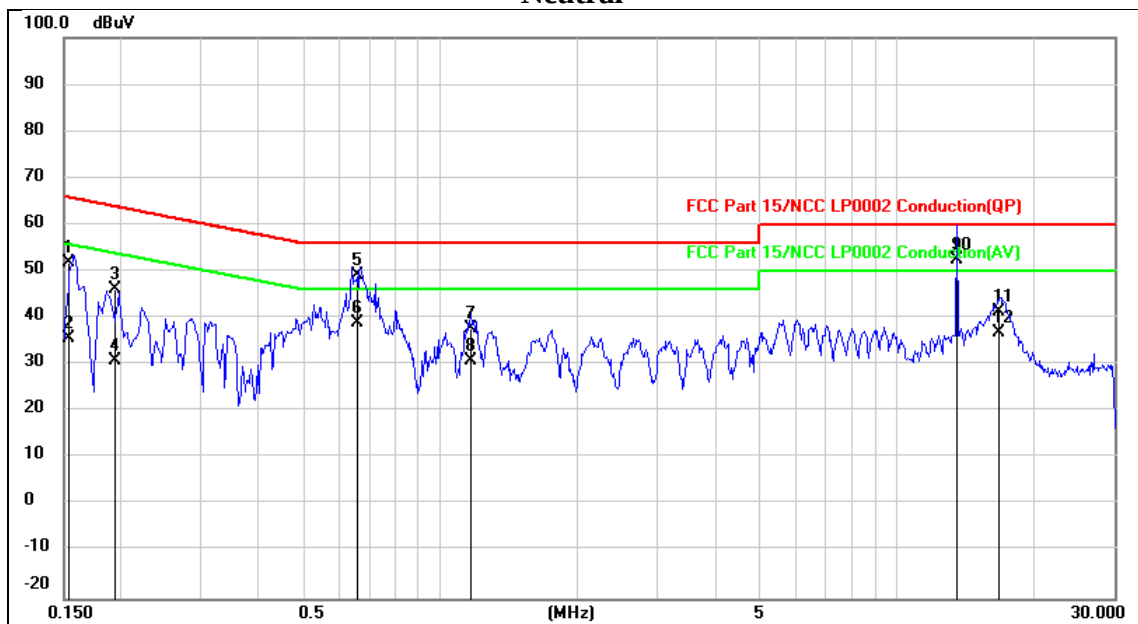
### Neutral

| No. | Frequency<br>(MHz) | Reading<br>(dBuV) | Correct<br>dB | Result<br>(dBuV) | Limit<br>(dBuV) | Margin<br>(dB) | Remark |
| 1 | 0.1538 | 32.41 | 19.59 | 52.00 | 65.79 | -13.79 | QP |

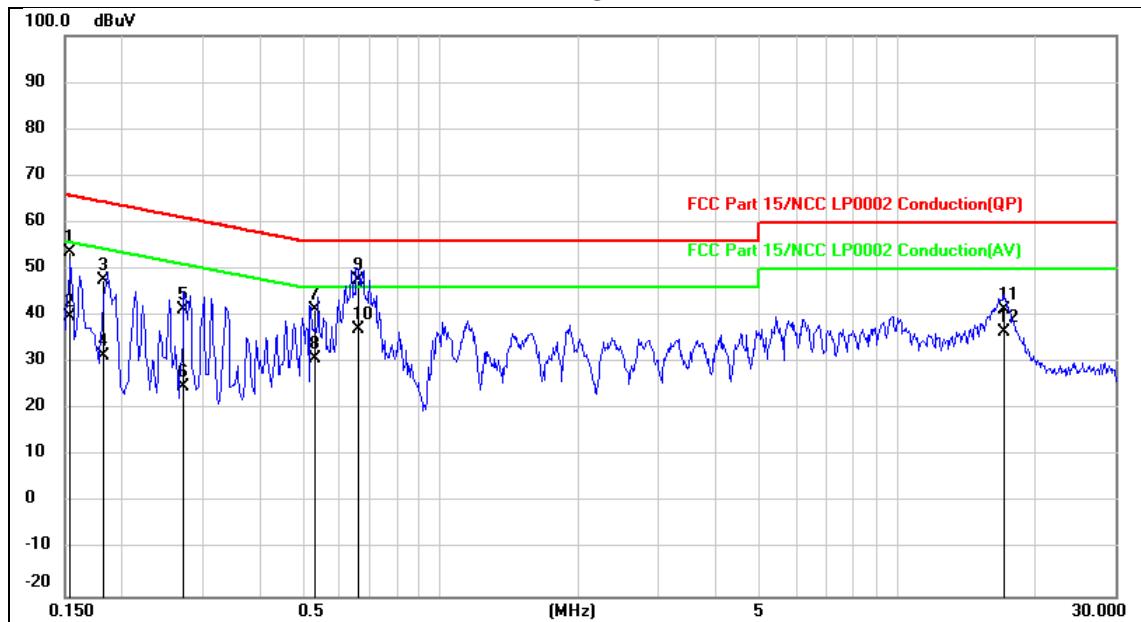
### Line

Retest with a dummy load in lieu of the NFC antenna to determine compliance.

| No. | Frequency (MHz) | Reading (dBuV) | Correct (dB) | Result (dBuV) | Limit (dBuV) | Margin (dB) | Remark |
| 1 | 0.1545 | 34.12 | 19.57 | 53.69 | 65.75 | -12.06 | QP |

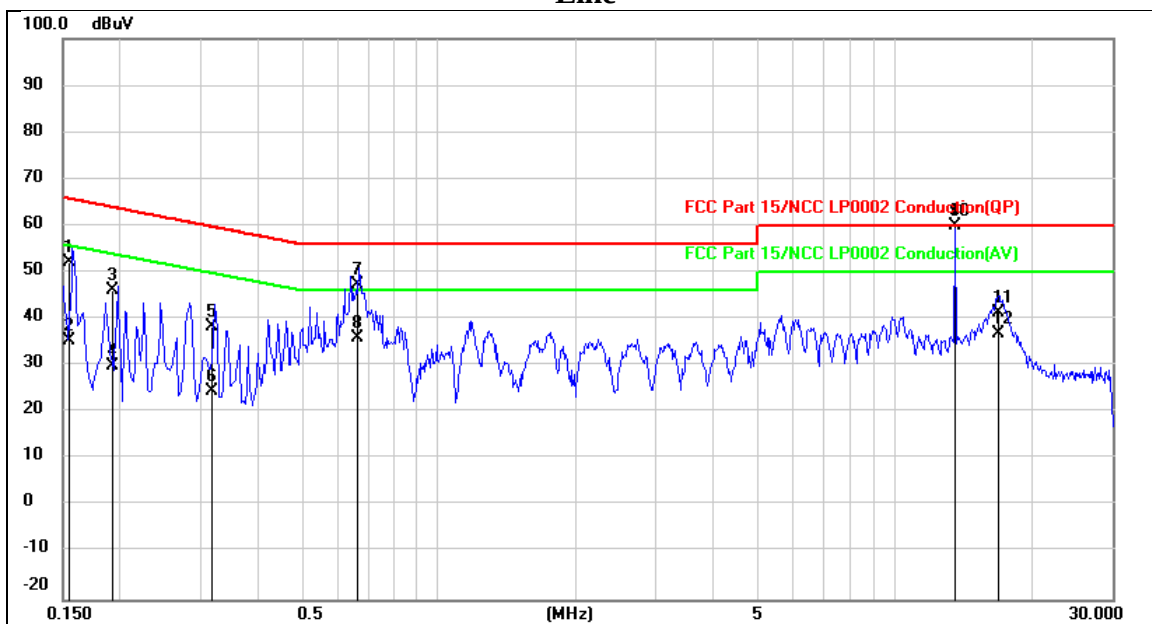
### Line

Perform the AC power-line conducted tests with the NFC antenna connected to determine compliance.

| No. | Frequency<br>(MHz) | Reading<br>(dBuV) | Correct<br>dB | Result<br>(dBuV) | Limit<br>(dBuV) | Margin<br>(dB) | Remark |
| 1 | 0.1545 | 32.52 | 19.57 | 52.09 | 65.75 | -13.66 | QP |

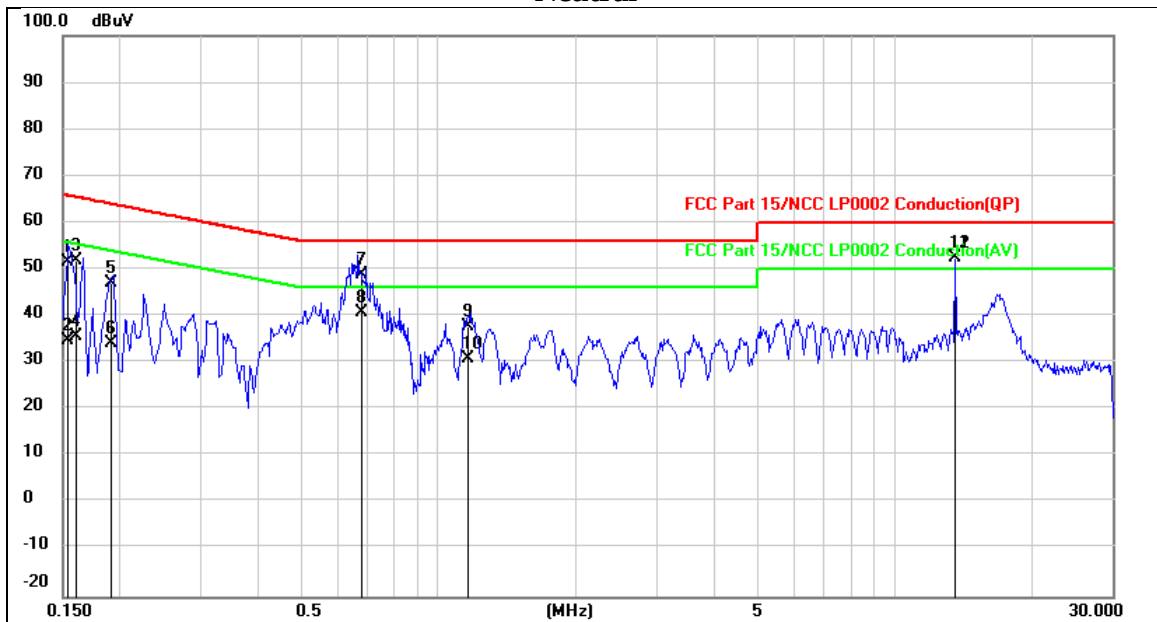
### Neutral

| No. | Frequency<br>(MHz) | Reading<br>(dBuV) | Correct<br>dB | Result<br>(dBuV) | Limit<br>(dBuV) | Margin<br>(dB) | Remark |
| 1 | 0.1535 | 31.91 | 19.59 | 51.50 | 65.81 | -14.31 | QP |

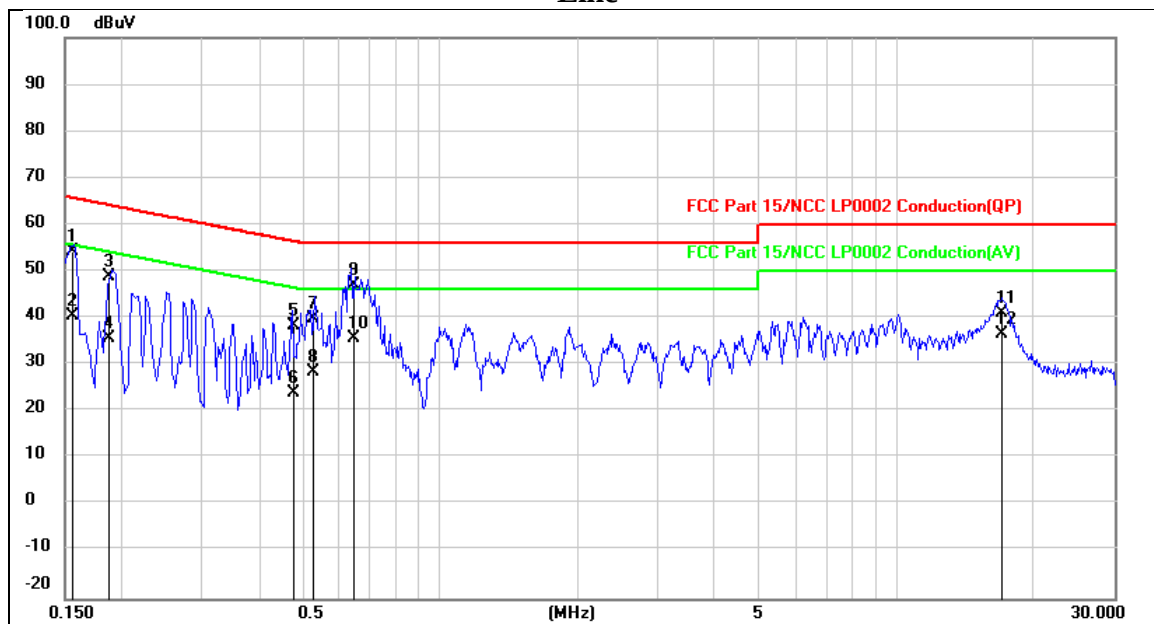
### Line

Retest with a dummy load in lieu of the NFC antenna to determine compliance.

| No. | Frequency<br>(MHz) | Reading<br>(dBuV) | Correct<br>dB | Result<br>(dBuV) | Limit<br>(dBuV) | Margin<br>(dB) | Remark |
| 1 | 0.1556 | 34.58 | 19.57 | 54.15 | 65.70 | -11.55 | QP |
