Becton Dickinson and Company
200 Bulfinch Drive
Suite 100
Andover, MA 01810, USA

IDD(328623) Internal photographs

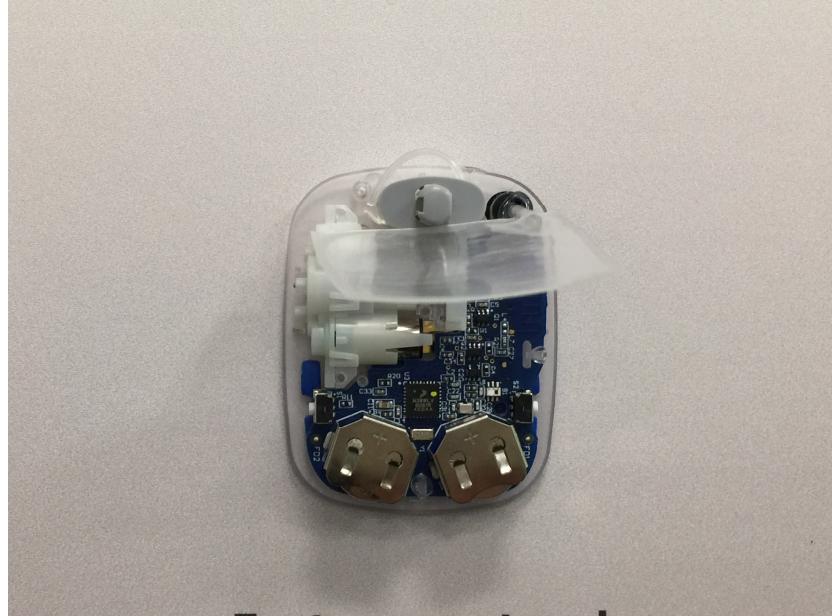
Figure 1 : IDD with Top enclosure removed

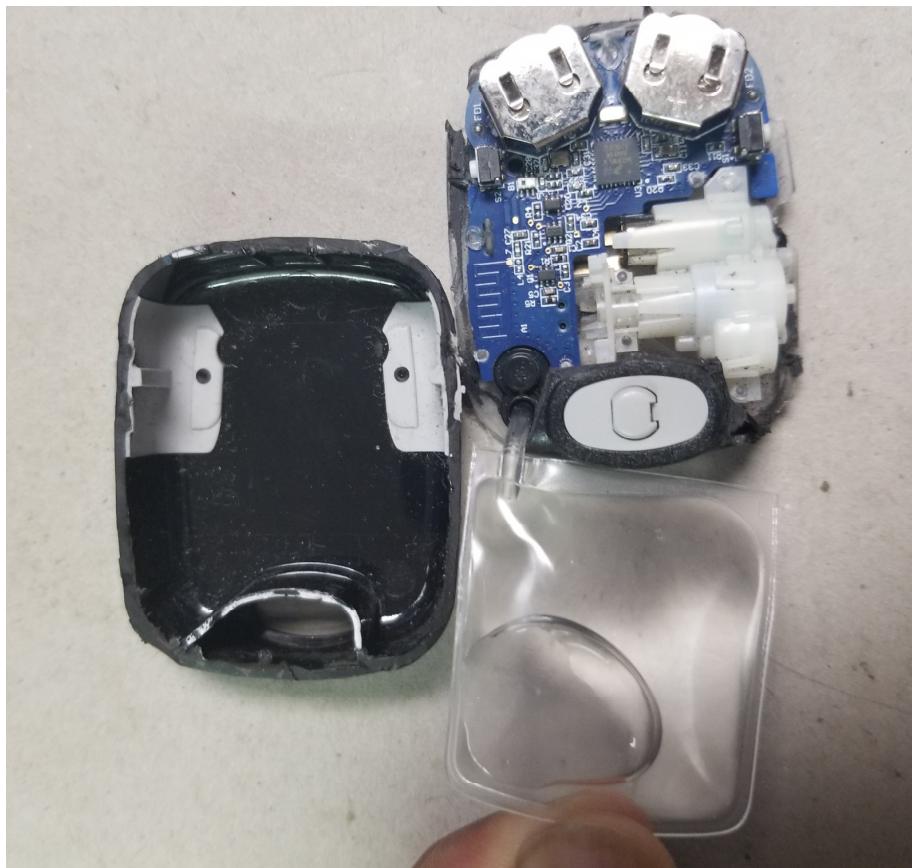
Figure 2: TOP enclosure, Integrated subassembly and reservoir bag
