| Revision History Table | | |
|---|---|---|
| 01 | 2022-04-28 | First version shared with TÜV SÜD |

## Internal Photos

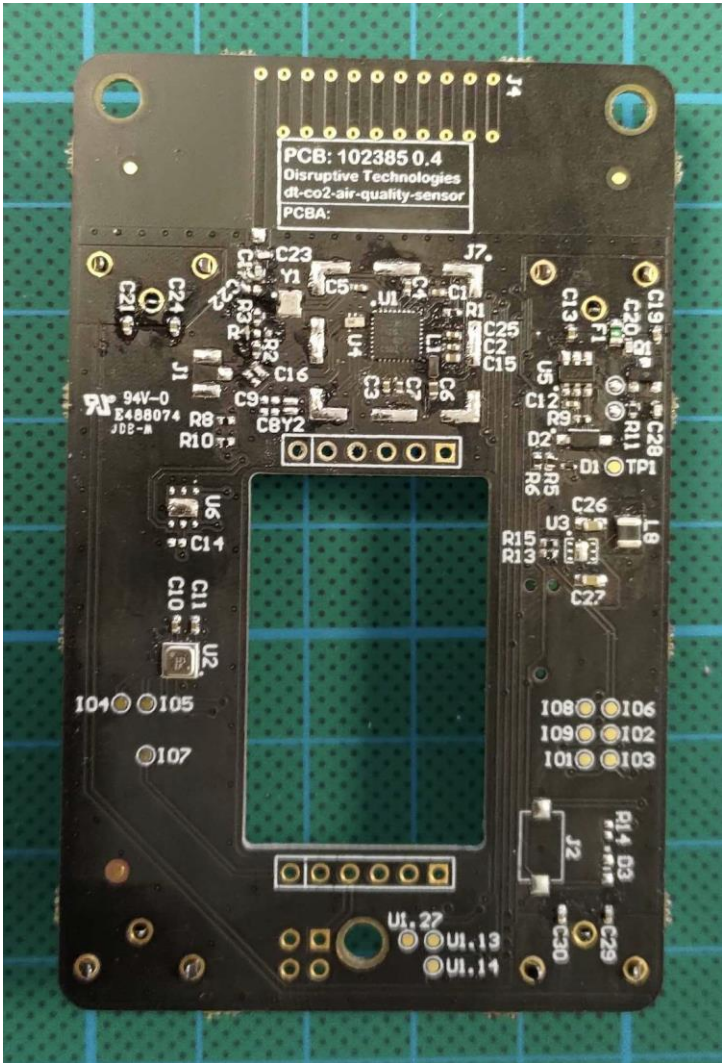
Figure 1: Picture of **component side** of part 102540 - Sensor RF module 2AA (US).  
The RF shield box is removed.  
The antenna location is at the top of the PCB

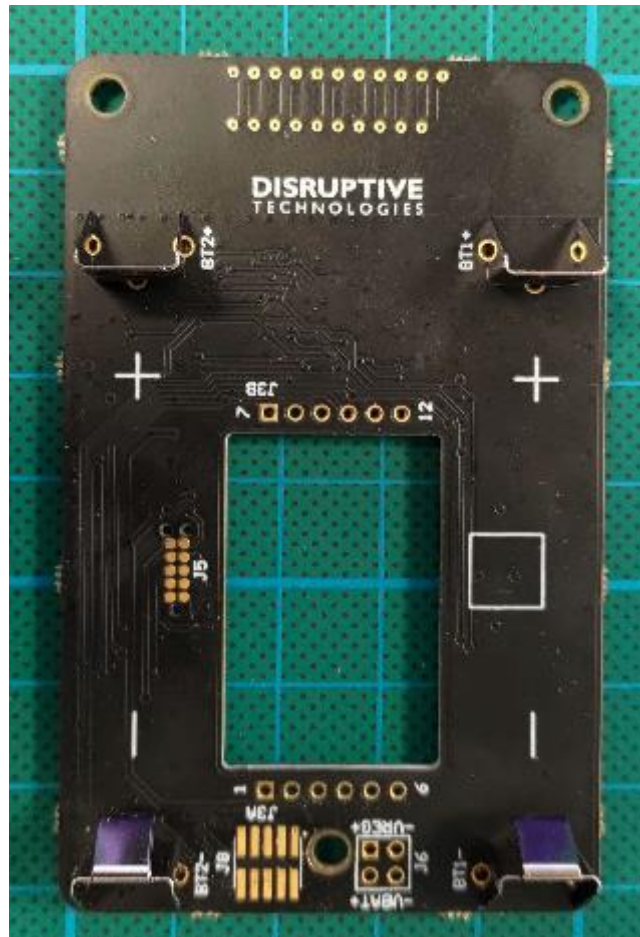
Figure 2: Picture of **bottom side** of part 102540 - Sensor RF module 2AA (US).  
The antenna location is at the top of the PCB

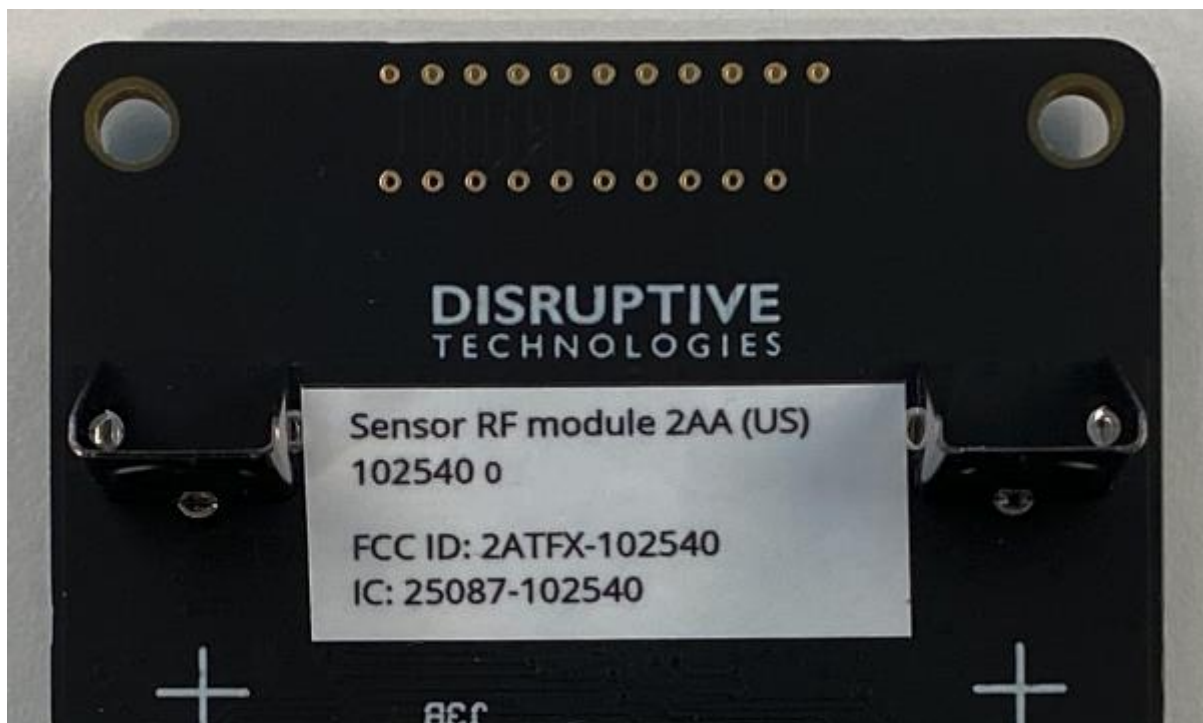
Figure 3: Picture of the label location
