## Appendix B: photographs of test setup

Reference to the test report no. BLA-EMC-202502-A3801

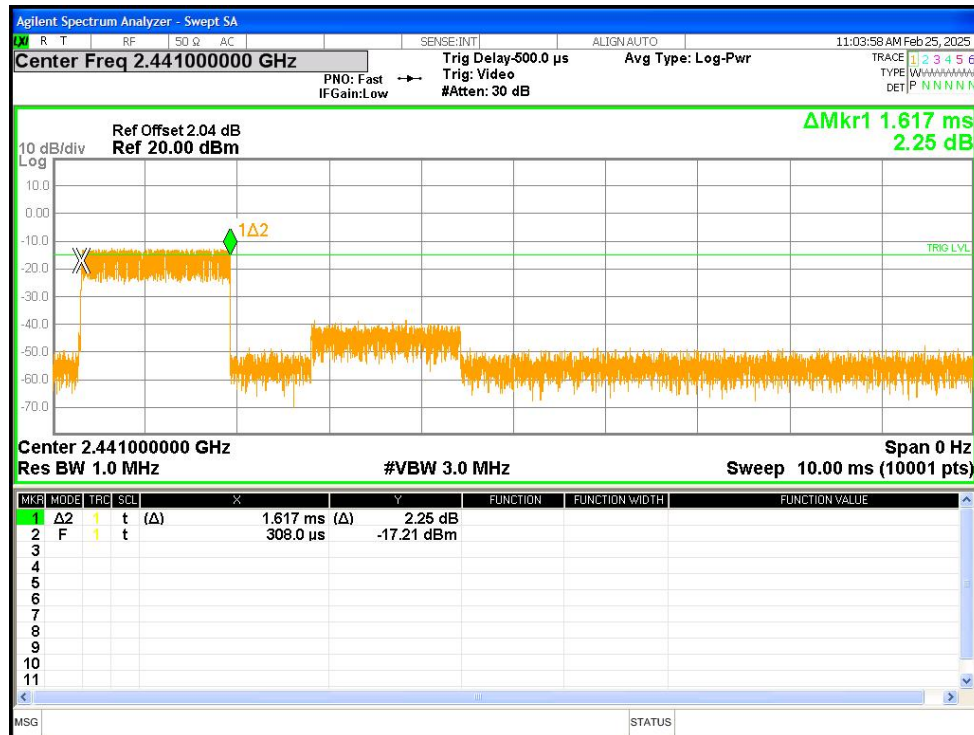
### Dwell NVNT 1-DH3 2441MHz Ant1 One Burst

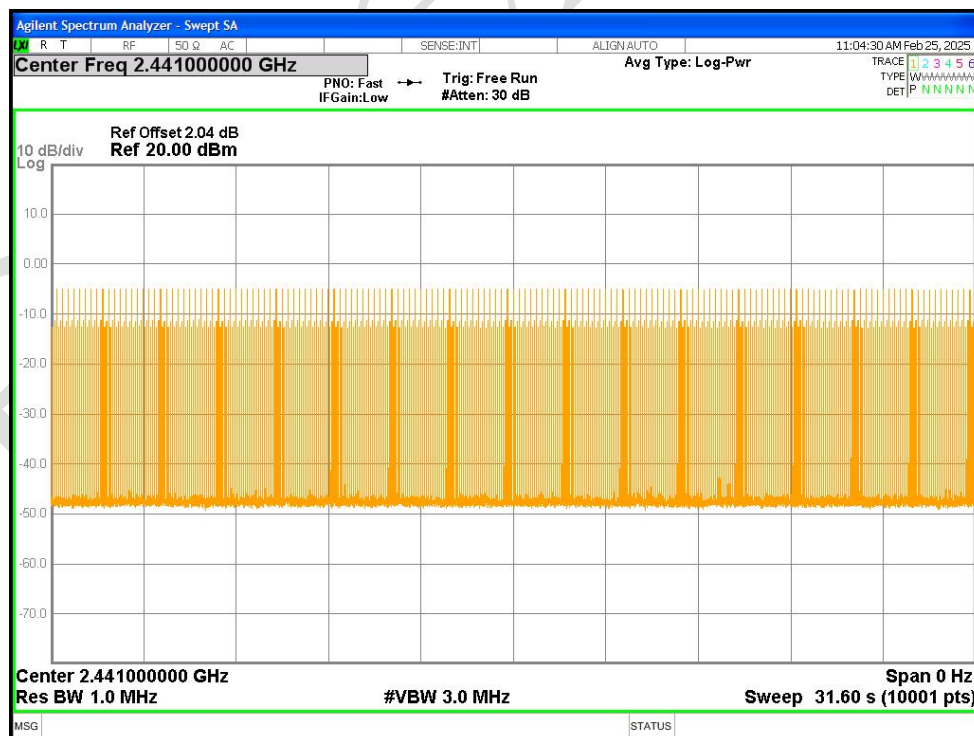
### Dwell NVNT 1-DH3 2441MHz Ant1 Accumulated

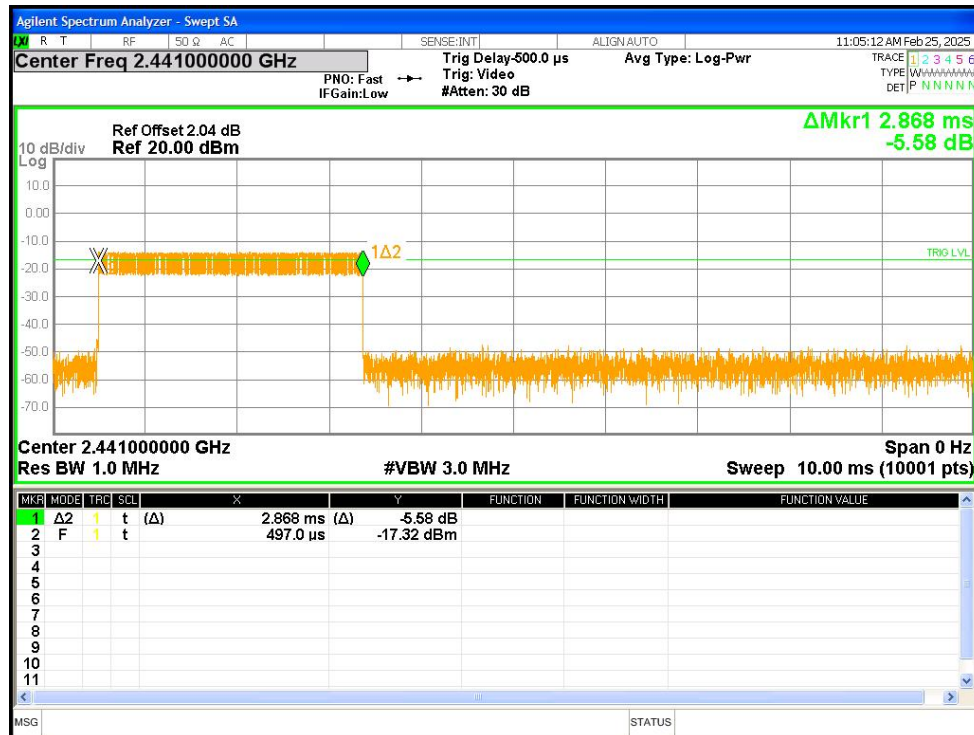
### Dwell NVNT 1-DH5 2441MHz Ant1 One Burst

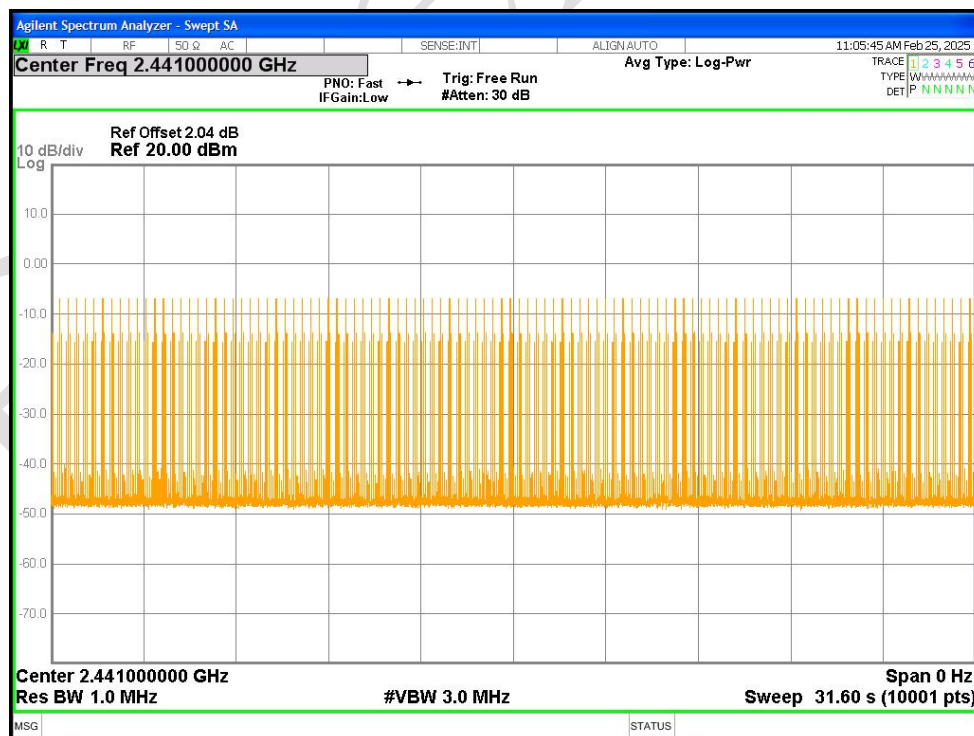
### Dwell NVNT 1-DH5 2441MHz Ant1 Accumulated

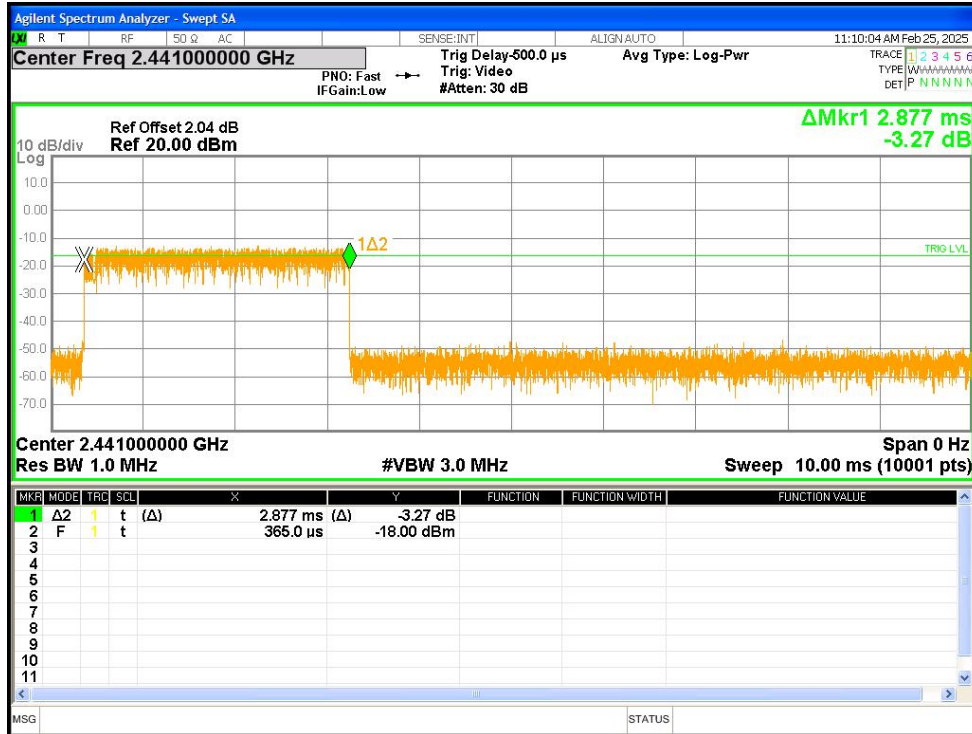
### Dwell NVNT 2-DH5 2441MHz Ant1 One Burst

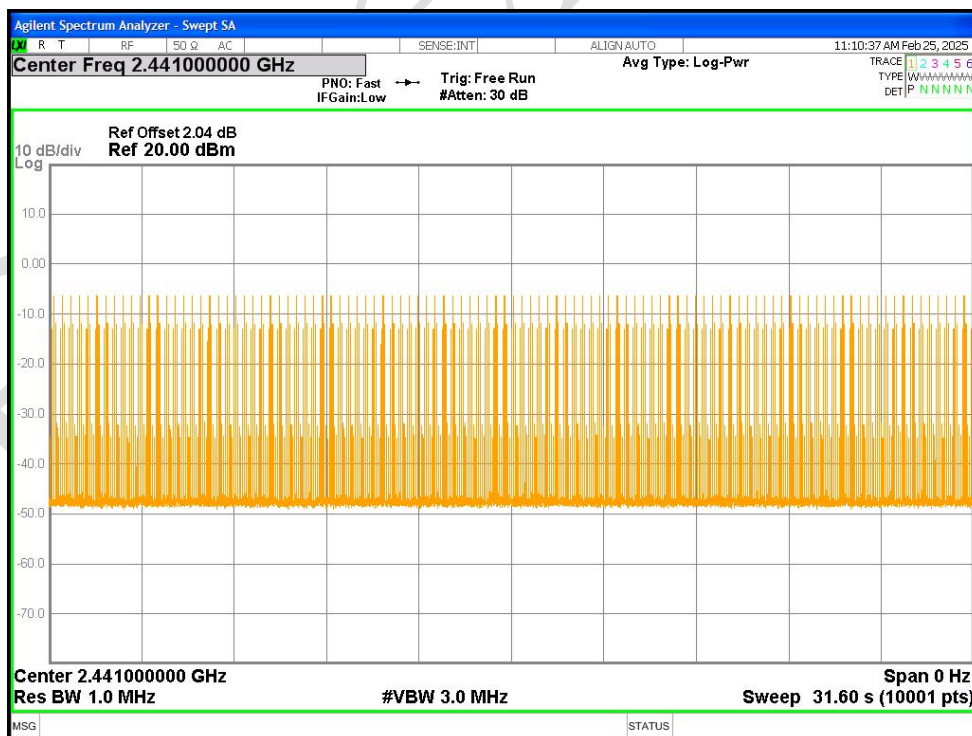
### Dwell NVNT 2-DH5 2441MHz Ant1 Accumulated

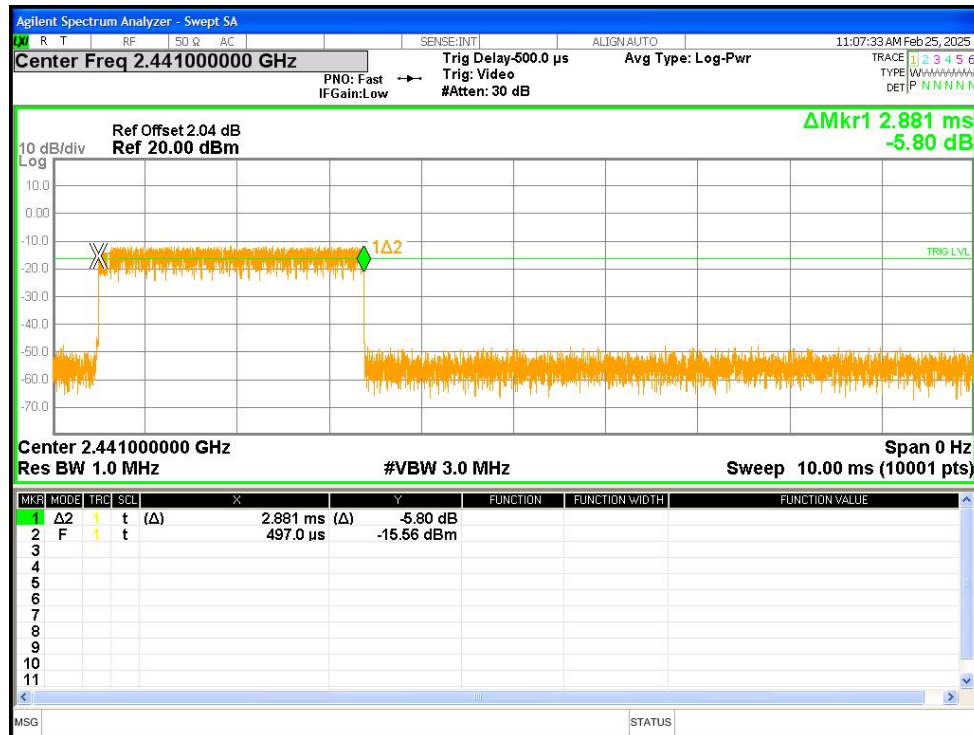
### Dwell NVNT 3-DH5 2441MHz Ant1 One Burst

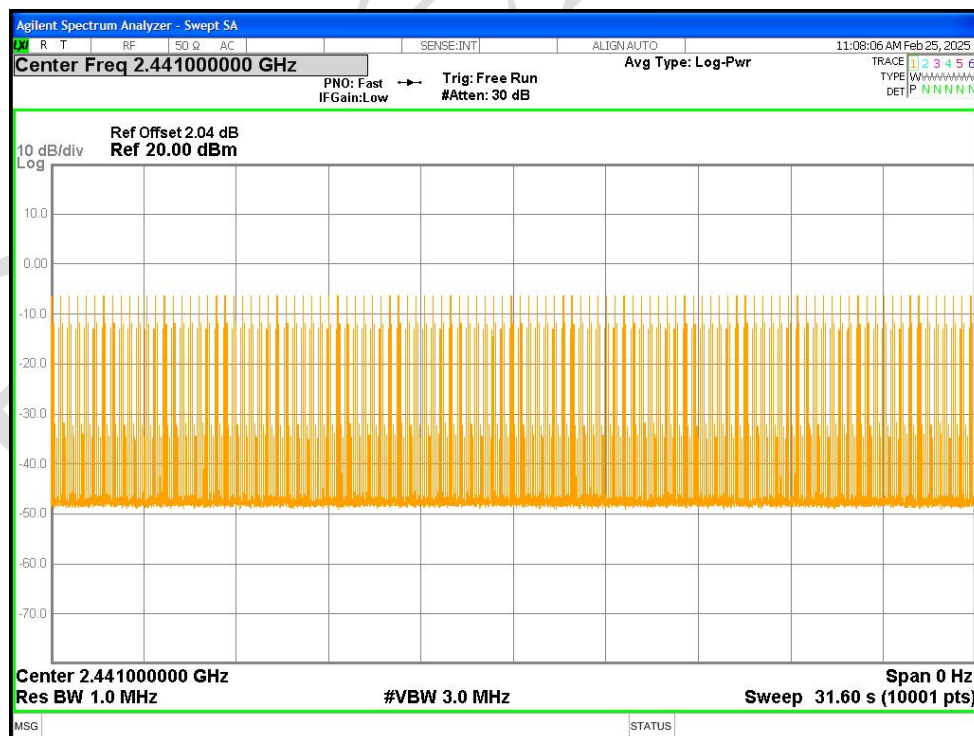
### Dwell NVNT 3-DH5 2441MHz Ant1 Accumulated

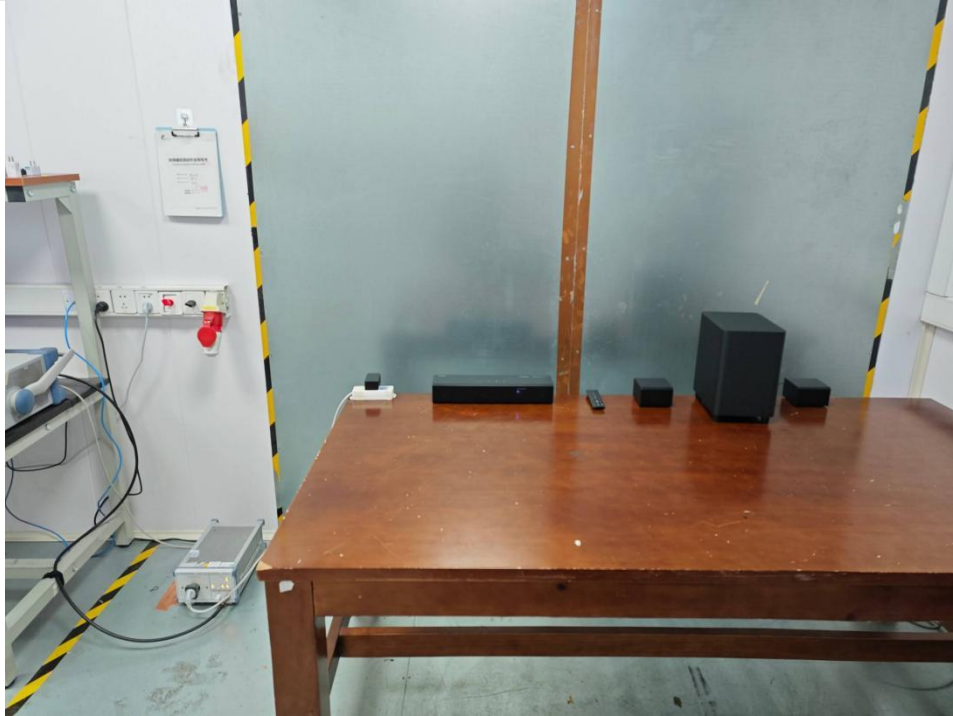
Conducted emissions at AC power line (150kHz-30MHz)

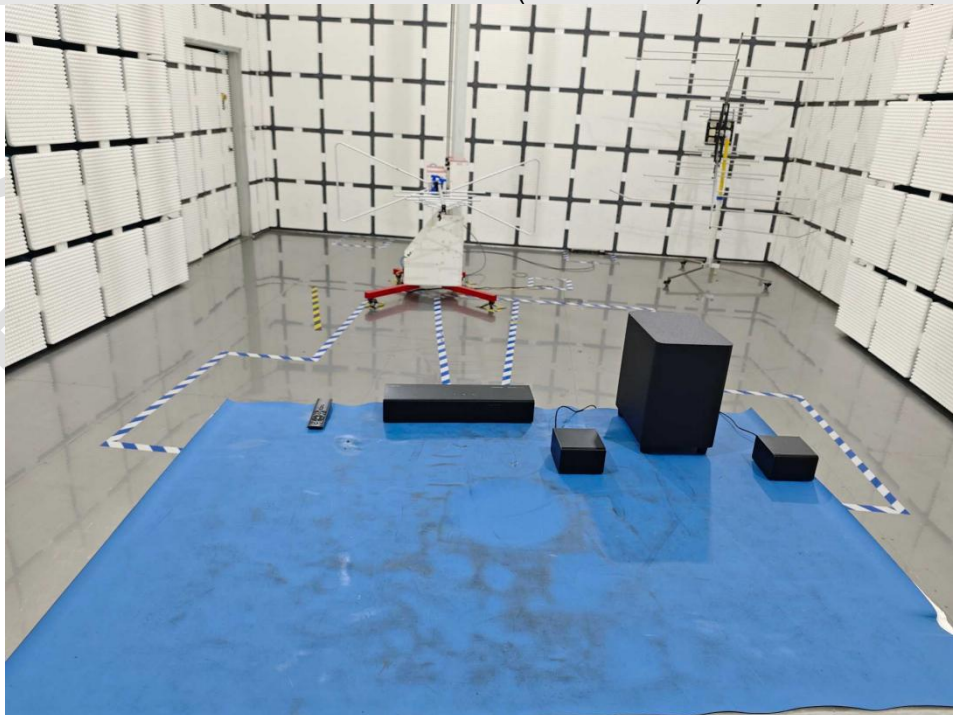
Radiated Emissions (30MHz-1GHz)

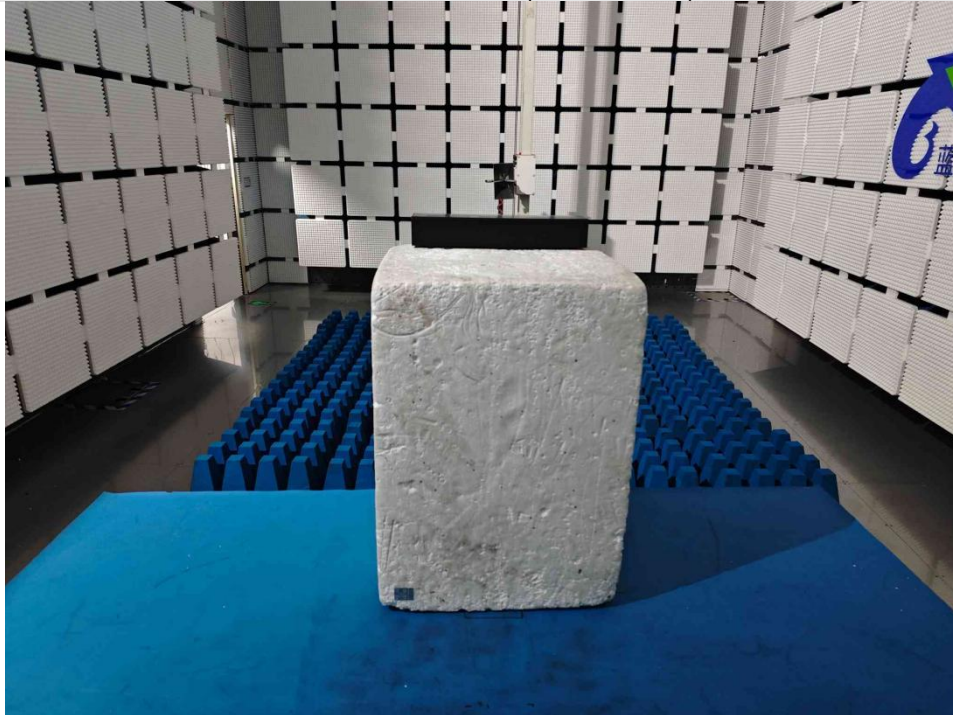
Radiated Emissions (above 1GHz)
